Site Drainage Study

Buckner Performing Arts Magnet Elementary School

USD # 259 Wichita, Kansas

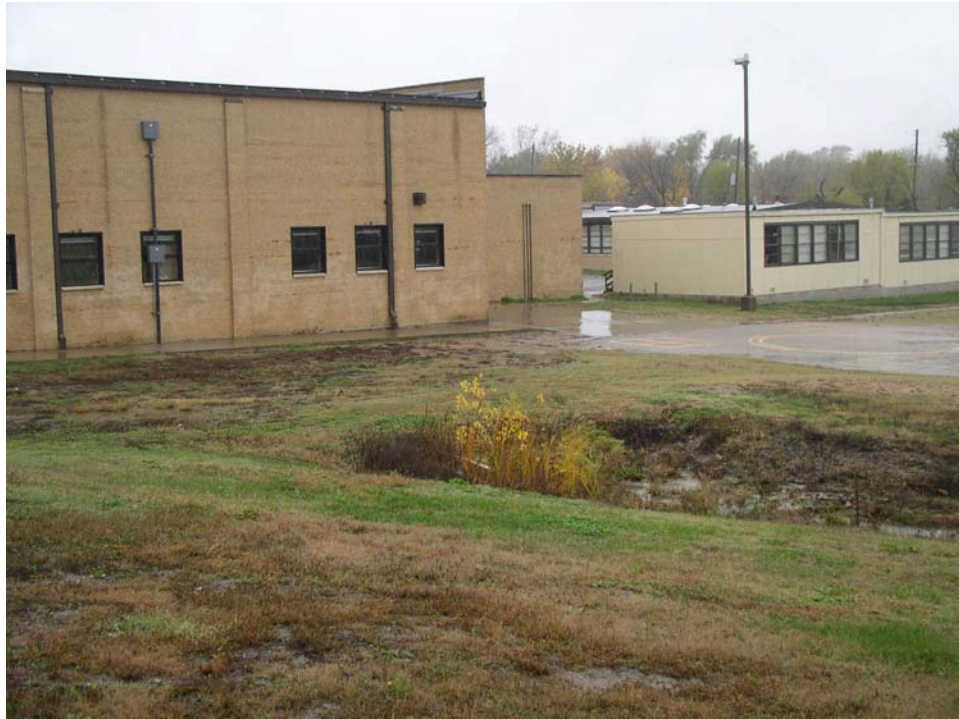
A drainage system was designed to pick up runoff from various locations around the new building addition and route it away from the building. A 15" drainage pipe from the courtyard and an 18" pipe from the south side of the building and parking converge to a headwall (Figure 1—see Appendix B for photograph locations) and outlet onto the playground. Runoff from these pipes flows through a shallow ditch to the northwest (Figure 2). Runoff continues off the school site and enters a small ditch that is a tributary to one of the branches of Chisholm Creek. Neighbors to the west have complained about increased flows from the playground.

Figure 1. Headwall.

Removal of the headwall and construction of additional underground drainage piping would reduce the amount of water running across the playground. Approximately 750 feet of drainage pipe will be necessary to convey the flow from the headwall to the northwest edge of the playground. A 12" pipe will convey the 2-year design storm or an 18" pipe will convey the 100-year design storm. If inlets are installed, portions of the playground could be graded to the inlets for better drainage. Any excess dirt should be used to construct a berm along the west edge of the site to force the drainage north rather than through neighbors' yards.

- Construct additional underground drainage
- Grading in the playground
- Construct a berm to block drainage to neighbors

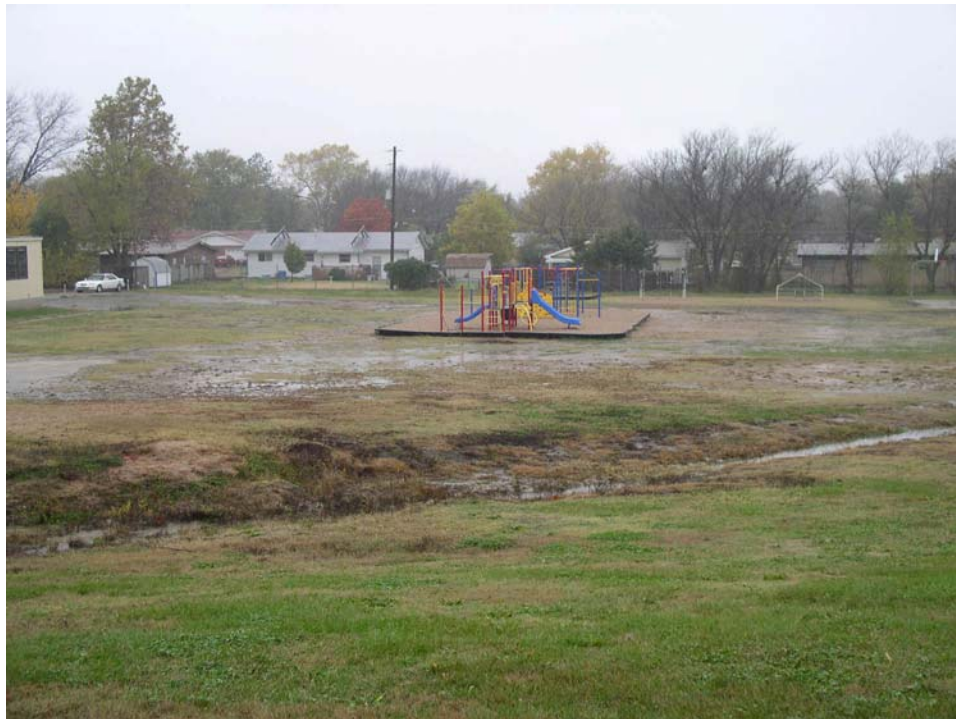
Figure 2. Water flowing across the playground.

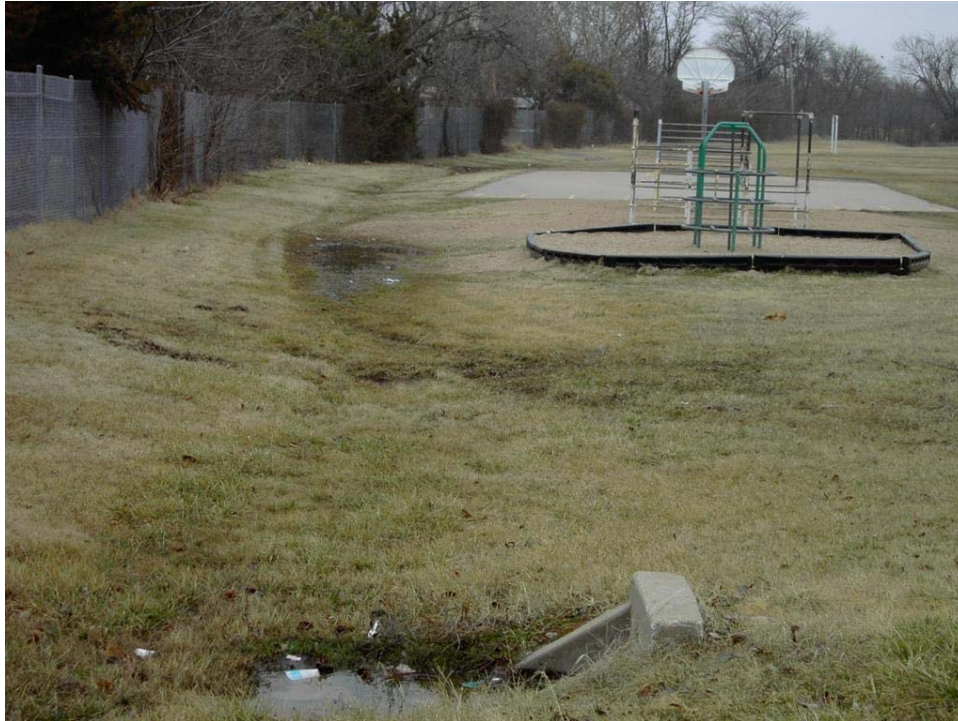
Figure 3. Swale along west property line.

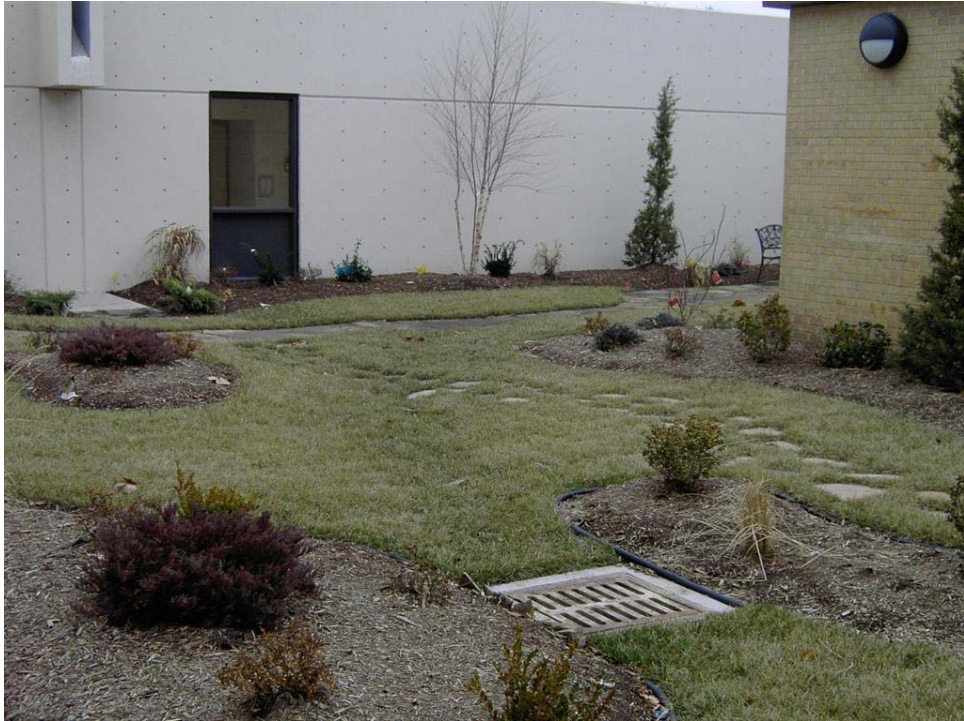
A courtyard was created by the addition to the building. The courtyard is surrounded on all sides by the building and an enclosed walkway. The courtyard is susceptible to rainfall and runoff from the roof. An inlet was placed in the courtyard to drain the area (Figure 4). The relatively flat grades of both the courtyard area and concrete landings at the doors prevents water from reaching the inlet. During rainfall events this area collects standing water which allows seepage under doors and a window, then into the building.

Figure 4. Inlet in the courtyard.

Lowering the inlet top and re-grading the area south of the inlet will help provide positive drainage in the courtyard. If problems with water seeping under the doors persists, reconstructing the concrete landings and sidewalk will help provide fall away from the building. Tying roof drains directly into drainage inlets via underground piping would help reduce the amount of surface water.

- Lower Inlet
- Re-grade
- Reconstruct concrete landings and sidewalk to provide fall away from the building
- Tie roof drains into underground pipe system

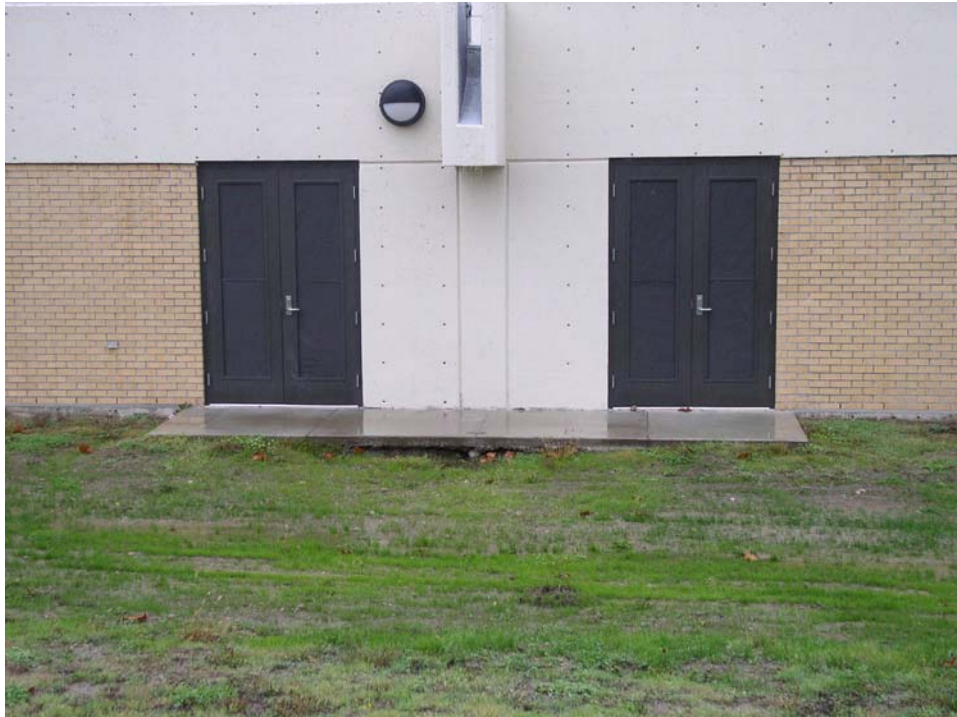
There are two sets of exterior doors with flat concrete pads along the south side of the building (Figures 5 & 6). A drainage inlet has been constructed to carry runoff away from the building and to the playground. Water drains from the roof through scuppers and onto concrete pads (Figure 7). This area stands in water after a rain event (Figures 8 & 9). Water stands on flat landings at doors and seeps through thresholds and into the building.

Figure 5. East door on the south side.

Lowering the inlet top and grading the surrounding area will produce positive drainage. Reconstructing concrete landings and sidewalk will provide fall away from the building. Roof drains could be tied into the underground drainage system to further reduce standing water and erosion around scuppers.

- Lower inlet top
- Re-grade
- Reconstruct concrete landings and sidewalk

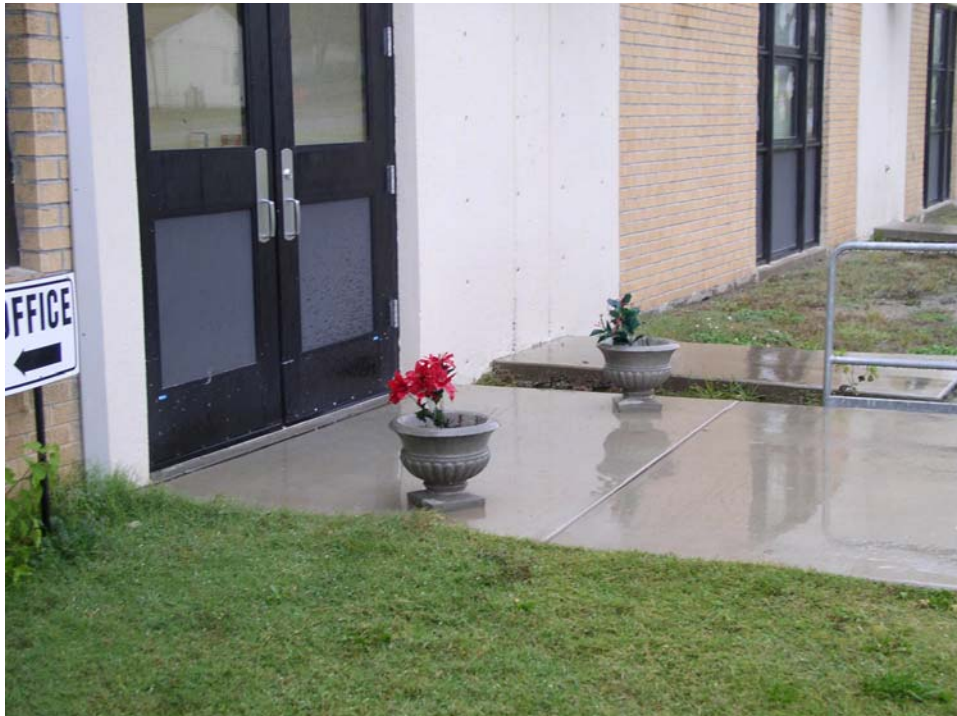
Figure 6. West door on the south side.

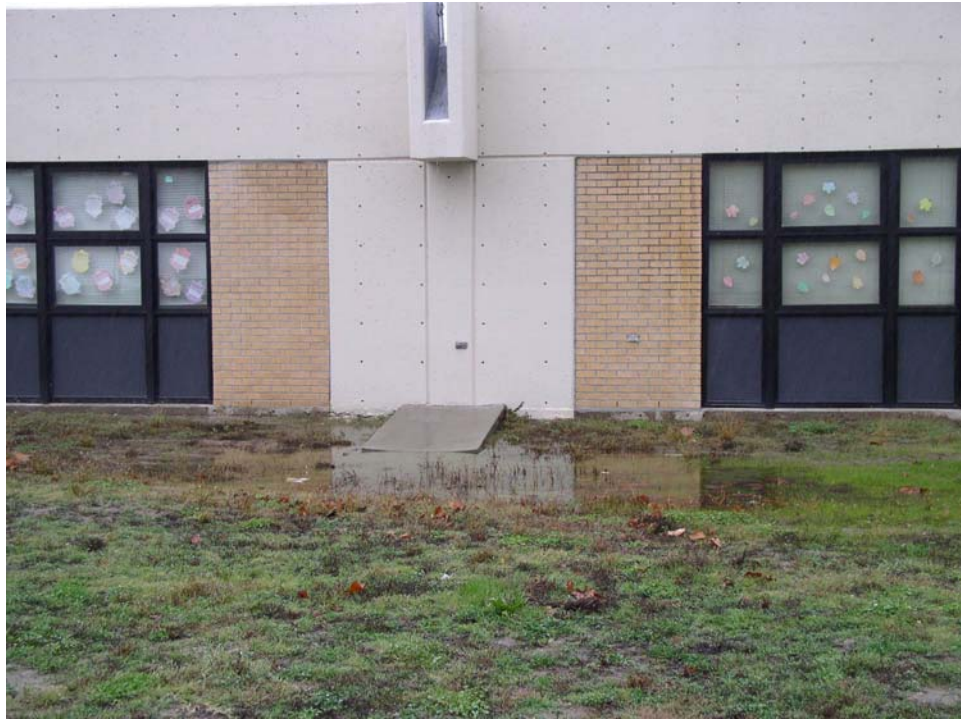
Figure 7. Scupper

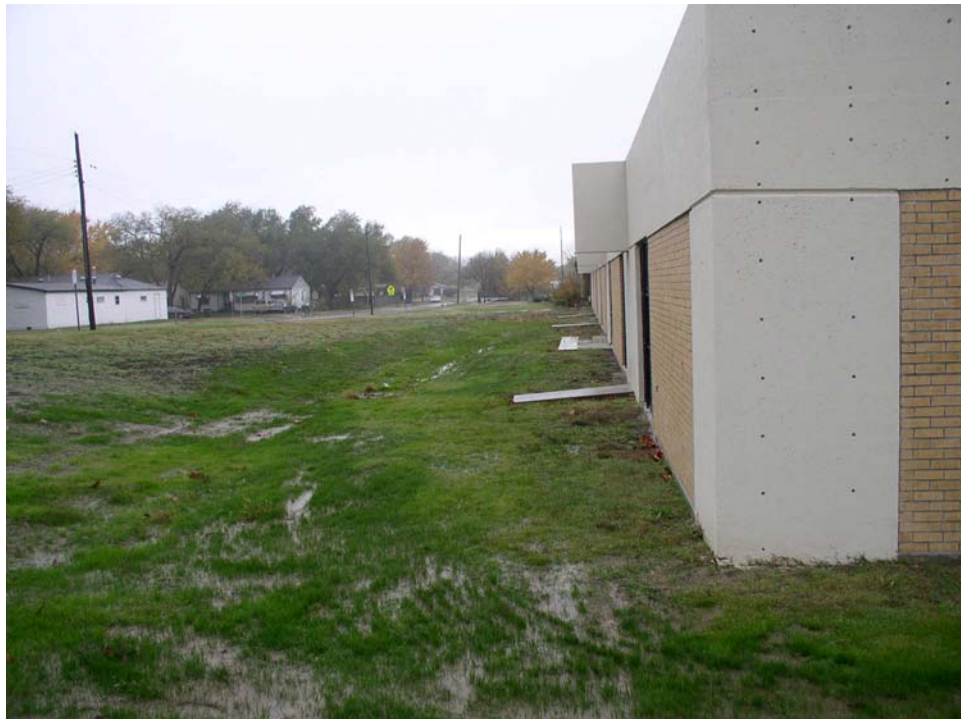
Figure 8. South side looking west.

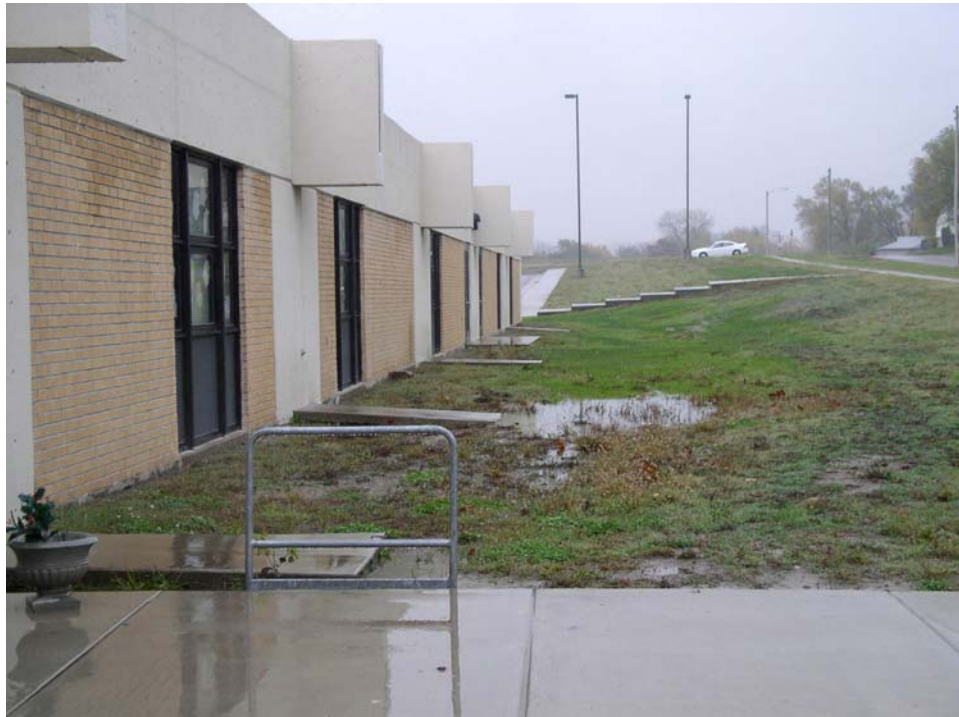
Figure 9. South side looking east.

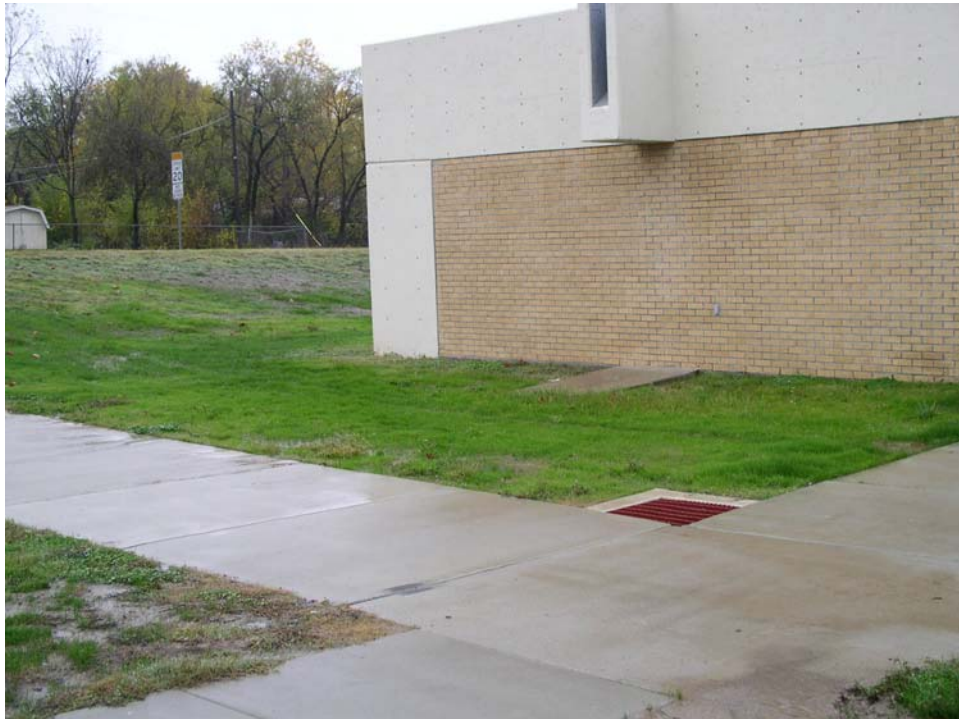
Three inlets were placed on the east side of the building to pick up runoff from the building and parking lot (Figures 10-12). Grading around the inlets does not provide positive drainage. Roof runoff drains onto concrete pads and then to the ground. Ground surrounding the concrete pads does not have positive drainage (Figure 13). Seepage occurs under an exterior door to the building that has a flat concrete landing and a scupper draining next to it (Figure 14). A concrete barrier has been constructed to direct runoff from the scupper away from the door. The barrier has reduced, but not eliminated the seepage of water under the door.

Figure 10. Inlet east of the building.

Inlets in this area could be lowered and the areas could be graded to drain to the inlets. Concrete approaches that are flat could be re-constructed to drain away from the building. Roof drains could be tied into the underground drainage system to further reduce standing water and erosion around scuppers.

- Lower one inlet top
- Re-grade areas around inlets
- Re-construct concrete approaches
- Re-grade north and east of library
- Tie roof drains nearest the library entrance into drainage system

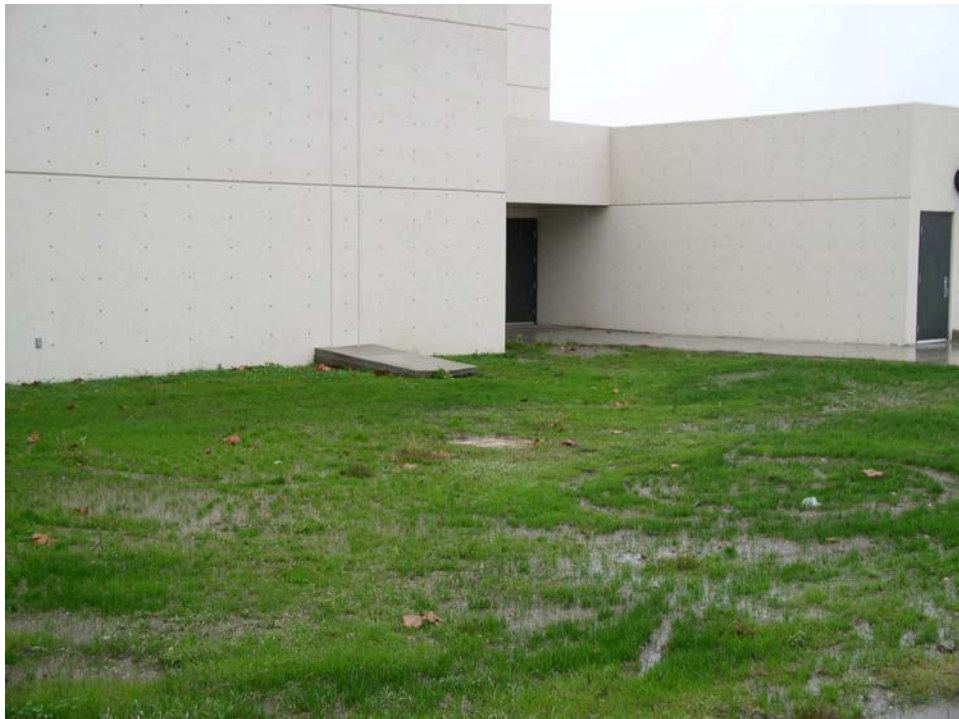
Figure 11. Inlet east of the building.

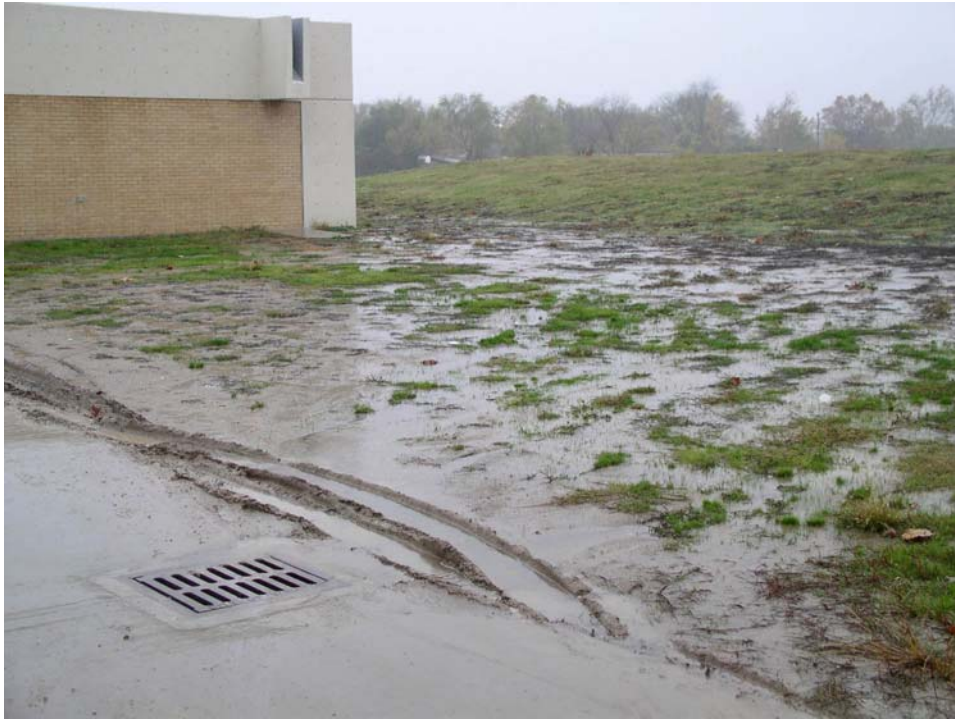
Figure 12. Inlet east of the building.

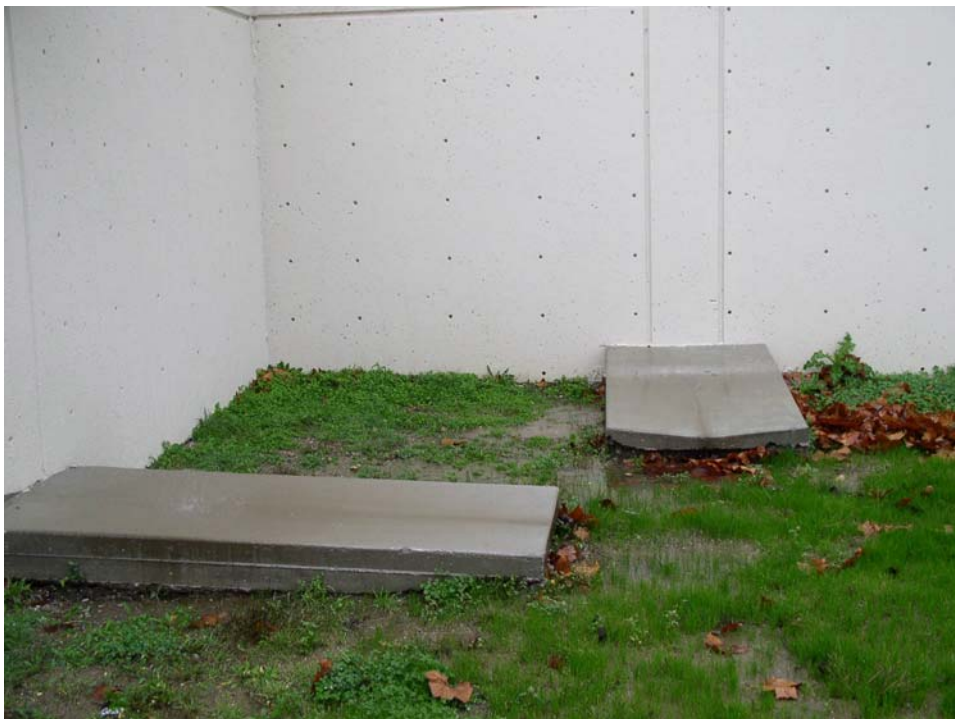
Figure 13. Scupper on east side of building.

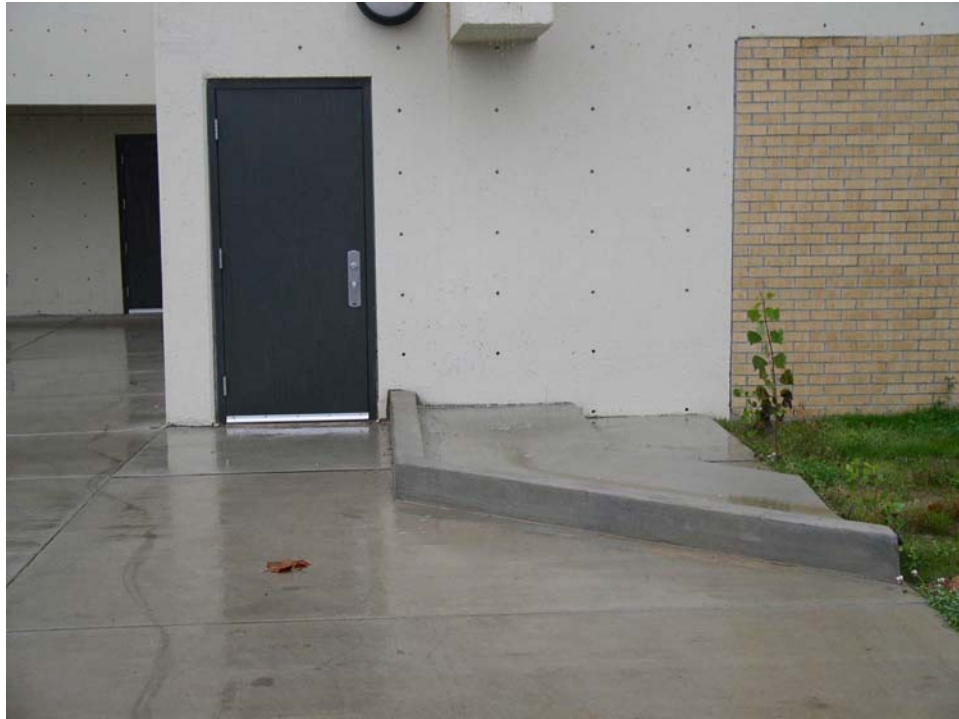
Figure 14. Door and scupper on east side of building.
