**SITE 2**

# Television Inspection Master Report

US Structure: 5447-158  
DS Structure: 5447-157

Project No. : L-011      Dia/Ht: 10      Material: VCP      Length: 155.0      Tape ID: DVD #0588

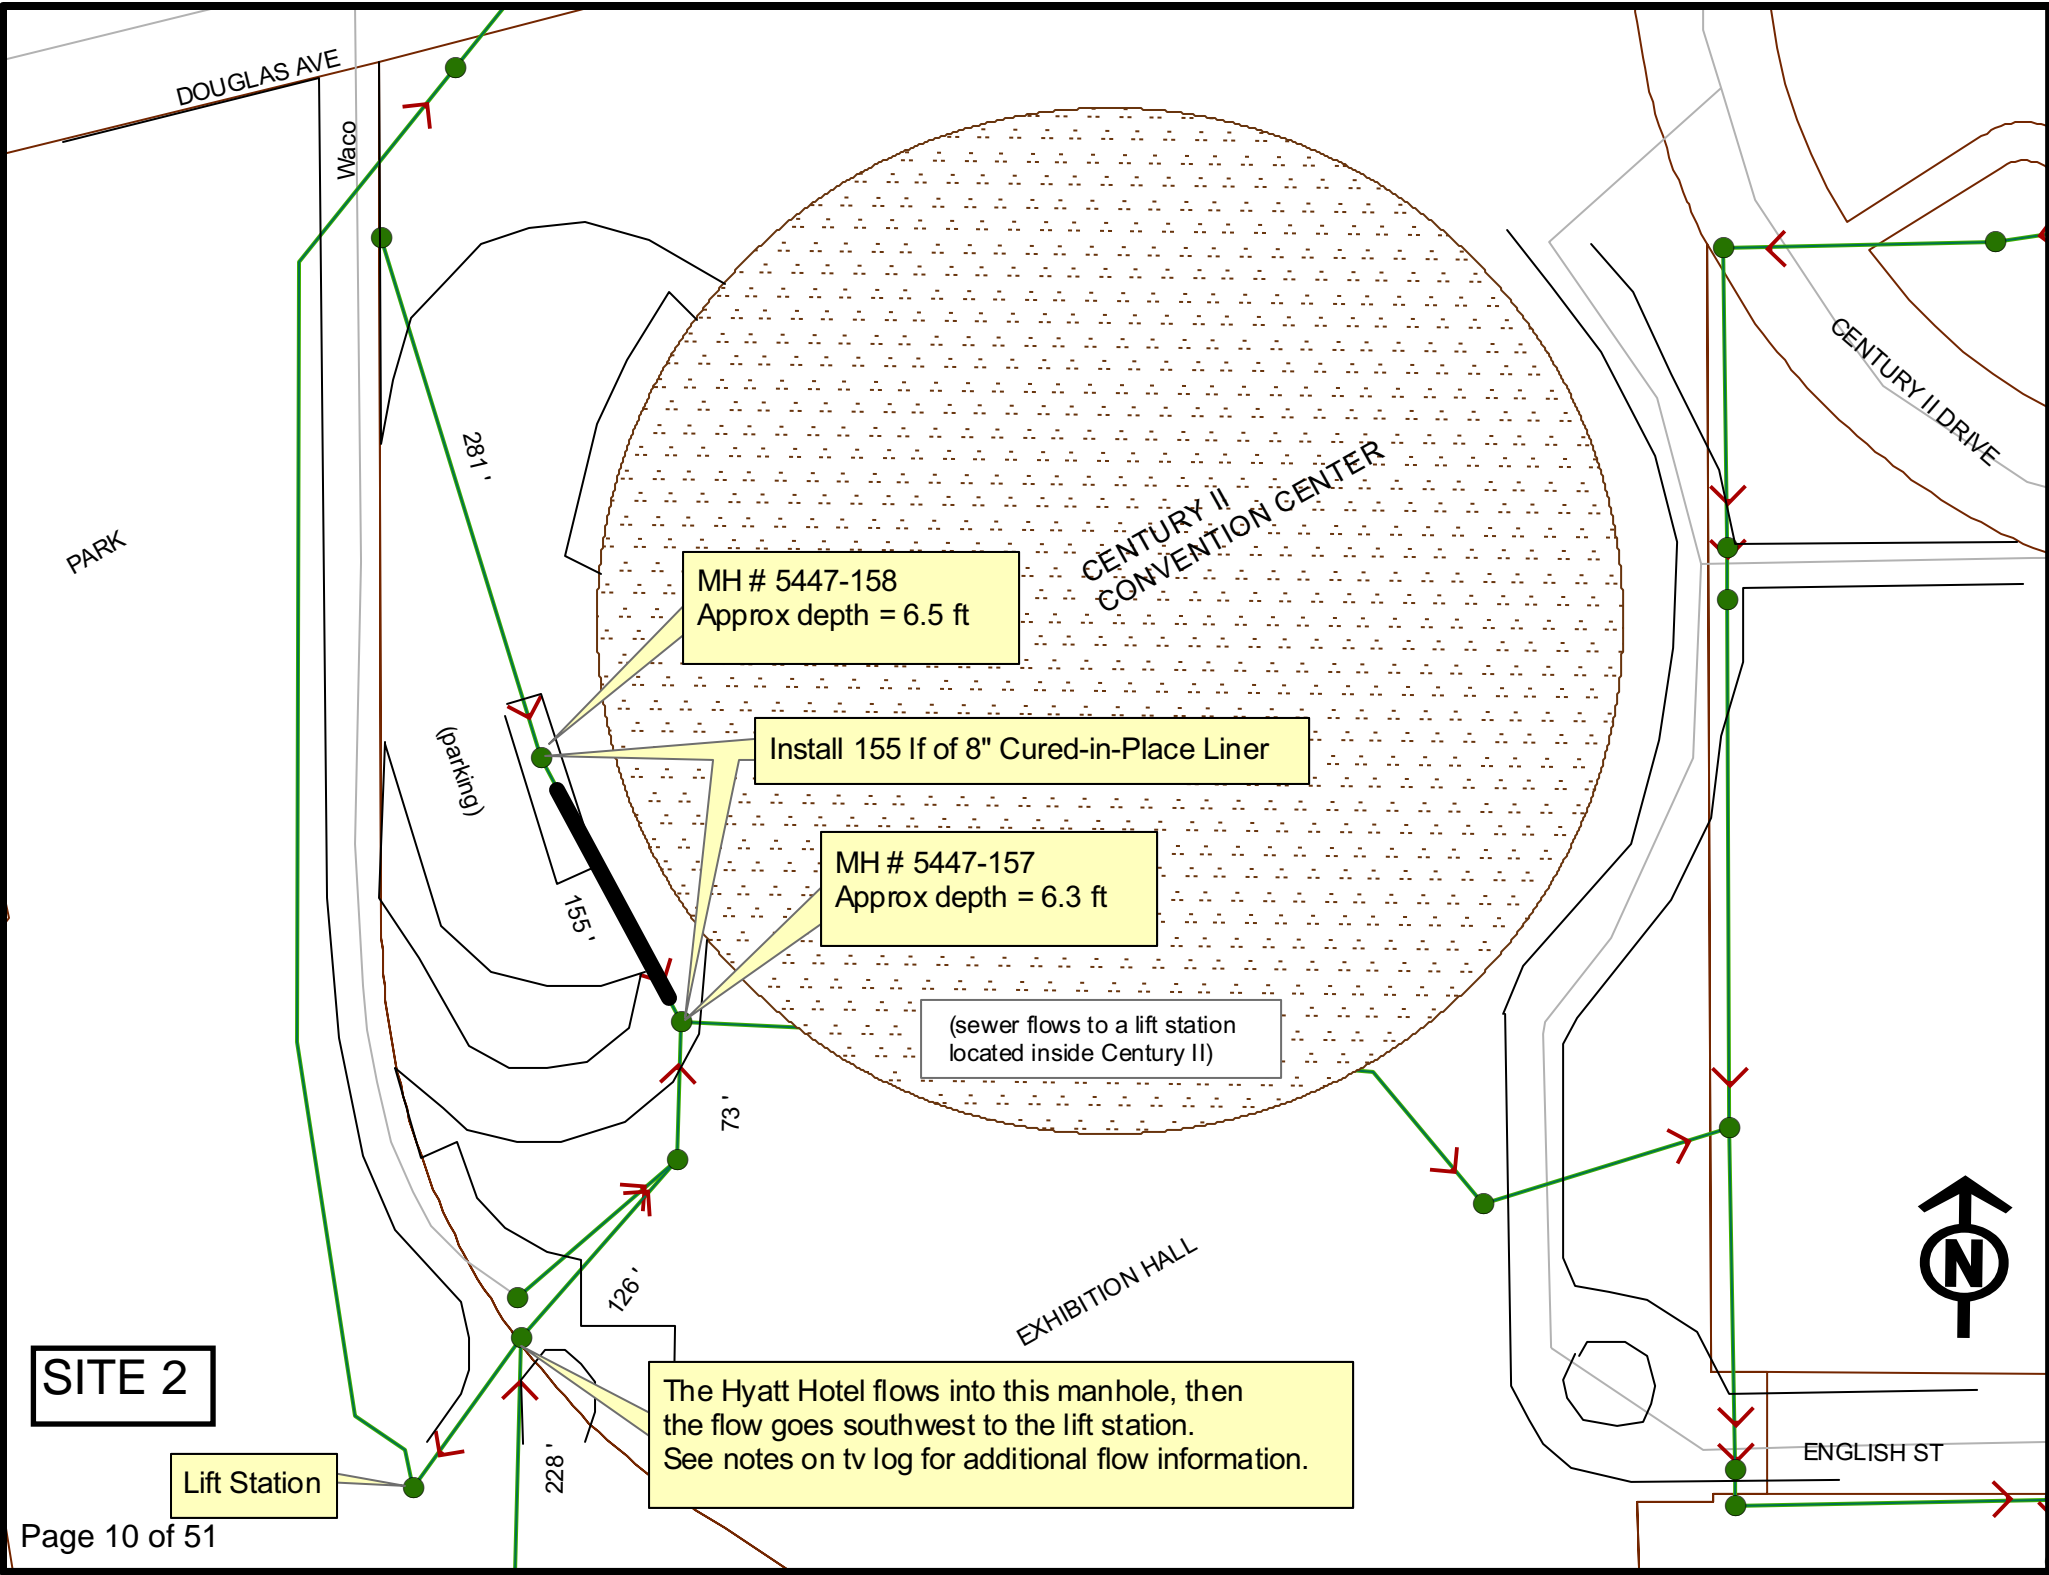
MH # 5447-158  
Approx depth = 6.5 ft

MH # 5447-157  
Approx depth = 6.3 ft

(sewer flows to a lift station located inside Century II)

The Hyatt Hotel flows into this manhole, then the flow goes southwest to the lift station. See notes on tv log for additional flow information.

Install 155 lf of 8" Cured-in-Place Liner
