SITE 1

Sheet 3 of 32

Television Inspection Master Report

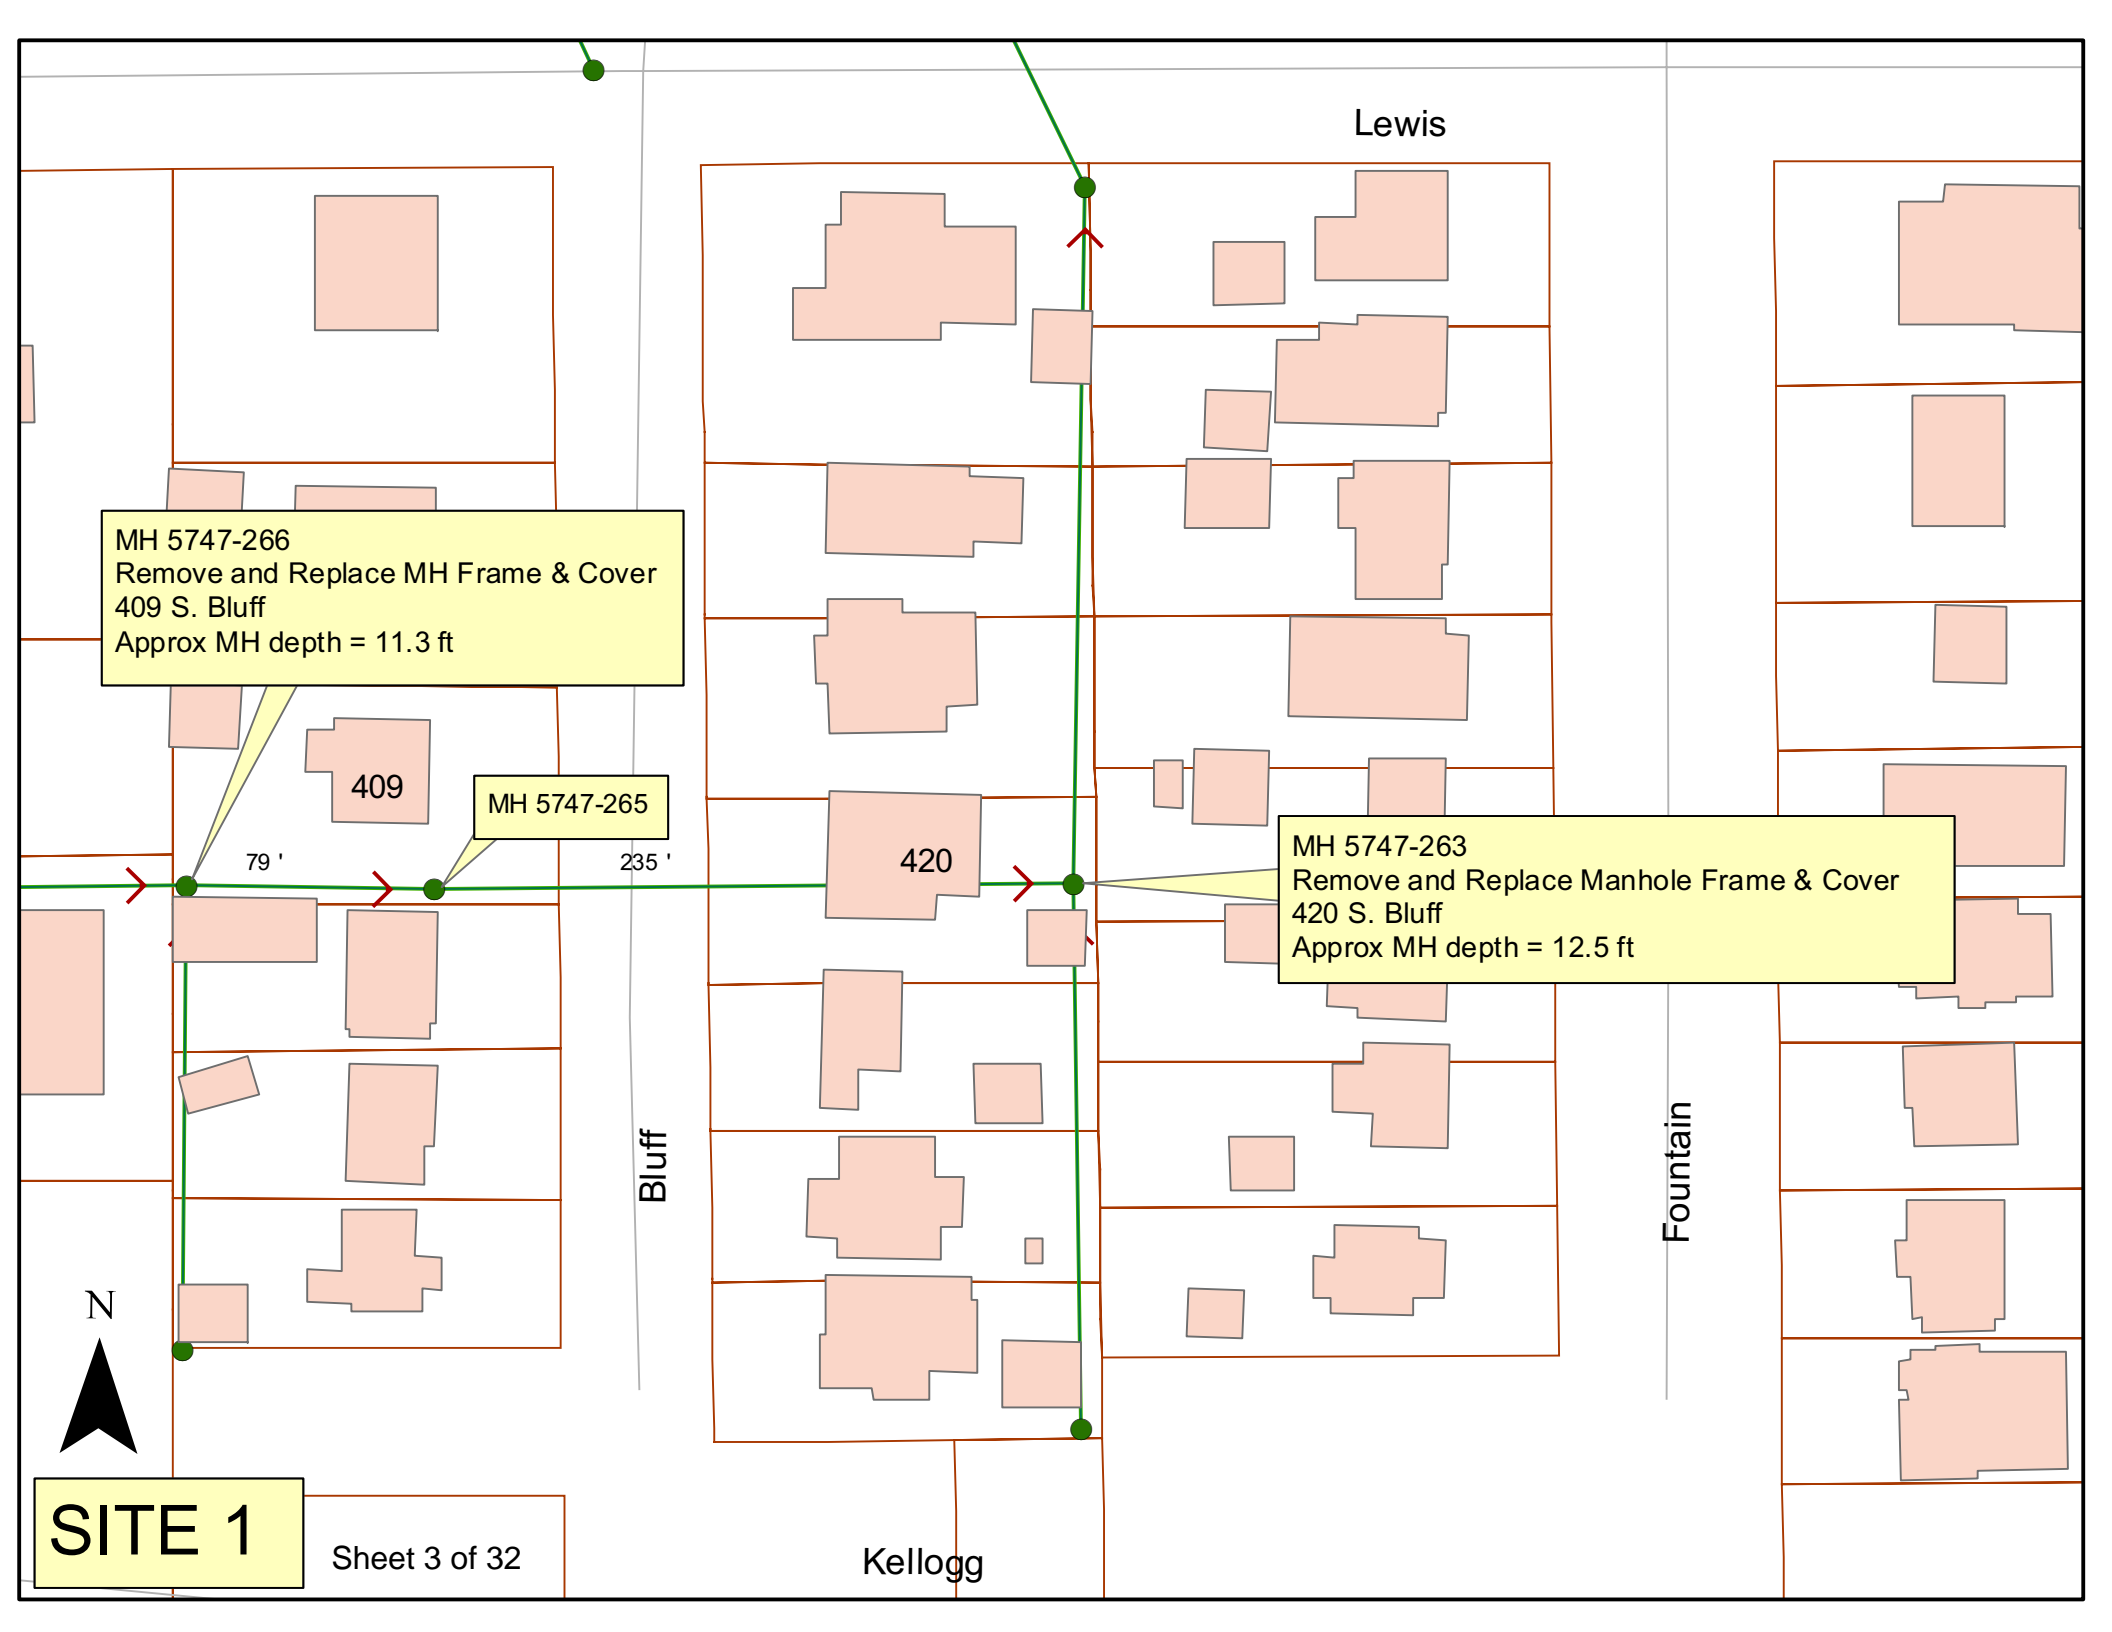
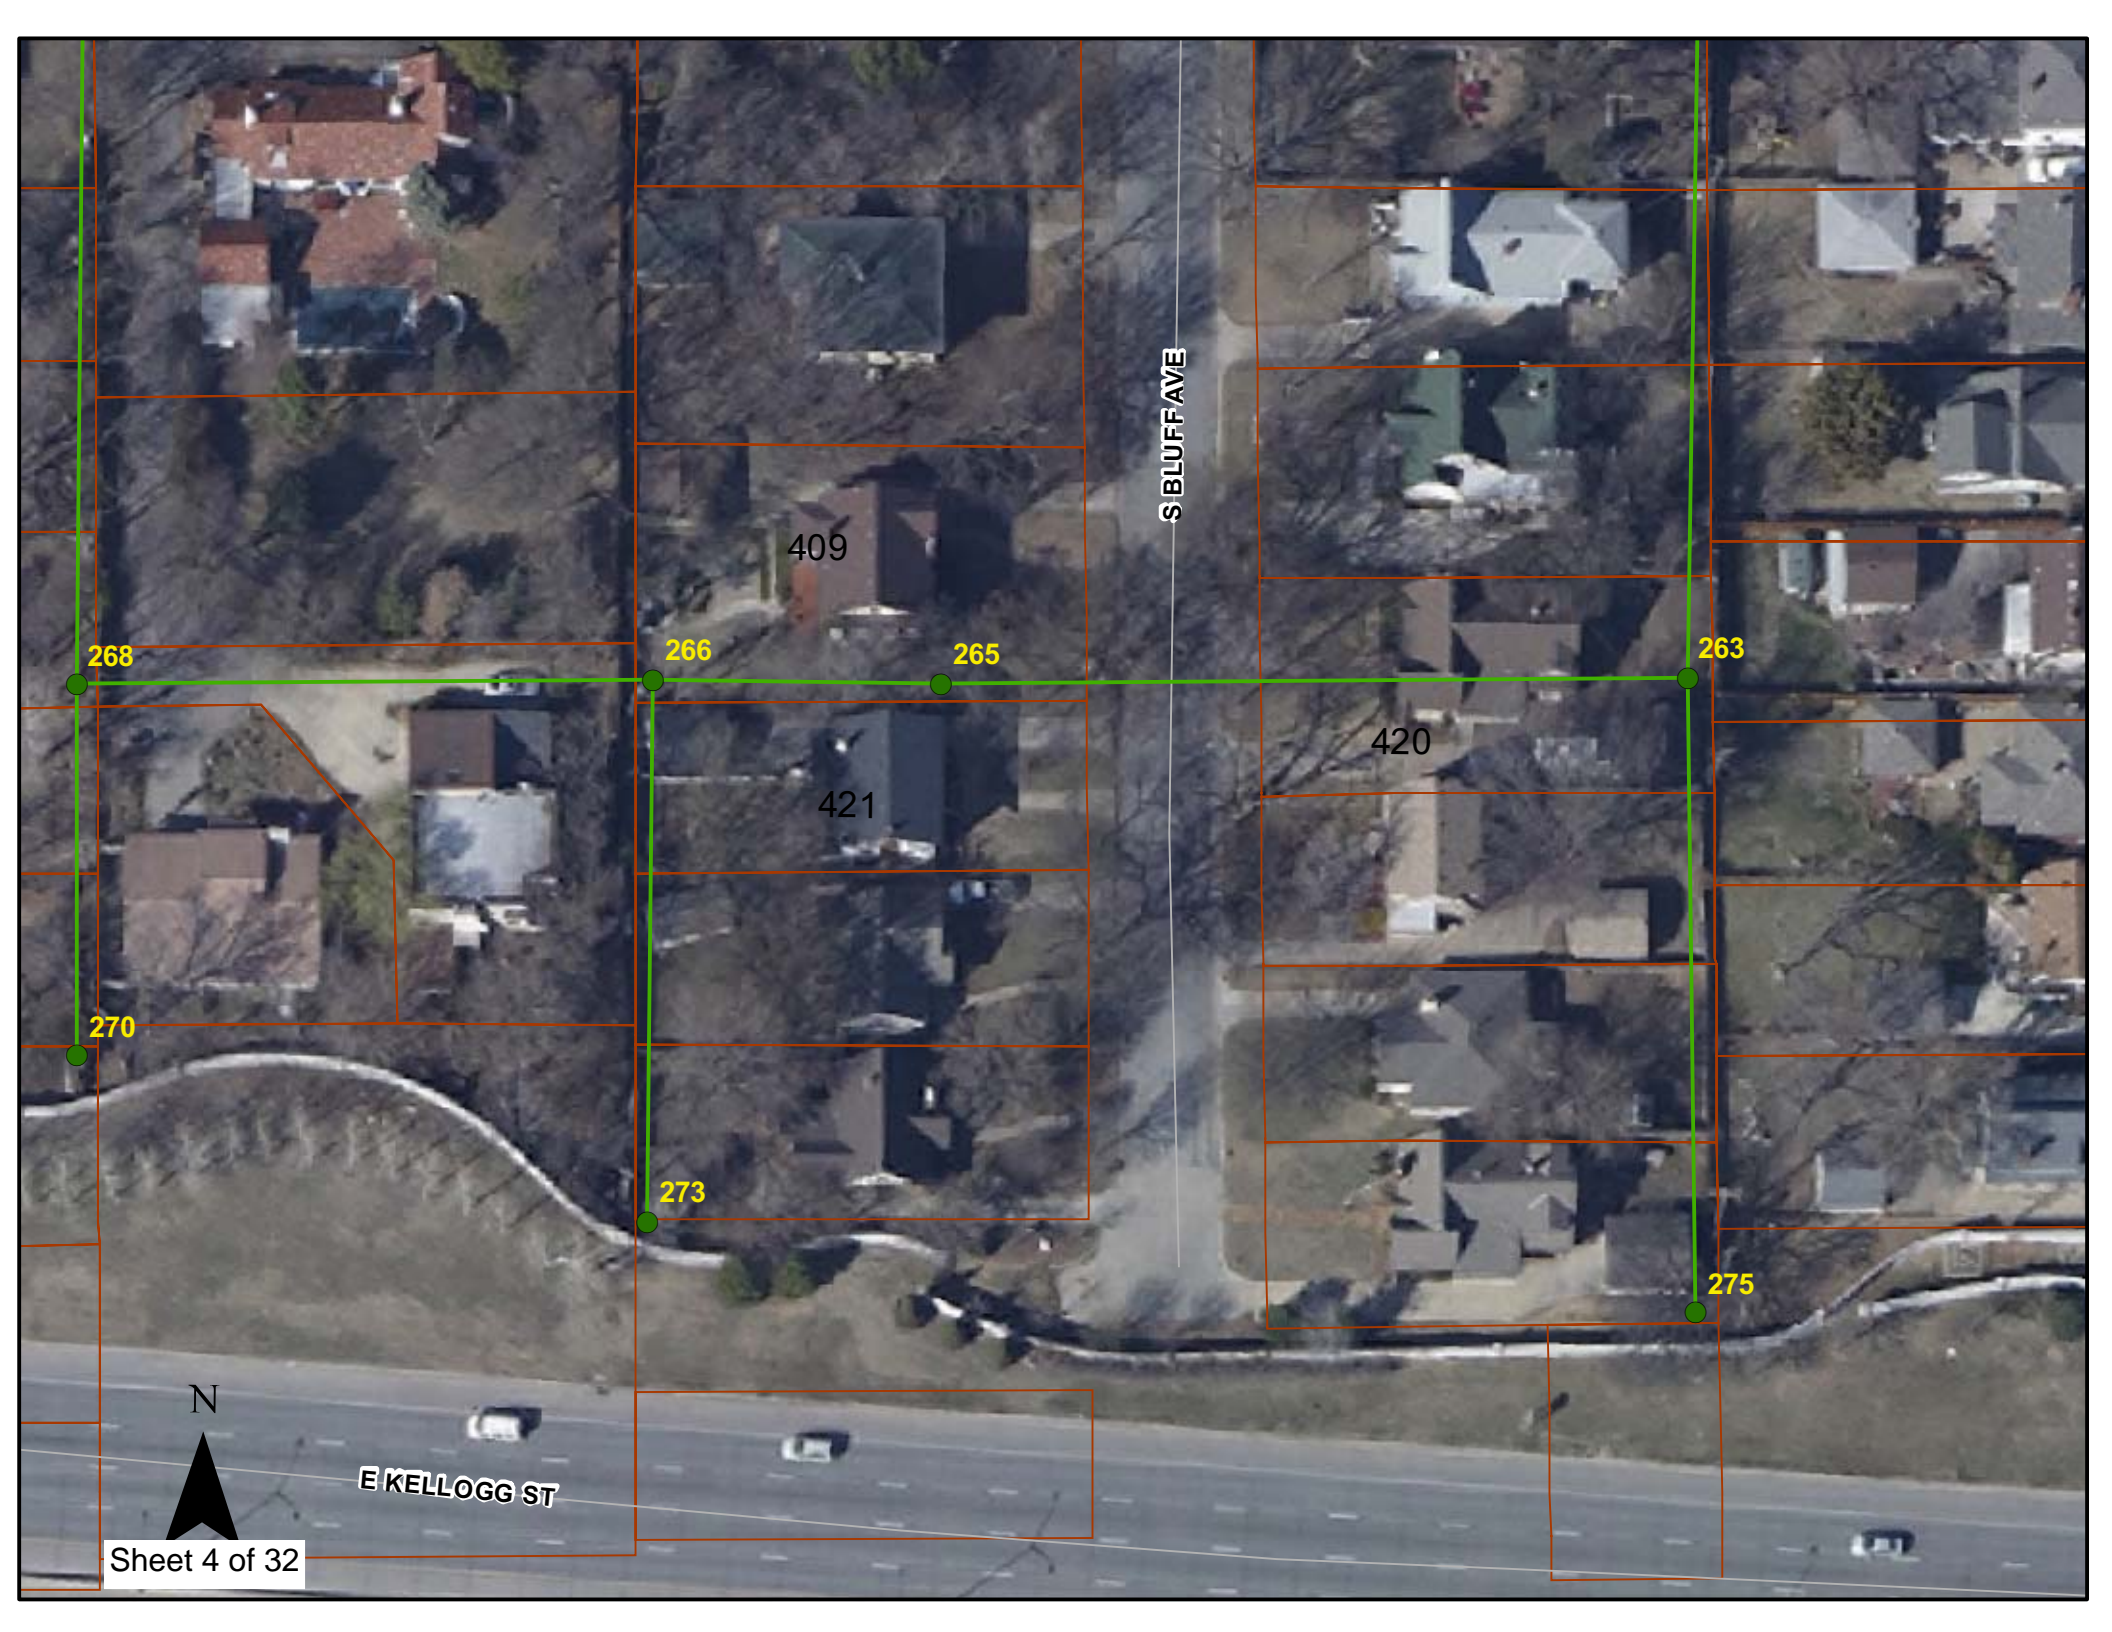
MH 5747-266
Remove and Replace MH Frame & Cover
409 S. Bluff
Approx MH depth = 11.3 ft

MH 5747-263
Remove and Replace Manhole Frame & Cover
420 S. Bluff
Approx MH depth = 12.5 ft

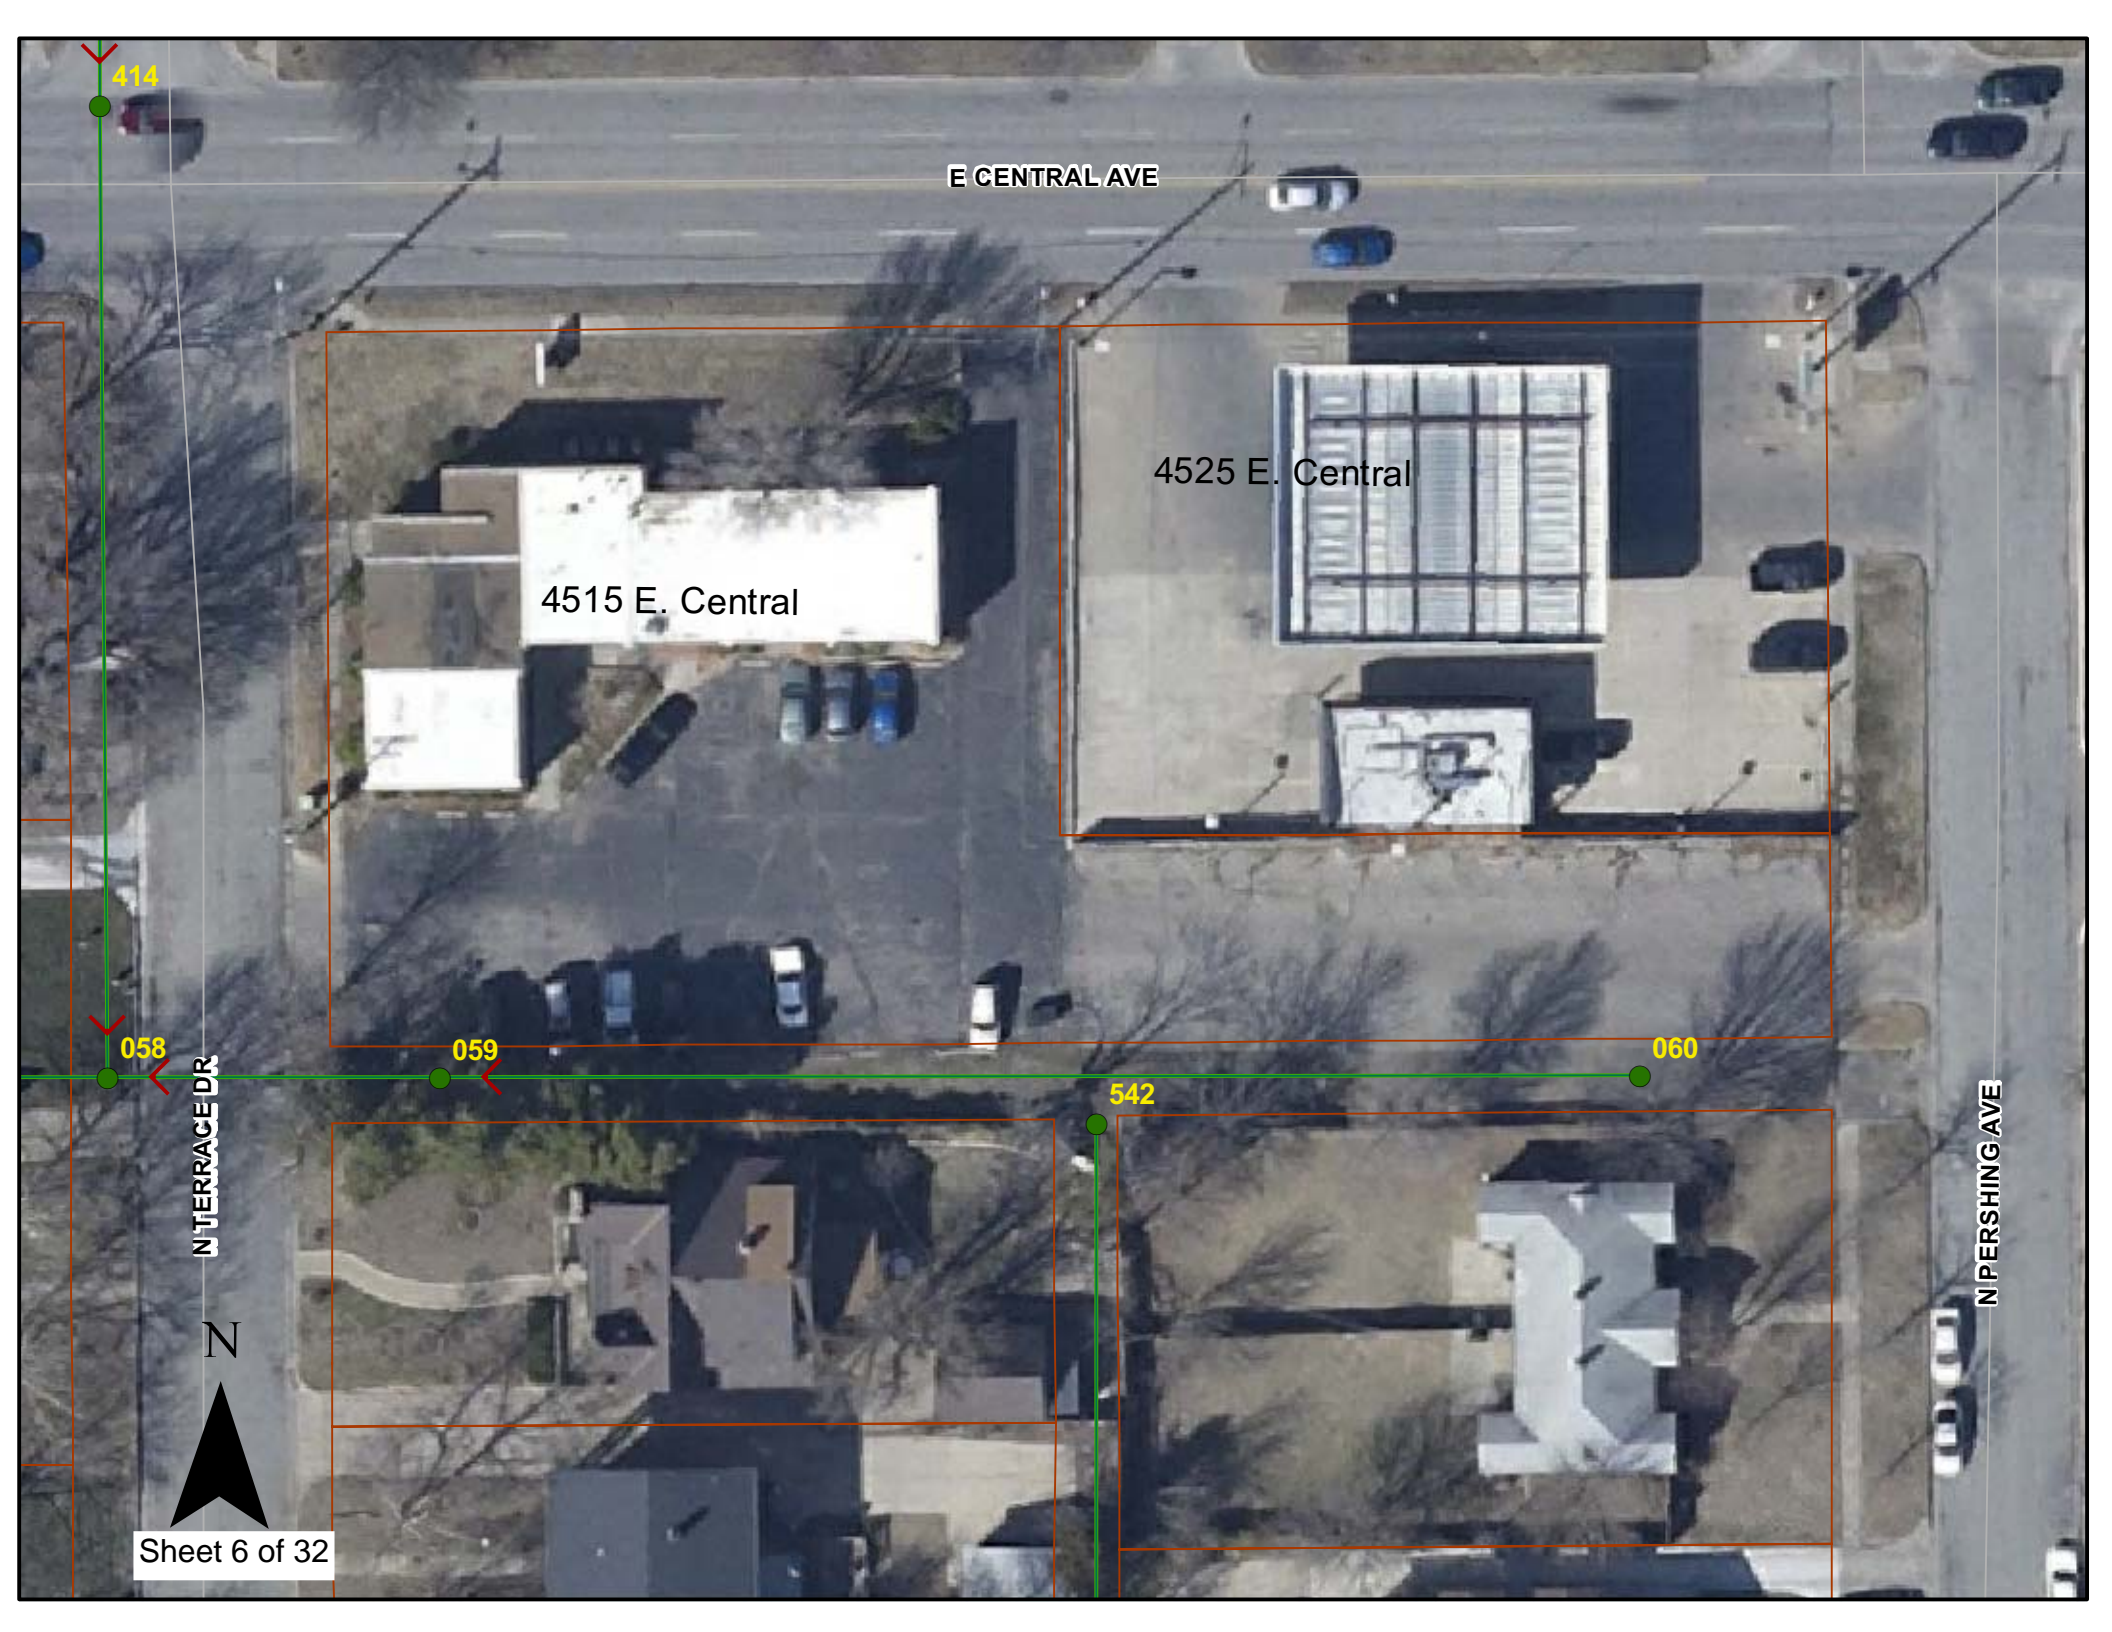
SITE 2

MH 5747-059
Adjust Manhole to Grade (6" to 12")
(includes new manhole frame & cover)
Approx MH depth = 12.0 ft

MH 5747-060
Remove and Replace
Manhole Frame & Cover
Approx MH depth = 8.8 ft

Remove 236 lf of 8" Pipe
Install 236 lf of 8" Pipe

Remove approx. 80 lf of asphalt (remove asphalt for the width of the alley, and only for the length necessary for pipe replacement and manhole work. Restore the disturbed area with seeding. Costs shall be subsidiary to Site Clearing and Site Restoration.

Estimated 30 lf of Silt Fence
Estimated 3 Service Reconnections (4")
Estimated 1 Service Reconnection (6")

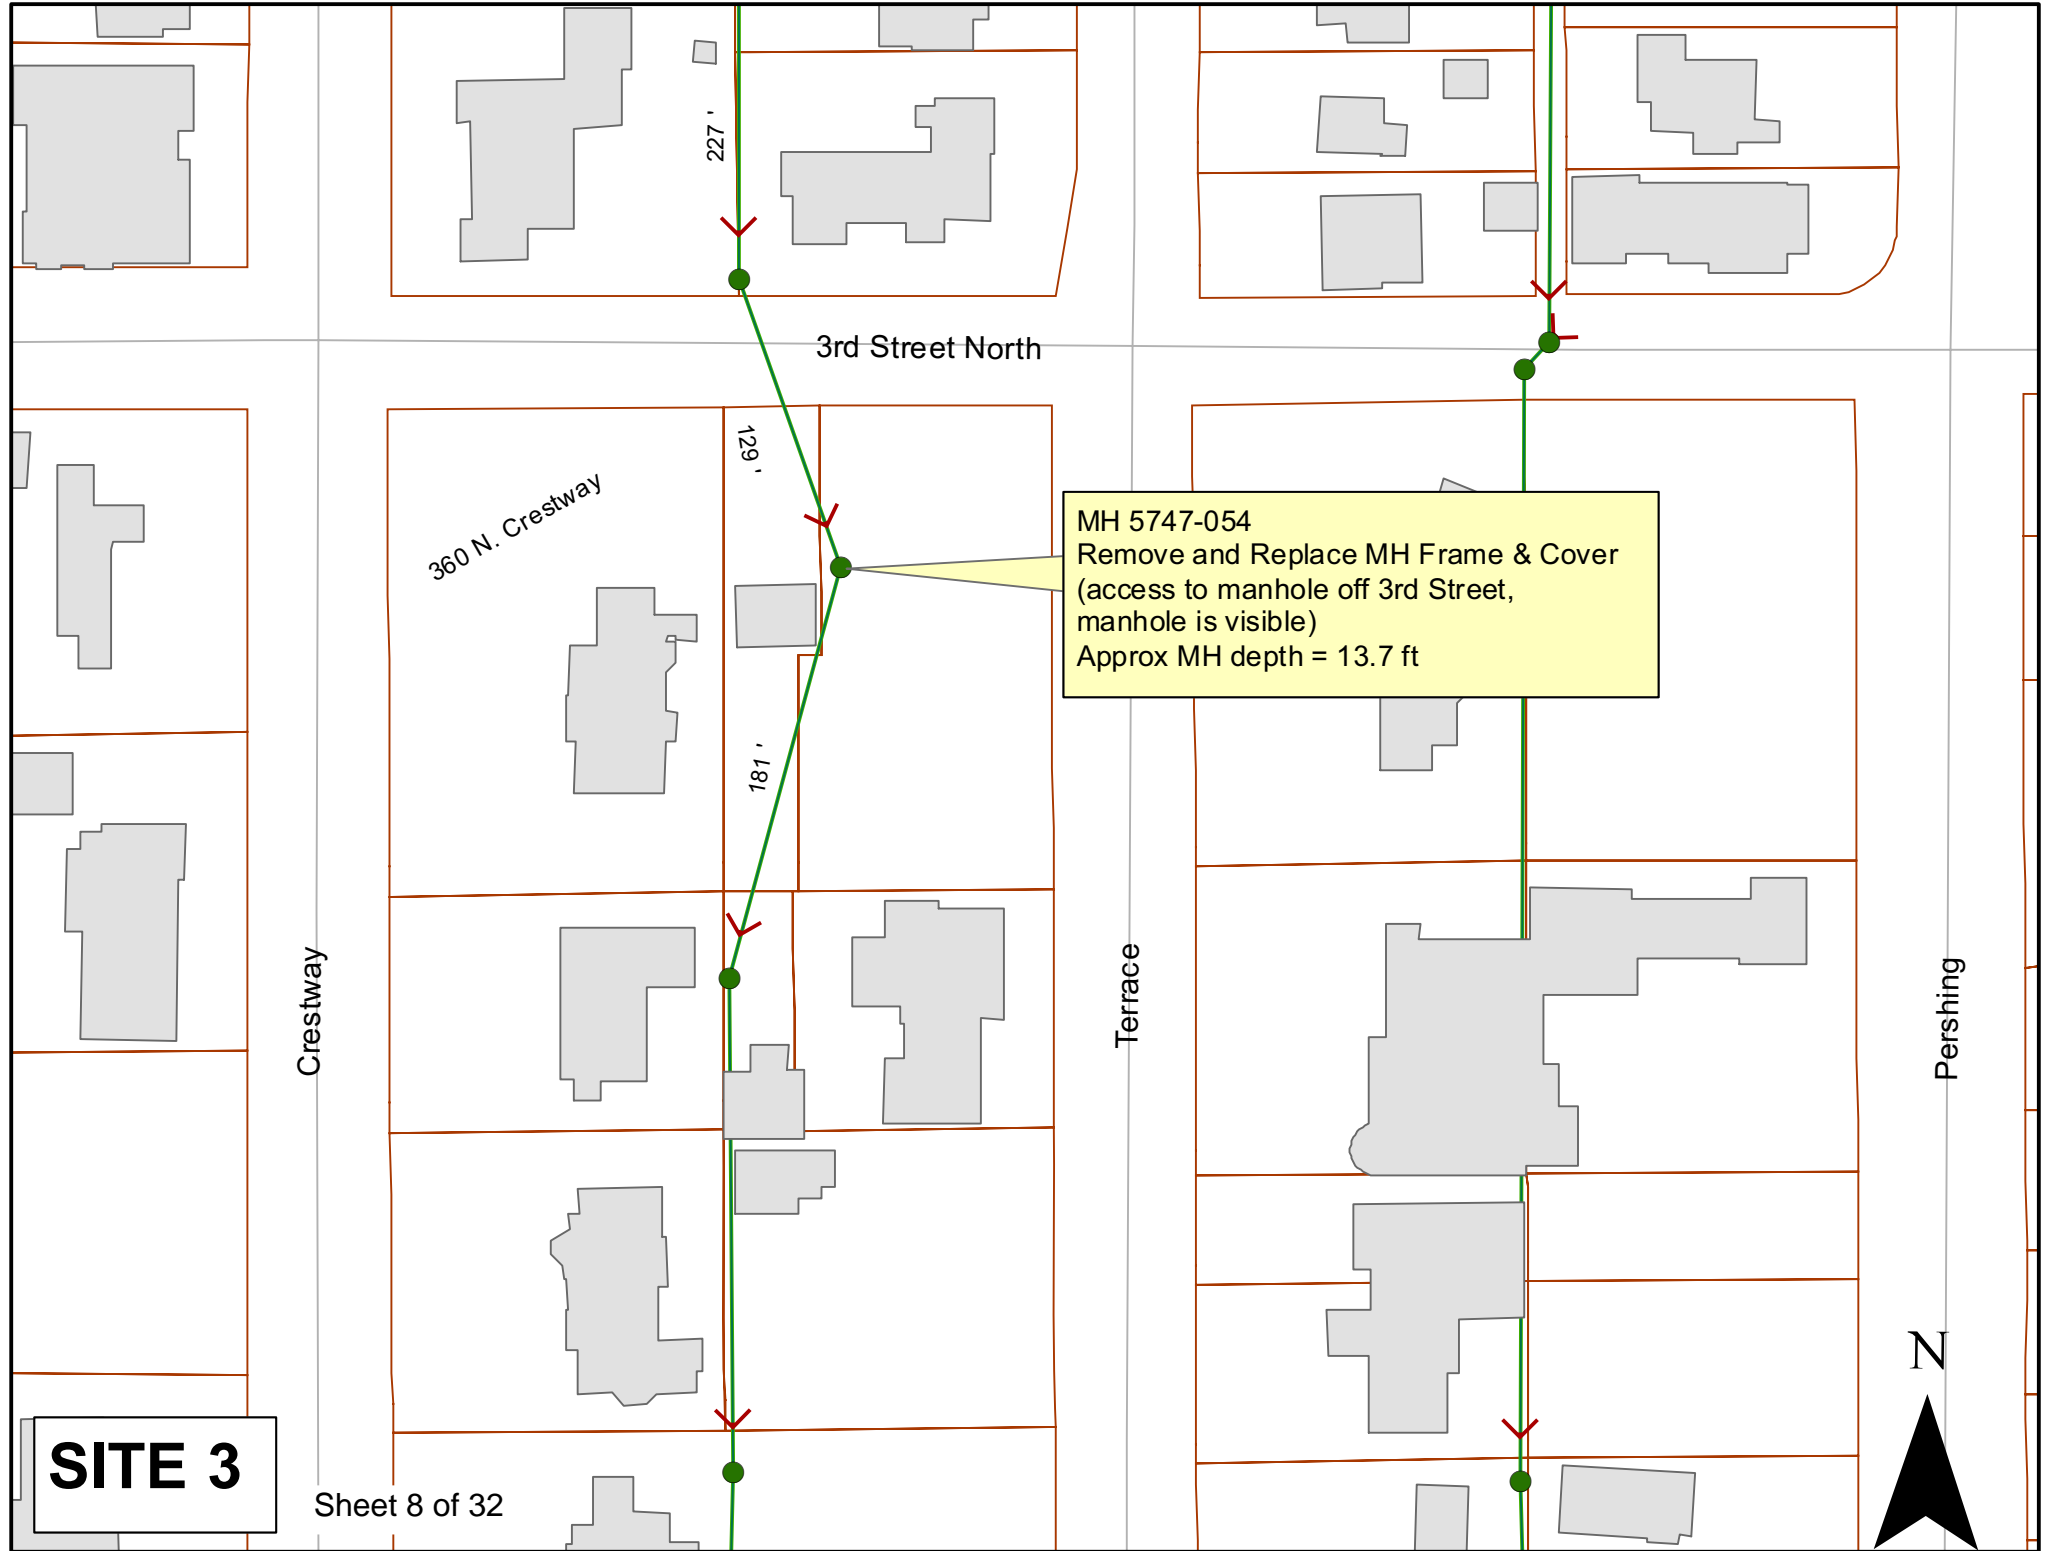
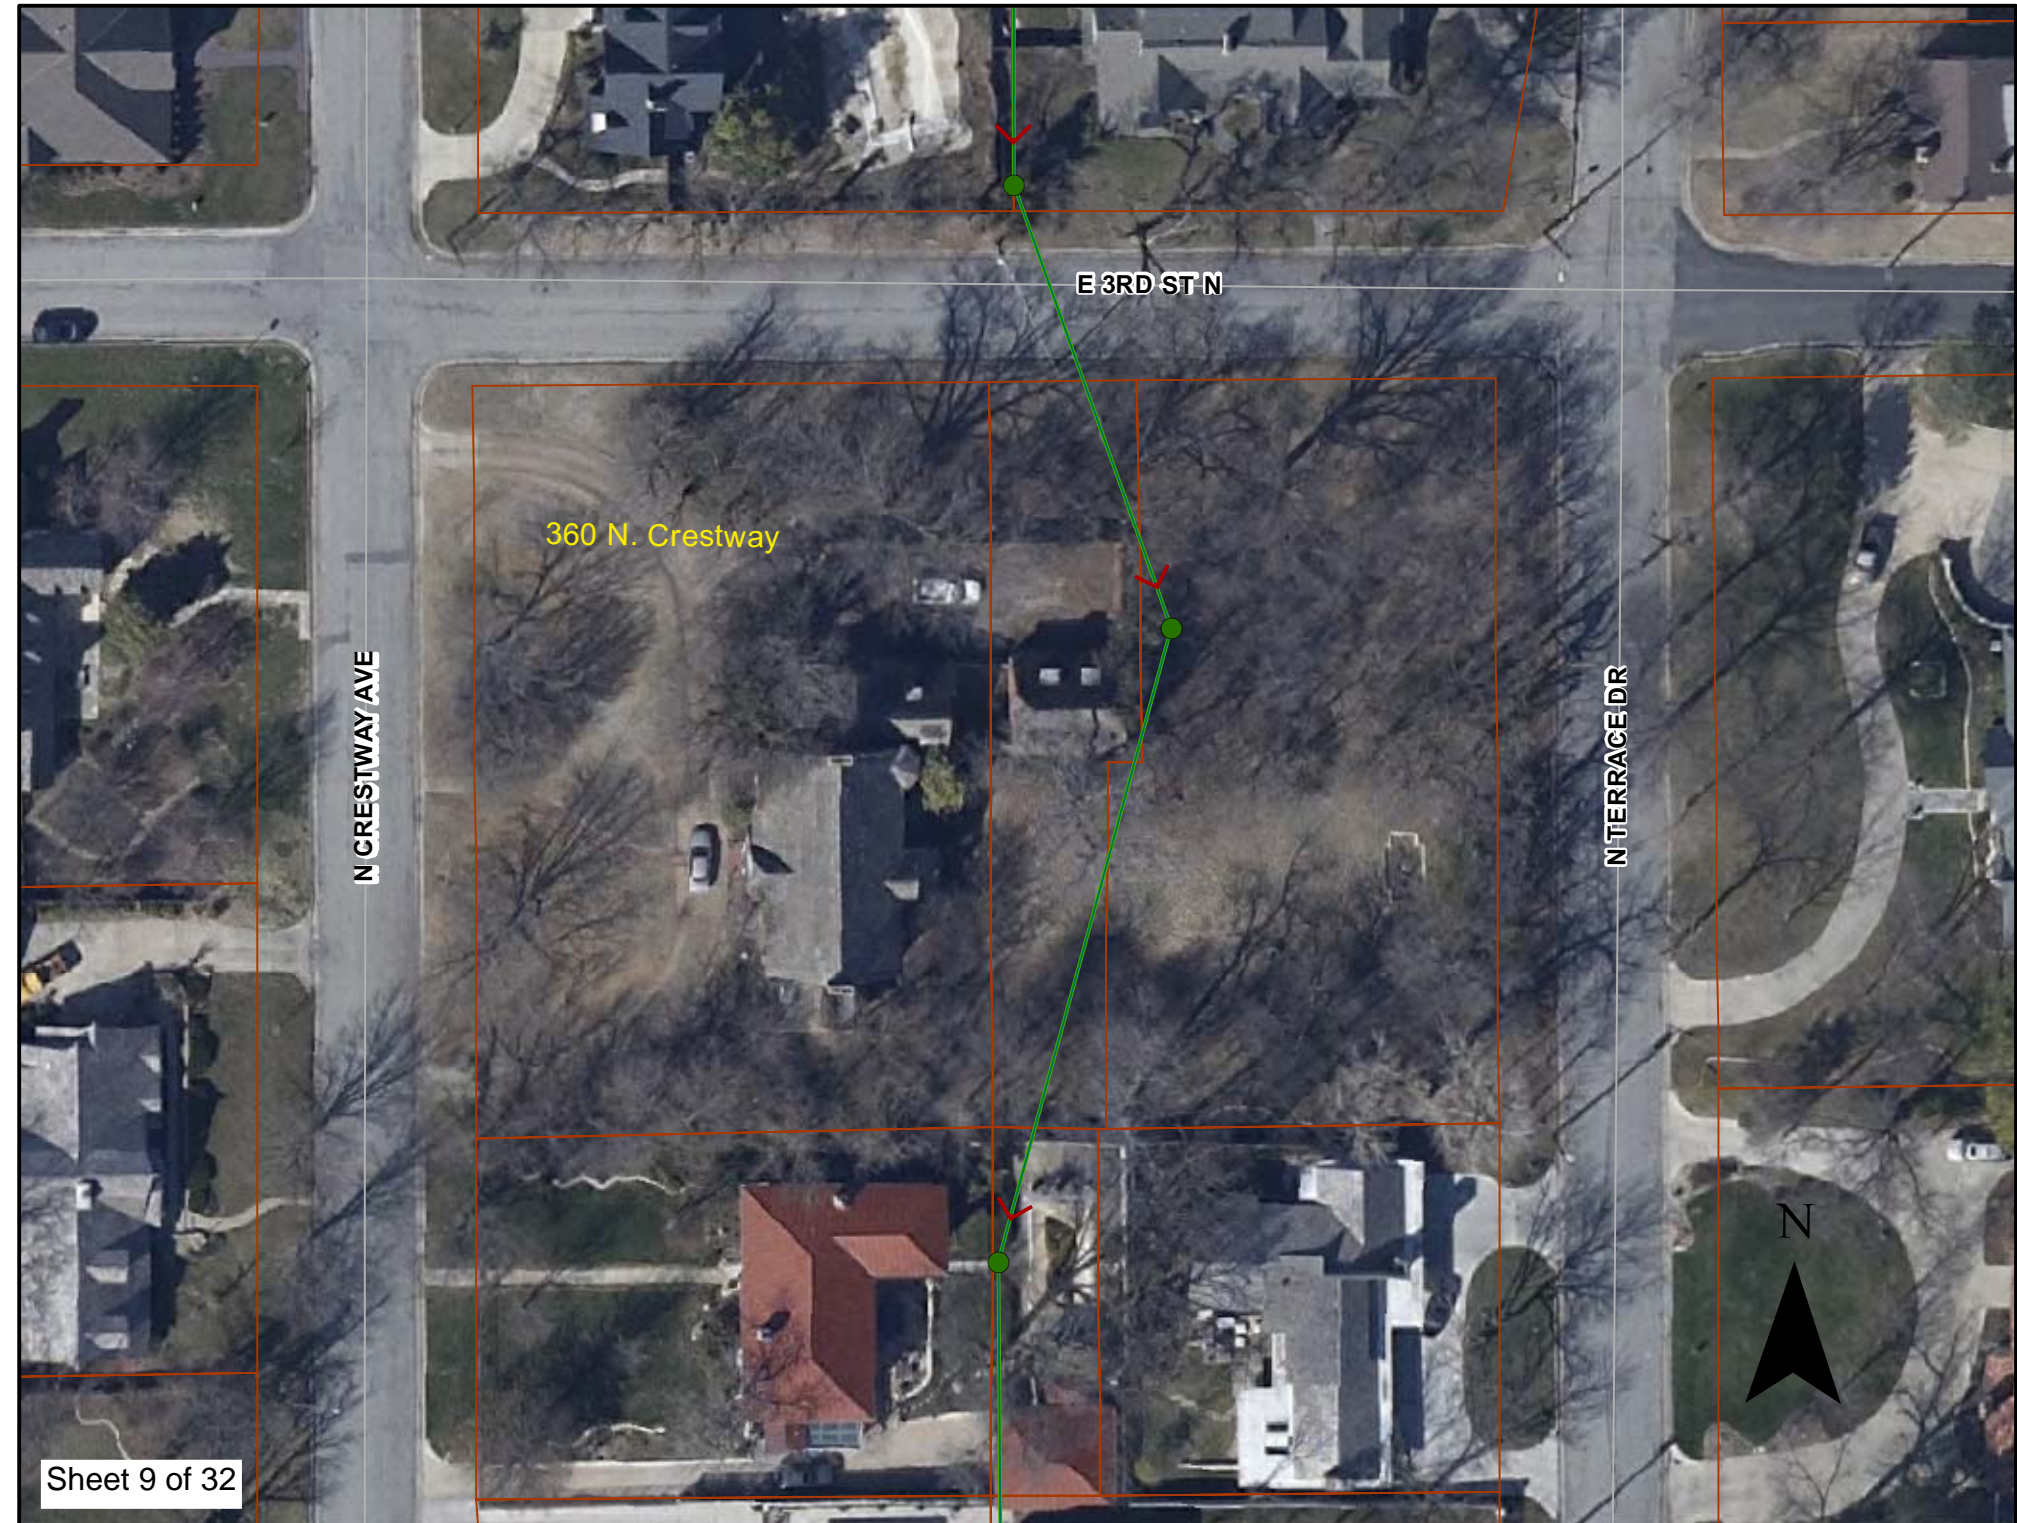
SITE 3

MH 5747-054
Remove and Replace MH Frame & Cover
(access to manhole off 3rd Street,
manhole is visible)
Approx MH depth = 13.7 ft
