SITE 4

Sheet 10 of 32

SITE 5

Sheet 14 of 32

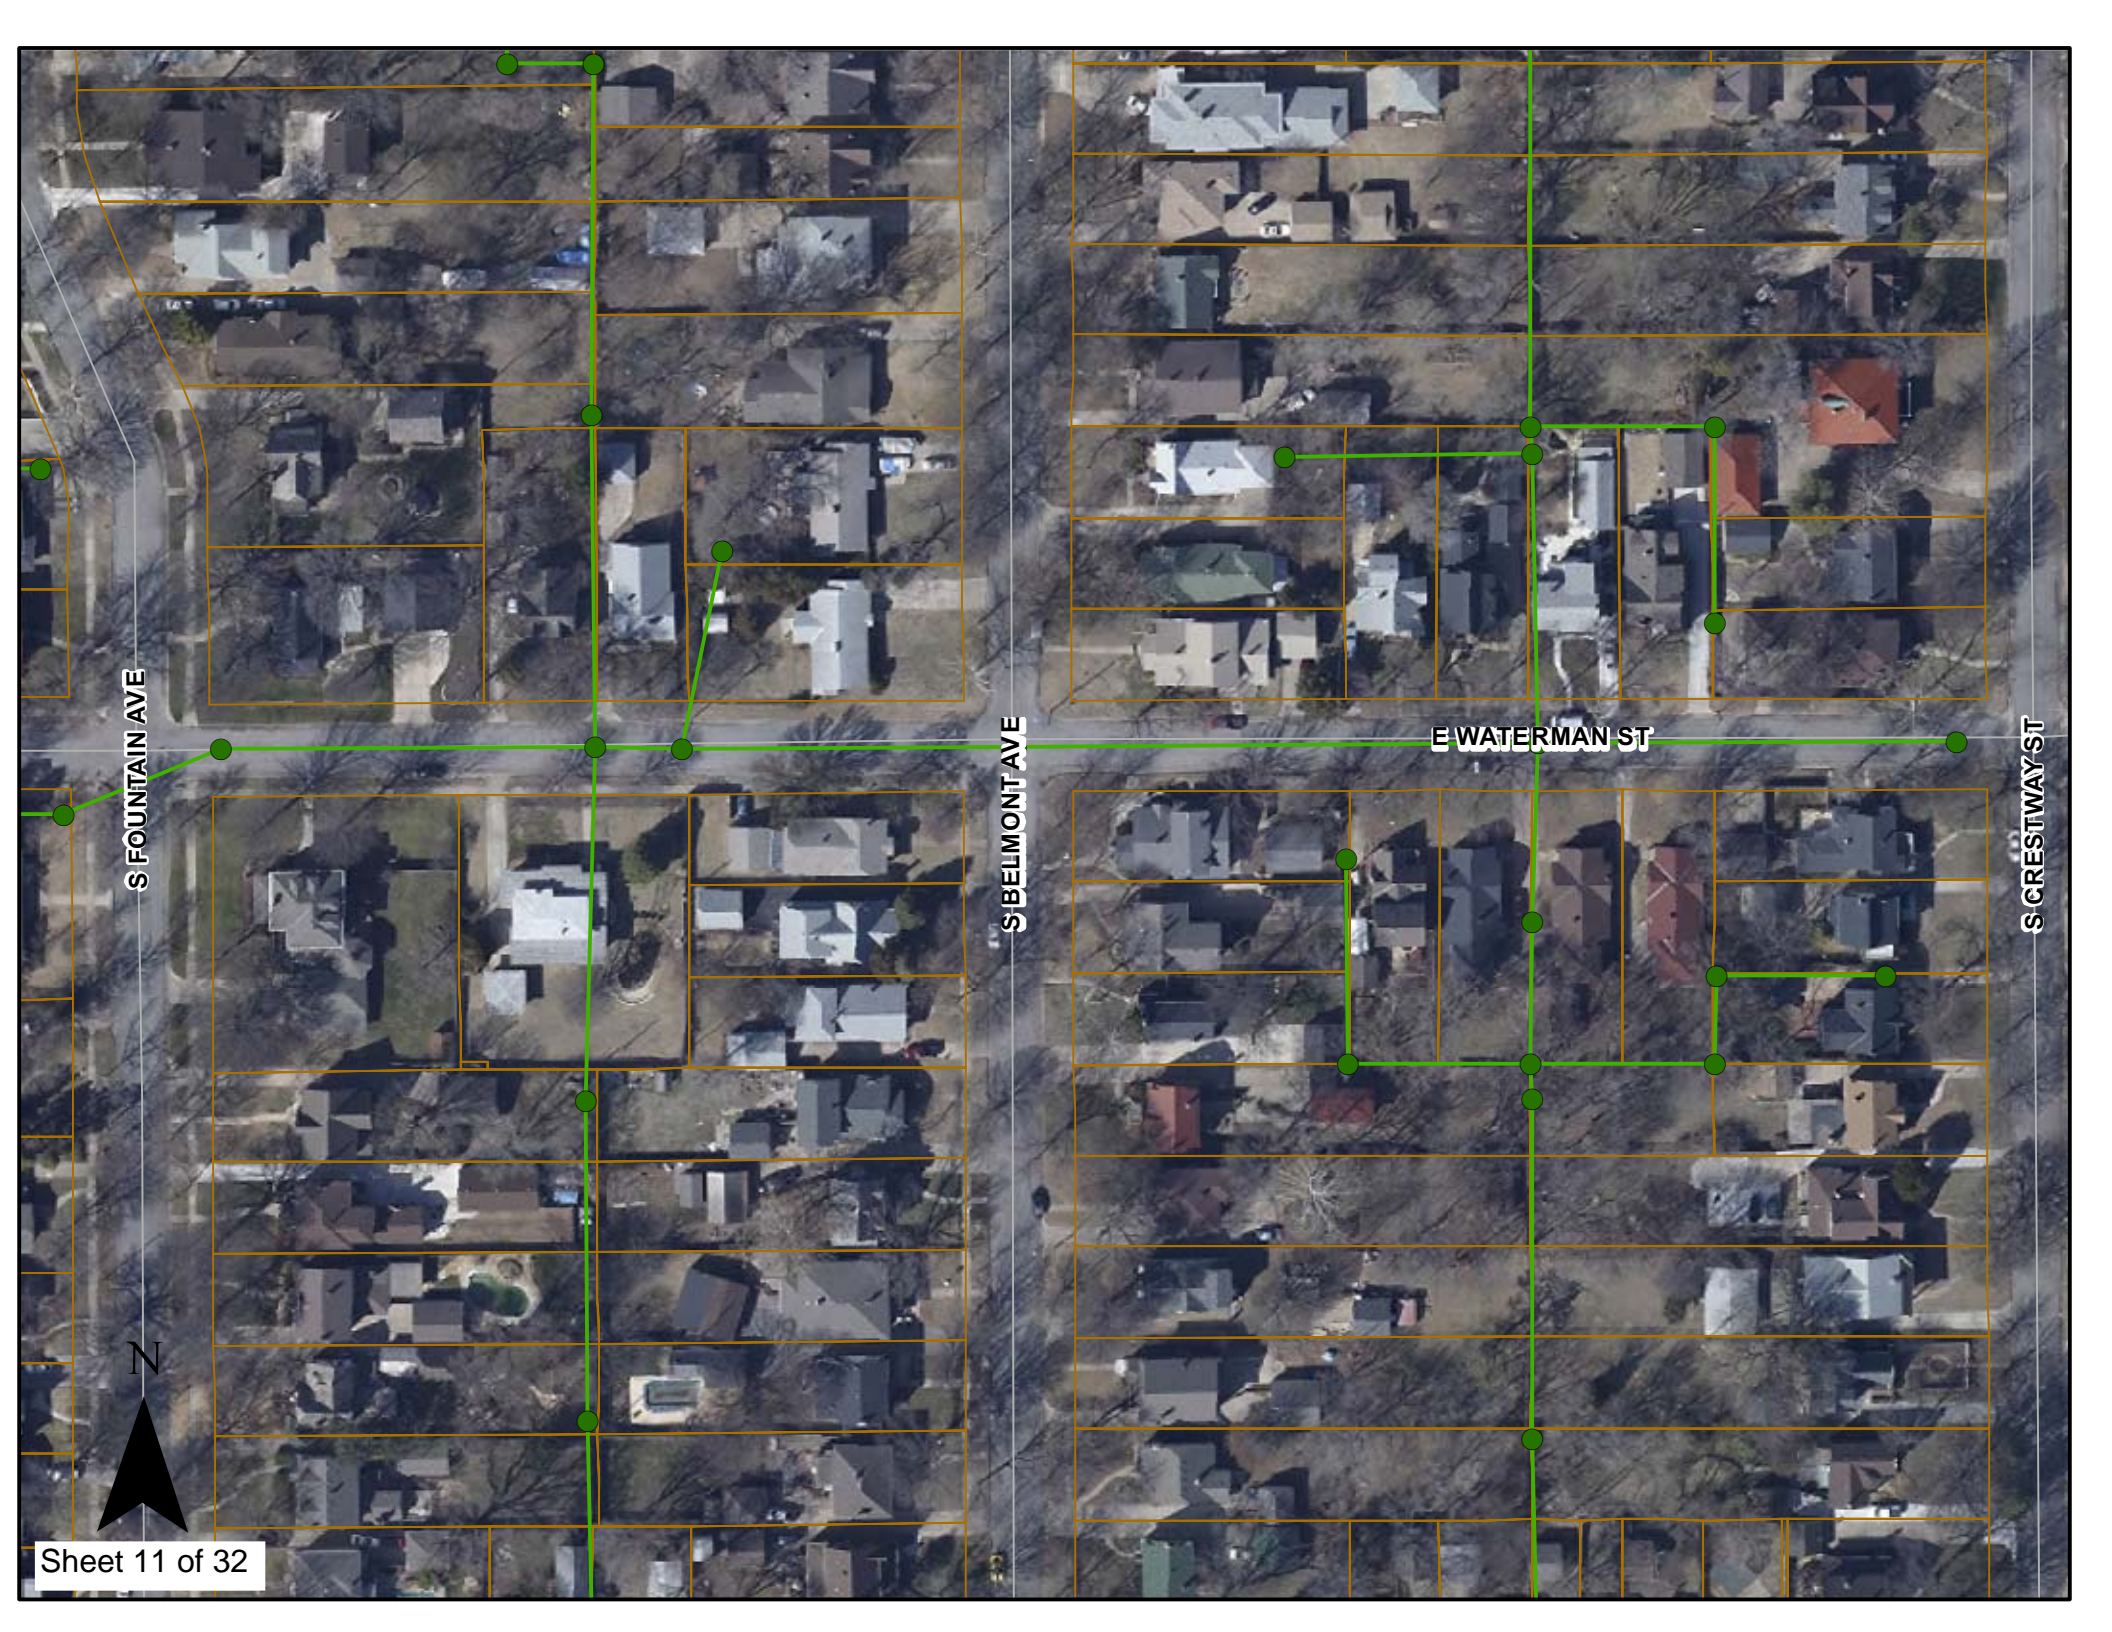
Obs. #	VTR Counter	Distance	Location	Description	Rating	Obsrvd (gpm)	Ratings			Remain (gpm)	
							Est. (gpm)	Struct	Clean		
1		0.0		5747-186 US Manhole	1						
2		0.0		Broken Pipe	5						
3		18.2		Sealed Off Wye	1						
4		20.7		Sealed Off Wye	1						
5		43.5		Sealed Off Wye	1						
6		46.1		Sealed Off Wye	1						
7		64.5		Roots	2						
8		67.3	251 S CRESTWAY	Wye Service	5						
9		71.5		Sealed Off Wye	1						
10		79.9		Crack-Radial	2						
11		85.2		Crack-Radial	2						
12		87.3	4311 E WATERMAN	S. Wye Service	5						
				Tap is broken off the main. Pipe missing outside of main / cavity. Tap is active.							
										Should be able to replace the tap without a point repair to the 8" pipe.	
14		94.3		Sealed Off Wye	1						
15		96.9		Sealed Off Wye	1						
16		106.0		Observation Hole	1						
17		117.3		Sealed Off Wye	1						
18		119.7		Sealed Off Wye	1						
19		142.6		Sealed Off Wye	1						
20		145.0		Sealed Off Wye	1

21		168.0		Sealed Off Wye	1						
22		170.4		Sealed Off Wye	1						
23		186.6		Roots	1						
24		189.1		Roots	1						
25		193.4		Sealed Off Wye	1						
26		194.2		Roots	1						
27		195.8		Sealed Off Wye	1						
28		209.4		Roots	1						
29		211.9		Roots	2						
30		214.5		Roots	1						
31		217.0		Roots	2						
32		218.6		Sealed Off Wye	1						
33		219.6		Roots	3						
34		221.2		Sealed Off Wye	1						
35		222.0		Roots	3						
36		223.6		Roots	1						
37		224.8		Mat'l Chngs to PVC	1						
38		228.5		5747-184 DS Manhole	1

US Structure: **5747-179** 4023 E WATERMAN ST Date Insp: 2/13/2012 Basin: EC01G
 DS Structure: **5747-177** 250 S FOUNTAIN AVE Dir Televised: Upstream To Downstream

15	175.0		Break-In Conn	4					
250 SOUTH FOUNTAIN / Tap is broken off the main and creating a cavity. Missing pipe outside of the main. Active.										
Should be able to replace the tap without a point repair to the 8" pipe.										
16		176.5		Sealed Off Wye	1					
17		199.5		Sealed Off Wye	1					
18		202.2		Sealed Off Wye	1

MH 5747-054
Remove and Replace MH Frame & Cover
303 S. Fountain (visible in yard)
Approx MH depth = 12.2 ft

Replace Service Connection
for 250 S. Fountain (4")
Located 175 lf west of MH 5747-179.
Pavement removal and replacement
shall be subsidiary to the bid item.

Replace Service Connection
for 4311 E. Waterman (4")
Located 87 lf west of MH 5747-186.
Pavement removal and replacement
shall be subsidiary to the bid item.

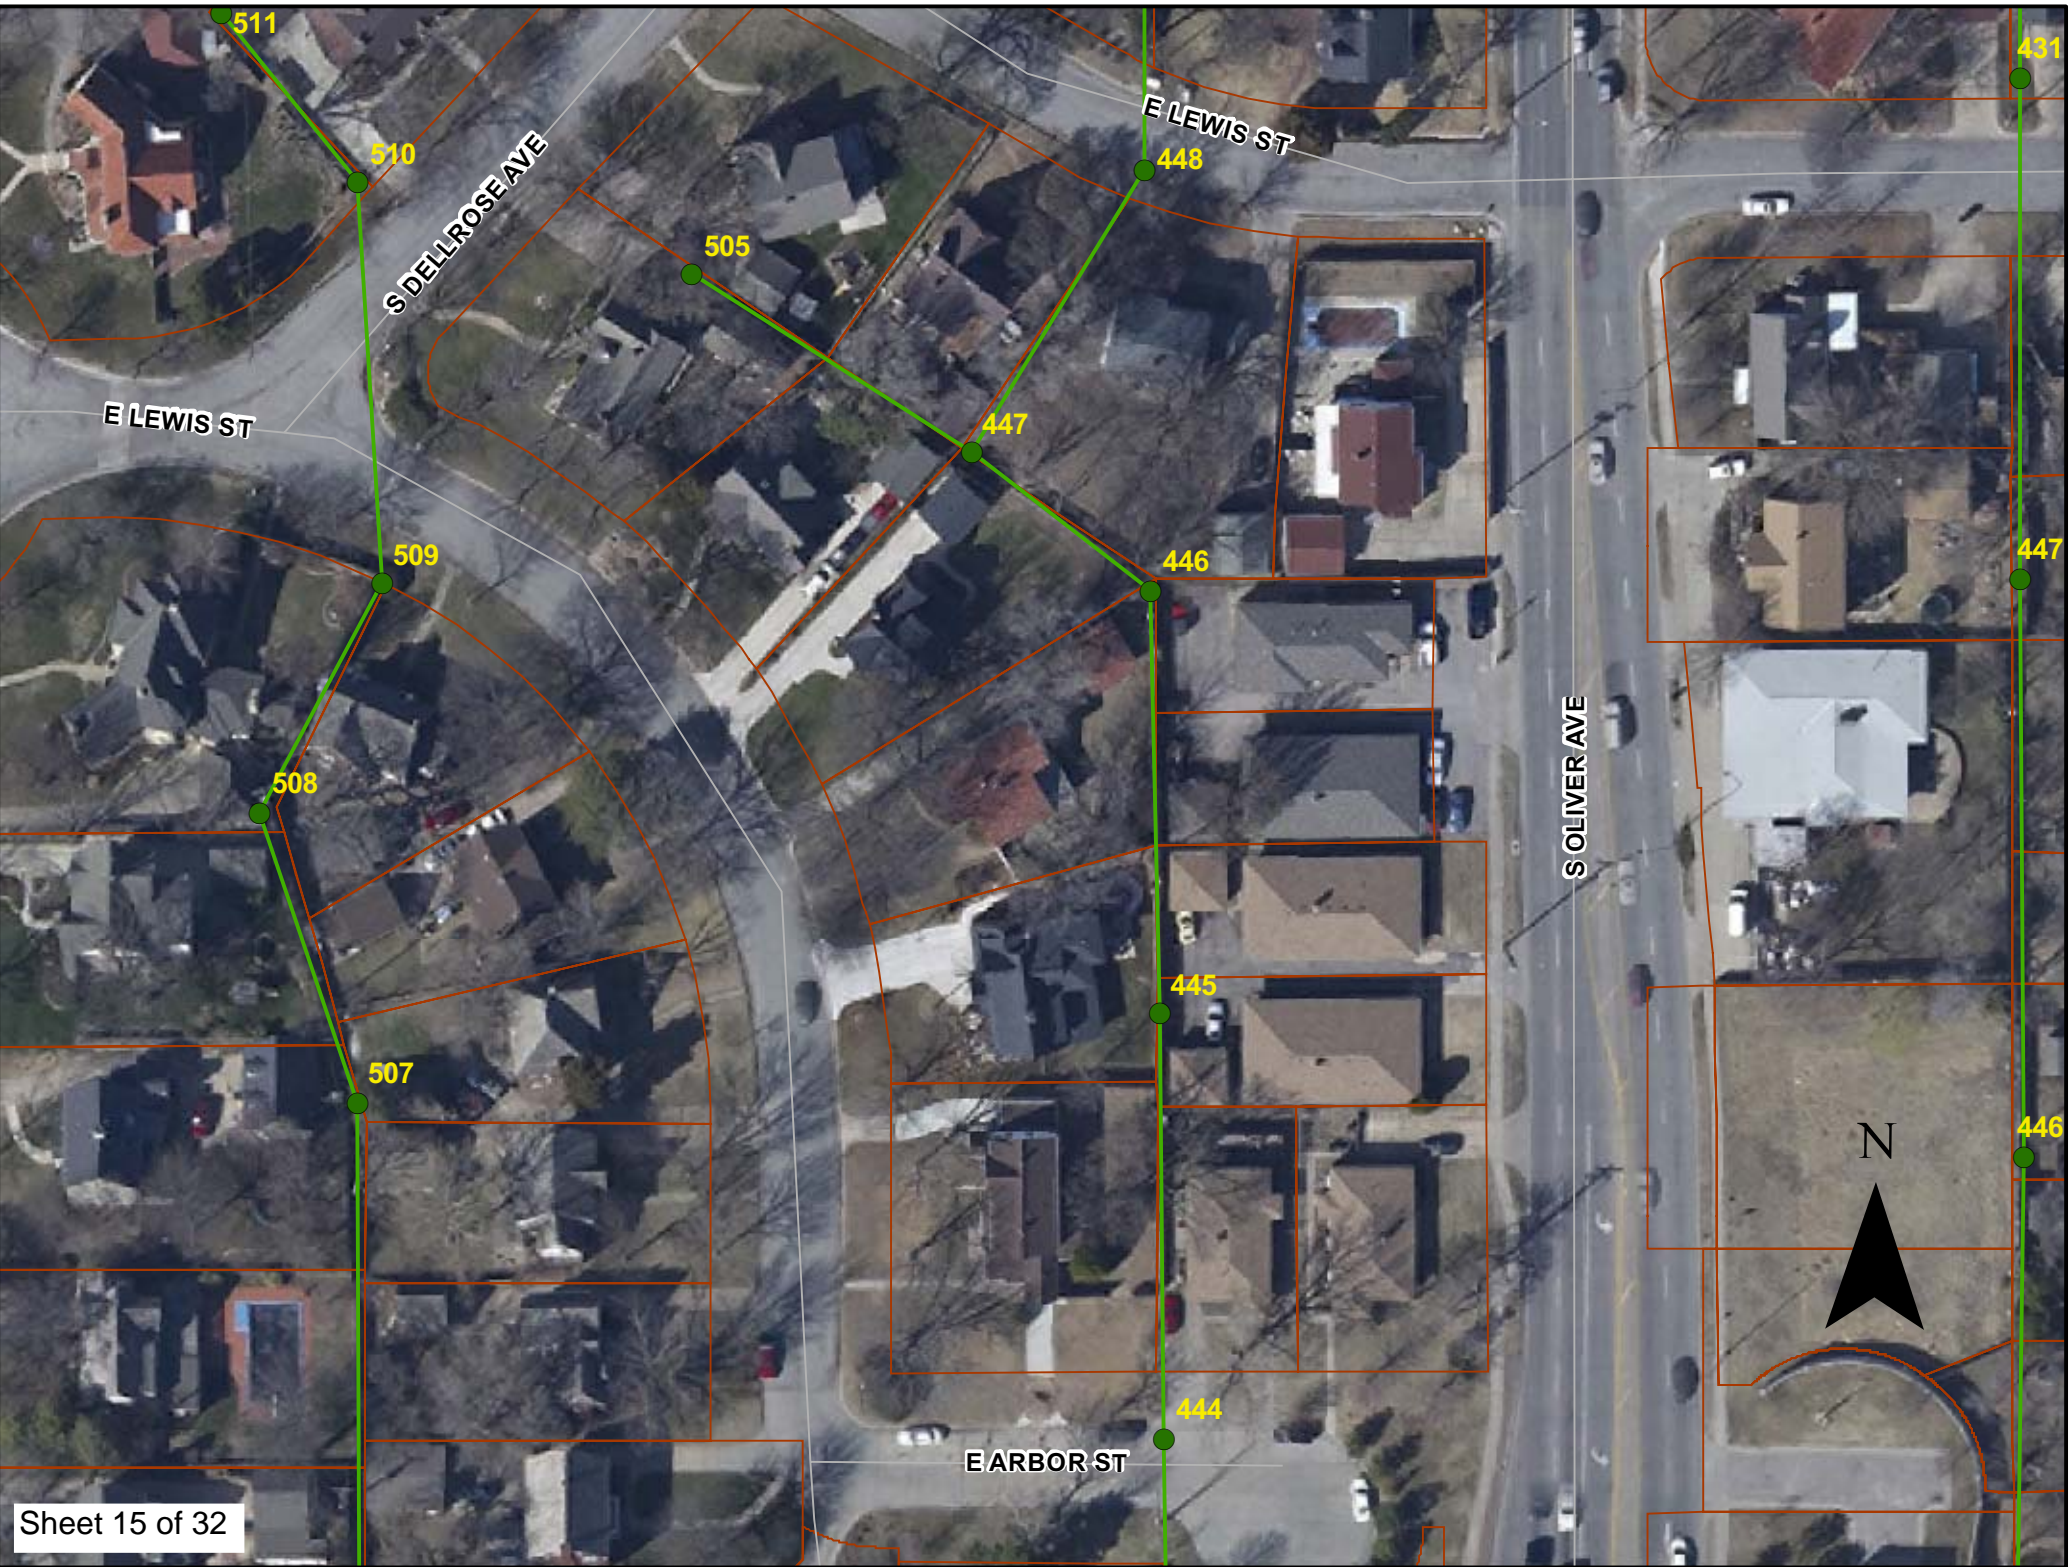
Obs. #	VTR Counter	Distance	Location	Description	Rating	Obsrvd (gpm)	Ratings		Remain (gpm)	
							Struct	Clean		
1		0.0	US Manhole	5747-447 (access from 4719 E. Lewis)	1					
2		6.0		Sealed Off Wye South	1	0.000	0	0	0.000	
3		8.1		Sealed Off Wye North	1	0.000	0	0	0.000	
4		10.2	Joint	Offset	3	0.010	20	0	0.010	
5		26.3		Sealed Off Wye South	1	0.000	0	0	0.000	
6		28.3	Lower Right	Crack-Radial	3	0.004	5	0	0.004	
7		29.3		Sealed Off Wye North	1	0.000	0	0	0.000	
8		33.3	Upper Right	Broken Pipe	2	0.008	44	0	0.008	
9		36.0	Upper Right	Broken Pipe	3	0.010	60	0	0.010	
10		37.1	South	Extended Tap	5	0.002	400	0	0.002	
				424 S DELLROSE / dropped into the main	4" Break In Connection	Comment: PIPE MISSING / needs point repair				
11		49.3		Sealed Off Wye South	1	0.000	0	0	0.000	
12		51.5		Sealed Off Wye North	2	0.002	0	0	0.002	
13		58.5	Crown	Broken Pipe	2	0.008	44	0	0.008	
14		61.3	Crown	Broken Pipe	2	0.008	44	0	0.008

15		63.9	Crown	Broken Pipe	2	0.008	44	0	0.008	
16		69.5		Sealed Off Wye South	1	0.000	0	0	0.000	
17		71.2	Upper Right	Debris / tile	5	0.000	0	75	0.000	
18		72.8		Sealed Off Wye North	1	0.000	0	0	0.000	
19		88.0	North	Break-In Conn	1	0.001	0	0	0.001	
				4719 E LEWIS ST	4" VCP MH Stub					
20		88.0	North	Break-In Conn	1	0.001	0	0	0.001	
				401 S OLIVER ST	4" VCP MH Stub					
21		88.0	South	Break-In Conn	1	0.001	0	0	0.001	
				430 S DELLROSE	4" VCP MH Stub					
22		88.0	DS Manhole	5747-446	1	0.000	0	0	0.000

Obs. #	VTR Counter	Distance	Location	Description	Rating	Obsrvd (gpm)	Ratings			Remain (gpm)
							Est. (gpm)	Struct	Clean	
1		0.0	US Manhole	5747-445	1	0.000	0	0	0.000	
2	433 S OLIVER	4.0	East	Break-In Conn 4" Break In Connection	5	0.010	400	0	0.010	Comment: BROKEN PIPE & PIPE MISSING.
3		5.1		Sealed Off Wye West	1	0.000	0	0	0.000	
4		7.4		Sealed Off Wye East	1	0.000	0	0	0.000	
5		13.7	Invert	Broken Pipe	5	0.060	100	0	0.060	
6		27.2		Sealed Off Wye West	1	0.000	0	0	0.000	
7		30.0		Sealed Off Wye East	1	0.000	0	0	0.000	
8		35.4	East	Break-In Conn	3	0.004	2	0	0.004	
	4718 & 4720 E. Arbor (tap repaired in 2011)			4" Break In Connection						
9		42.0	Upper Left	Crack-Horizontal	2	0.002	2	0	0.002	
10		52.8		Sealed Off Wye West	1	0.000	0	0	0.000	
11		55.9		Sealed Off Wye East	1	0.000	0	0	0.000	
12		74.6	Upper Right	Mat. Chngs to PVC	1	0.000	0	0	0.000	
13		78.5	E / 4714 E ARBOR	Break-In Conn 4" PVC Saddle "T" Conn	1	0.001	0	0	0.001

14		79.9	W / 440 S DELLROSE	Break-In Conn 4" PVC Saddle "T" Conn	1	0.001	0	0	0.001	
15		84.1	Upper Right	Mat. Chngs to VCP	1	0.000	0	0	0.000	
16		92.8	Joint	Roots	1	0.002	1	1	0.002	
17		100.6	Crown	Broken Pipe	4	0.030	78	0	0.030	
18		103.7		Sealed Off Wye West	1	0.000	0	0	0.000	
19		106.2		Sealed Off Wye East	1	0.000	0	0	0.000	
20		129.2		Sealed Off Wye West	1	0.000	0	0	0.000	
21		132.2		Sealed Off Wye East	1	0.000	0	0	0.000	
22		148.1		Sealed Off Wye East	1	0.000	0	0	0.000	
23		150.8		Sealed Off Wye East	1	0.000	0	0	0.000	
24		155.2	Lower Left	Broken Pipe	3	0.010	60	0	0.010	
25		159.4	DS Manhole	5747-444	1

MH 5747-447
 4719 E. Lewis
 Approx depth = 18.1 ft

Point Repair: Replace 5 lf of 8" pipe, located at 37 feet downstream of MH 5747-447, including the 4" tap connection for 424 S. Dellrose

Point Repair: Replace 10 lf of 8" pipe from the south wall of MH 5747-445 to 10 lf south of the manhole, including the 4" tap connection for 435 S. Oliver (tall fence over sewer line)

MH 5747-445
 Remove and Replace MH Frame & Cover (including fence adjustment over manhole)
 433 S. Oliver
 Approx depth = 16.3 ft

Estimated 40 lf of Silt Fence
