SITE 1

Video Inspection Master Report

US Structure: 5445-351 2100 S BROADWAY AVE ST Date Insp: 9/21/2010 Basin: C05D
 DS Structure: 5445-350 2122 S MARKET AVE ST Dir Televised: Upstream To Downstream

Shape: Round Length Status: Project No. : D-150
 Dia/Ht: 8 Material: VCP Index:
 Length: 215.0 Slope: 0.102 Surface:

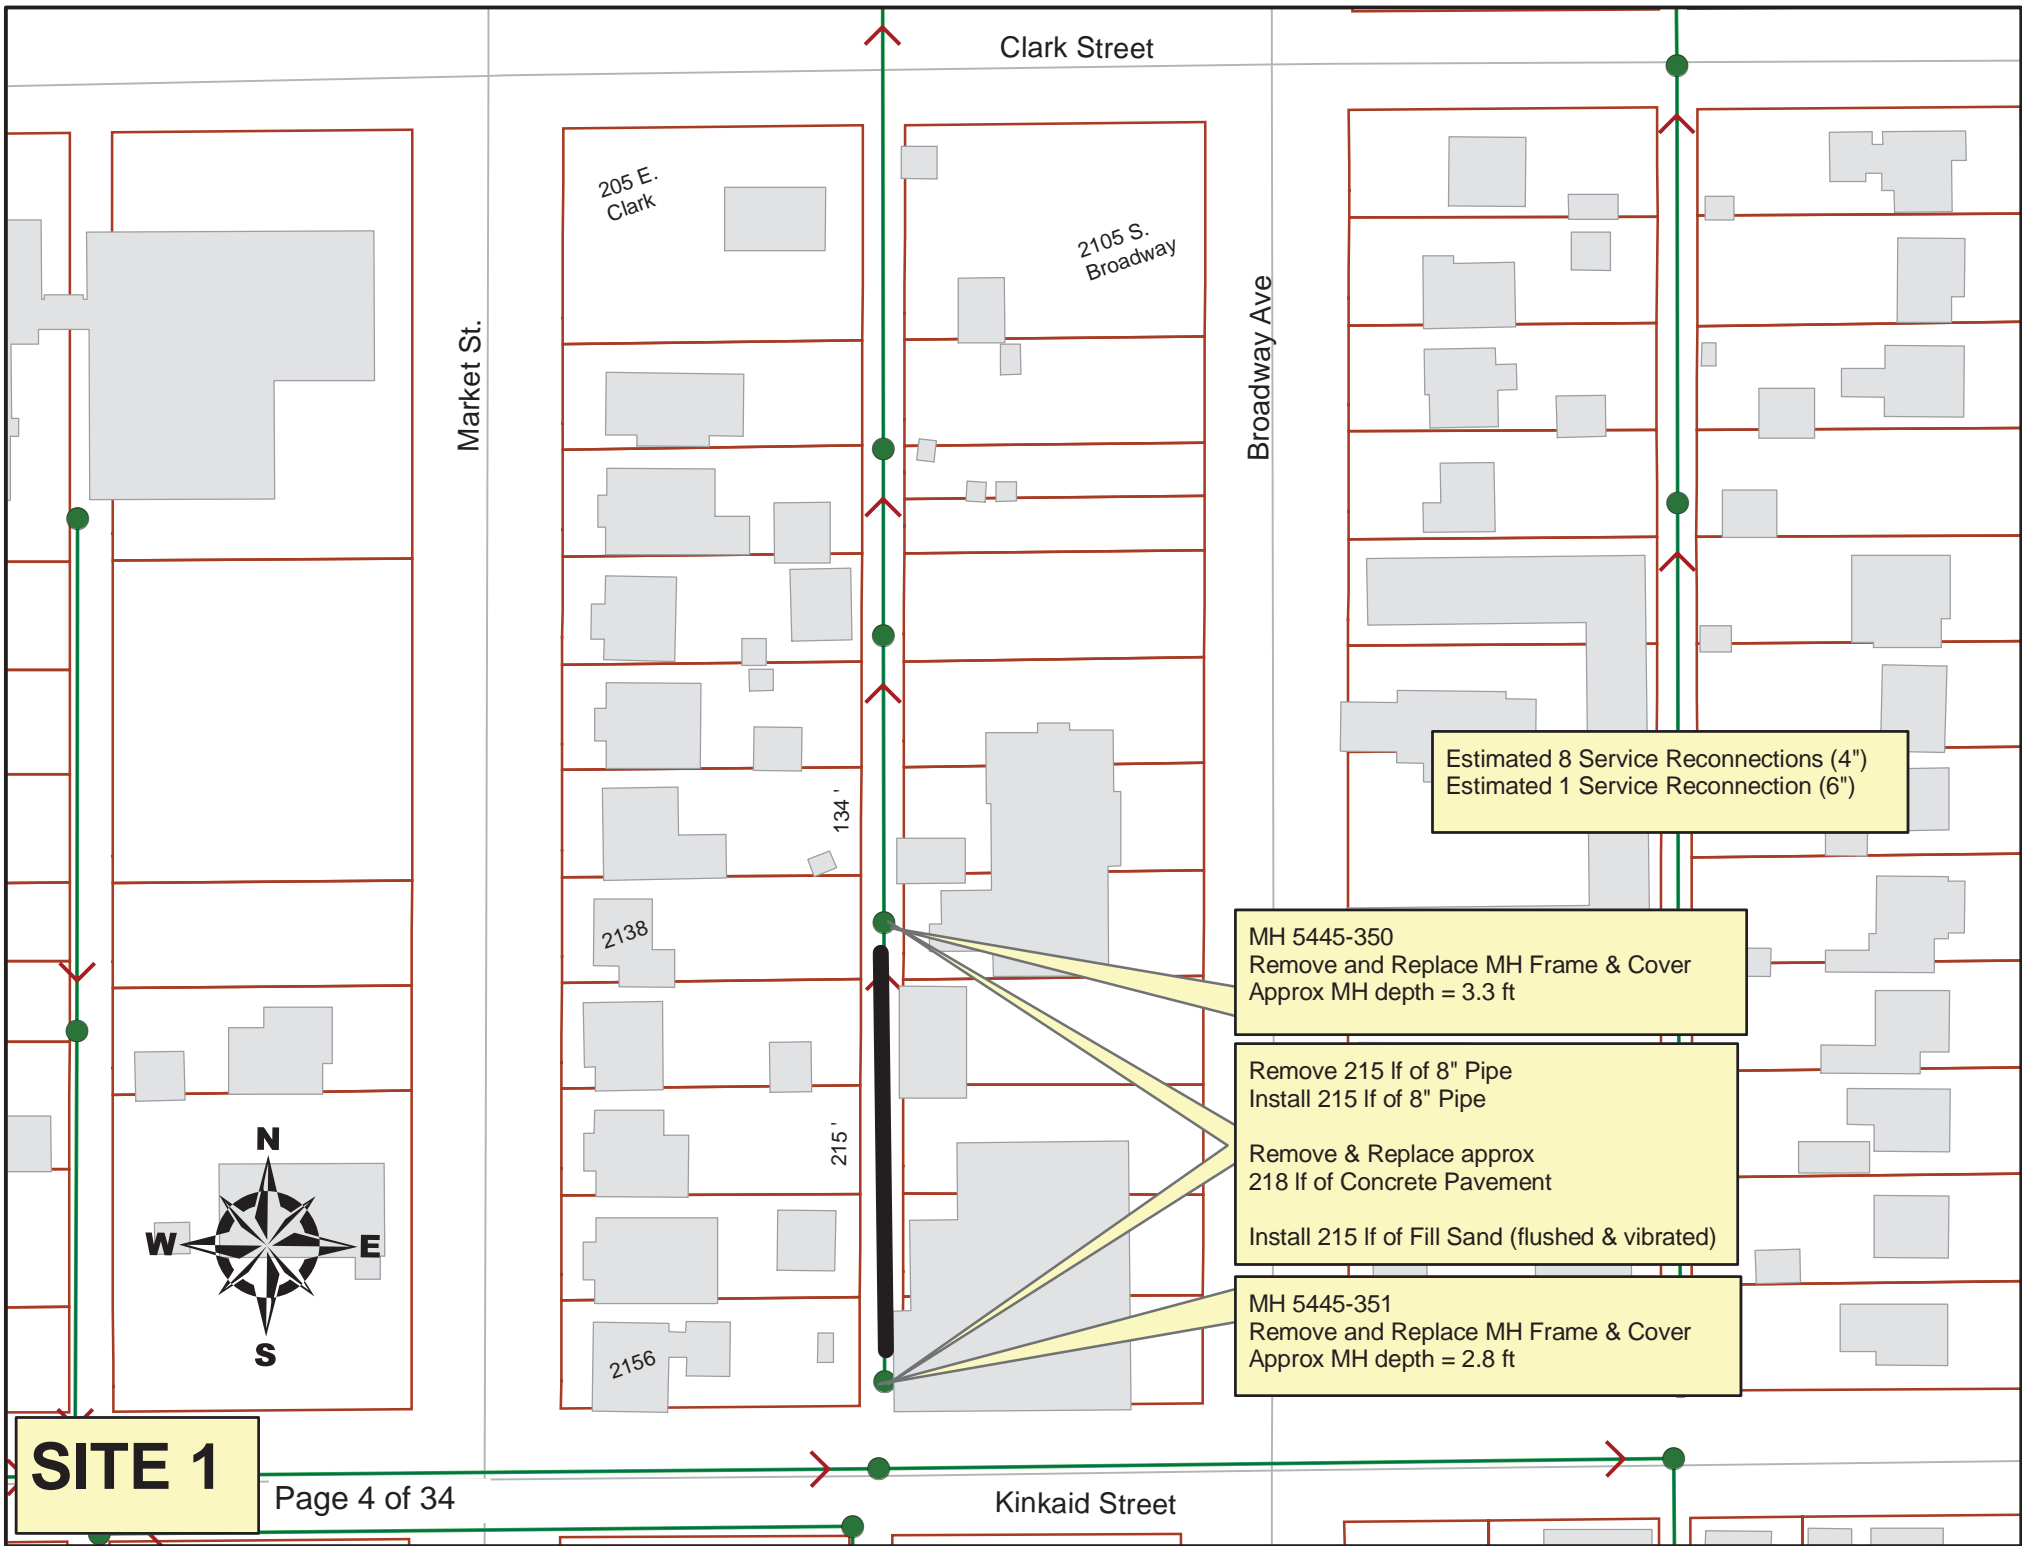
Estimated 8 Service Reconnections (4")
Estimated 1 Service Reconnection (6")

Line has poor grade. Some taps in poor condtion. -LML

MH 5445-350
Remove and Replace MH Frame & Cover
Approx MH depth = 3.3 ft

Remove 215 lf of 8" Pipe
Install 215 lf of 8" Pipe
Remove & Replace approx
218 lf of Concrete Pavement
Install 215 lf of Fill Sand (flushed & vibrated)

MH 5445-351
Remove and Replace MH Frame & Cover
Approx MH depth = 2.8 ft
