SITE 3

Television Inspection Master Report

US Structure: 5445-233 1611 S PALISADE ST Date Insp: 5/6/2009 Basin: C05E
 DS Structure: 5445-232 1616 S GOLD ST Dir Televised: Upstream To Downstream

Project No. : D-121 Dia: 8 Material: VCP Length: 143.8 Slope: 0.400 DVD #0483

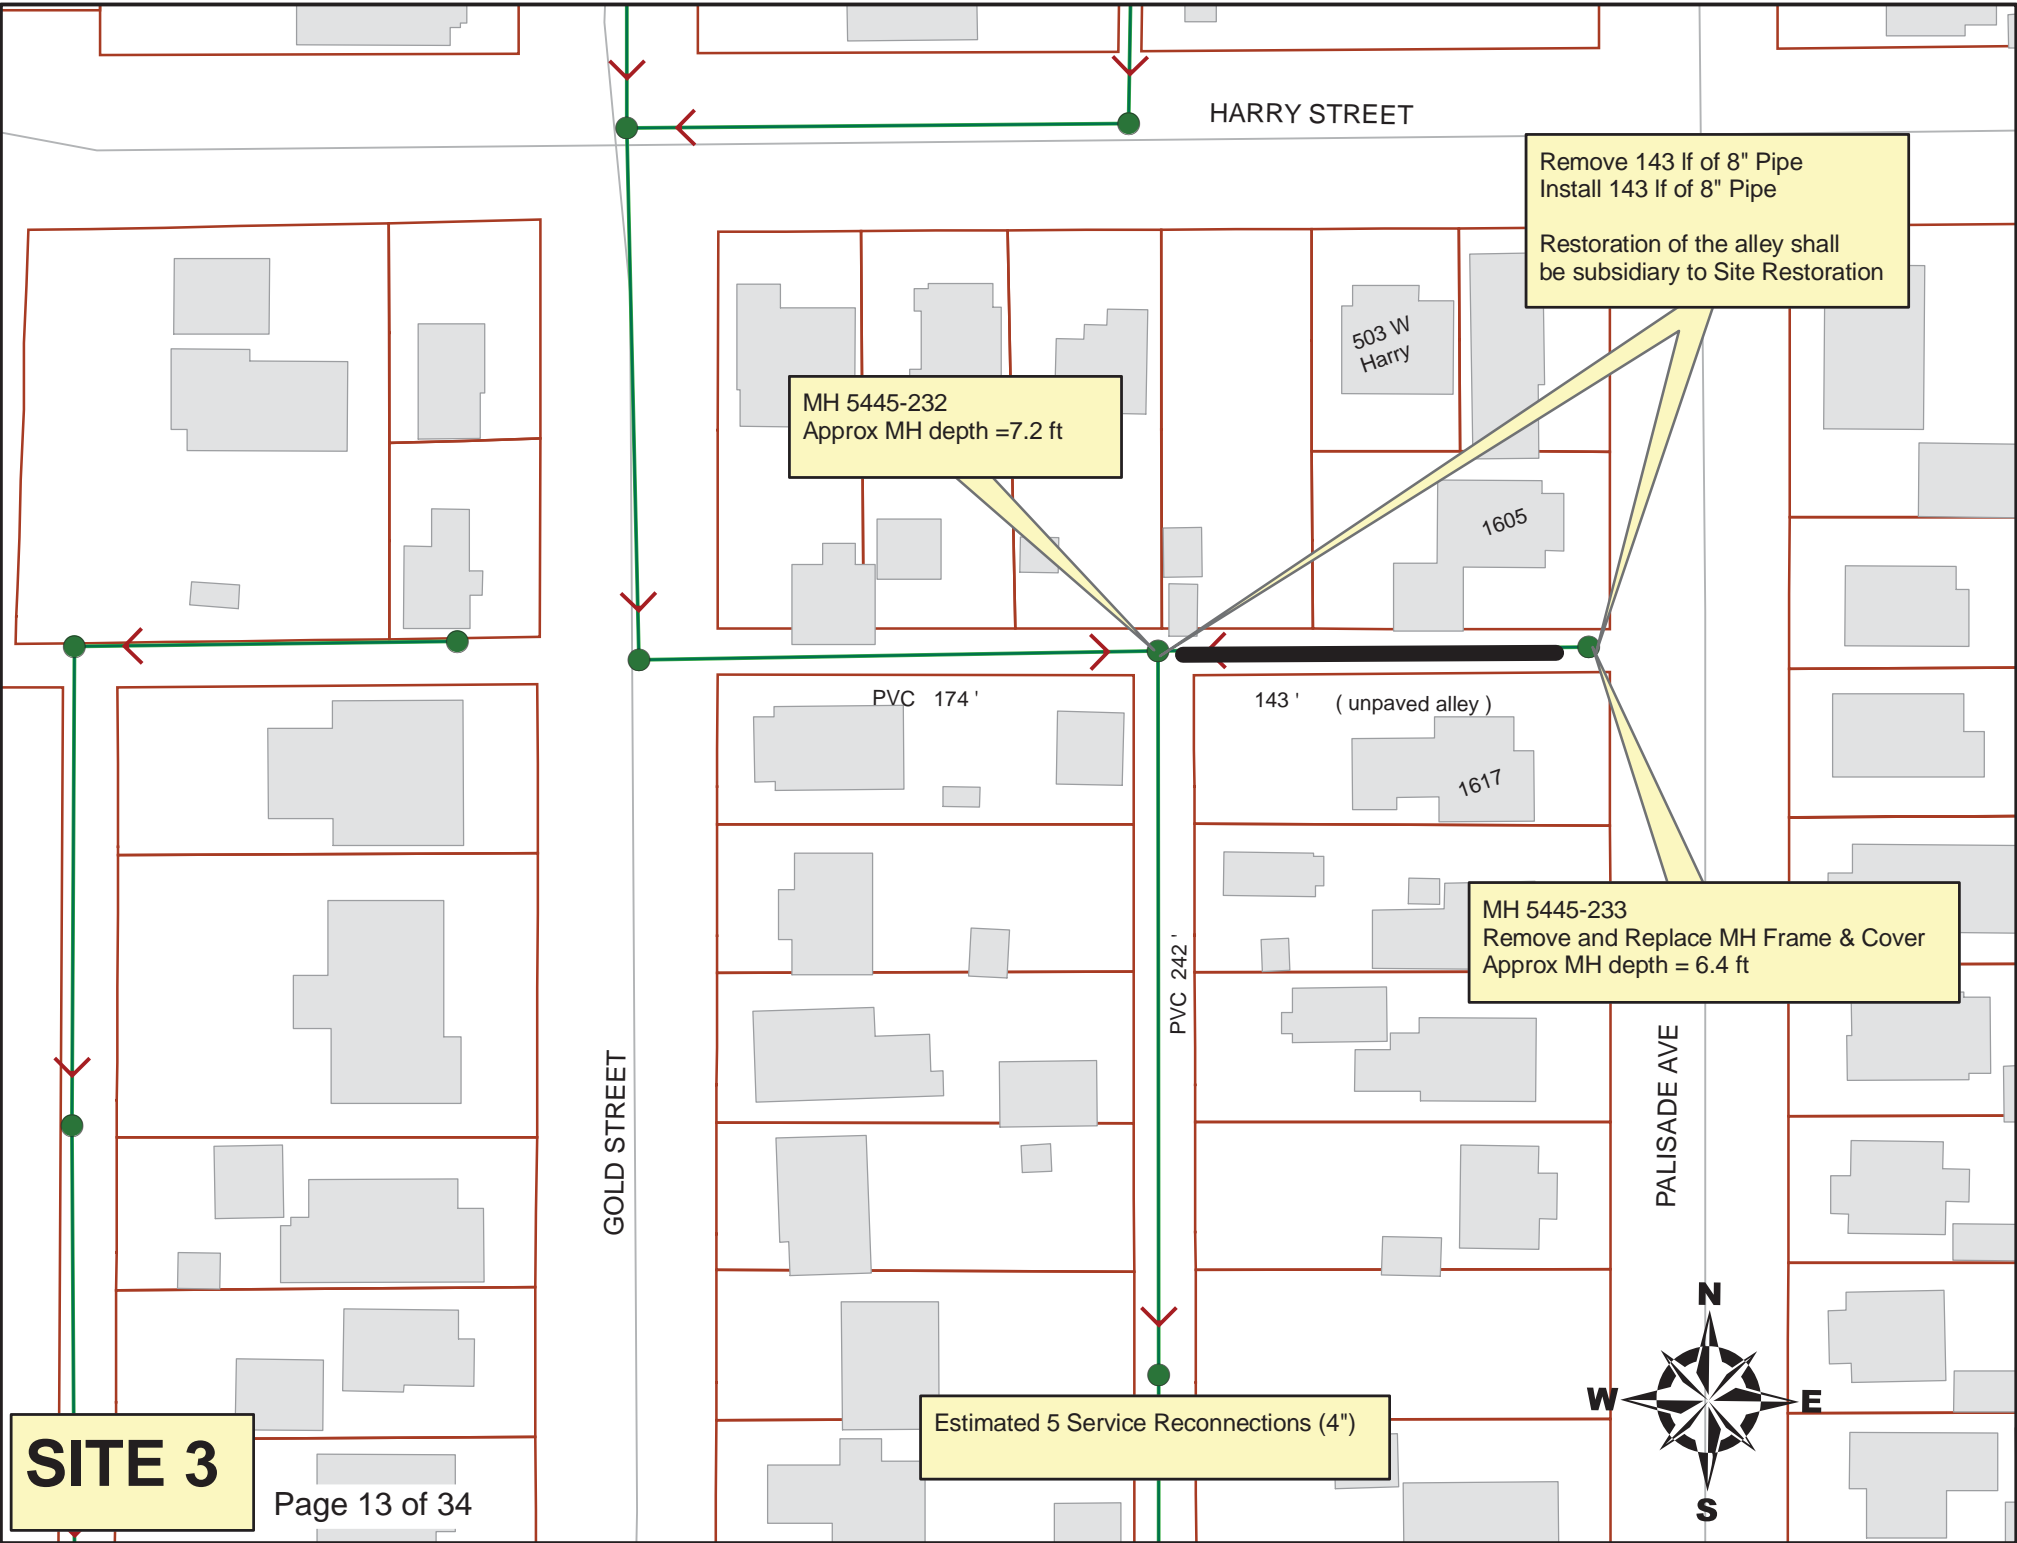
MH 5445-232
Approx MH depth =7.2 ft

MH 5445-233
Remove and Replace MH Frame & Cover
Approx MH depth = 6.4 ft

Remove 143 lf of 8" Pipe
Install 143 lf of 8" Pipe
Restoration of the alley shall be subsidiary to Site Restoration

Estimated 5 Service Reconnections (4")

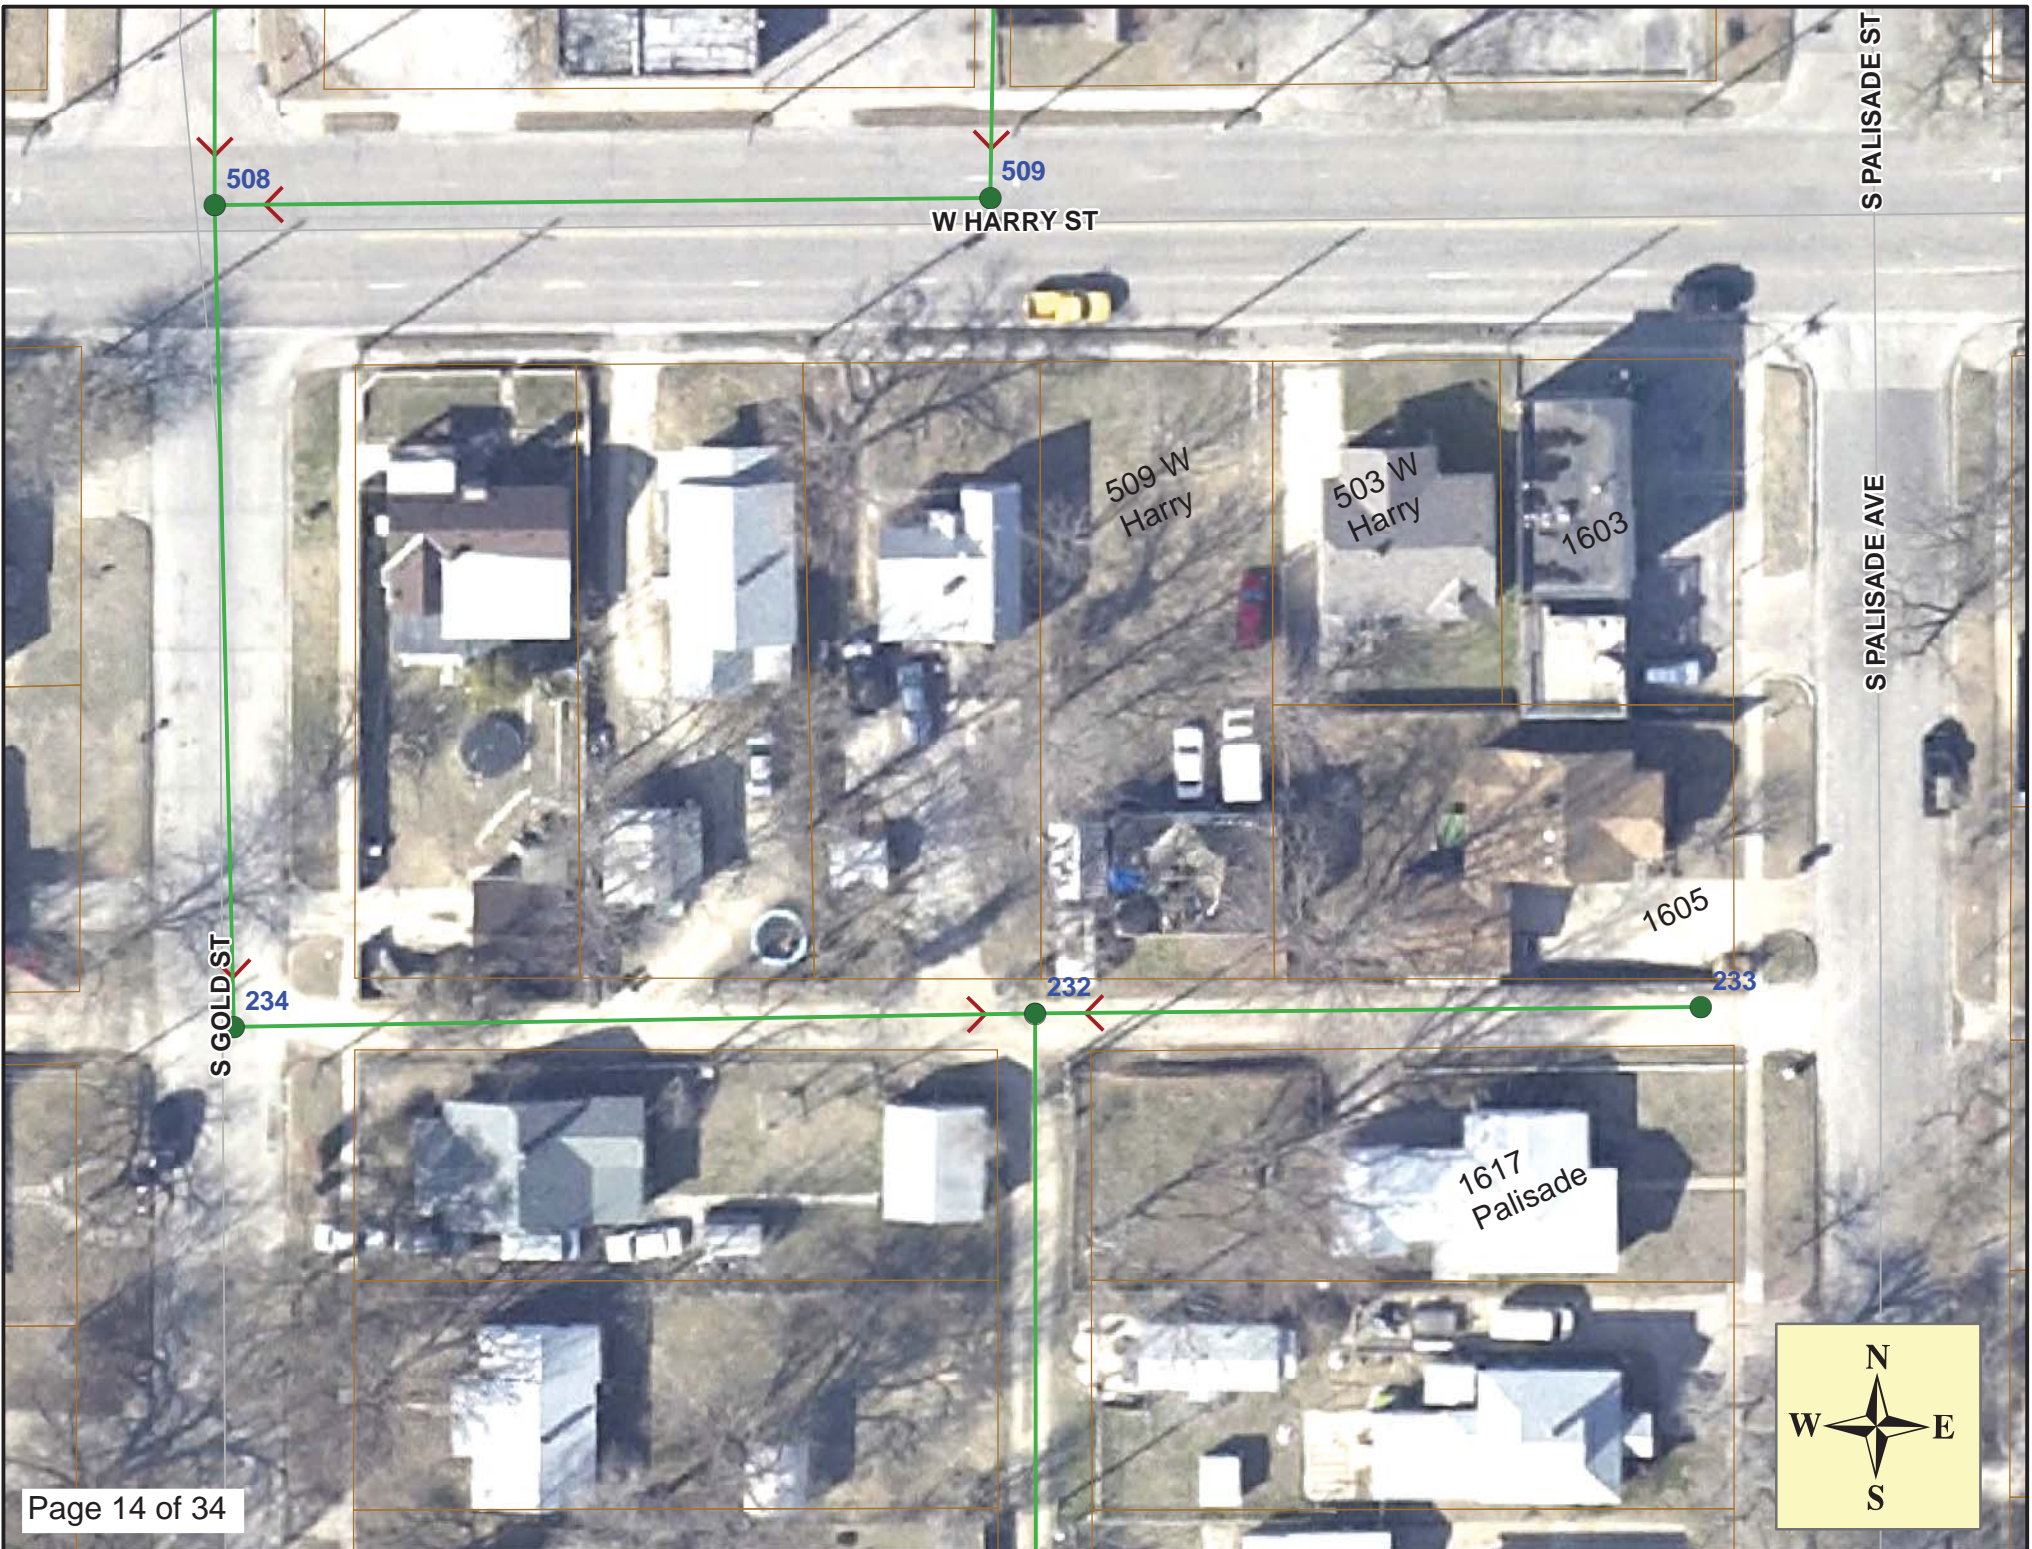
Obs. #	VTR Counter	Distance	Location	Description	Rating	Obsrvd (gpm)	Ratings			Remain (gpm)
							Est. (gpm)	Struct	Clean	
1		0.0		5445-233 US Manhole						
2		10.6		Broken Pipe	2	0.008	44	0	0.008	
3		20.6	(water is standing in pipe)	Broken Pipe	3	0.010	60	0	0.010	
4		28.9	1605 S PALISADE / roots	Wye Service	3	0.000	2	0	0.000	
5		30.7		Roots	1	0.002	1	1	0.002	
6		36.1		Roots	1	0.002	1	1	0.002	
7		38.6		Roots	1	0.002	1	1	0.002	
8		46.1		Roots	1	0.002	1	1	0.002	
9		48.7		Roots	1	0.002	1	1	0.002	
10		49.4	1617 S PALISADE / rough clay	Break-In Conn	1	0.001	0	0	0.001	
11		51.5		Roots	1	0.002	1	1	0.002	
12		54.0	ball of roots	Roots	3	0.008	5	8	0.008	
16		54.0	503 W HARRY / full of roots	Wye Service	5	0.000	400	0	0.000	
13		63.9		Roots	2	0.004	2	4	0.004	
14		66.5		Roots	3	0.008	5	8	0.008	
15		74.6		Roots	1	0.002	1	1	0.002	
17		77.6	501 W. Harry & 1603 S. Palisade (broken past first joint outside of main)	Wye Service	2	0.000	0	0	0.000

18		82.1		Broken Pipe	2	0.008	44	0	0.008	
19		86.9		Roots	3	0.008	5	8	0.008	
20		89.3	(roots bridged completely across the main)	Roots	4	0.010	10	25	0.010	
21		92.2		Roots	3	0.008	5	8	0.008	
22		94.6		Roots	2	0.004	2	4	0.004	
23		101.6	509 W HARRY	Wye Service	1	0.000	0	0	0.000	
24		107.8		Broken Pipe	2	0.008	44	0	0.008	
25		112.4		Heavy Roots	3	0.008	5	8	0.008	
26		122.9		Crack-Radial	3	0.004	5	0	0.004	
27		124.9		Ball of Roots / Wye Service / sealed off	5	0.000	400	0	0.000	
(there is a 2007 sewer permit that states this was a seal off for 509 Harry and it should be sealed 8 feet from the main / <u>verify that</u>) -LML										
28		130.9		Crack-Radial	1	0.001	1	0	0.001	
29		140.8		5445-232 DS Manhole	1

Poor grade / water is standing in the pipe most of the way. Roots could be holding back water too. -LML
