MH 5846-265
 Replace MH Frame & Cover
 Approx depth = 10.8 ft
 (located between fences)

SITE 2

Video Inspection Master Report

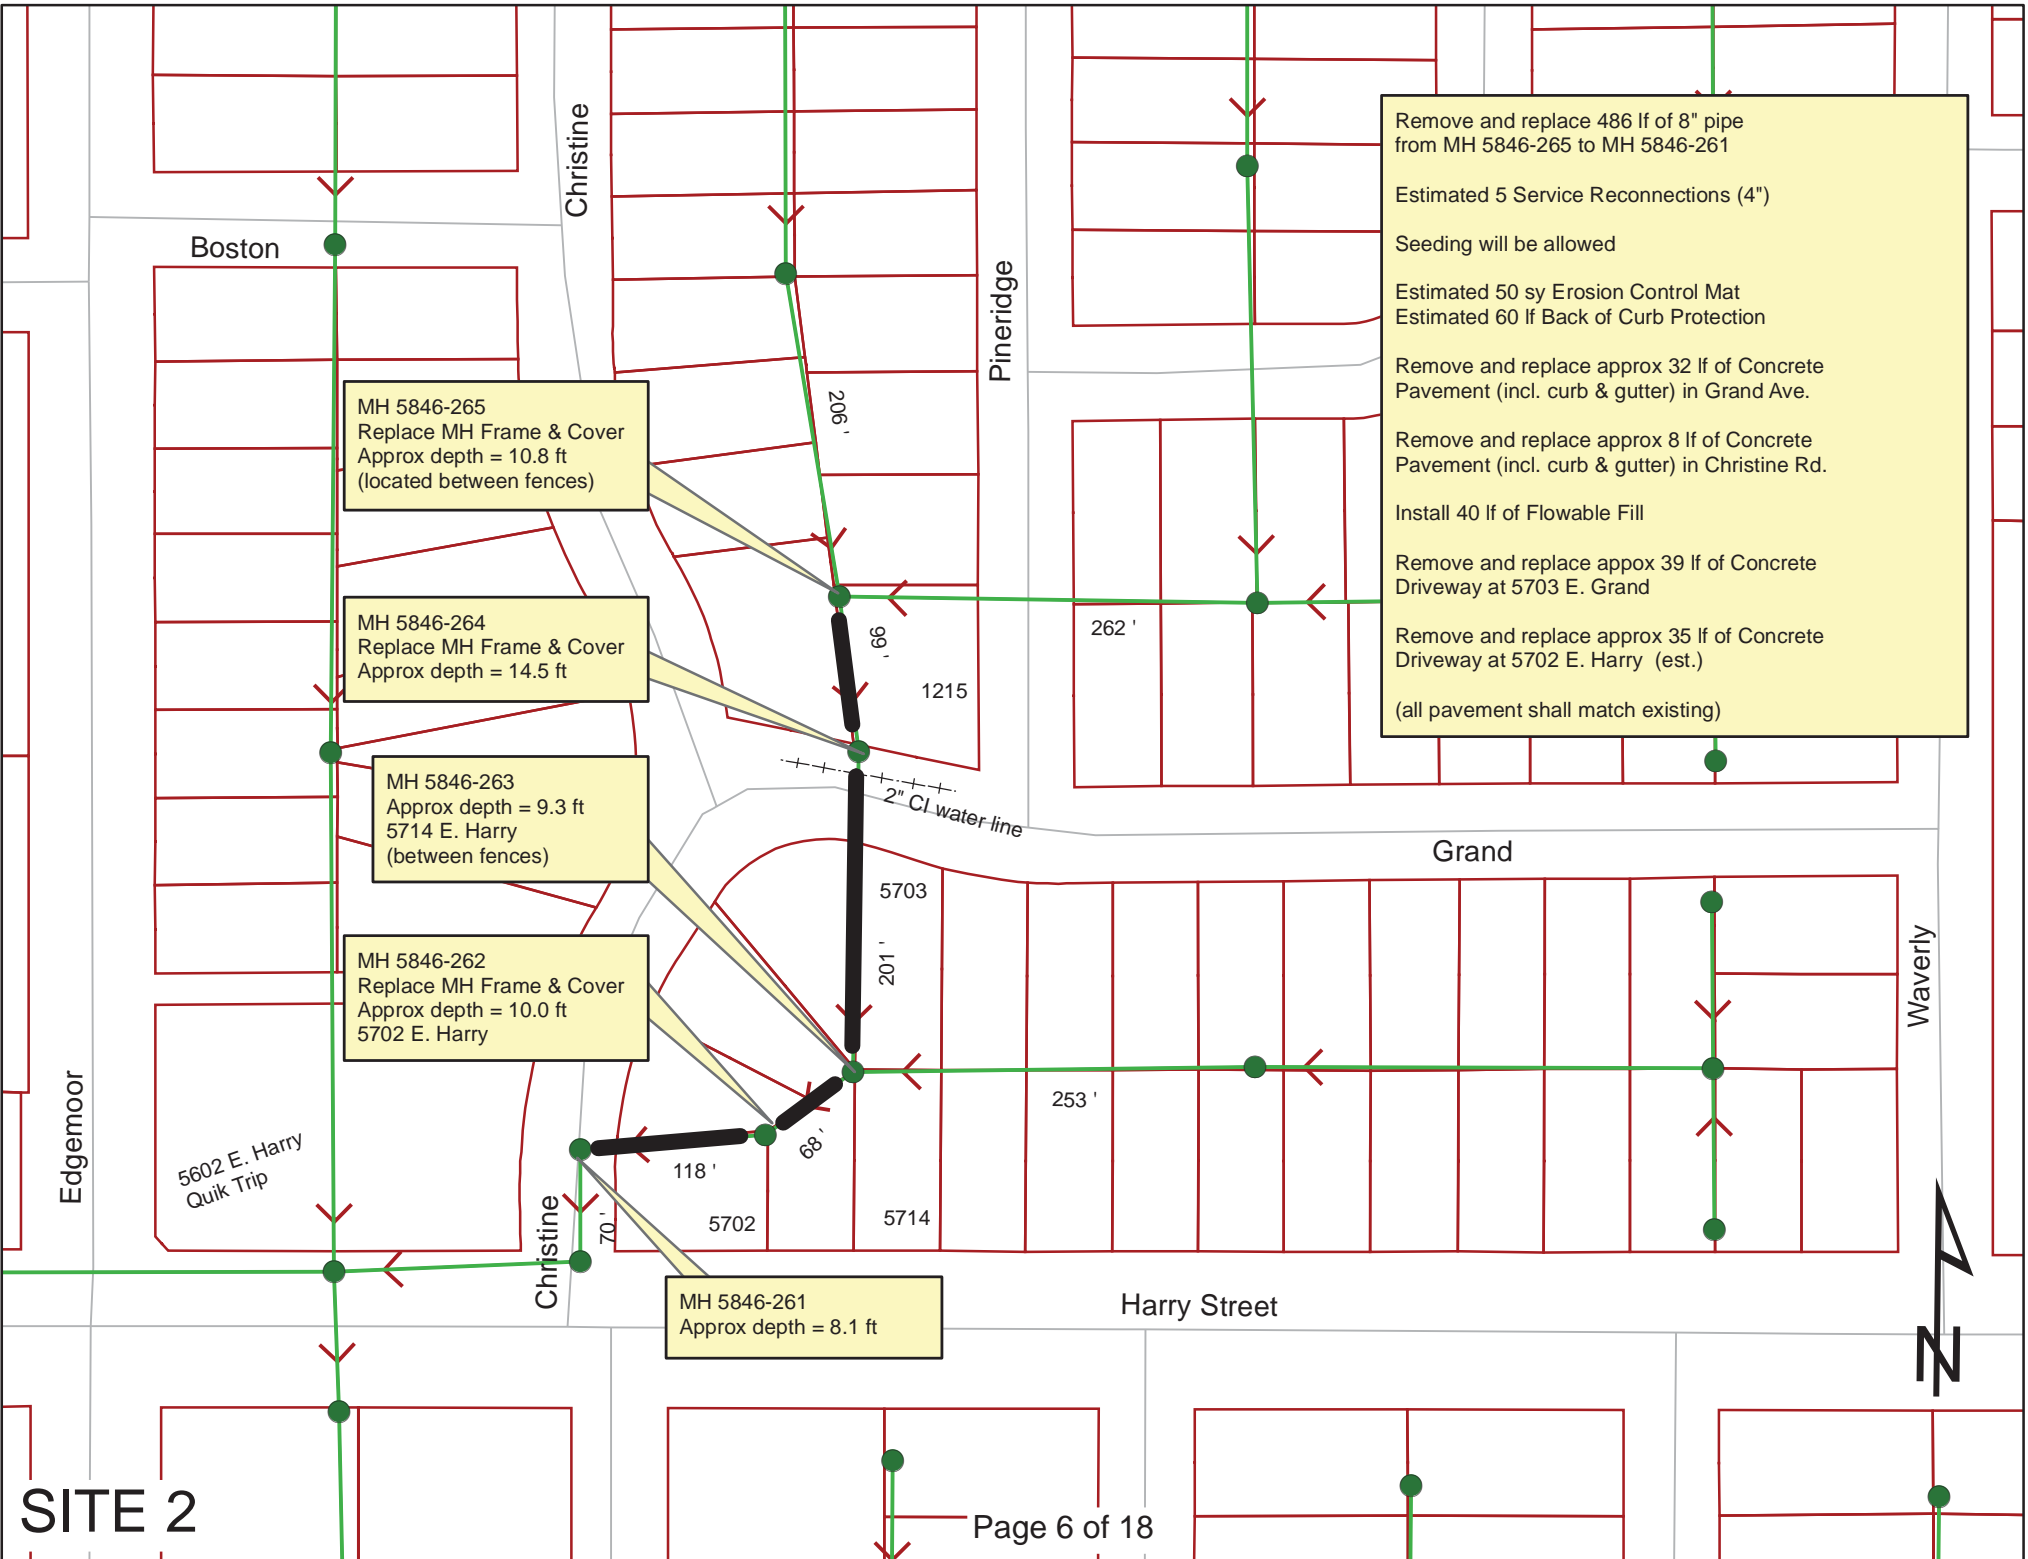
MH 5846-264
 Replace MH Frame & Cover
 Approx depth = 14.5 ft

MH 5846-263
 Approx depth = 9.3 ft
 5714 E. Harry
 (between fences)

MH 5846-262
 Replace MH Frame & Cover
 Approx depth = 10.0 ft
 5702 E. Harry

MH 5846-261
 Approx depth = 8.1 ft

Remove and replace 486 lf of 8" pipe from MH 5846-265 to MH 5846-261

Remove and replace approx 32 lf of Concrete Pavement (incl. curb & gutter) in Grand Ave.

Remove and replace approx 8 lf of Concrete Pavement (incl. curb & gutter) in Christine Rd.

Remove and replace approx 39 lf of Concrete Driveway at 5703 E. Grand

Remove and replace approx 35 lf of Concrete Driveway at 5702 E. Harry (est.)

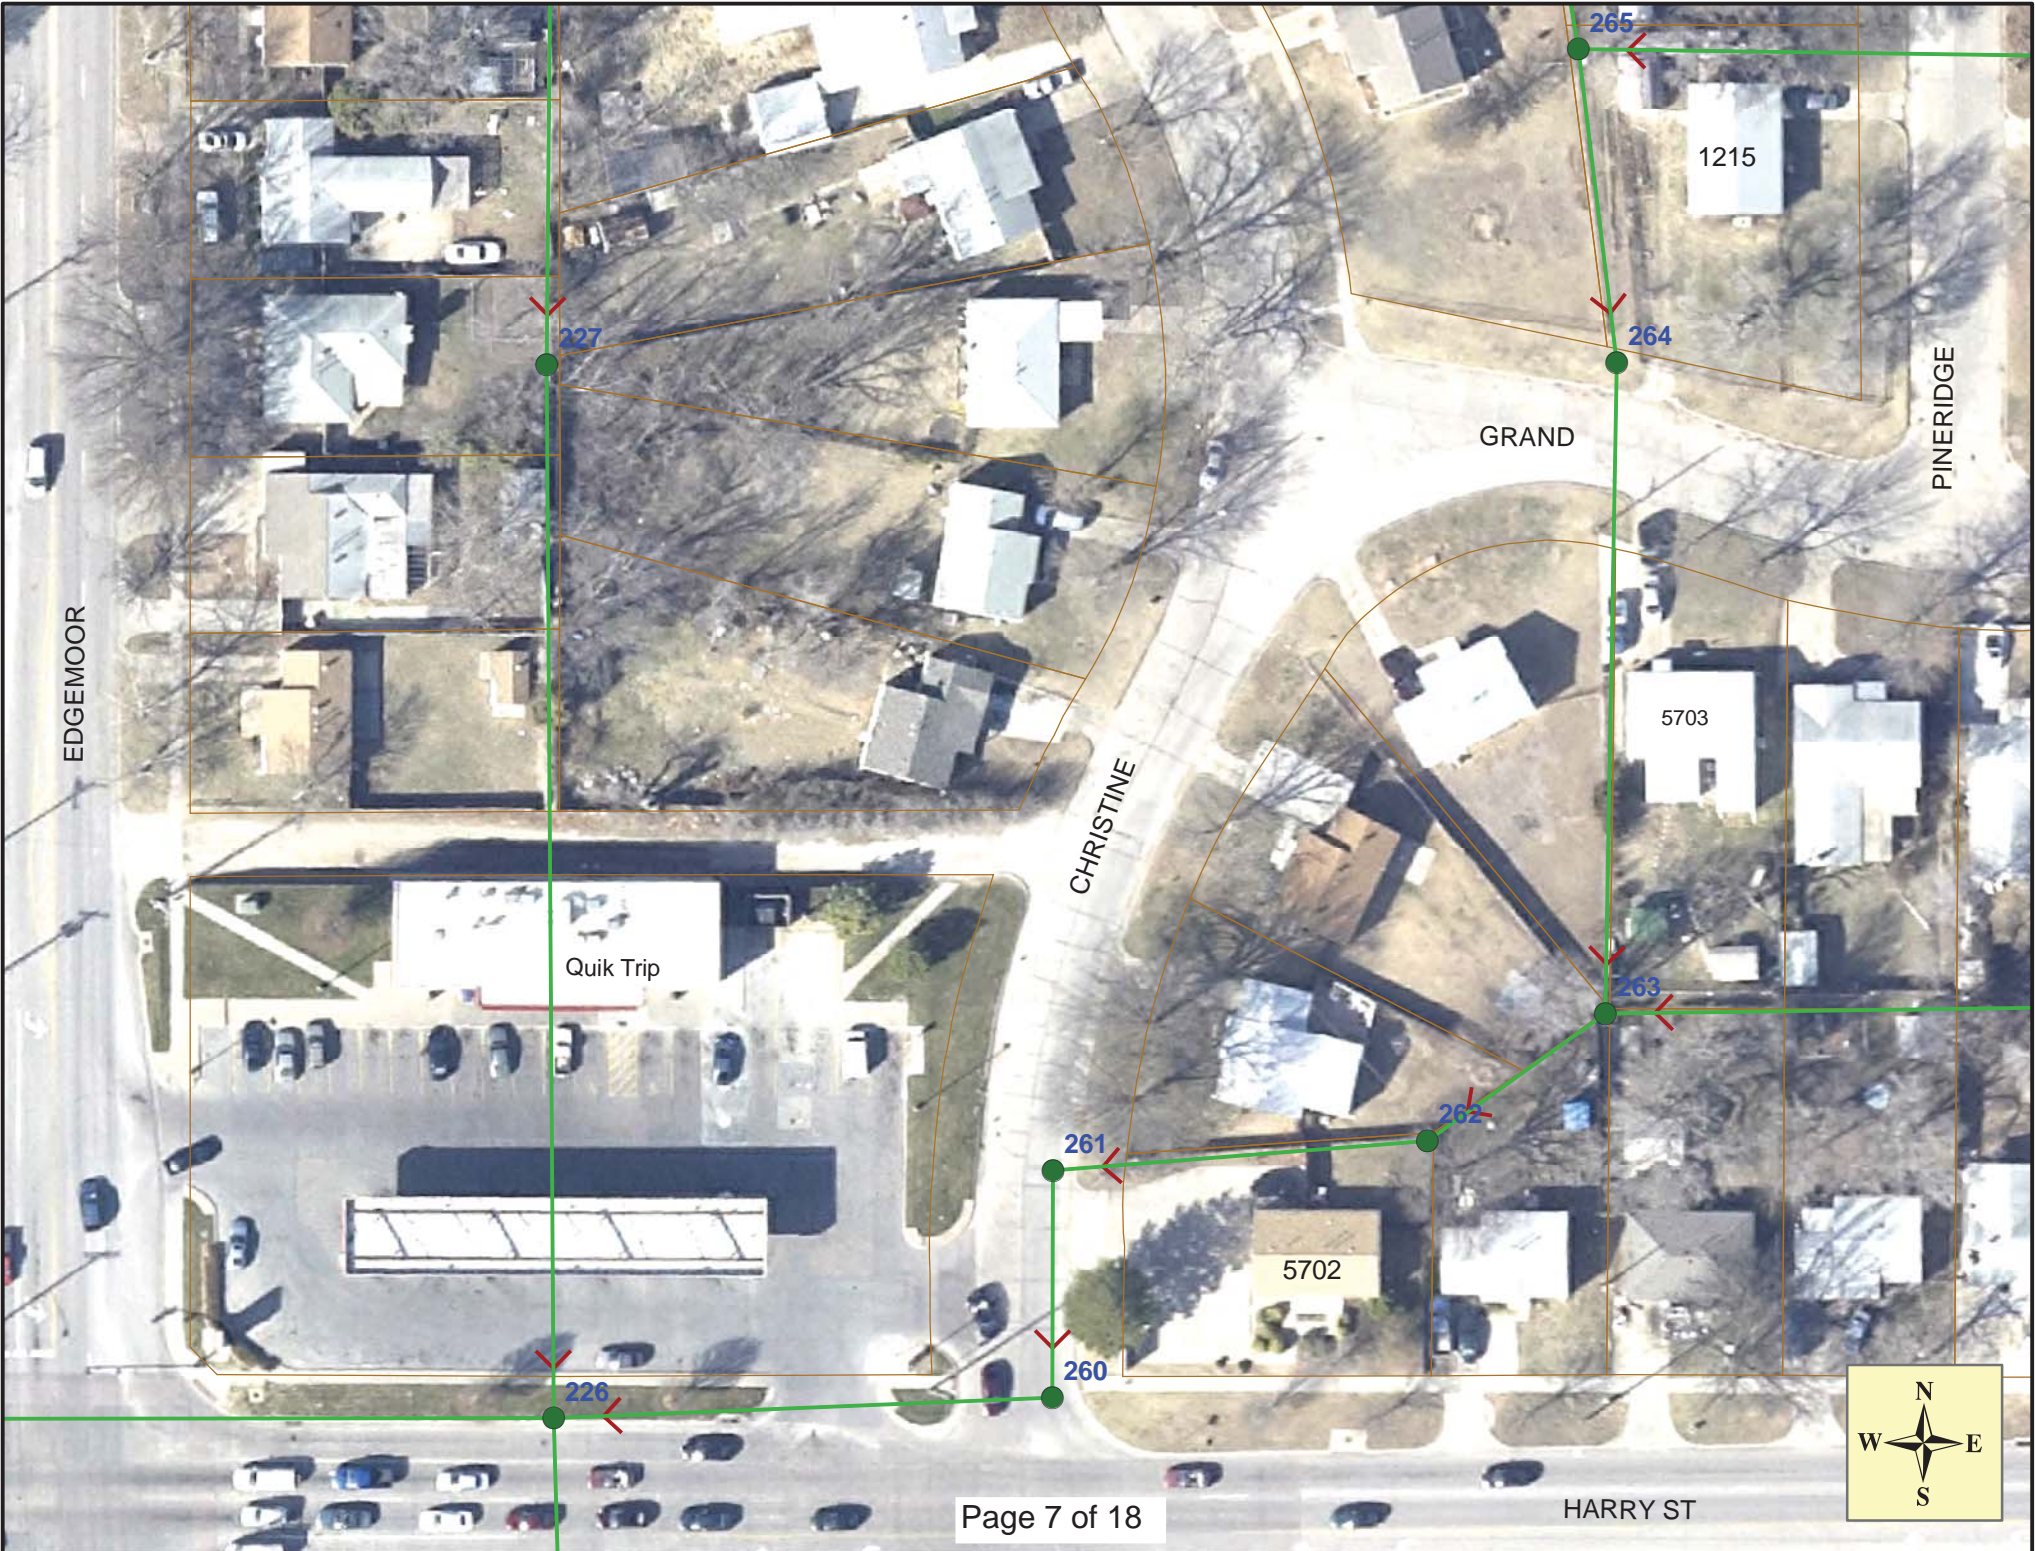
US Structure: 5846-265 1215 PINERIDGE ST Date Insp: 8/26/2008 Basin: E04A
 DS Structure: 5846-264 1215 PINERIDGE ST Dir Televised: Up->Down

Comments: PIPE IN GOOD CONDITION. SAGS THROUGH OUT LINE

SAGS THROUGH OUT LINE 5

Pipe grade is very flat. The area has maintenance problems. Need to eliminate the sags.
