MH 5650-267
Replace Manhole Frame & Cover

Sheet 4 of 22

SITE 1

Video Inspection Master Report

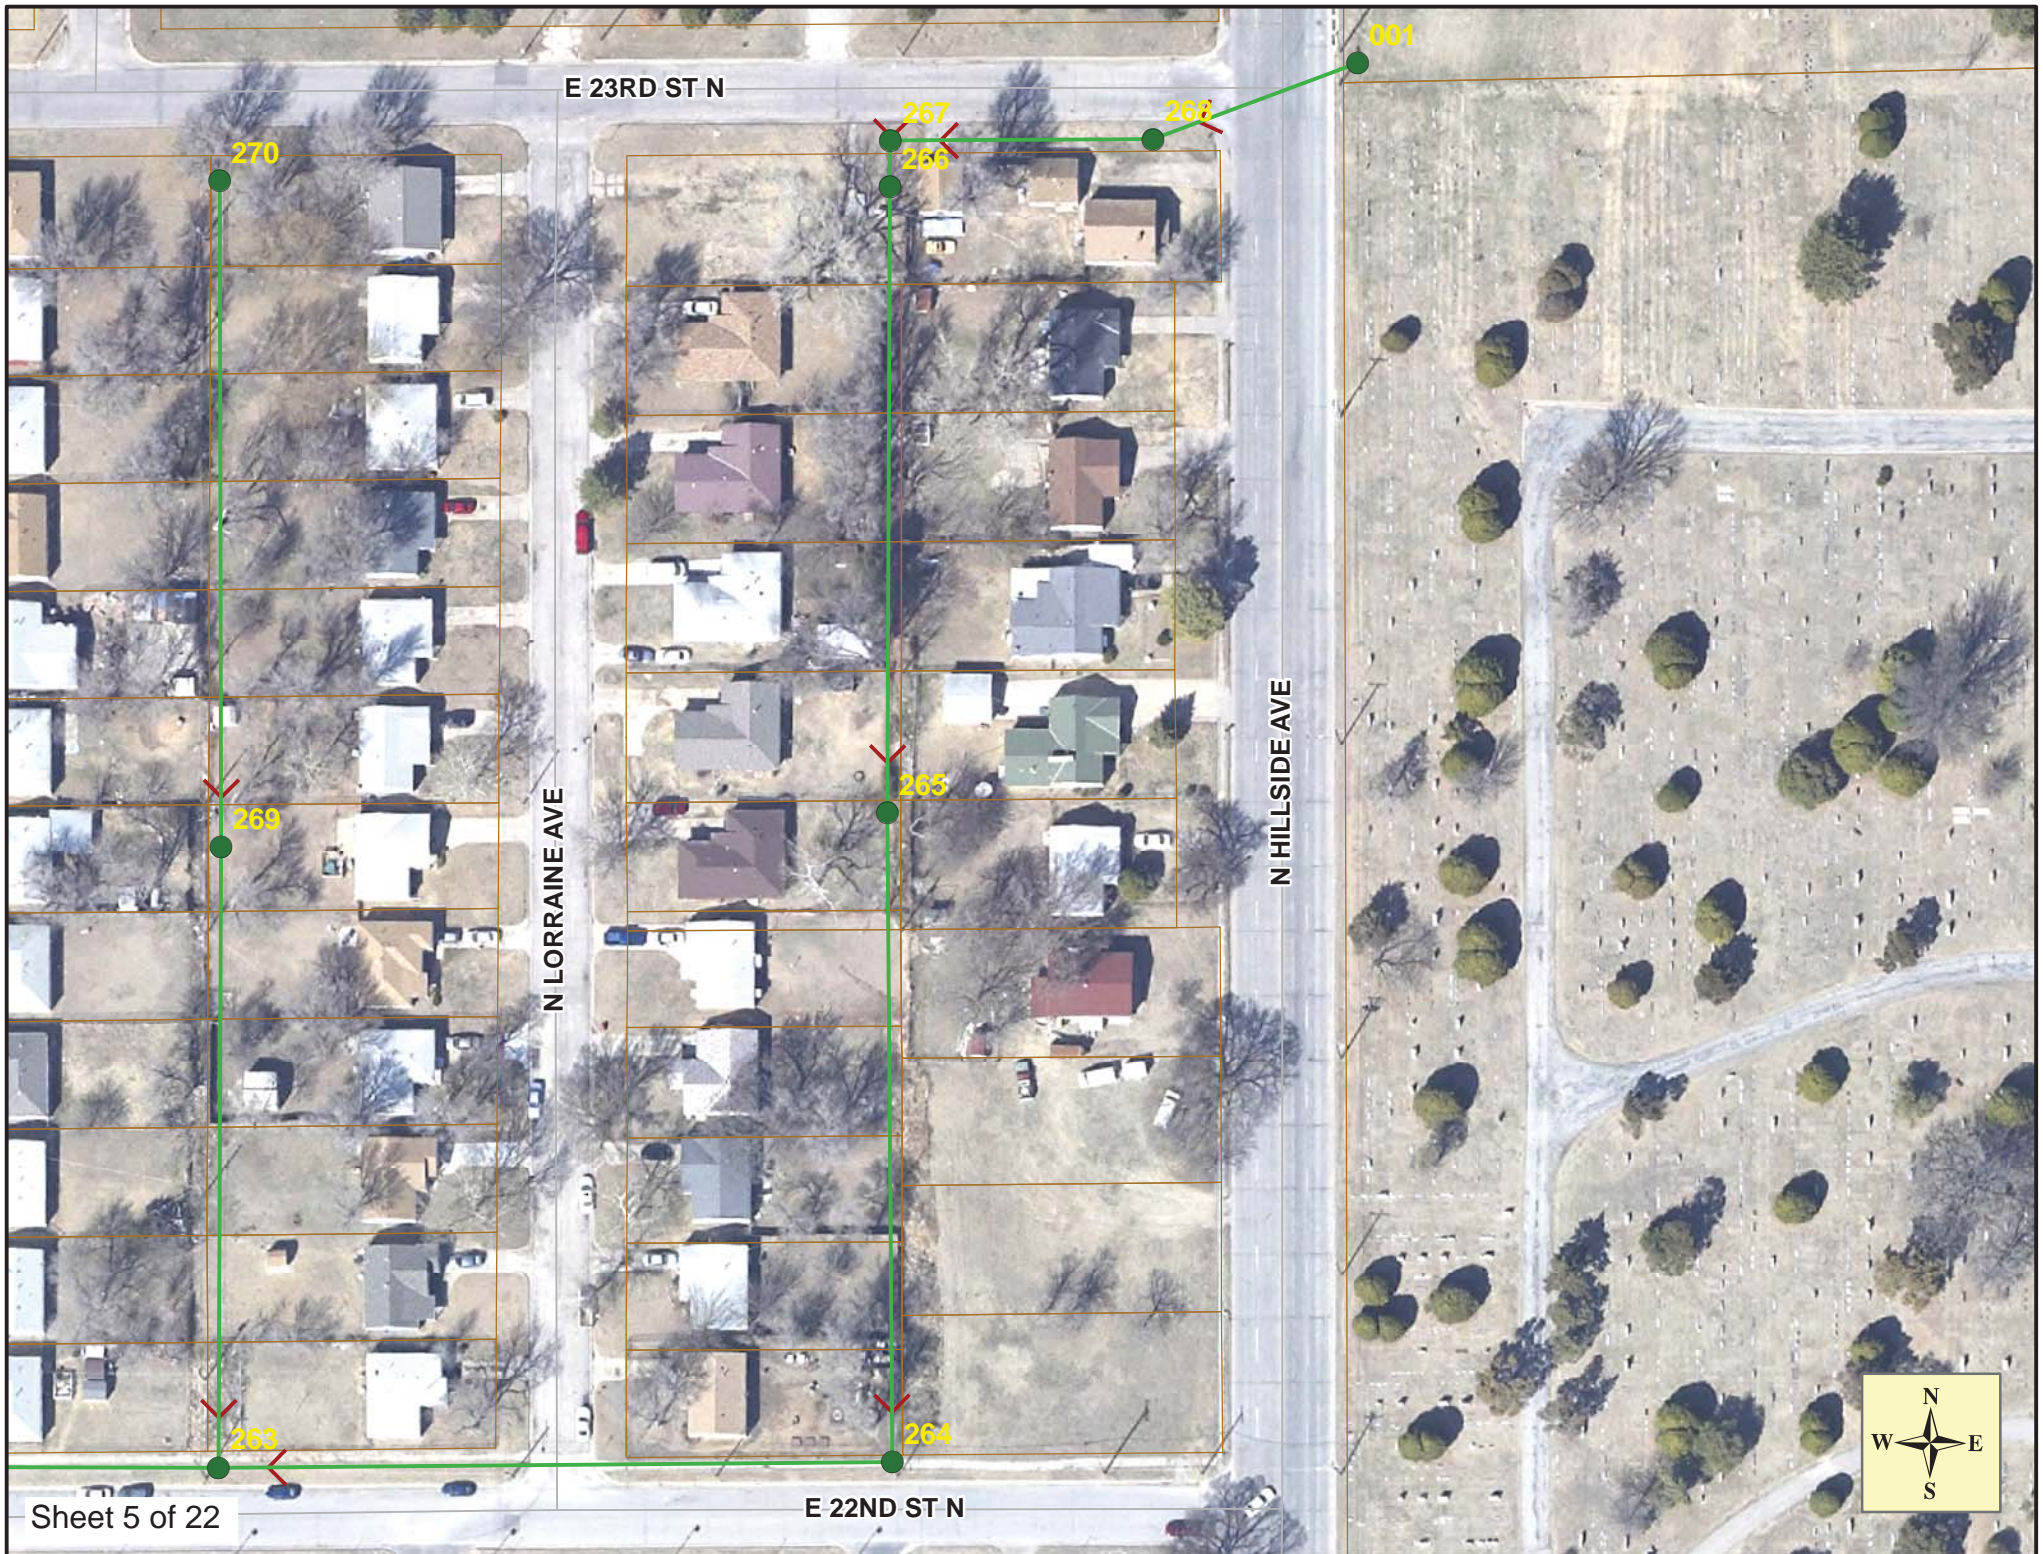
MH 5650-266
Replace Manhole Frame & Cover
Remove & Replace MH Bench & Invert
Approx MH depth = 8.8 ft

MH 5650-265
2326 N. Lorraine
Replace Manhole Frame & Cover
MH depth not measured

MH 5650-264
Replace Manhole Frame & Cover
Remove & Replace MH Bench & Invert
Approx pipe depth = 14.6 ft
Approx MH depth = 16.6 ft
Remove & Replace 4 lf Conc Sidewalk

Remove 593 lf of 8" Pipe
Install 593 lf of 8" Pipe
Estimated 17 Service Reconnections (4")
Estimated 1 Service Reconnection (6")
Easement is 16 ft wide

Estimated 20 lf Back of Curb Protection
Estimated 30 sy Erosion Control Mat
Estimated 20 lf Silt Fence
