Remove 311 lf of 6" pipe / Install 311 lf of 8" pipe  
from MH 5744-736 to MH 5744-684  
See site pictures / Contractor should review the site

# Television Inspection Master Report

3407 E SUNNYBROOK ST

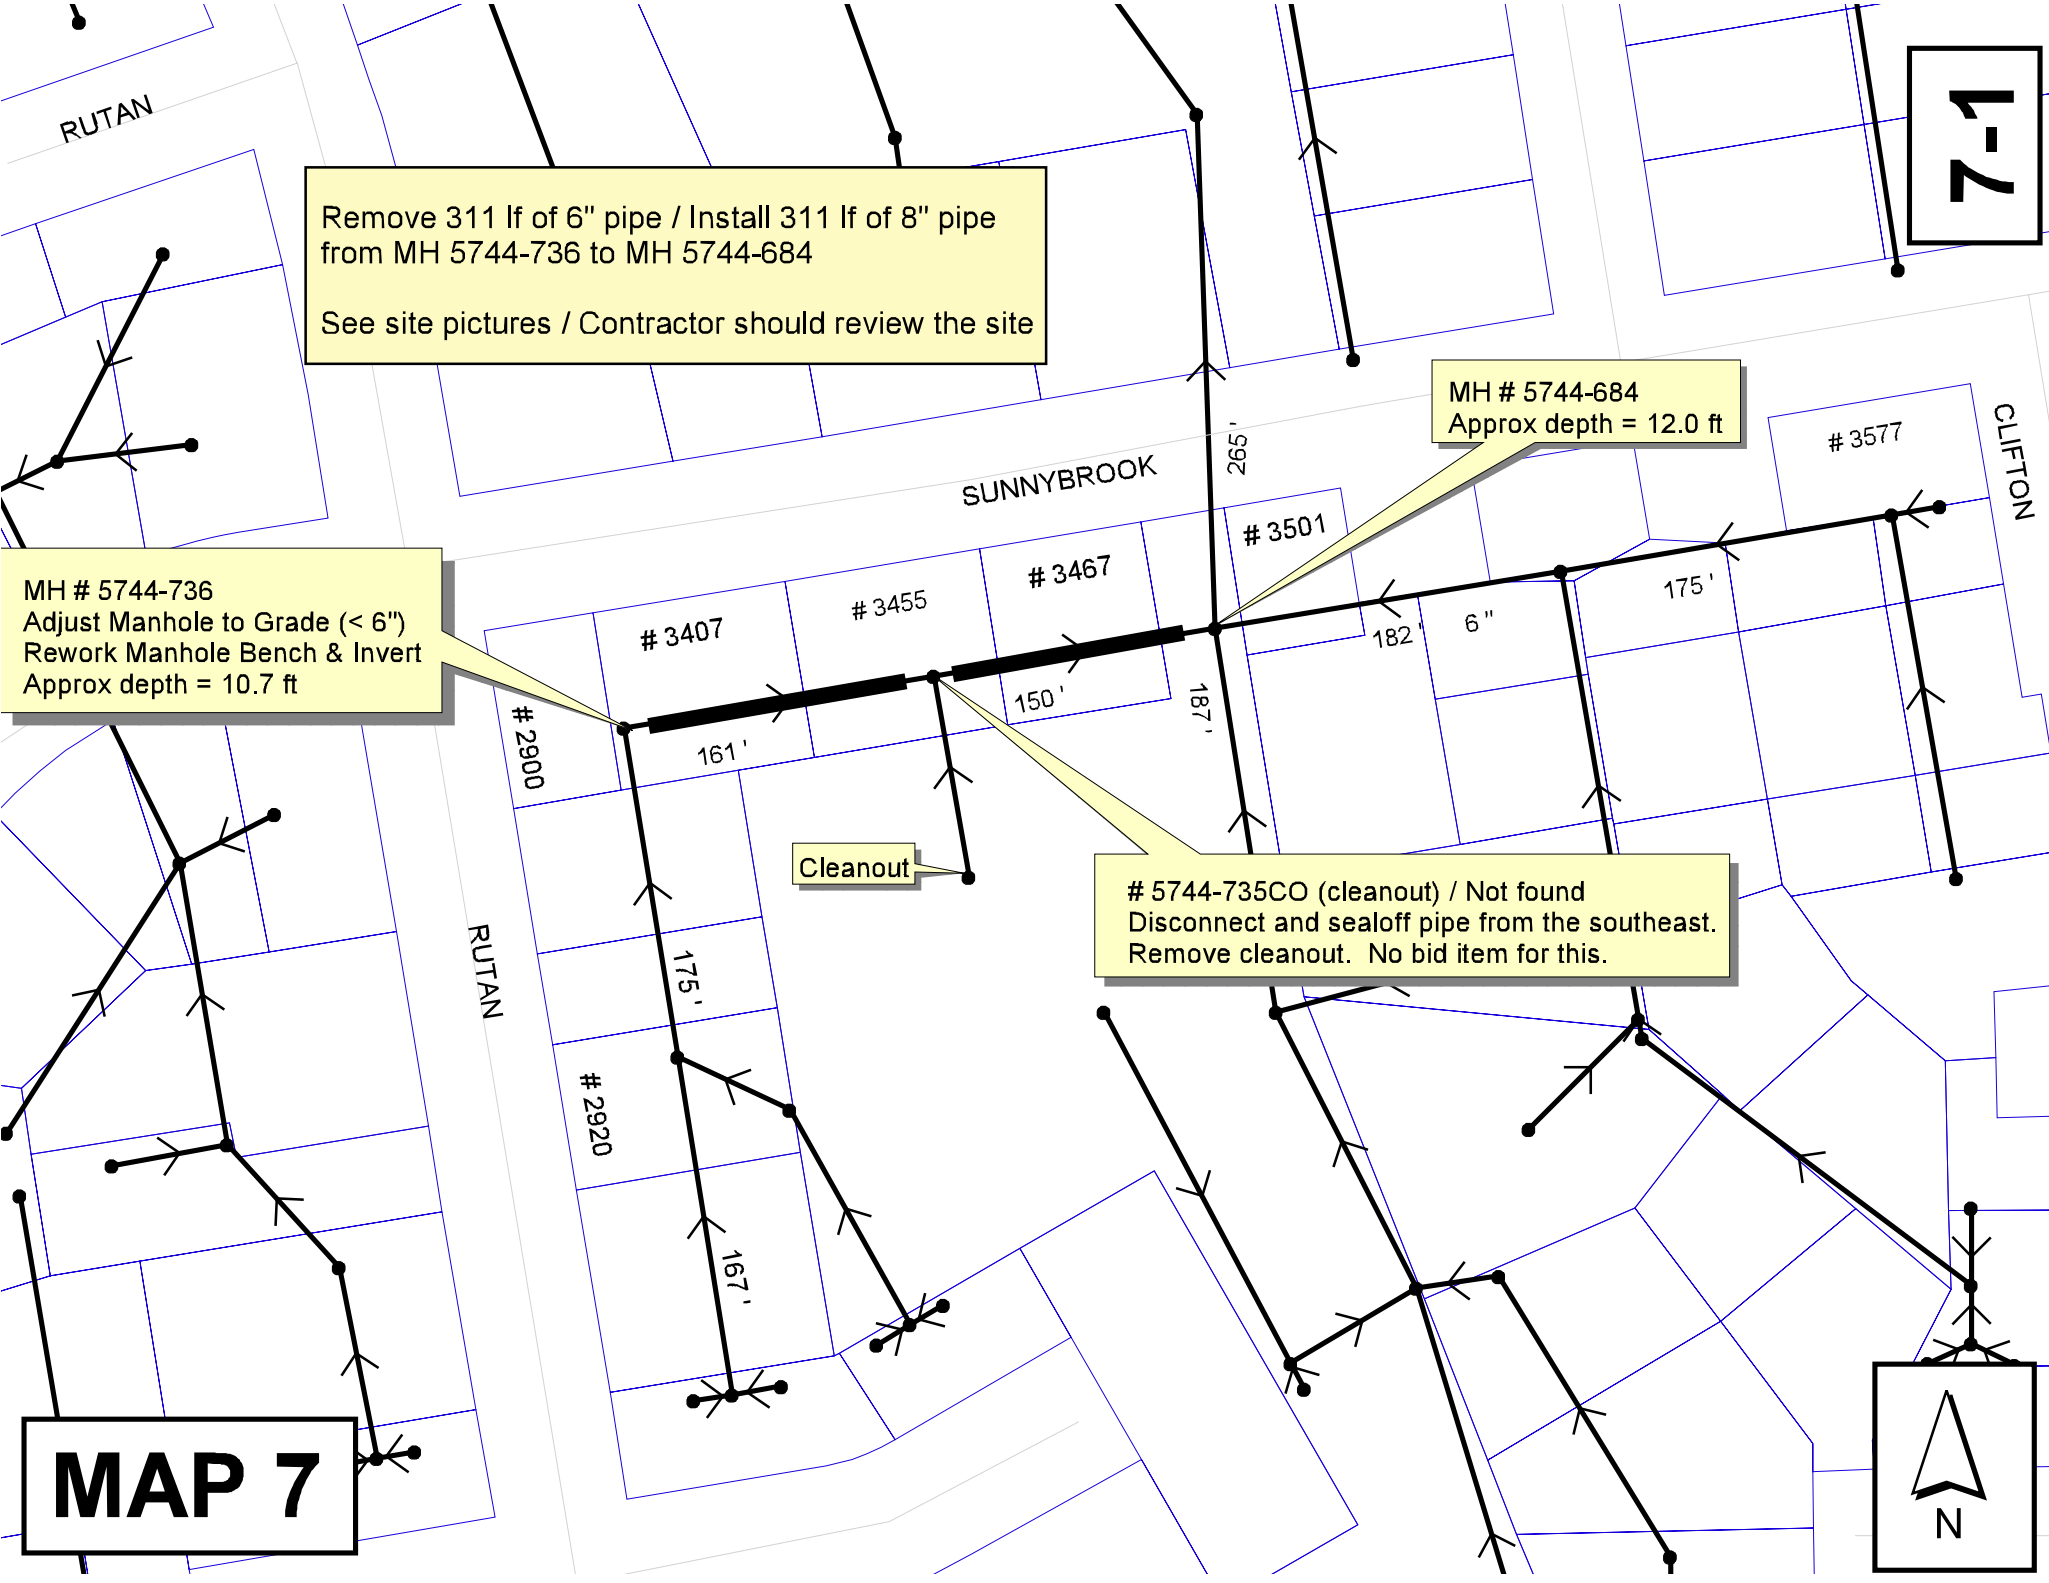
MH # 5744-684  
Approx depth = 12.0 ft

MH # 5744-736  
Adjust Manhole to Grade (< 6")  
Rework Manhole Bench & Invert  
Approx depth = 10.7 ft

# 5744-735CO (cleanout) / Not found  
Disconnect and sealoff pipe from the southeast.  
Remove cleanout. No bid item for this.

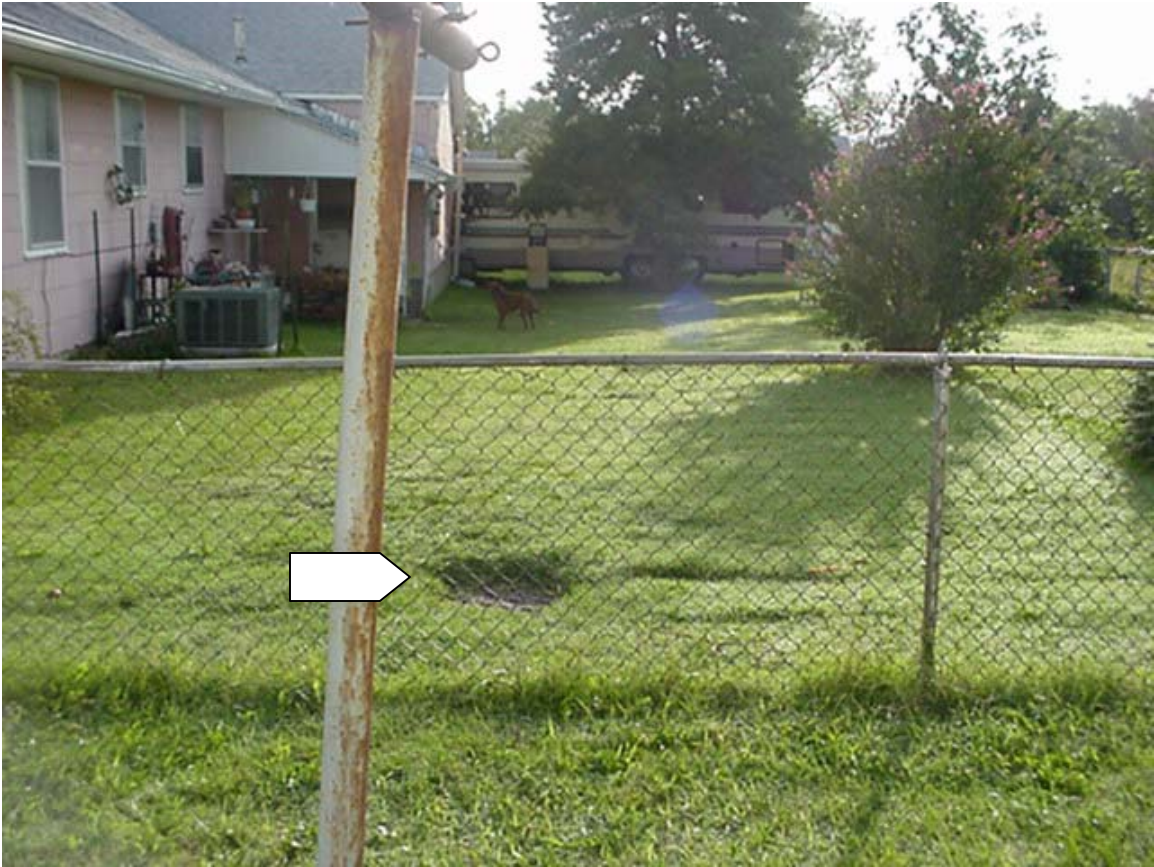
Standing west of MH 5744-736, looking east.

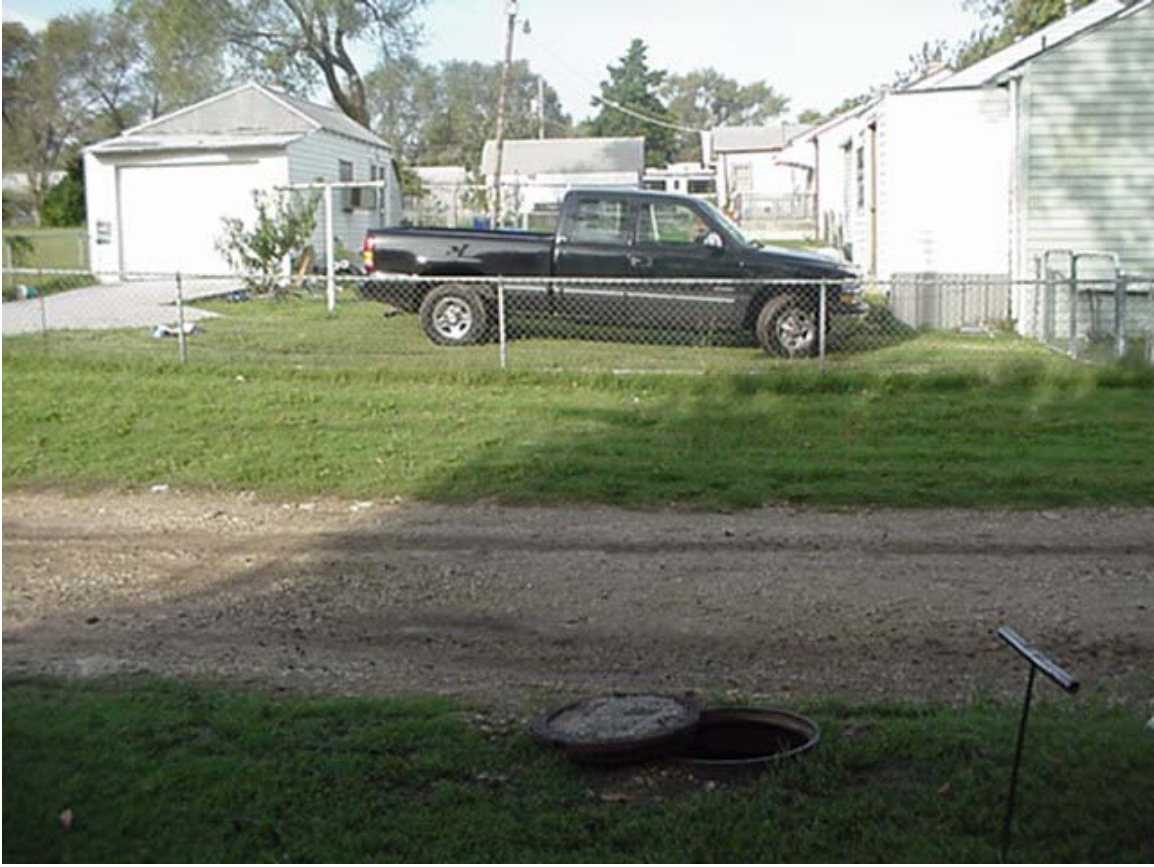
Standing east of MH 5744-684, looking west.  
Pipe goes between two buildings. Contractor should review the site.
