Television Inspection Master Report

US Structure: 5746-074
DS Structure: 5746-073

910 S BLUFFVIEW ST
4210 E BOSTON ST

Date Insp: 4/5/2006
Dir Televised: Upstream To Downstream

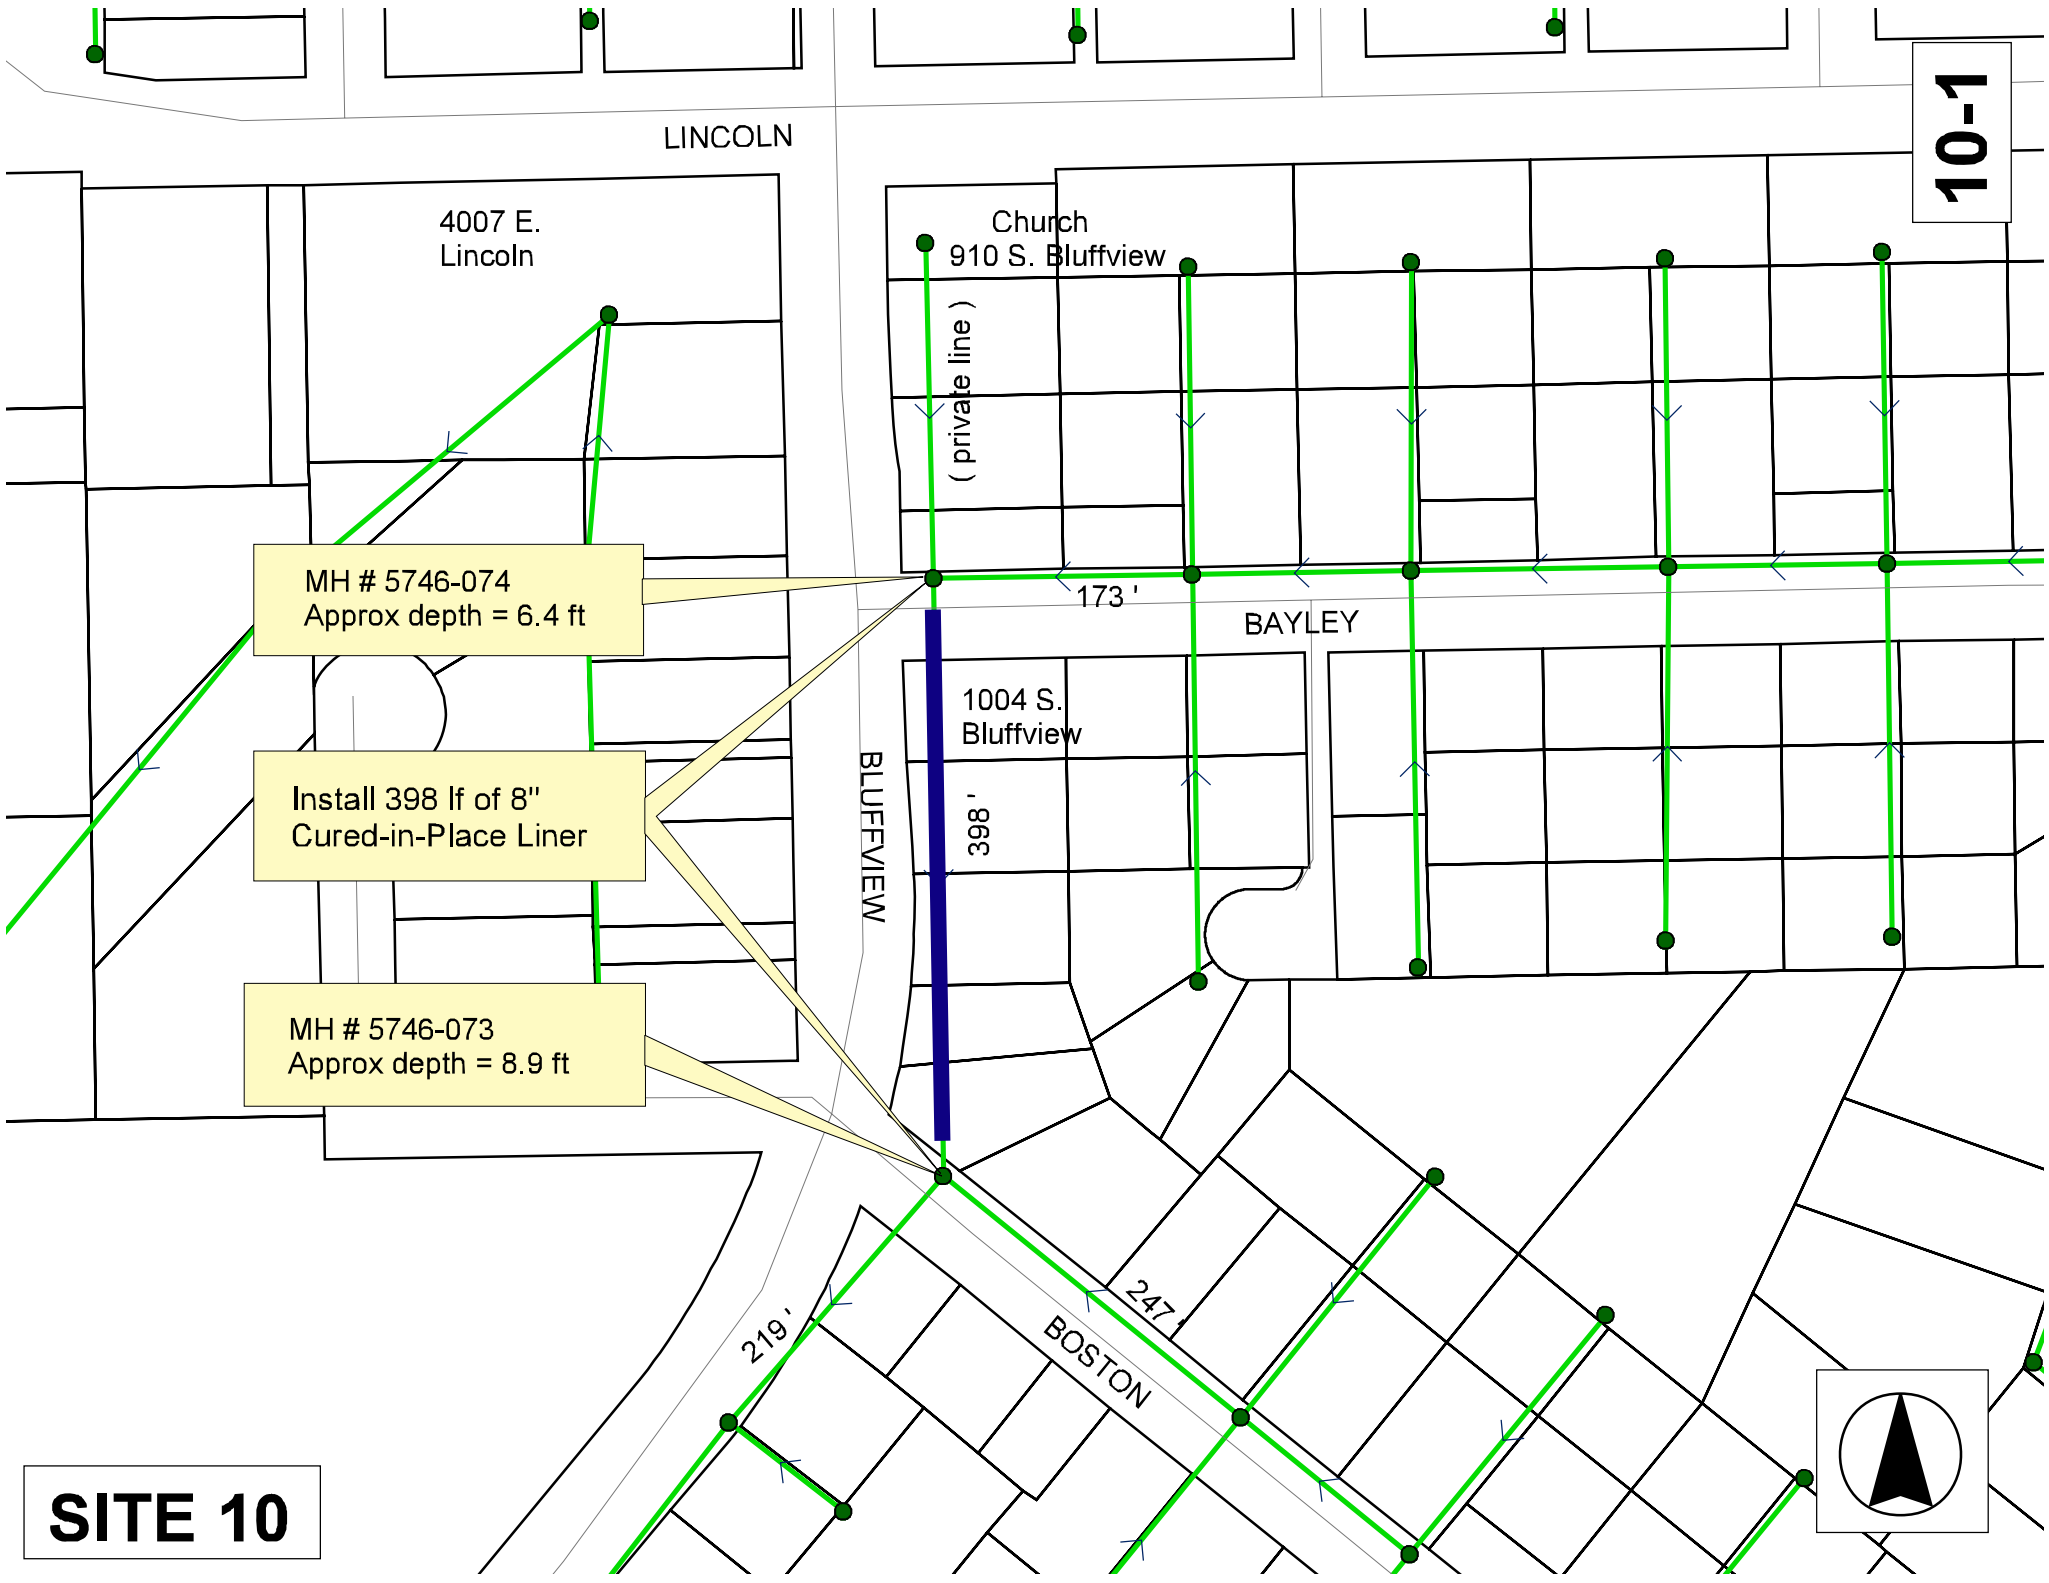
Aerial View

MH # 5746-074
Approx depth = 6.4 ft

MH # 5746-073
Approx depth = 8.9 ft

Install 398 lf of 8"
Cured-in-Place Liner

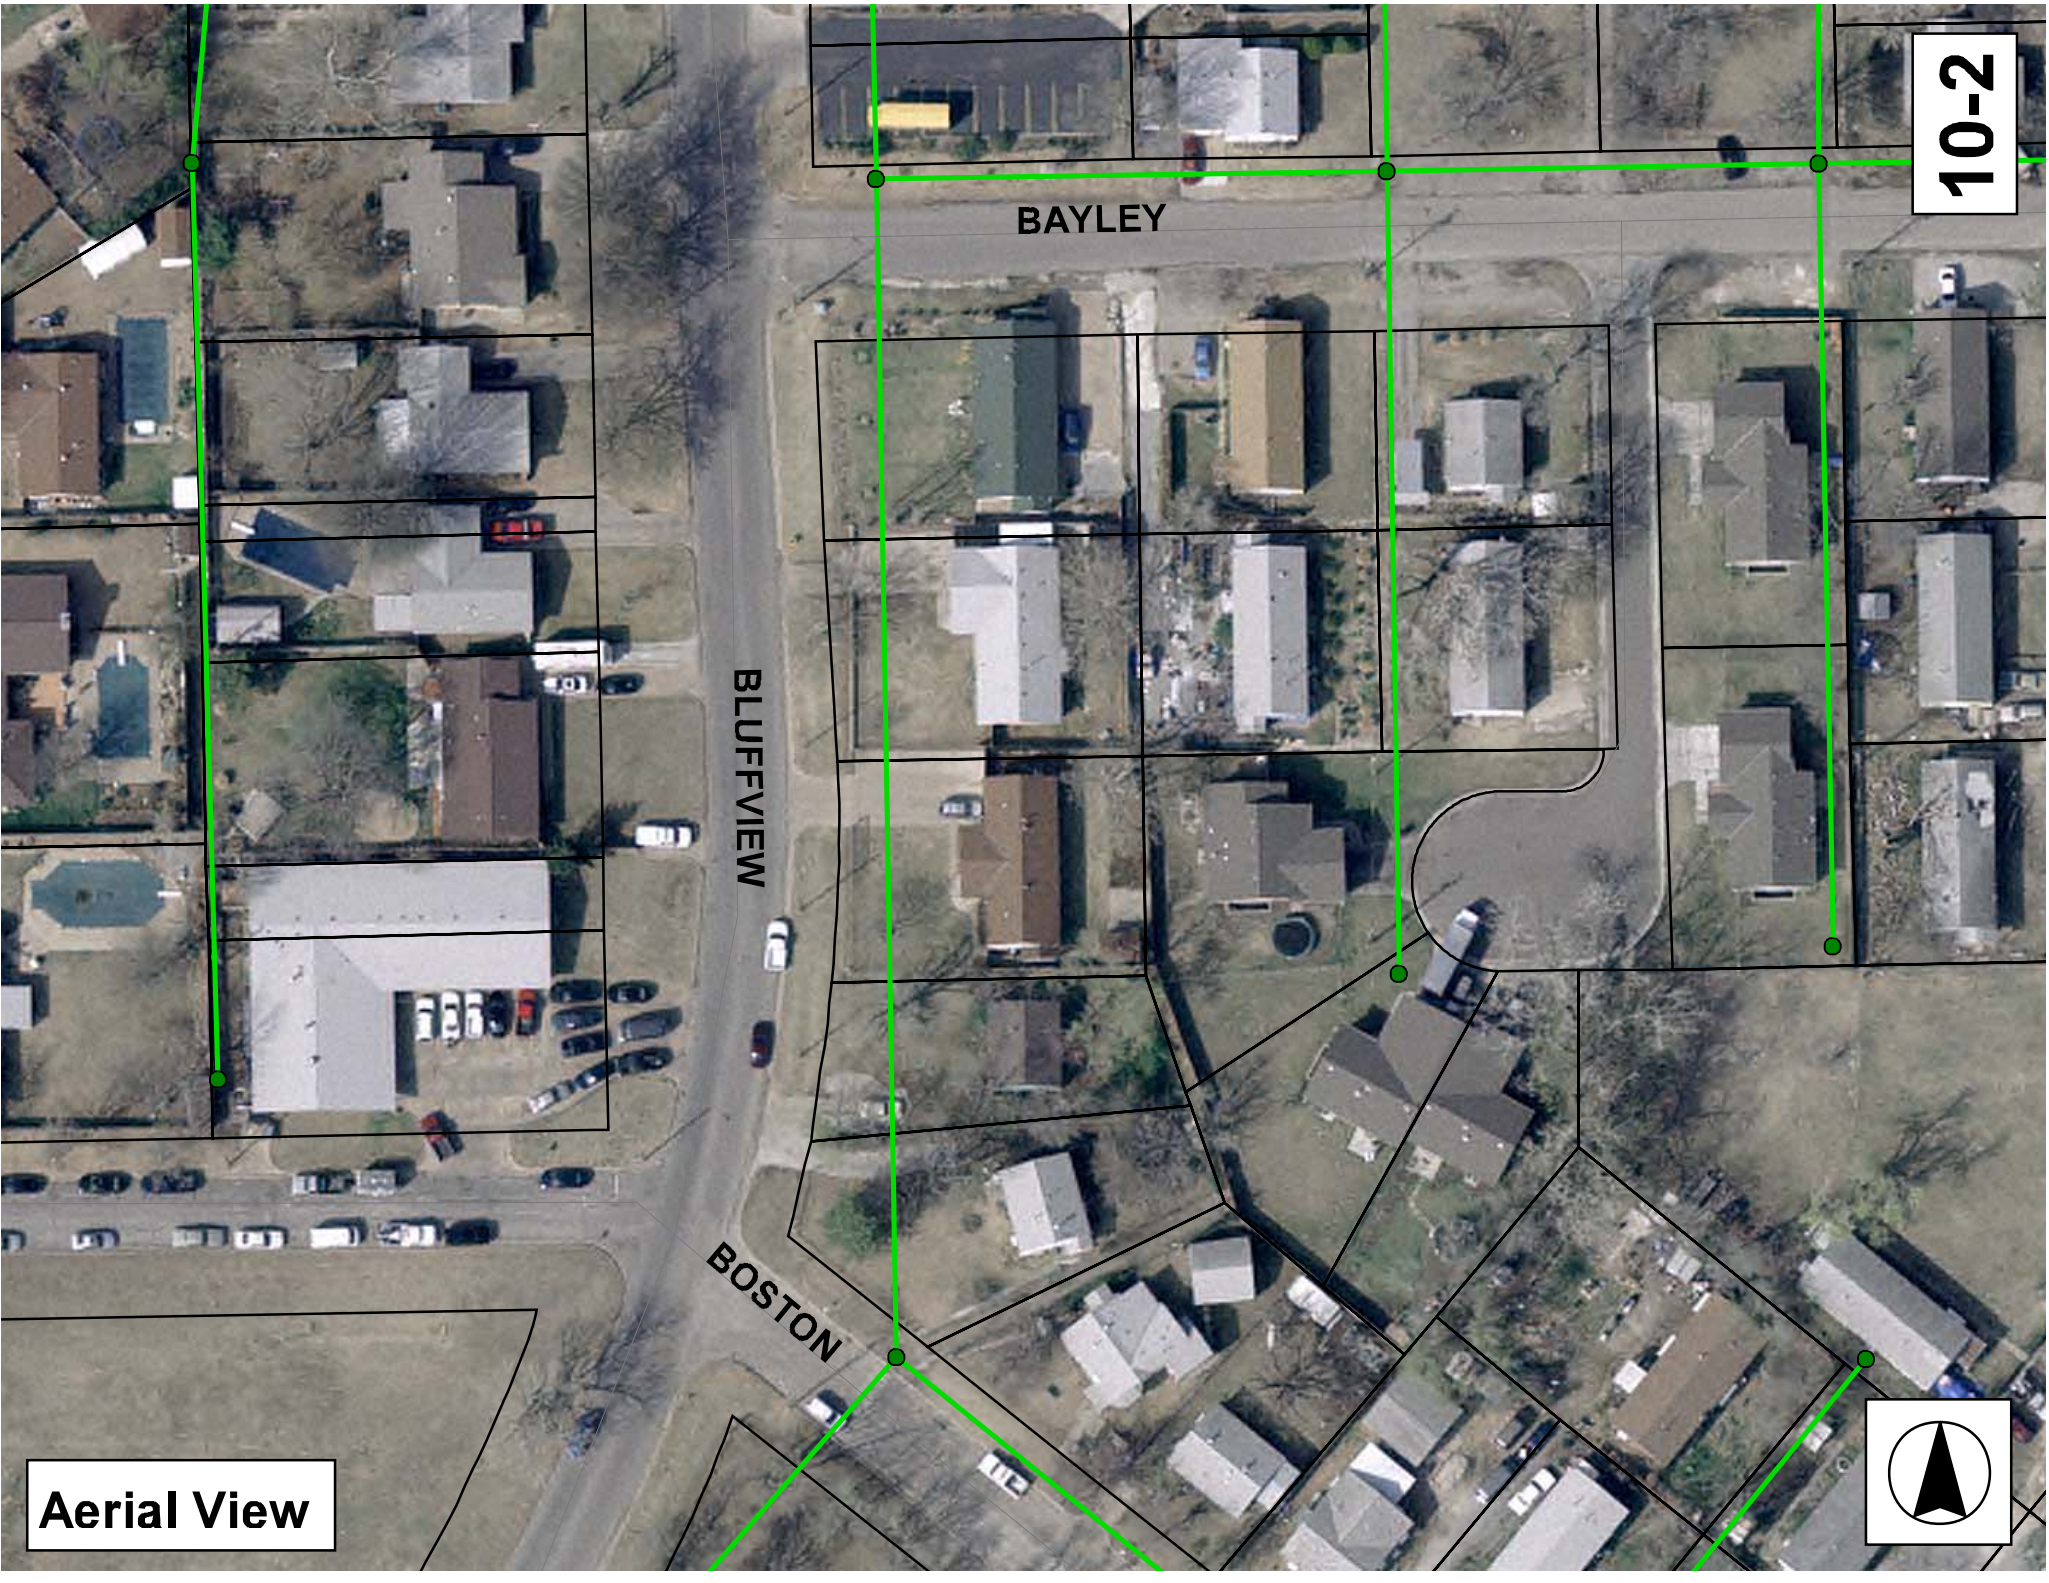
Obs. #	VTR Counter	Distance	Location	Description	Rating	Obsrvd (gpm)	Est. (gpm)	Ratings Struct	Clean	Remain (gpm)
1	00	0.0	US Manhole	5746-074	1		0.000	0	0	0.000
2	2:42	60.8	East	Break-In Conn	1		0.001	0	0	0.001
			1004 S BLUFFVIEW							
3	3:35	93.7	East	Wye Service	1		0.000	0	0	0.000
			1004 S BLUFFVIEW							
4	5:30	170.0	East	Wye Service	1		0.000	0	0	0.000
			1012 S BLUFFVIEW							
5	5:51	177.0	Quad 1 / U-Rt	Broken Pipe	2		0.008	44	0	0.008
6	7:45	243.7	East	Wye Service	3		0.000	2	0	0.000
			1020 S BLUFFVIEW / FULL OF ROOTS							
7		284.0	East	Break-In Conn	1		0.001	0	0	0.001
			1026 S. Bluffview							
8	9:21	318.9	Quad 4 / U-Lt	Roots	3		0.008	5	8	0.008
9	9:30	322.1	Quad 1 / U-Rt	Roots	2		0.004	2	4	0.004
10	10:36	368.4	Joint	PVC PIPE STARTS						
11	11:18	376.3	East	Break-In Conn	1		0.001	0	0	0.001
			4210 E BOSTON / PVC							
12	12:00	393.0	DS Manhole	5746-073	1		0.000	0	0	0.000

Line has a lot of grease in it. Some small cracks and several places with roots at the joints.
