Install 1100 lf of 8" Cured-in-Place Liner
from MH 5749-280 to MH 5749-268

SITE 13

Television Inspection Master Report

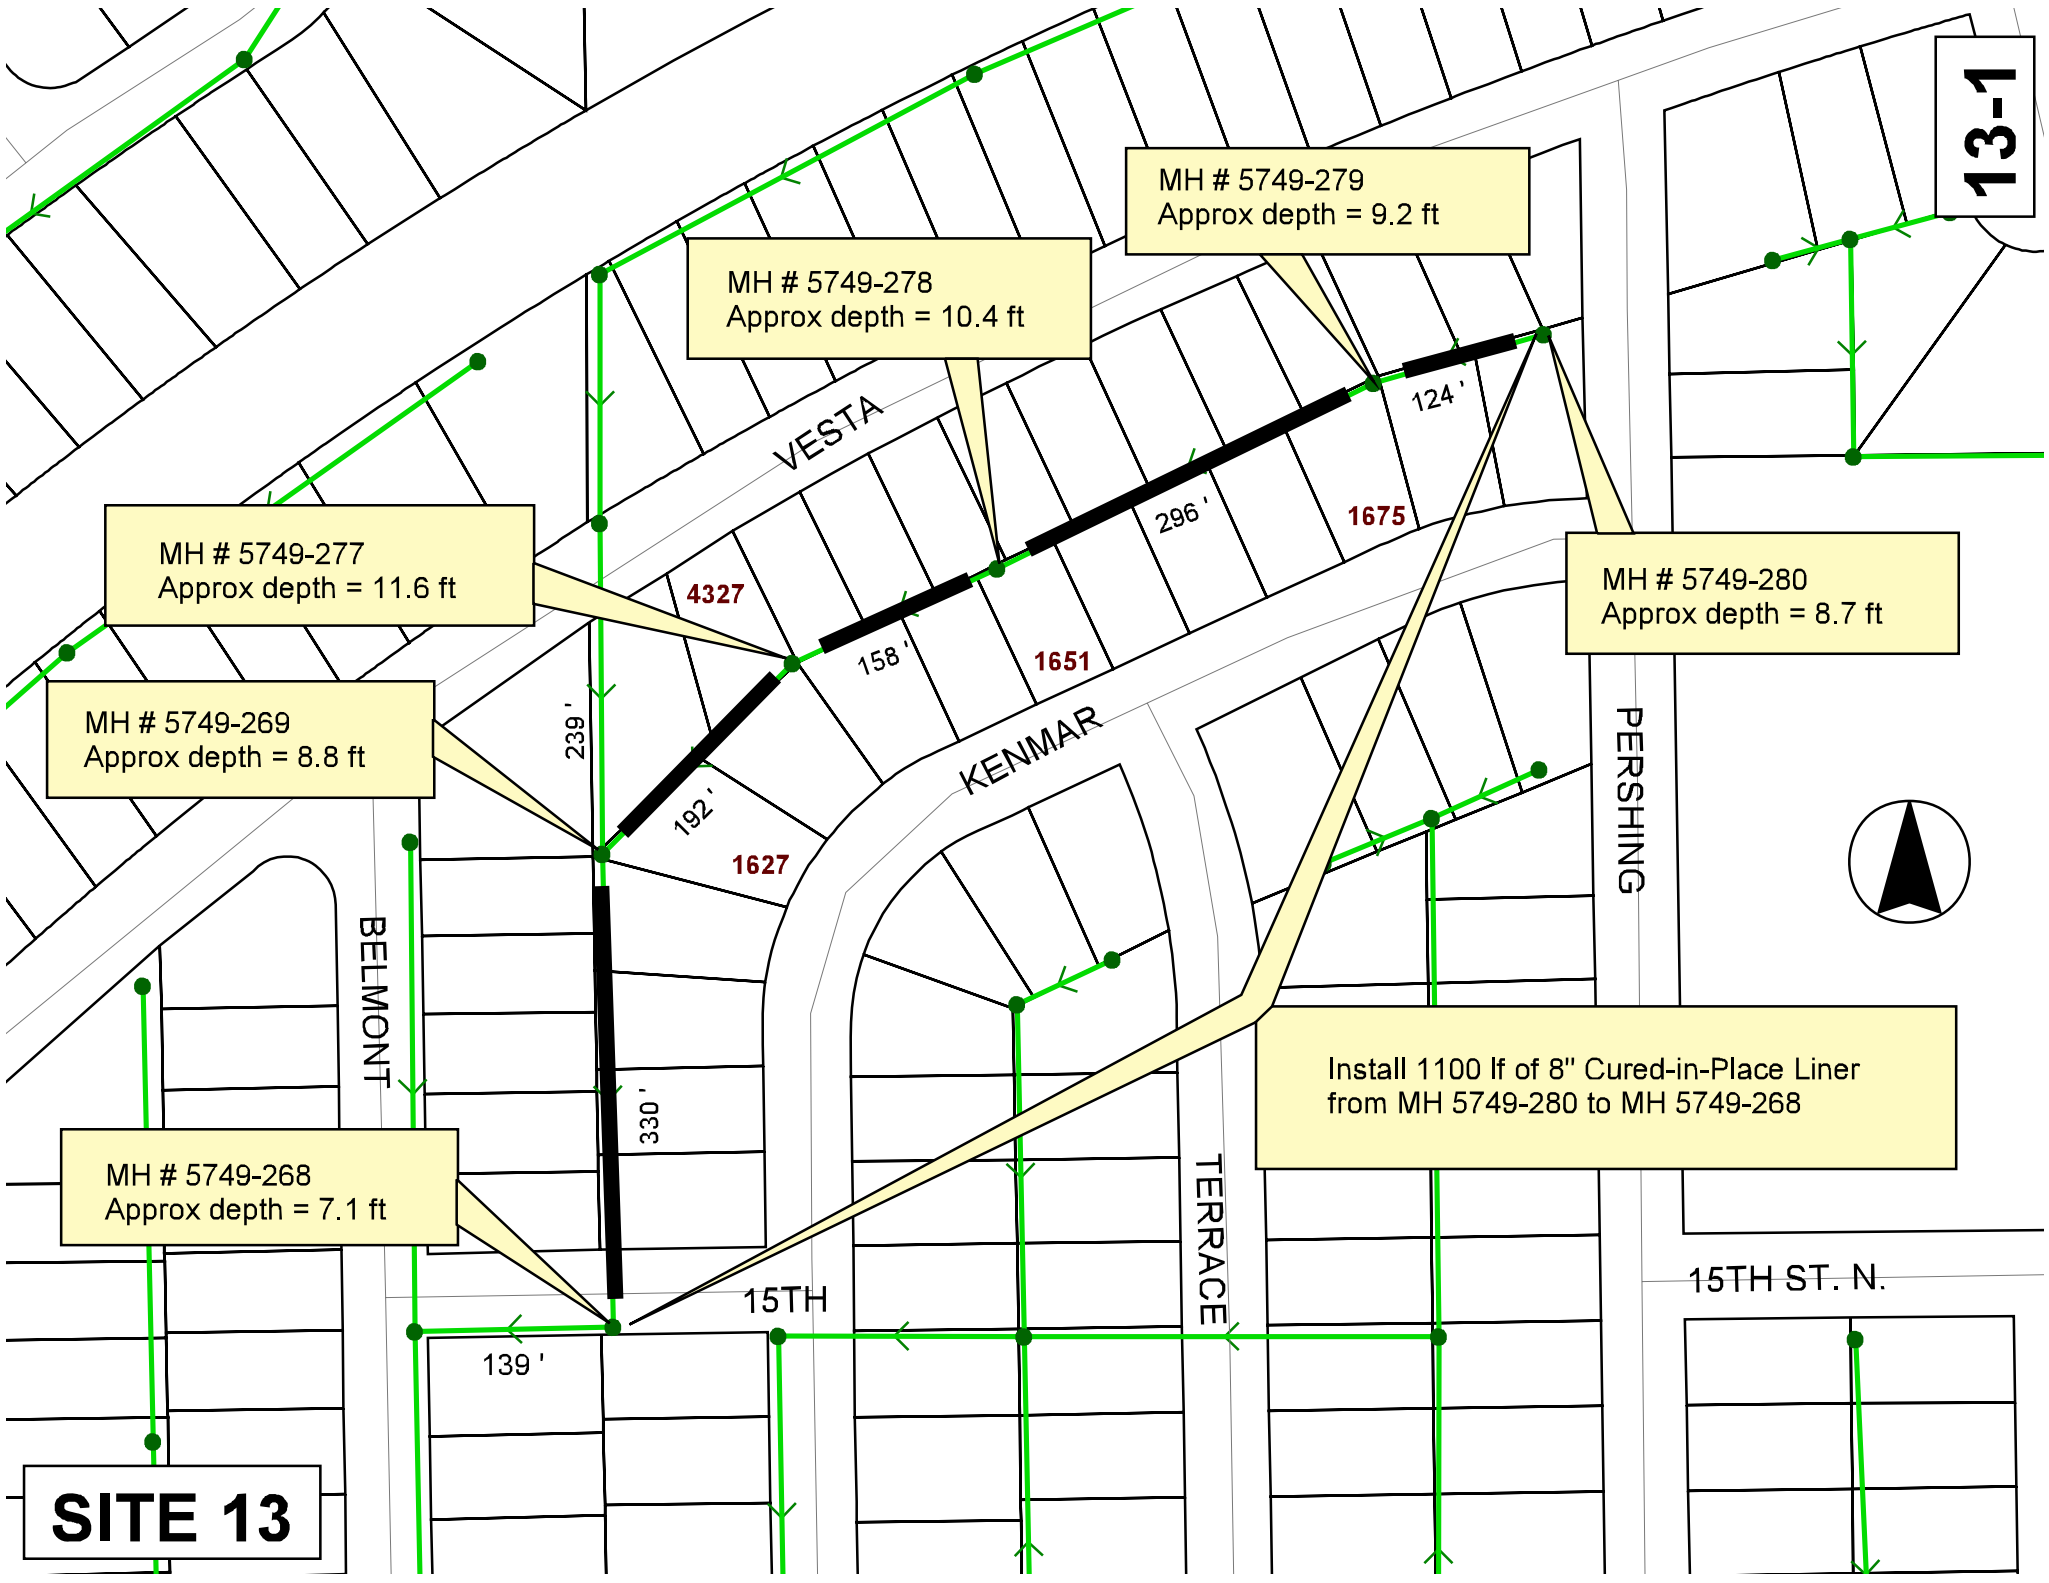
MH # 5749-279
Approx depth = 9.2 ft

MH # 5749-278
Approx depth = 10.4 ft

MH # 5749-280
Approx depth = 8.7 ft

MH # 5749-277
Approx depth = 11.6 ft

MH # 5749-269
Approx depth = 8.8 ft

MH # 5749-268
Approx depth = 7.1 ft
