Install 370 lf of 8" Cured-in-Place Liner from MH 5847-151 to MH 5847-486

**SITE 14**

# Television Inspection Master Report

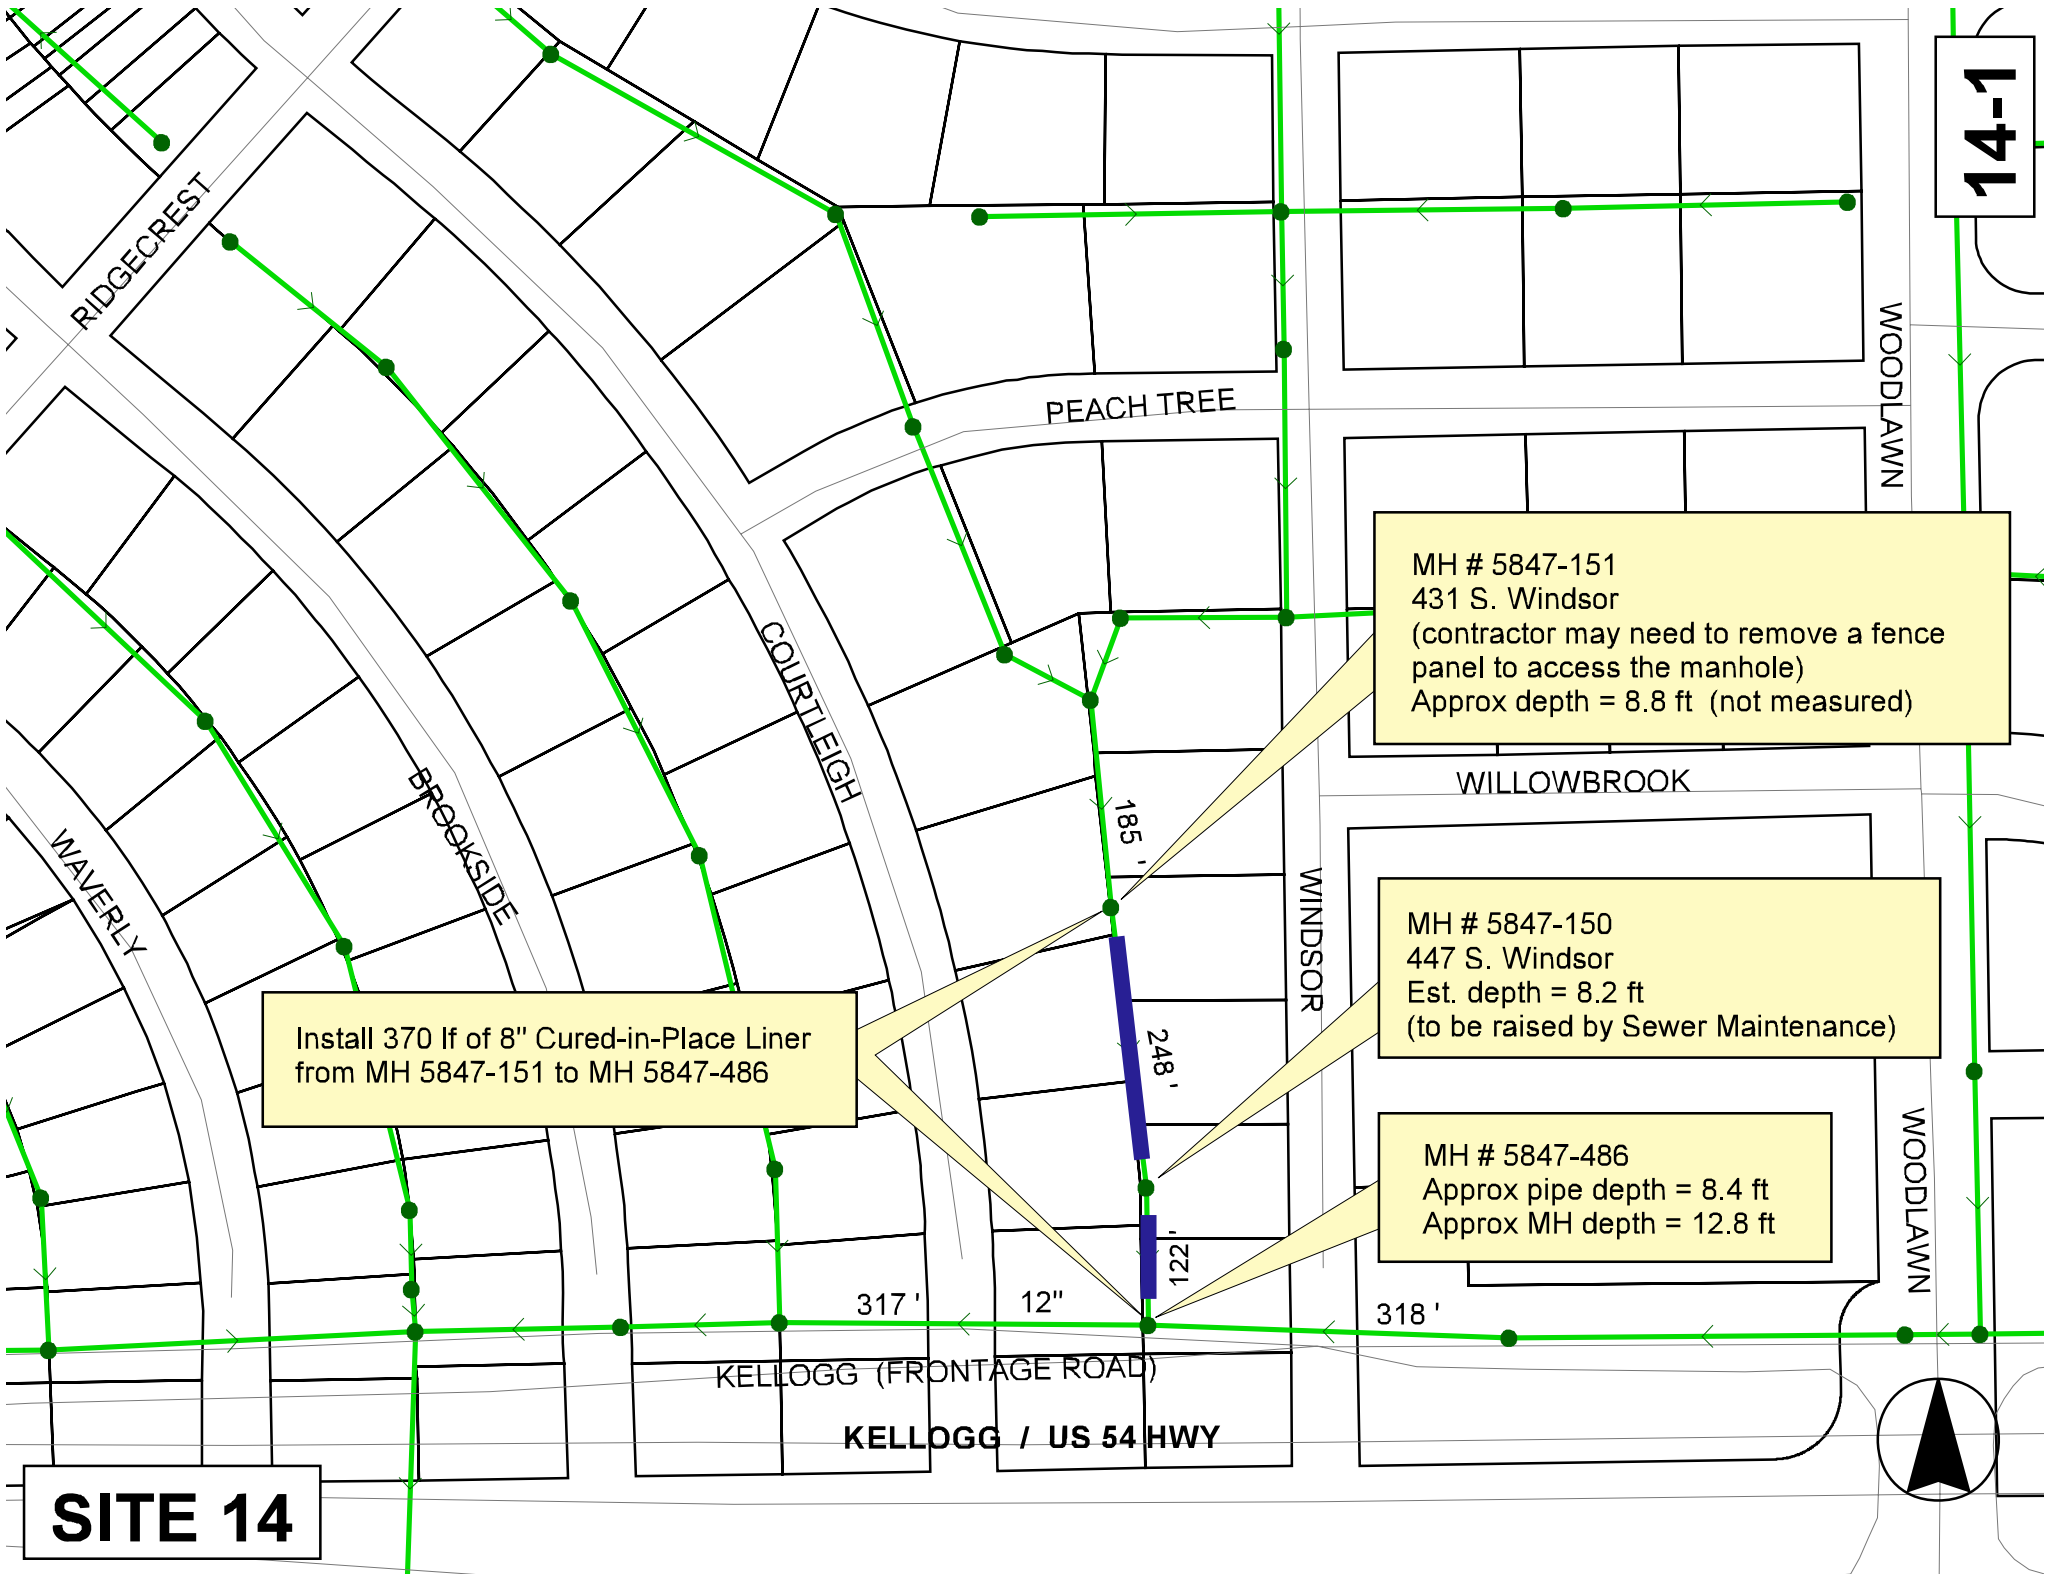
14-1

MH # 5847-151  
 431 S. Windsor  
 (contractor may need to remove a fence panel to access the manhole)  
 Approx depth = 8.8 ft (not measured)

MH # 5847-150  
 447 S. Windsor  
 Est. depth = 8.2 ft  
 (to be raised by Sewer Maintenance)

MH # 5847-486  
 Approx pipe depth = 8.4 ft  
 Approx MH depth = 12.8 ft
