Install 768 lf of 8" Cured-in-Place Liner
from MH 5648-333 to MH 5648-305

SITE 3

Television Inspection Master Report

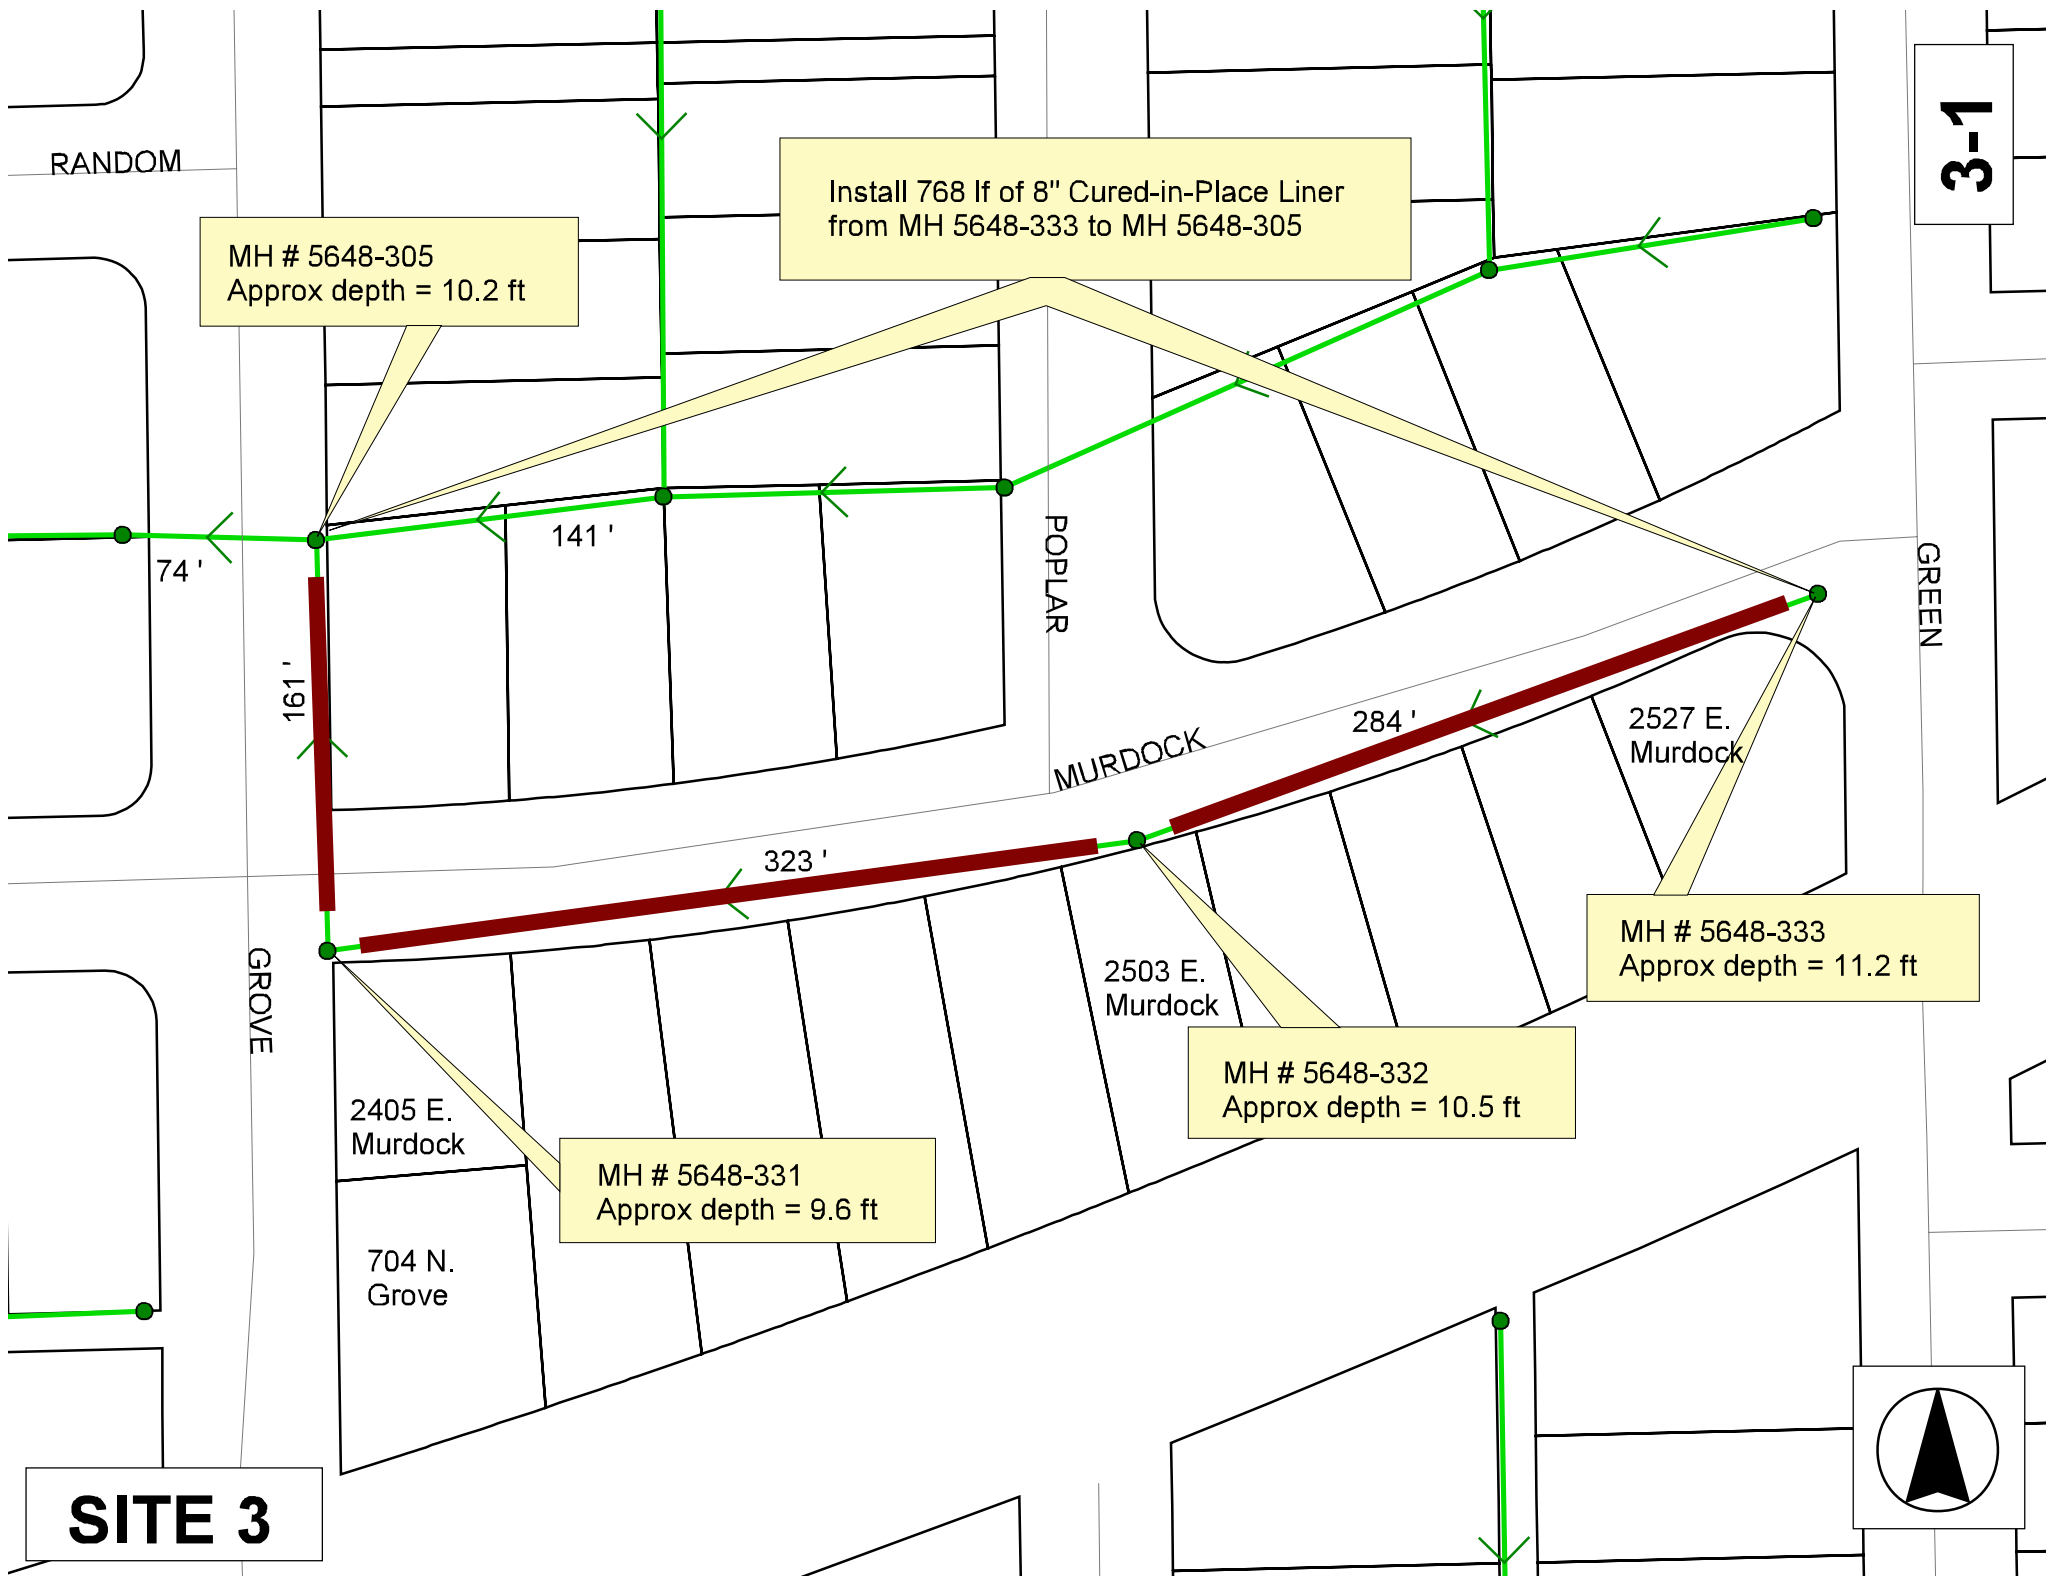
MH # 5648-305
Approx depth = 10.2 ft

MH # 5648-333
Approx depth = 11.2 ft

MH # 5648-331
Approx depth = 9.6 ft

MH # 5648-332
Approx depth = 10.5 ft
