**SITE 8**

# Television Inspection Master Report

US Structure: 5449-340      1749 N ARKANSAS AVE      Date Insp: 6/19/2006      Basin: C03F  
DS Structure: 5449-339      1757 N ARKANSAS ST      Dir Televised: Upstream To Downstream

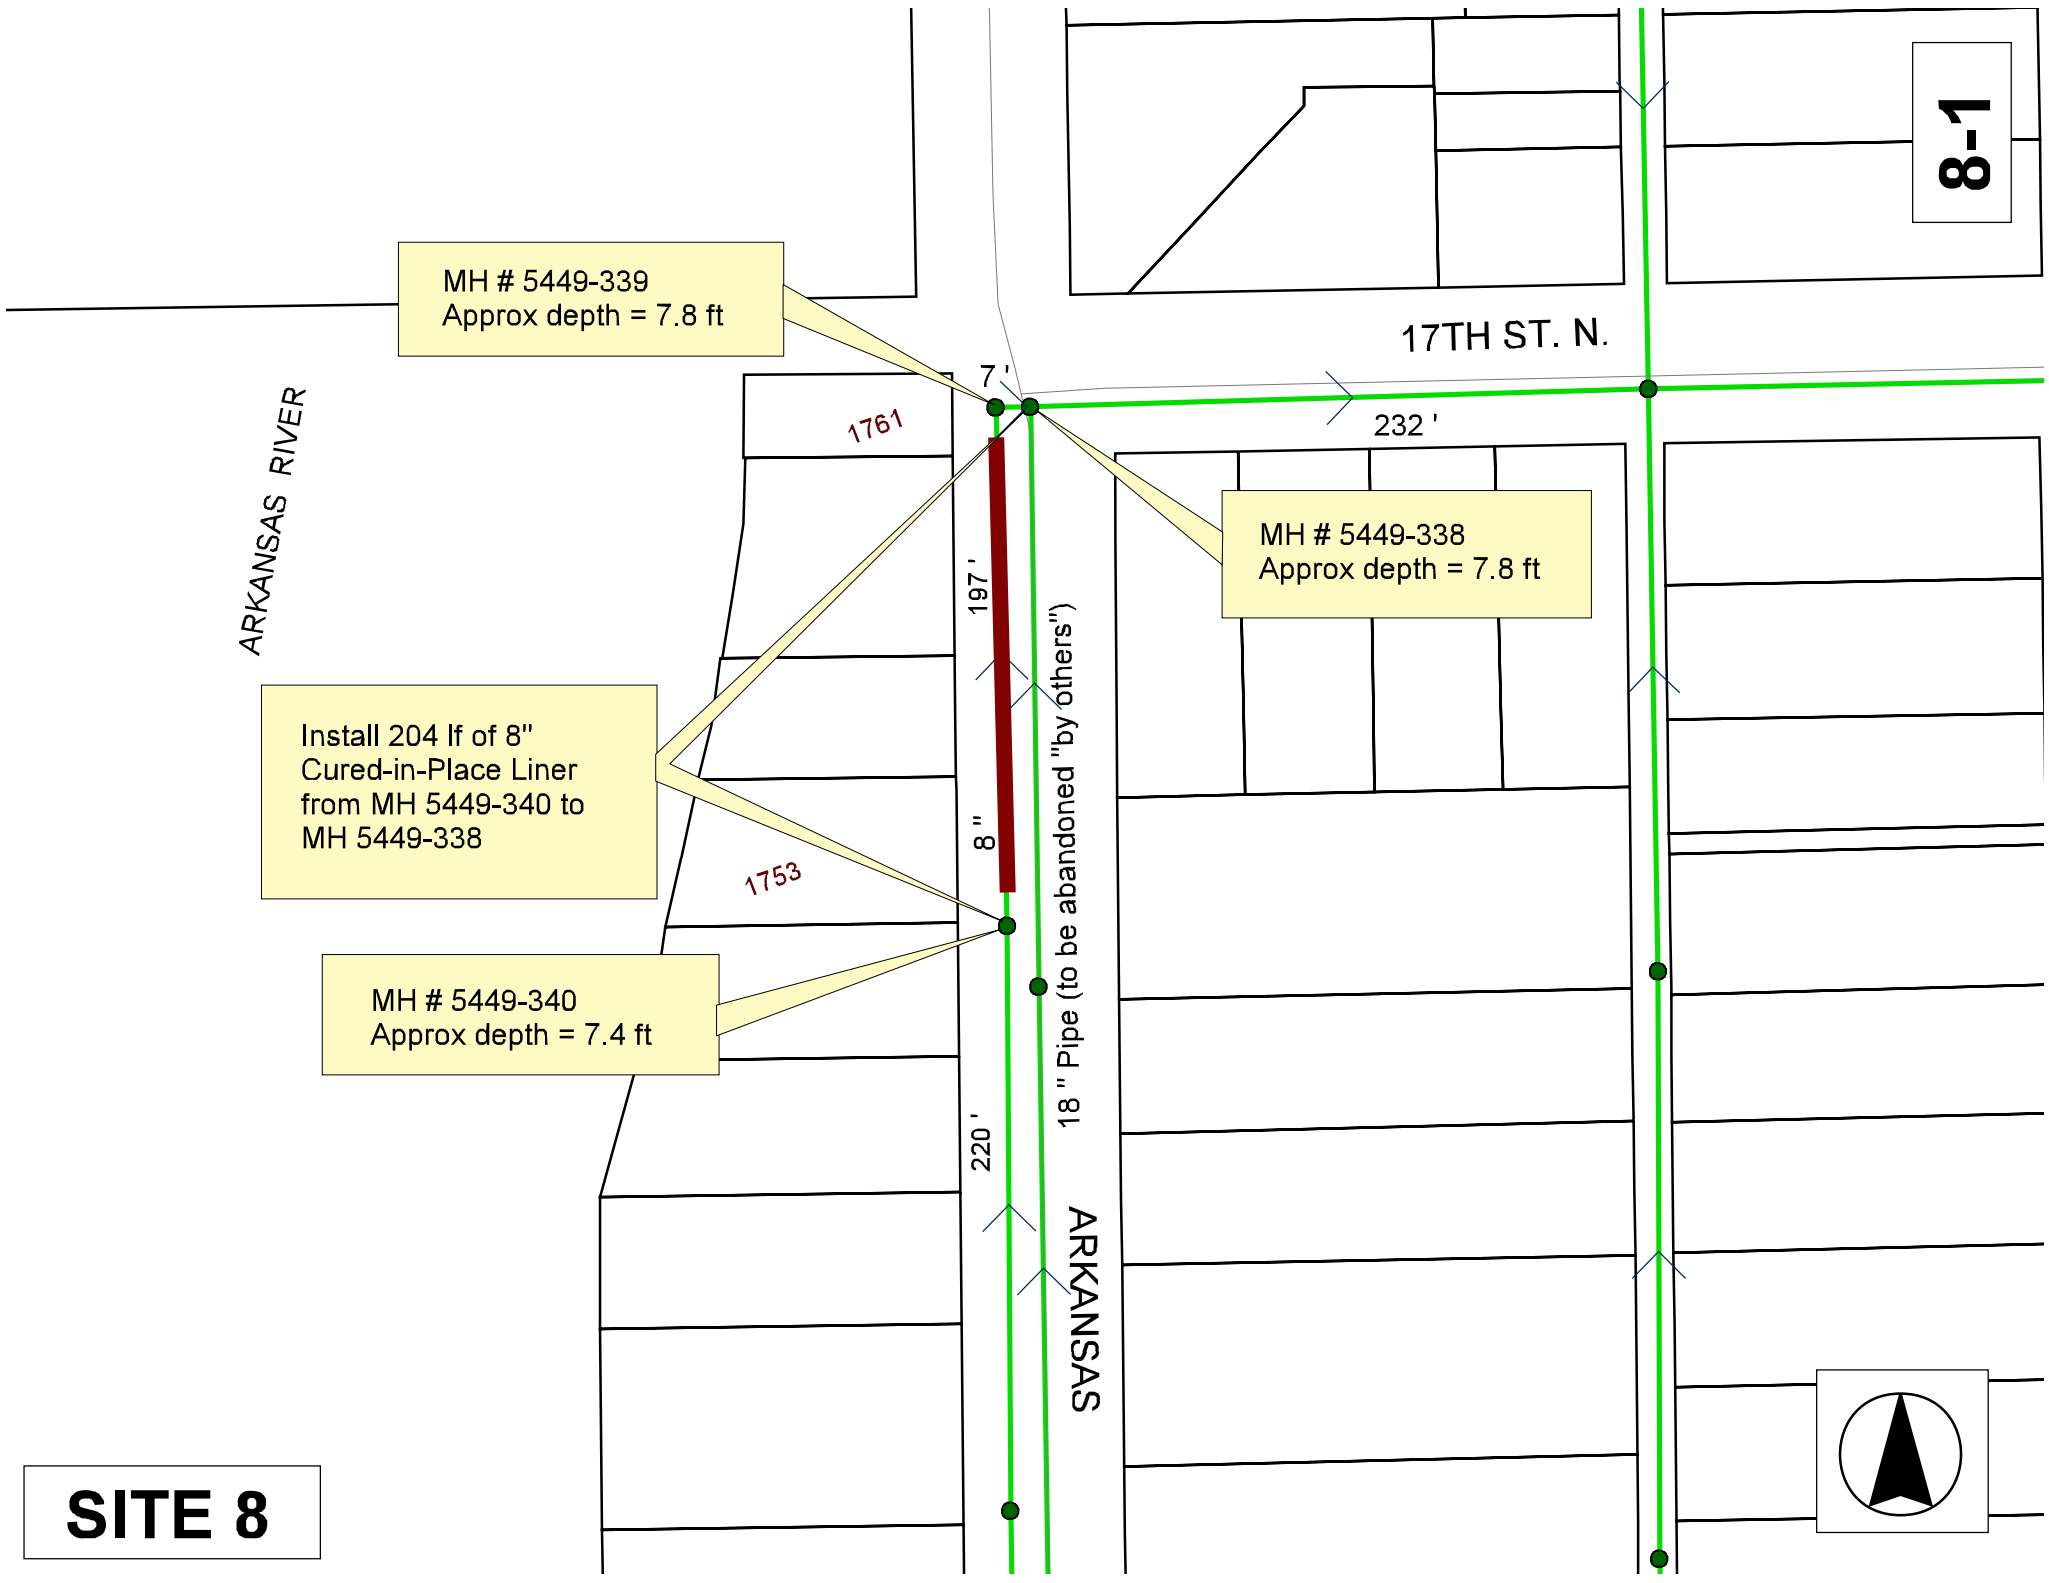
8-1

NOTE: The line between 5449-339 and 5449-338 has not been televised. We are lining this 7' of pipe because of a crack that is visible from the camera's point of view as it entered MH 5449-339 from the south.

Install 204 lf of 8"  
Cured-in-Place Liner  
from MH 5449-340 to  
MH 5449-338
