Install 608 lf of 8" Cured-in-Place Liner  
from MH 6045-233 to MH 6045-230

**SITE 3**

# Sewer CCTV Observations

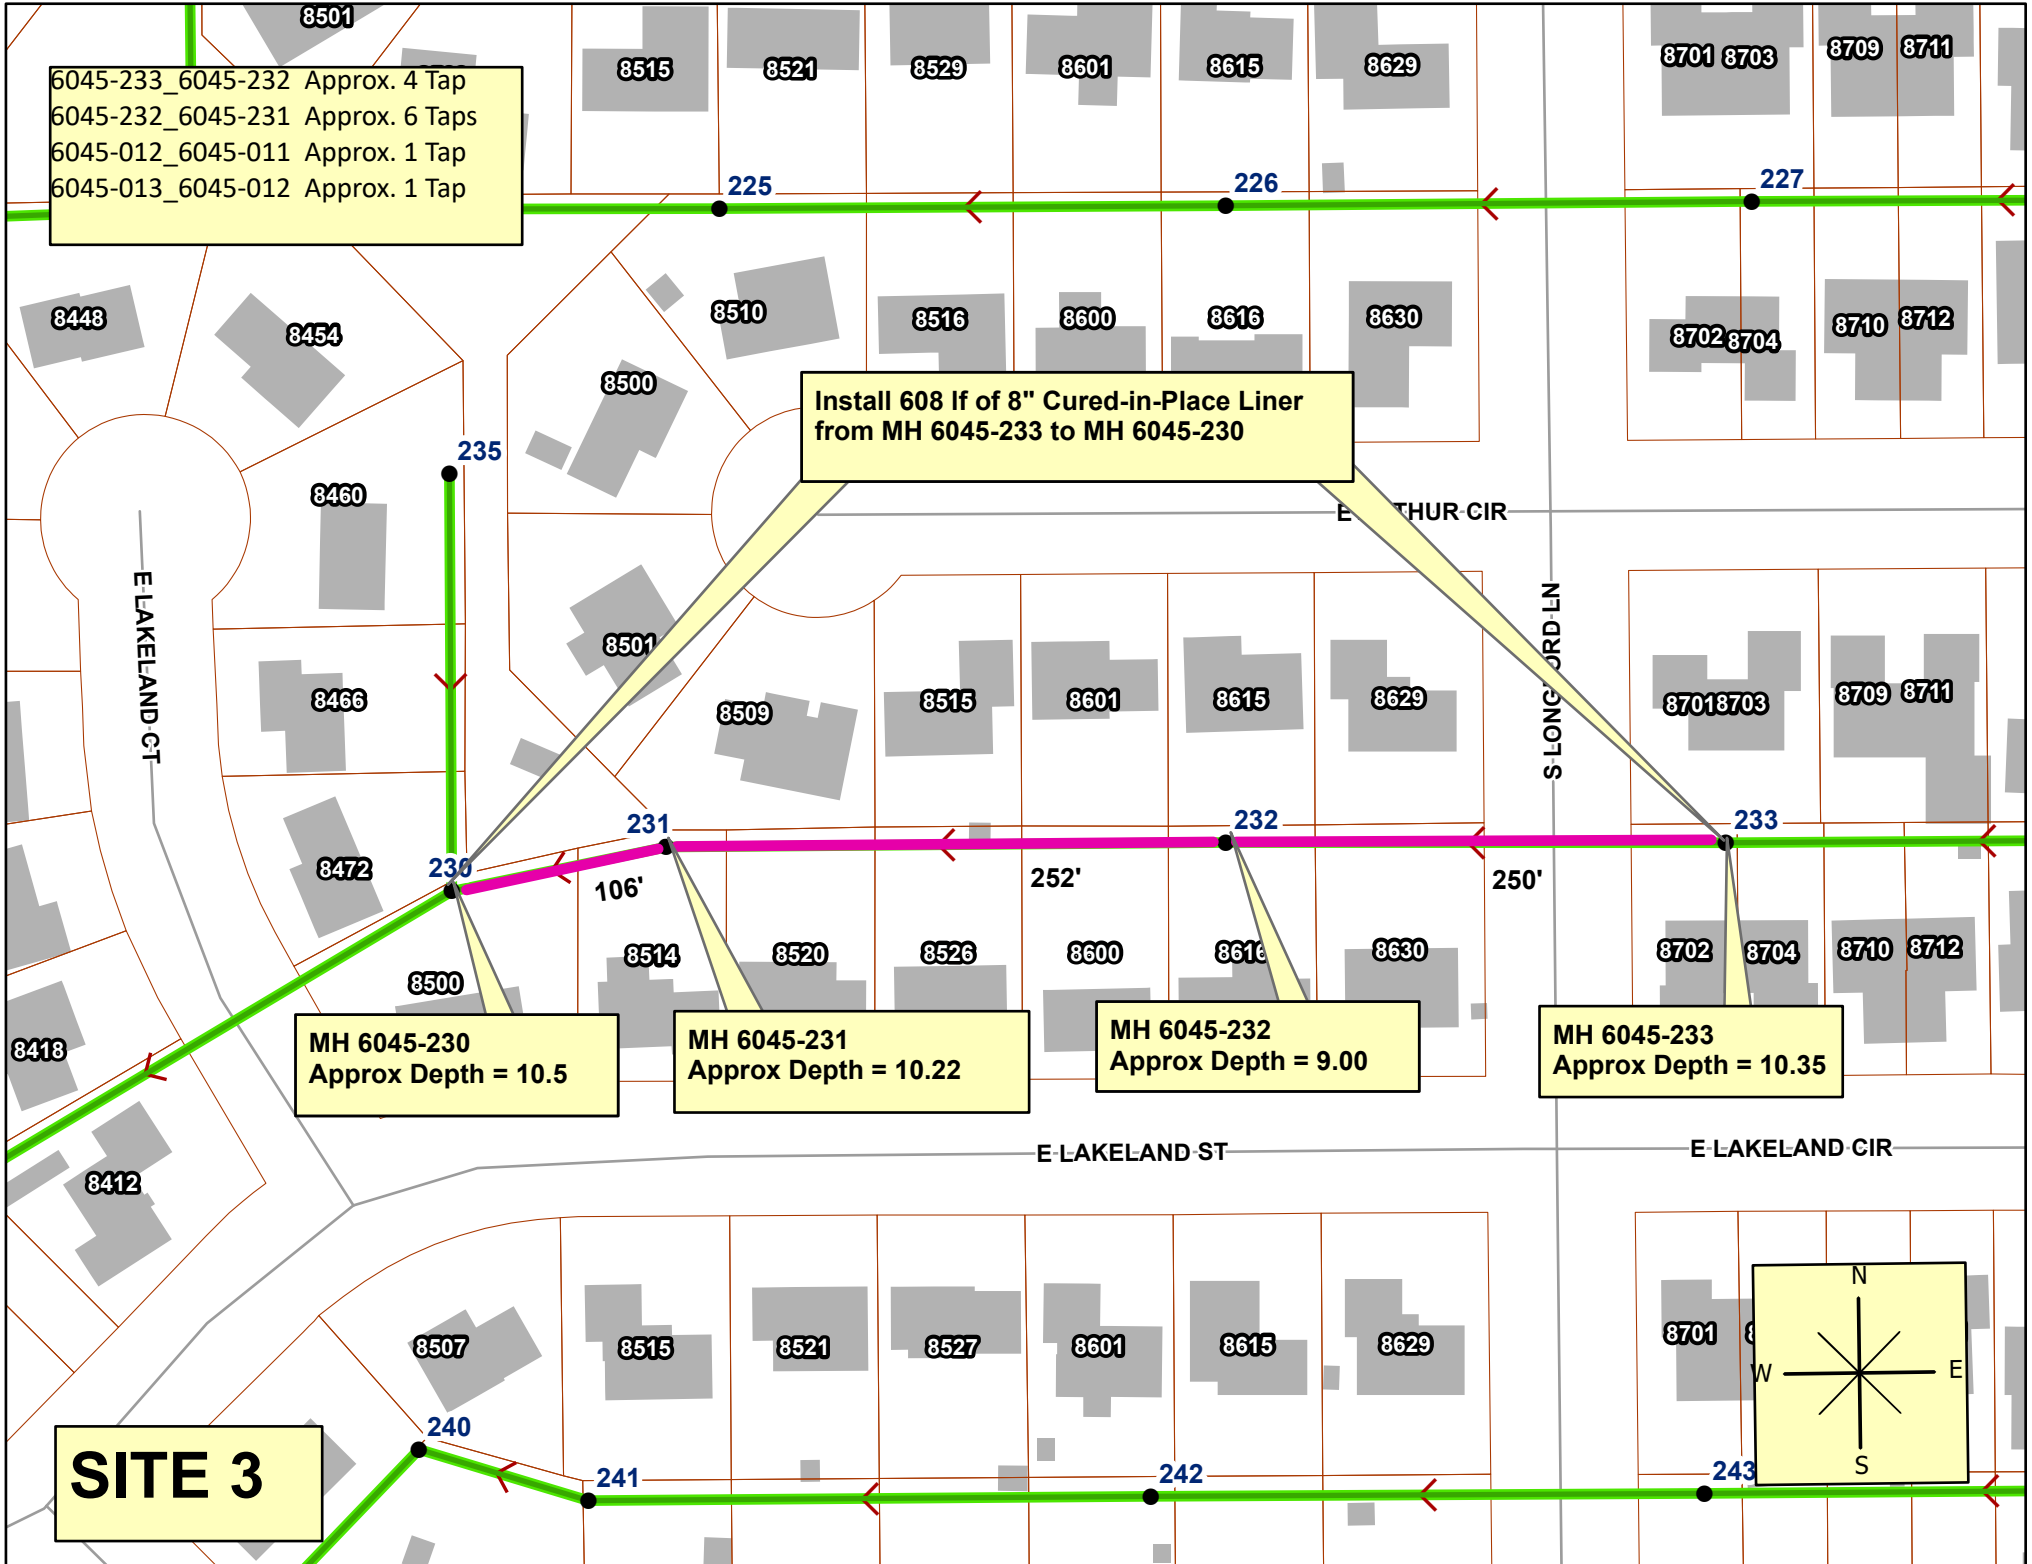
6045-233\_6045-232 Approx. 4 Tap  
6045-232\_6045-231 Approx. 6 Taps  
6045-012\_6045-011 Approx. 1 Tap  
6045-013\_6045-012 Approx. 1 Tap

MH 6045-230  
Approx Depth = 10.5

MH 6045-231  
Approx Depth = 10.22

MH 6045-232  
Approx Depth = 9.00

MH 6045-233  
Approx Depth = 10.35
