SITE 1

# Television Inspection Master Report

**US Structure:** 5448-080      1330 N WELLINGTON PL PL      **Date Insp:** 2/5/2007      **Basin:** C03D  
**DS Structure:** 5448-077      116 W 12TH ST      **Dir Televised:** Upstream To Downstream

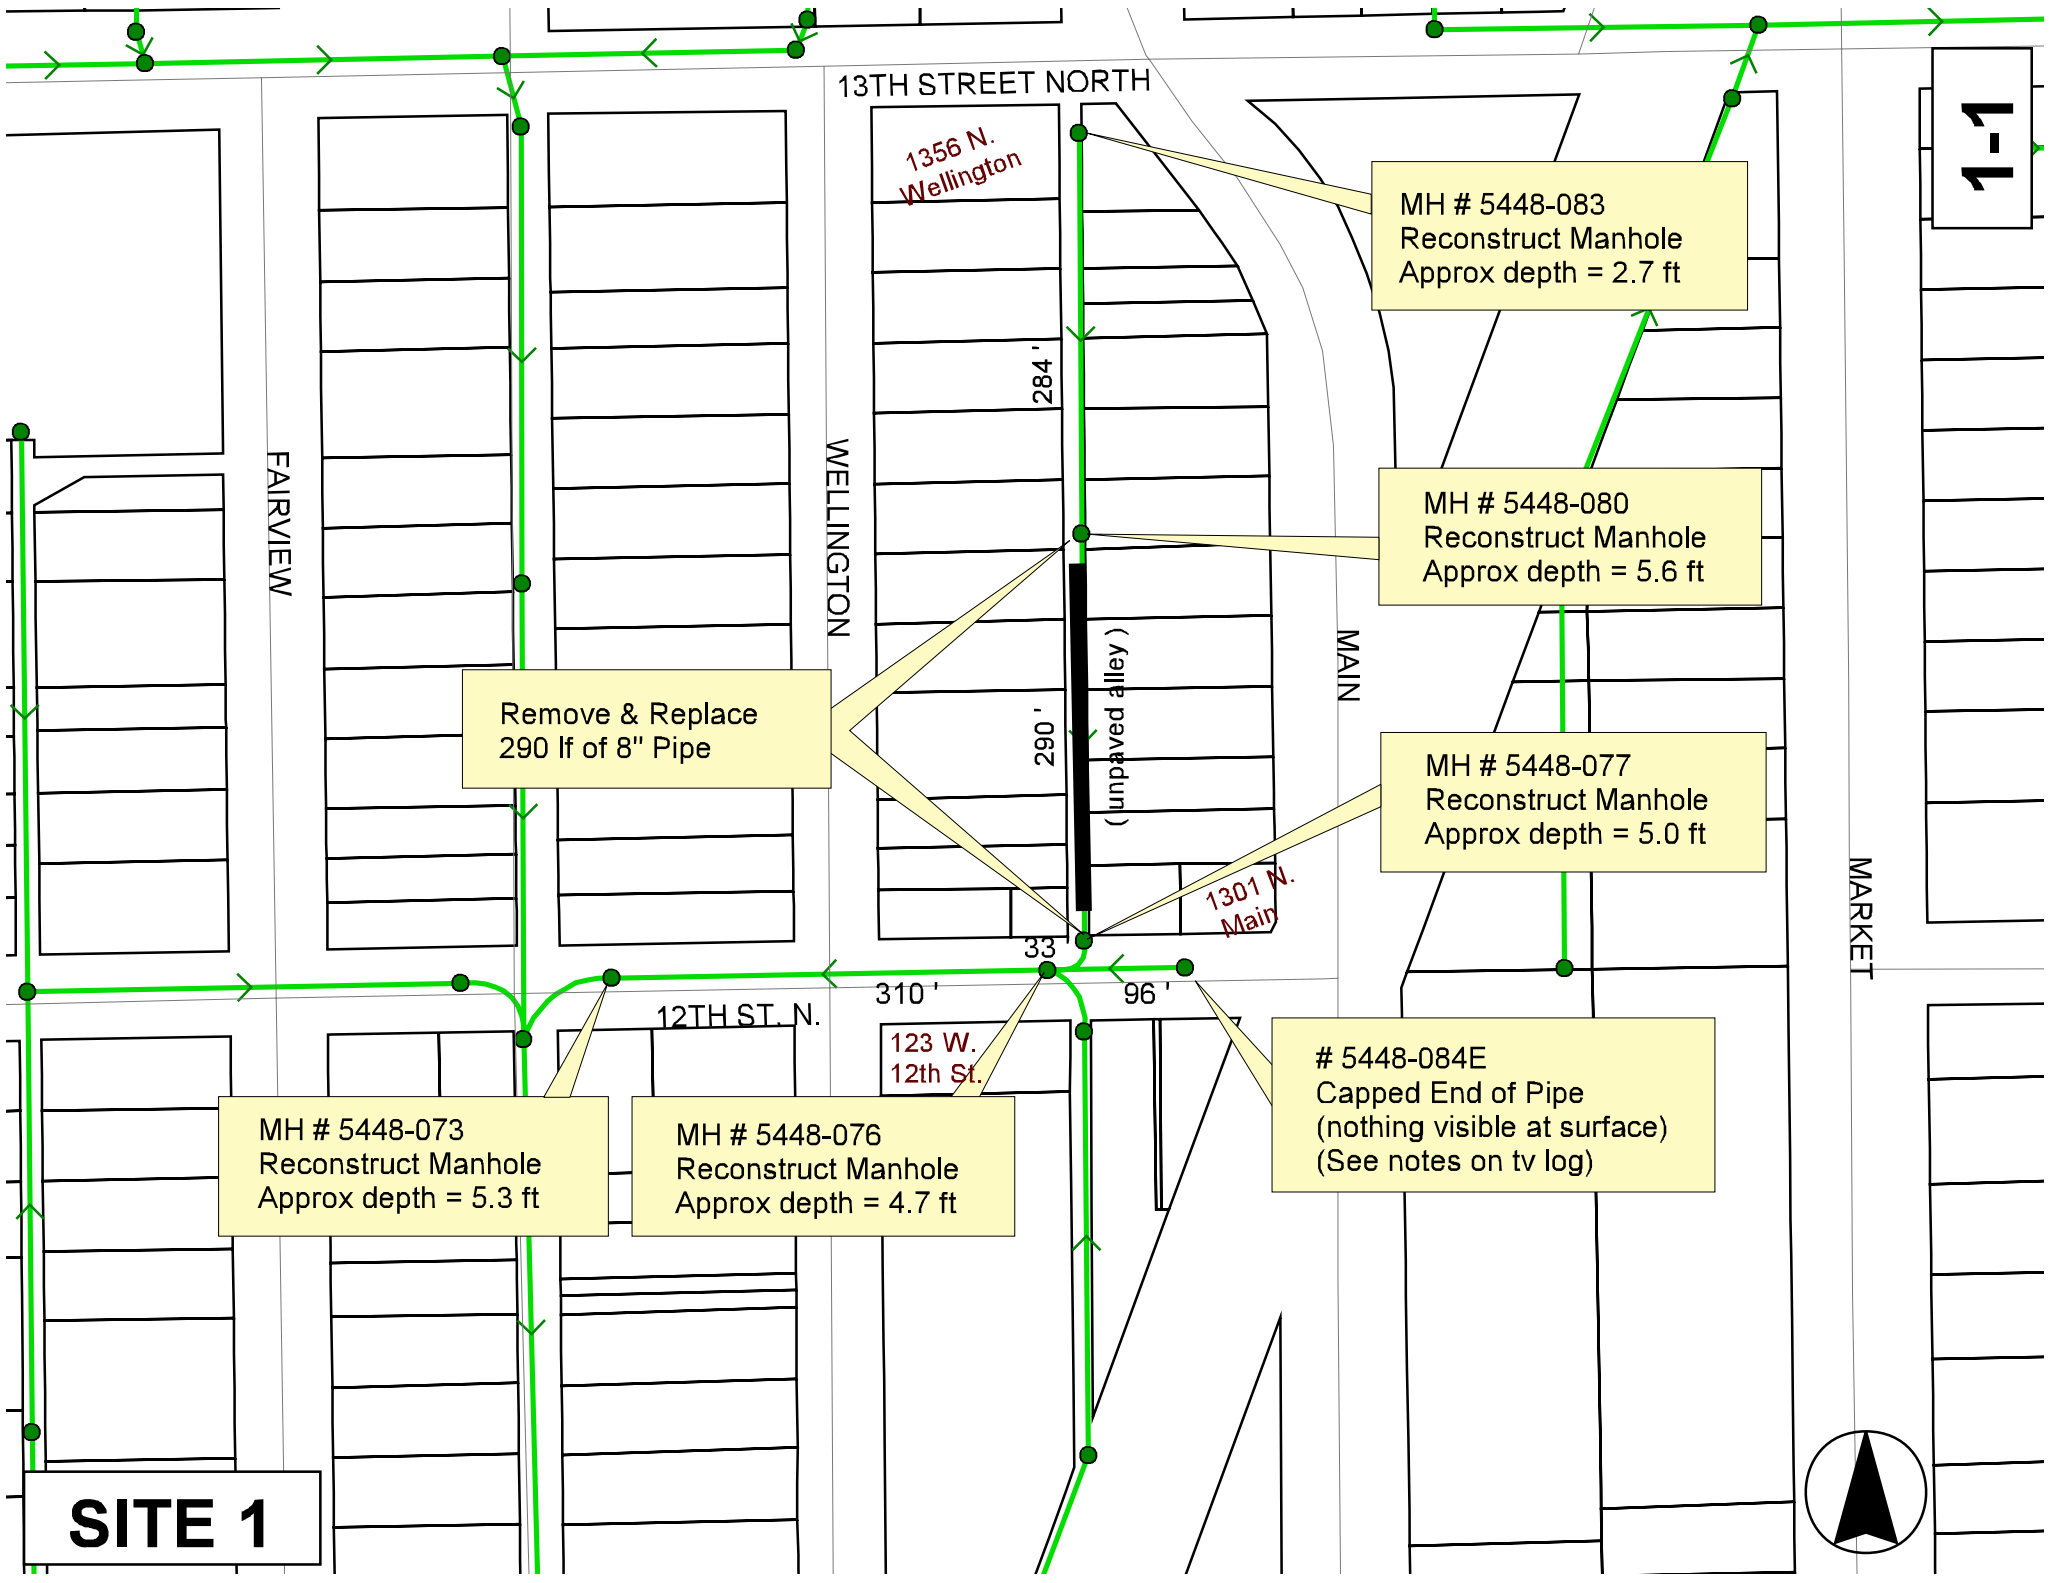
1-1

MH # 5448-083  
Reconstruct Manhole  
Approx depth = 2.7 ft

MH # 5448-080  
Reconstruct Manhole  
Approx depth = 5.6 ft

MH # 5448-077  
Reconstruct Manhole  
Approx depth = 5.0 ft

# 5448-084E  
Capped End of Pipe  
(nothing visible at surface)  
(See notes on tv log)

MH # 5448-073  
Reconstruct Manhole  
Approx depth = 5.3 ft

MH # 5448-076  
Reconstruct Manhole  
Approx depth = 4.7 ft

Remove & Replace  
290 lf of 8" Pipe
