SITE 2

Television Inspection Master Report

US Structure: 5547-358
DS Structure: 5547-357

357 S LULU ST
349 S LULU ST

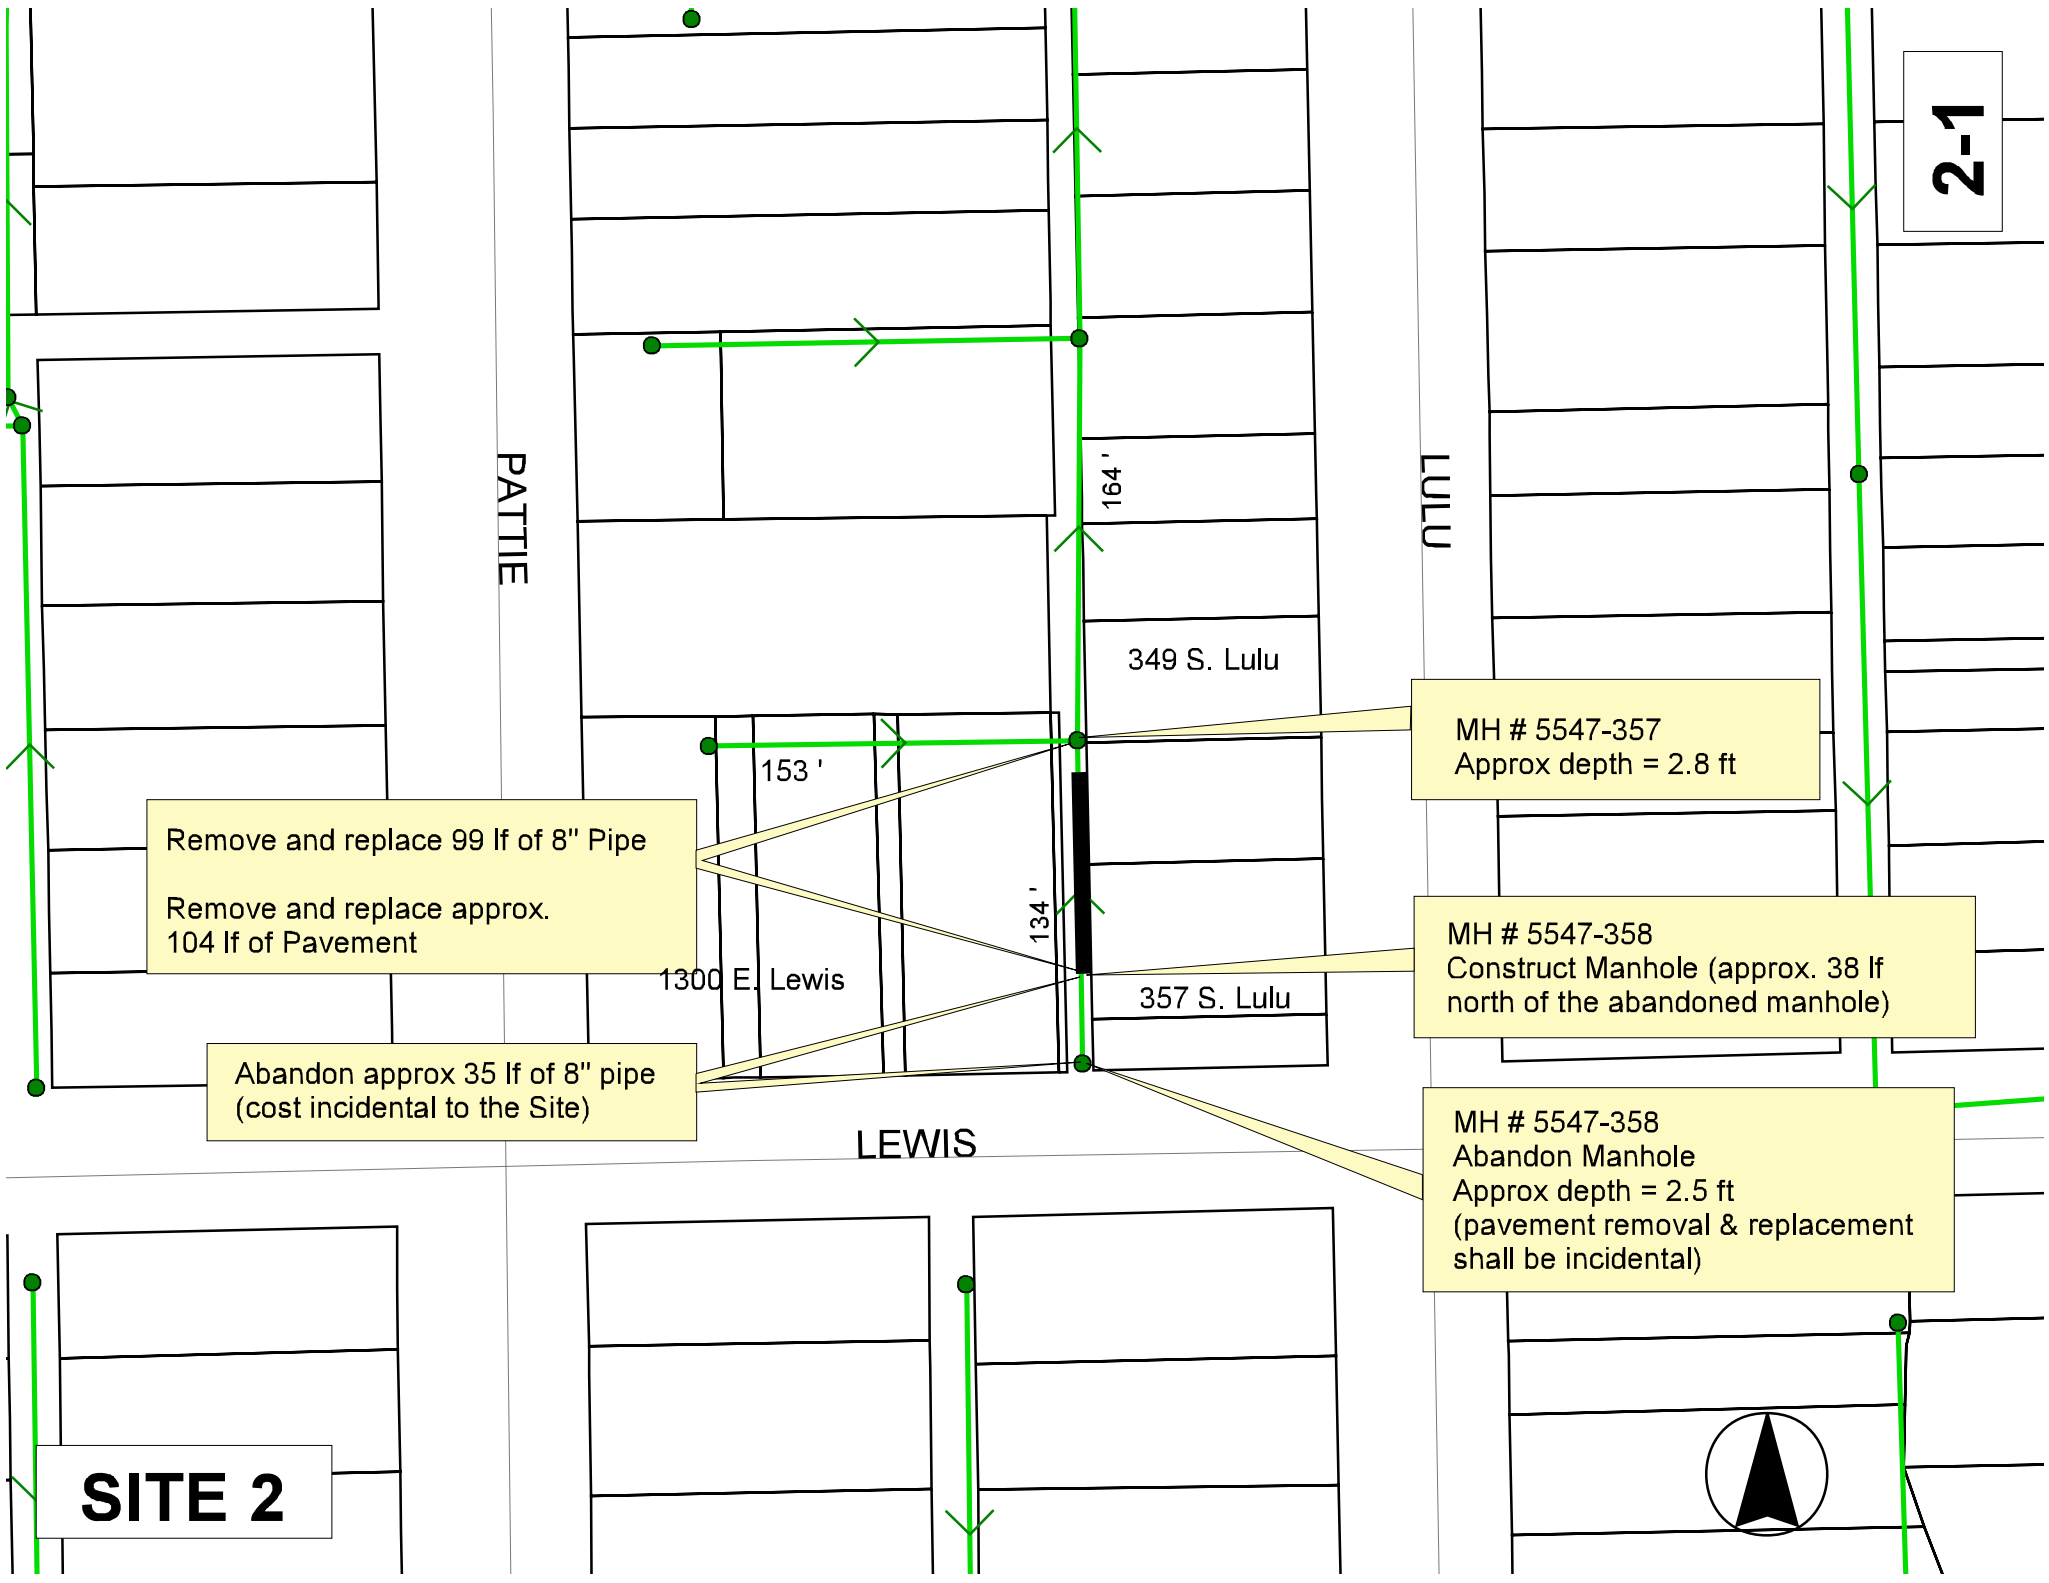
2-1

MH # 5547-357
 Approx depth = 2.8 ft

MH # 5547-358
 Abandon Manhole
 Approx depth = 2.5 ft
 (pavement removal & replacement
 shall be incidental)

Remove and replace 99 lf of 8" Pipe
 Remove and replace approx.
 104 lf of Pavement

Abandon approx 35 lf of 8" pipe
 (cost incidental to the Site)

MH # 5547-358
 Construct Manhole (approx. 38 lf
 north of the abandoned manhole)
