SITE 3

Television Inspection Master Report

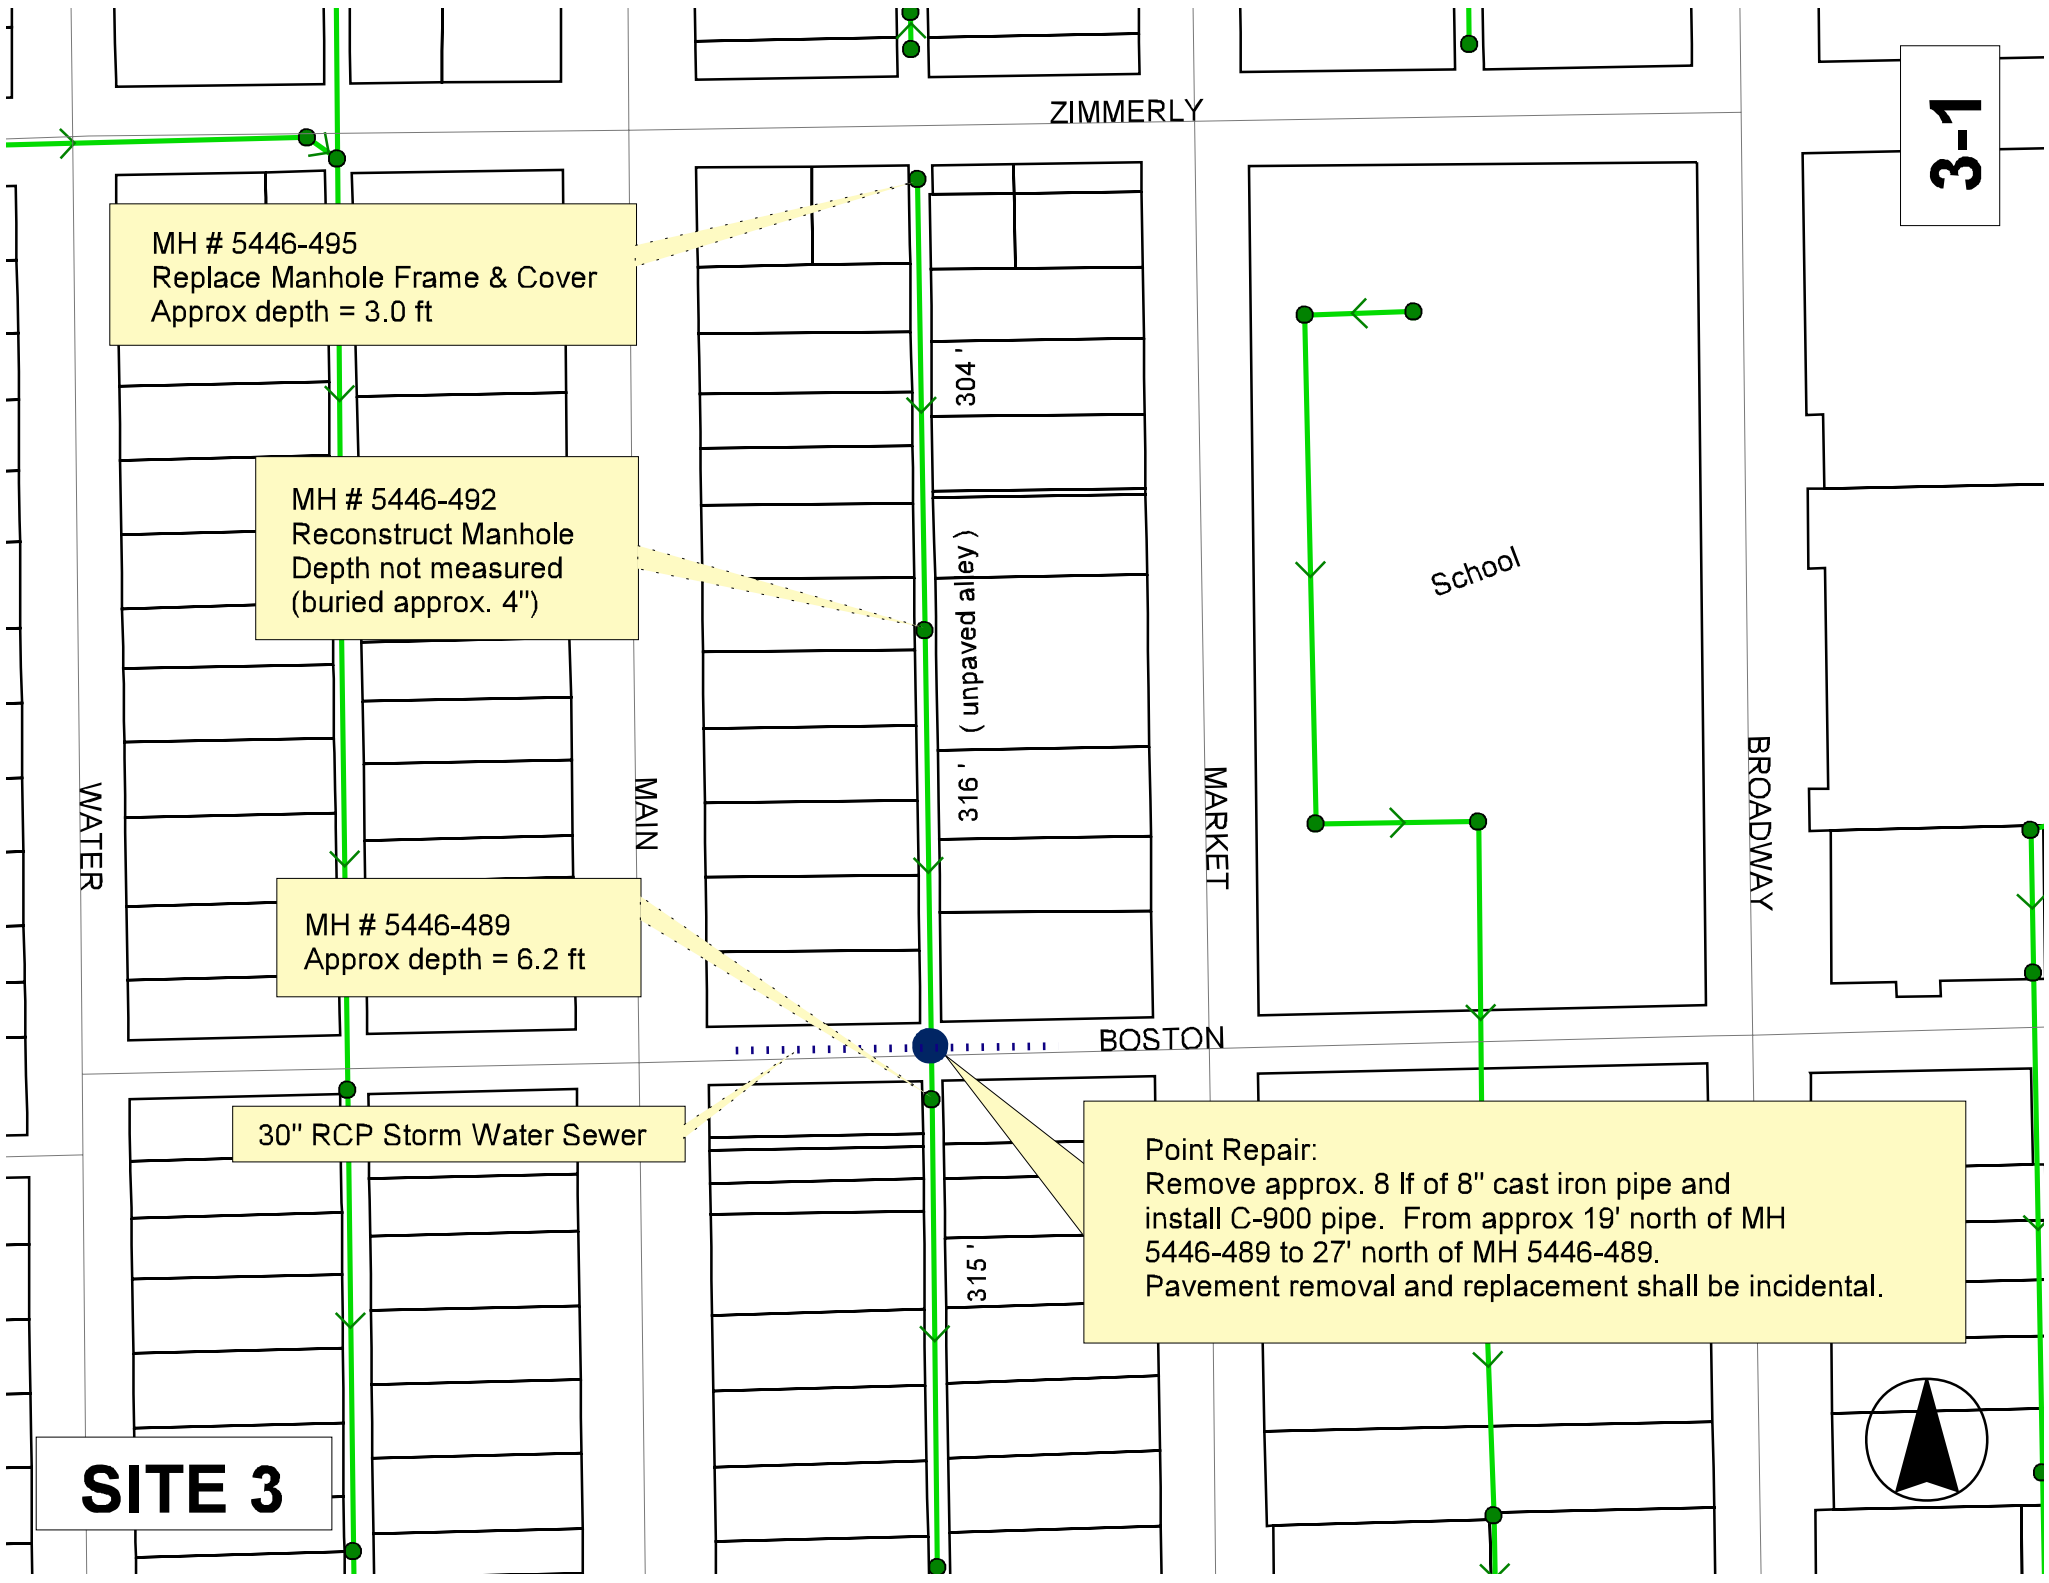
3-1

MH # 5446-495
Replace Manhole Frame & Cover
Approx depth = 3.0 ft

MH # 5446-492
Reconstruct Manhole
Depth not measured
(buried approx. 4")

MH # 5446-489
Approx depth = 6.2 ft

30" RCP Storm Water Sewer

Point Repair:
Remove approx. 8 lf of 8" cast iron pipe and
install C-900 pipe. From approx 19' north of MH
5446-489 to 27' north of MH 5446-489.
Pavement removal and replacement shall be incidental.
