SITE 4

Television Inspection Master Report

US Structure: 5346-425
DS Structure: 5346-424

1808 W MUNNELL AVE
912 S GLENN ST

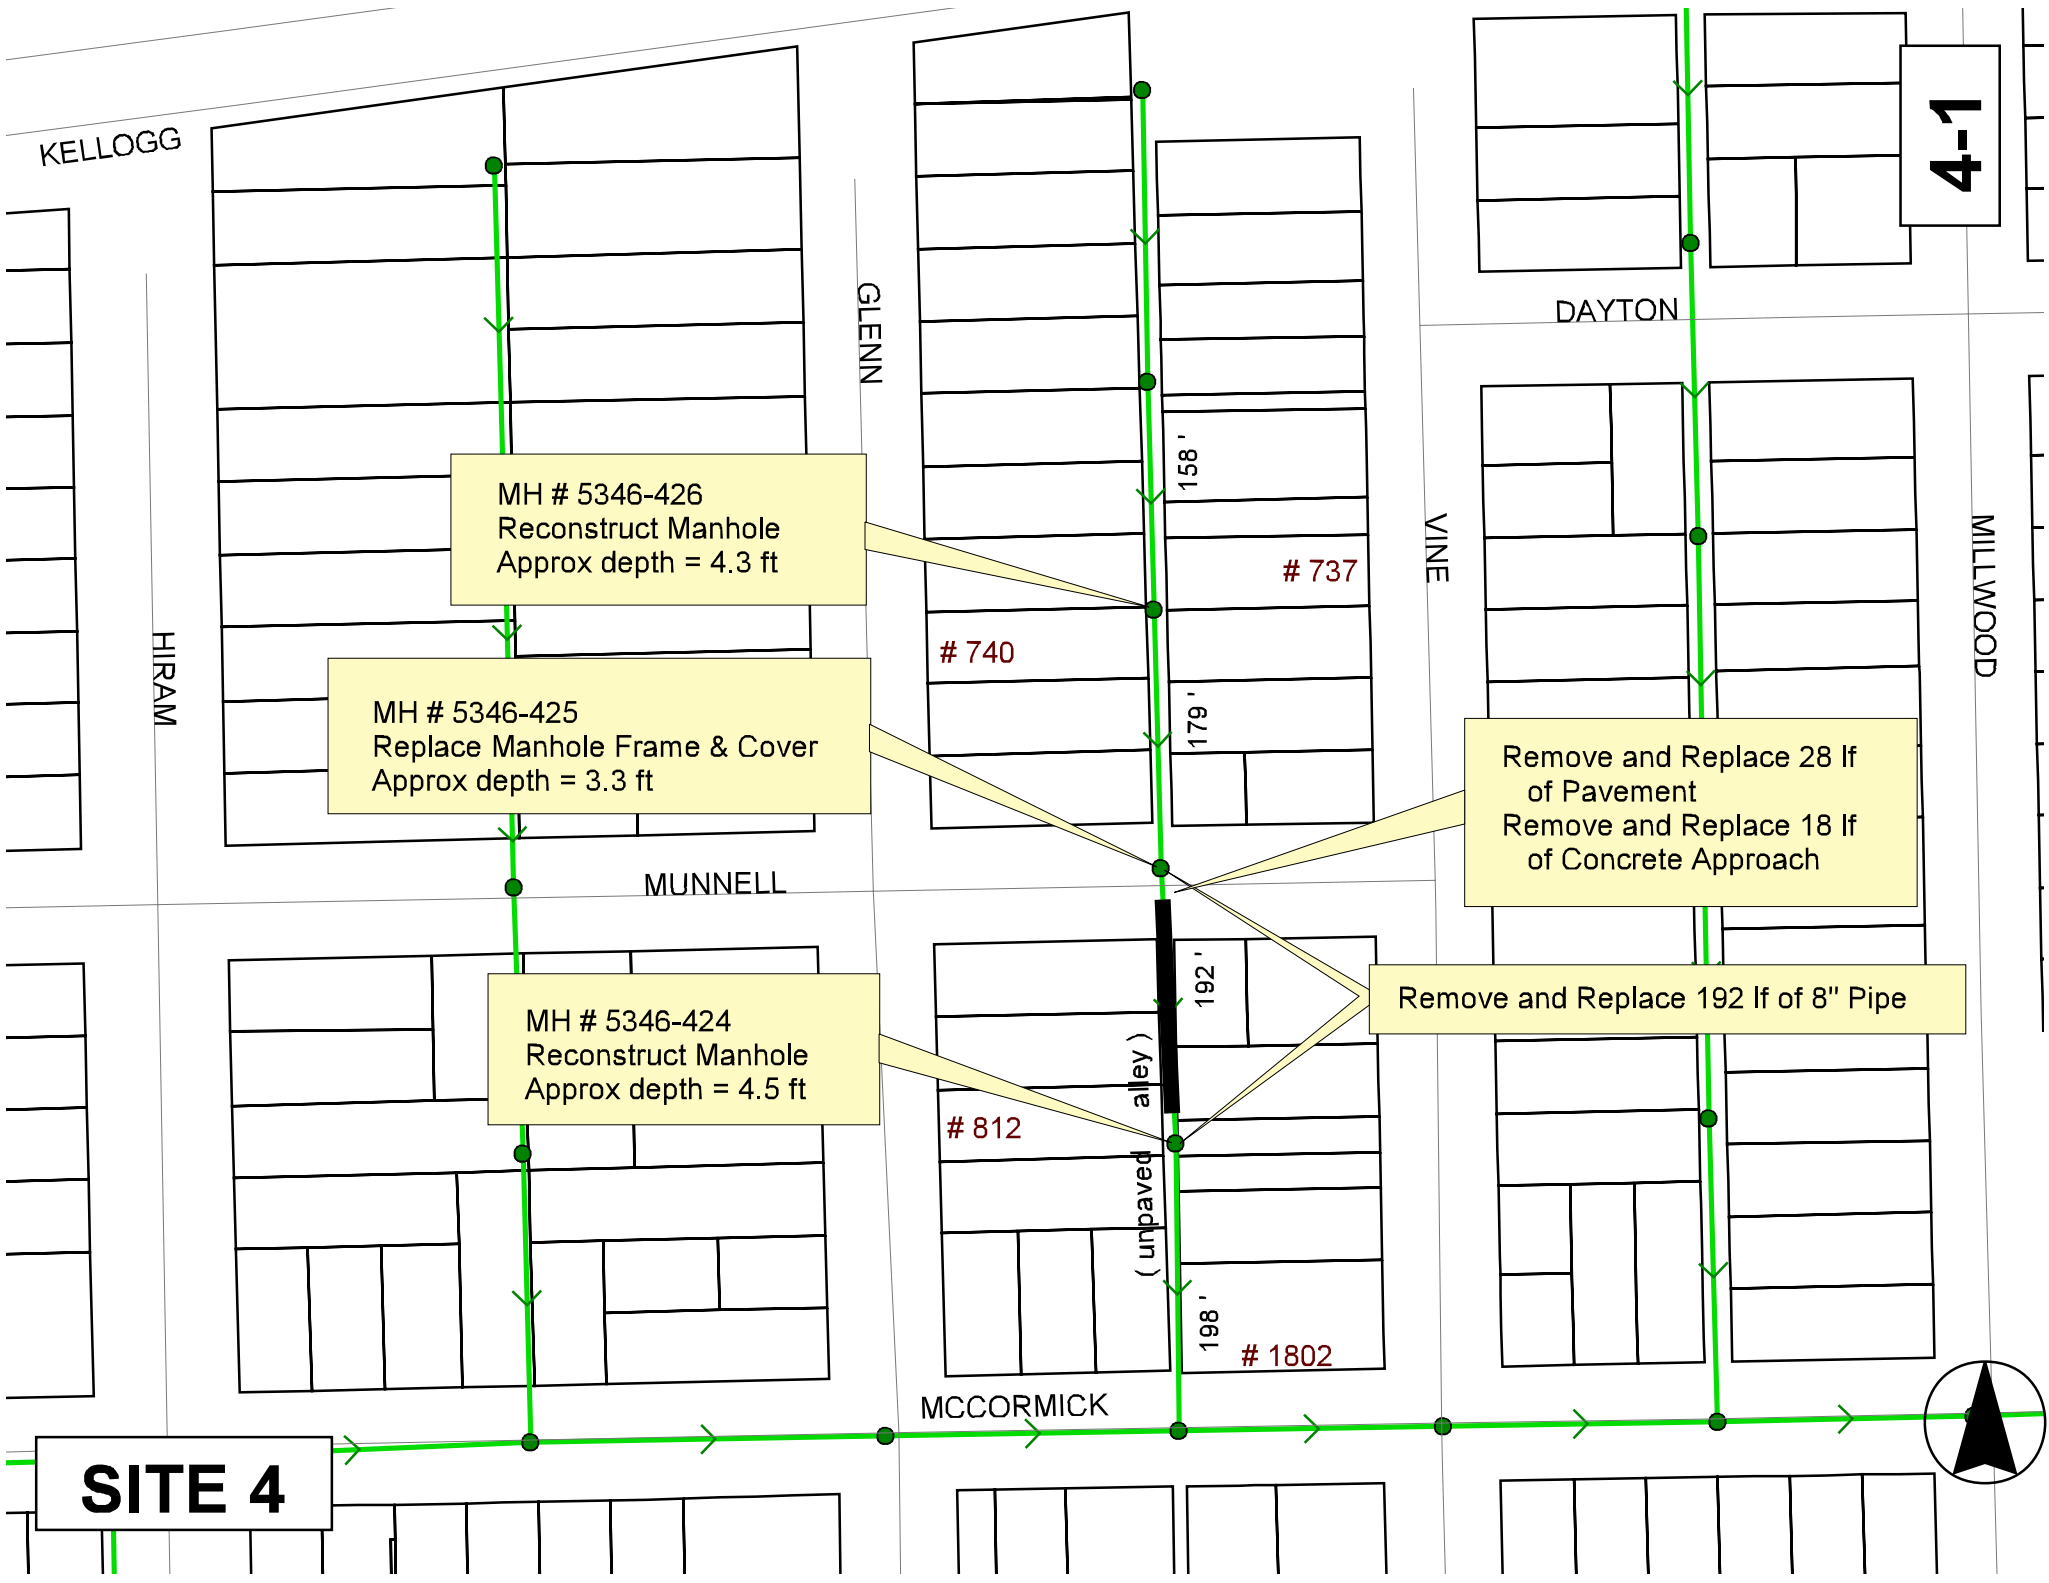
MH # 5346-426
Reconstruct Manhole
Approx depth = 4.3 ft

MH # 5346-425
Replace Manhole Frame & Cover
Approx depth = 3.3 ft

MH # 5346-424
Reconstruct Manhole
Approx depth = 4.5 ft

Remove and Replace 192 lf of 8" Pipe

Remove and Replace 28 lf
of Pavement
Remove and Replace 18 lf
of Concrete Approach
