### Defect Listing Plot

Pipe Segment Refere... <b>16</b>	City <b>WICHITA</b>	Street <b>MCLEAN BLVD</b>	Material <b>PolyVinyl Chloride</b>	Location C... <b>Easement/R...</b>	Sewer Use <b>Stormwater</b>
Upstream MH <b>3+44.32</b>	Total Length	Up Rim to Invert <b>12</b>	Shape <b>Circular</b>	Location Details <b>LINE 0</b>	
DS Manhole <b>2+31.24</b>	Length surveyed <b>114.5</b>	Down Rim to Invert <b>11.7</b>	Height <b>18</b>	Width <b>18</b>	Pipe Joint...

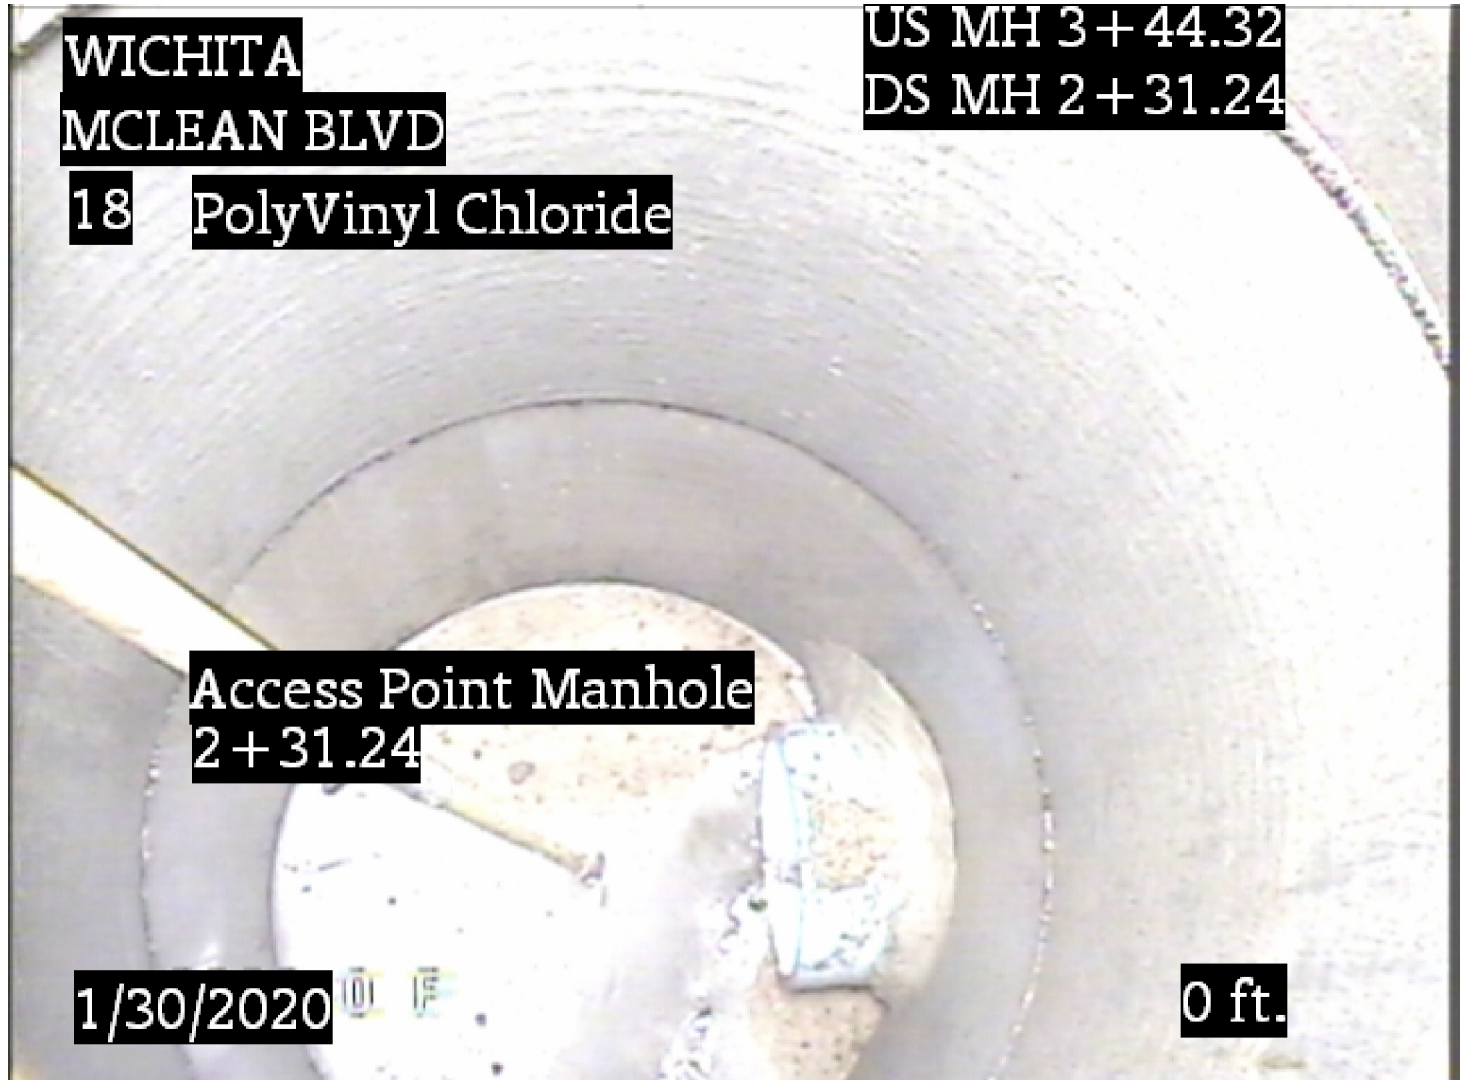
Distance:	0.0 ft.
Condition:	Access Point Manhole
Grade:	0
Remarks:	2+31.24

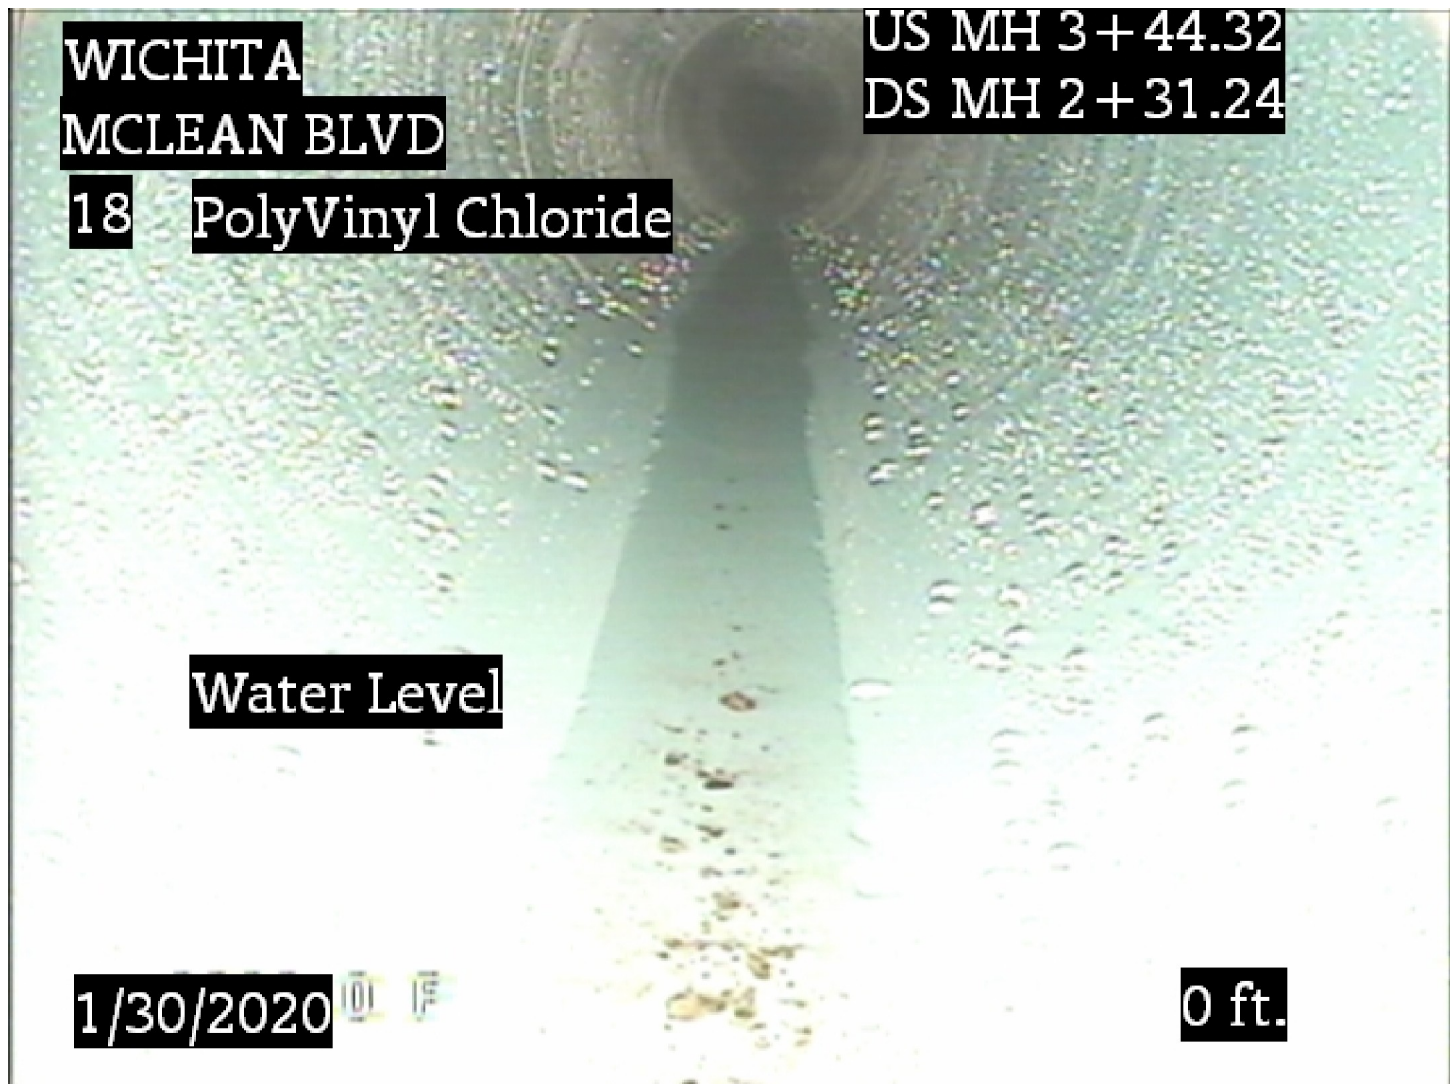
<b>Distance:</b>	0.0 ft.
<b>Condition:</b>	Water Level
<b>Grade:</b>	0
<b>Remarks:</b>	N/A

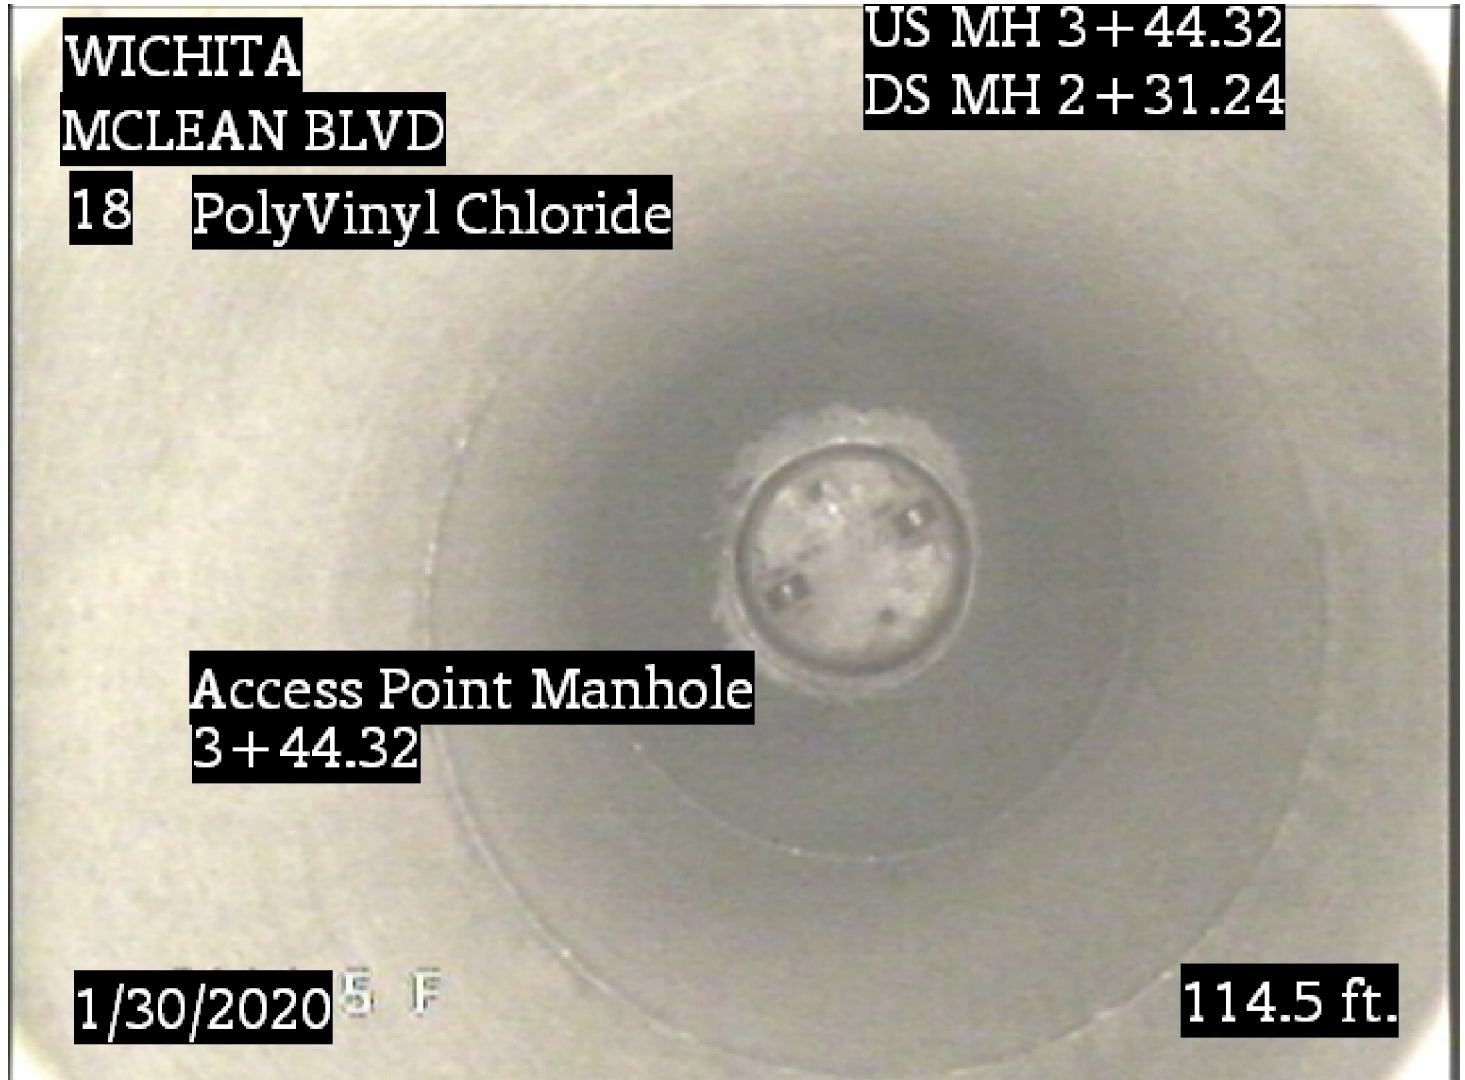
Distance:	114.5 ft.
Condition:	Access Point Manhole
Grade:	0
Remarks:	3+44.32
