Install 679 lf of 8"
Cured-in-Place Liner

SITE 8

Television Inspection Master Report

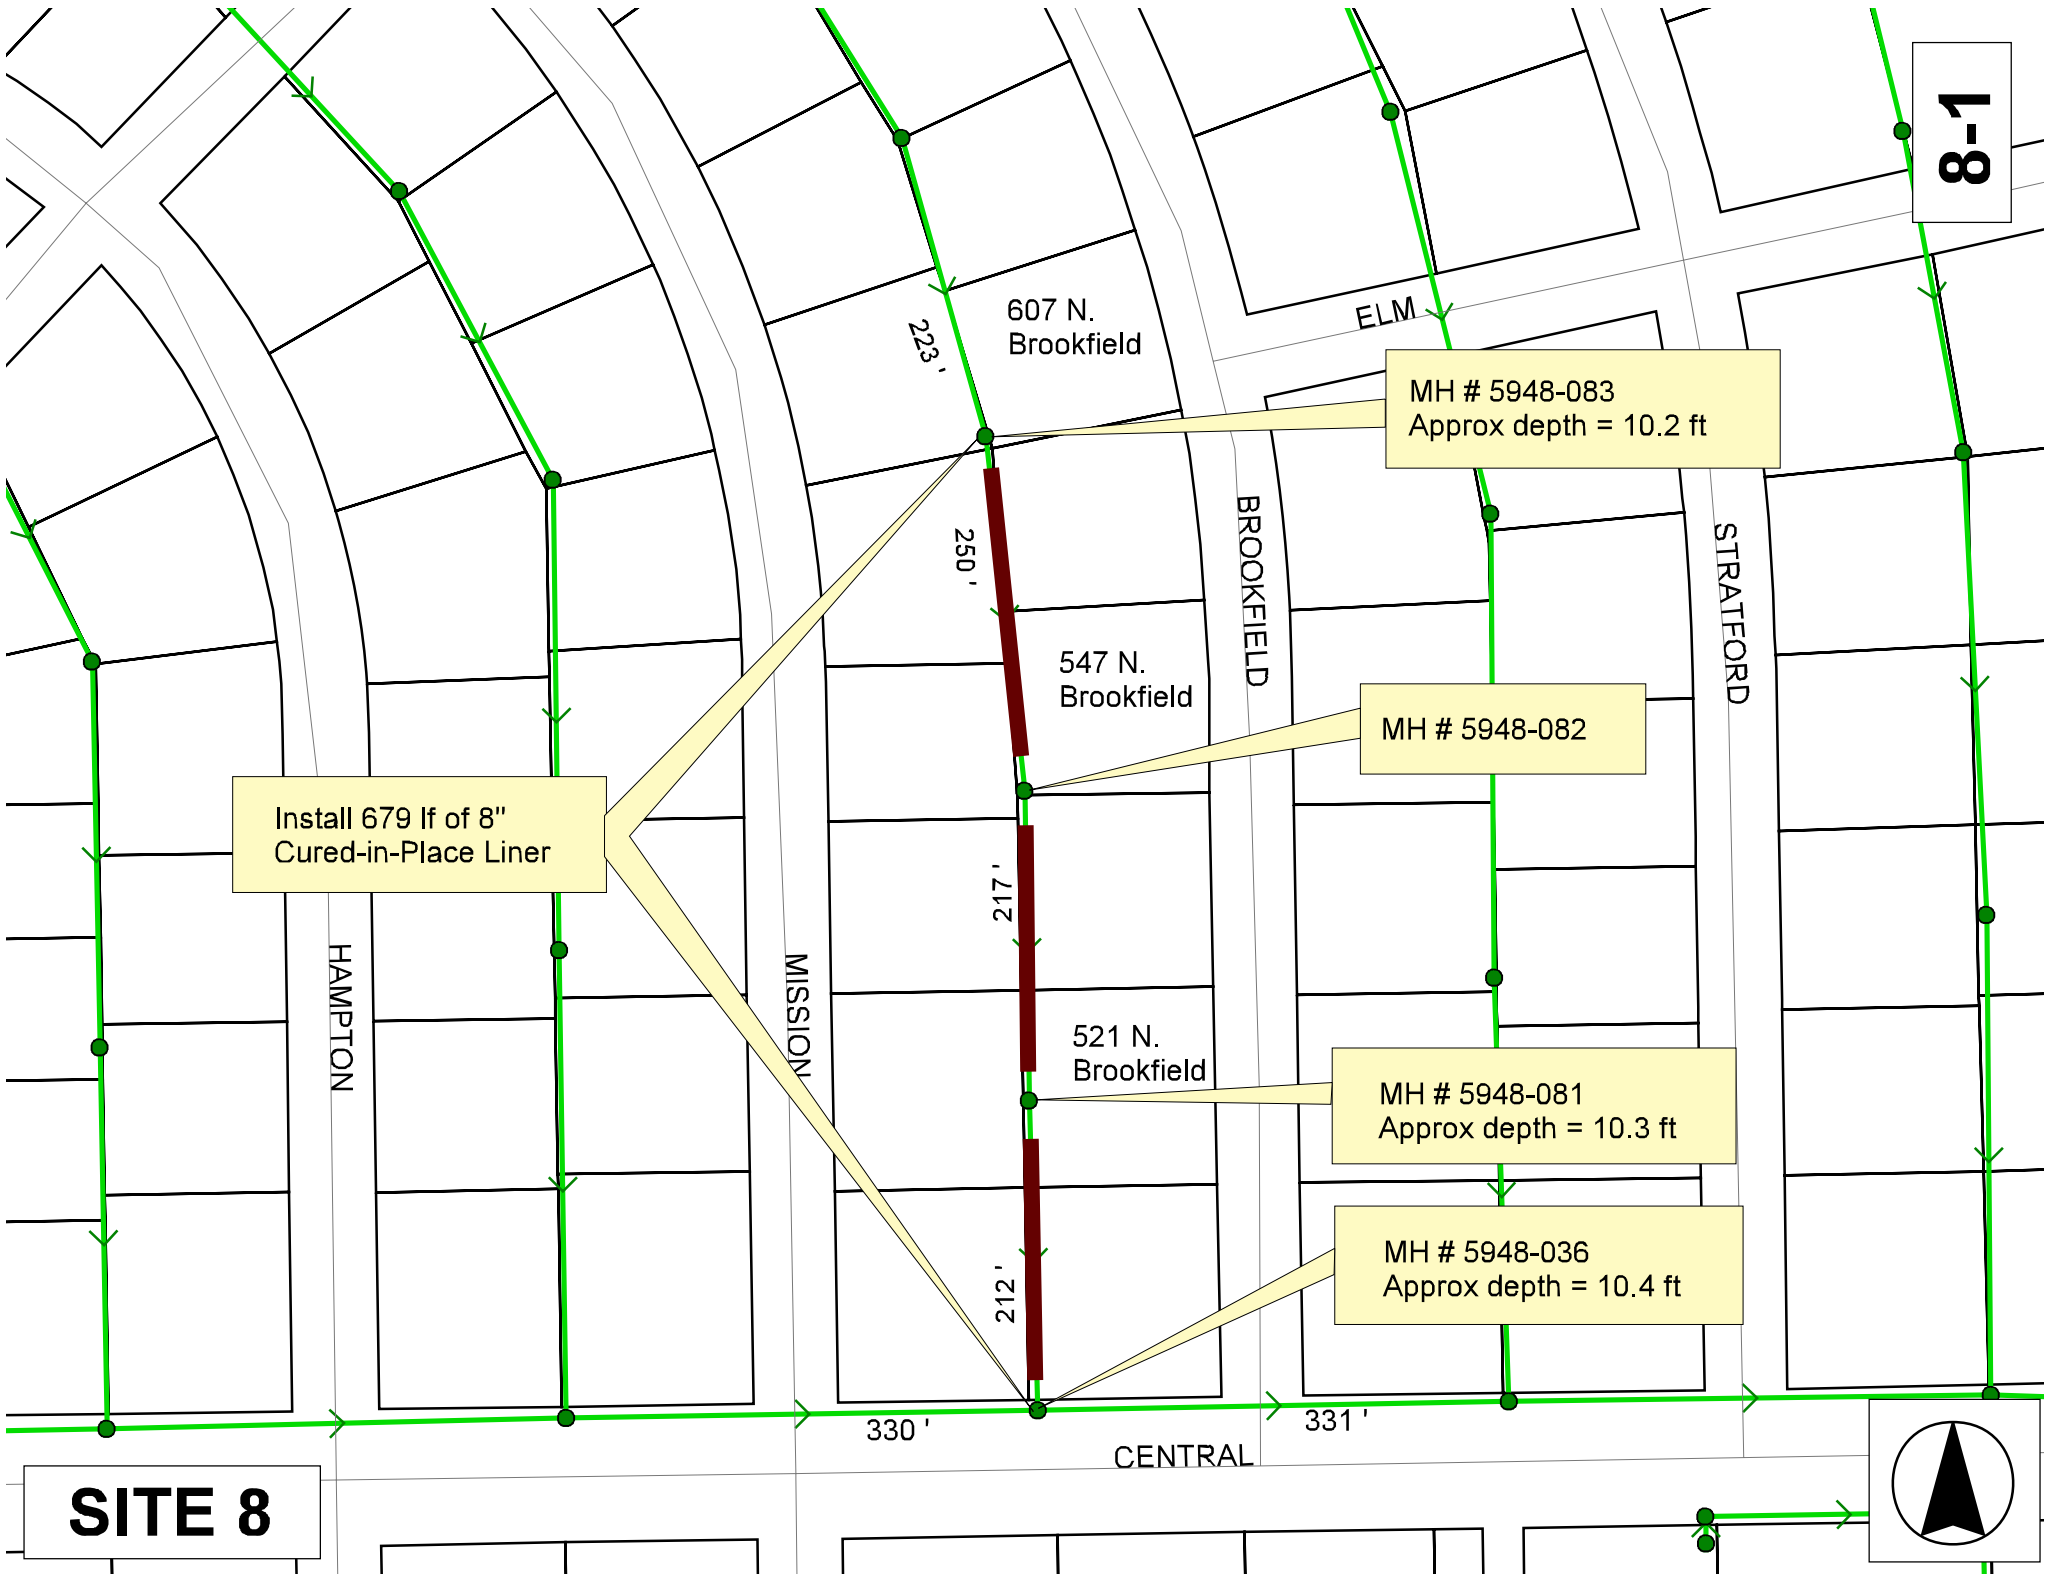
8-1

MH # 5948-083
Approx depth = 10.2 ft

MH # 5948-082

MH # 5948-081
Approx depth = 10.3 ft

MH # 5948-036
Approx depth = 10.4 ft
