Install 675 lf of 8" Cured-in-Place Liner
from MH 5348-030 to MH 5348-024

Install 306 lf of 8" Cured-in-Place Liner
from MH 5348-021 to MH 5348-018

SITE 12

Television Inspection Master Report

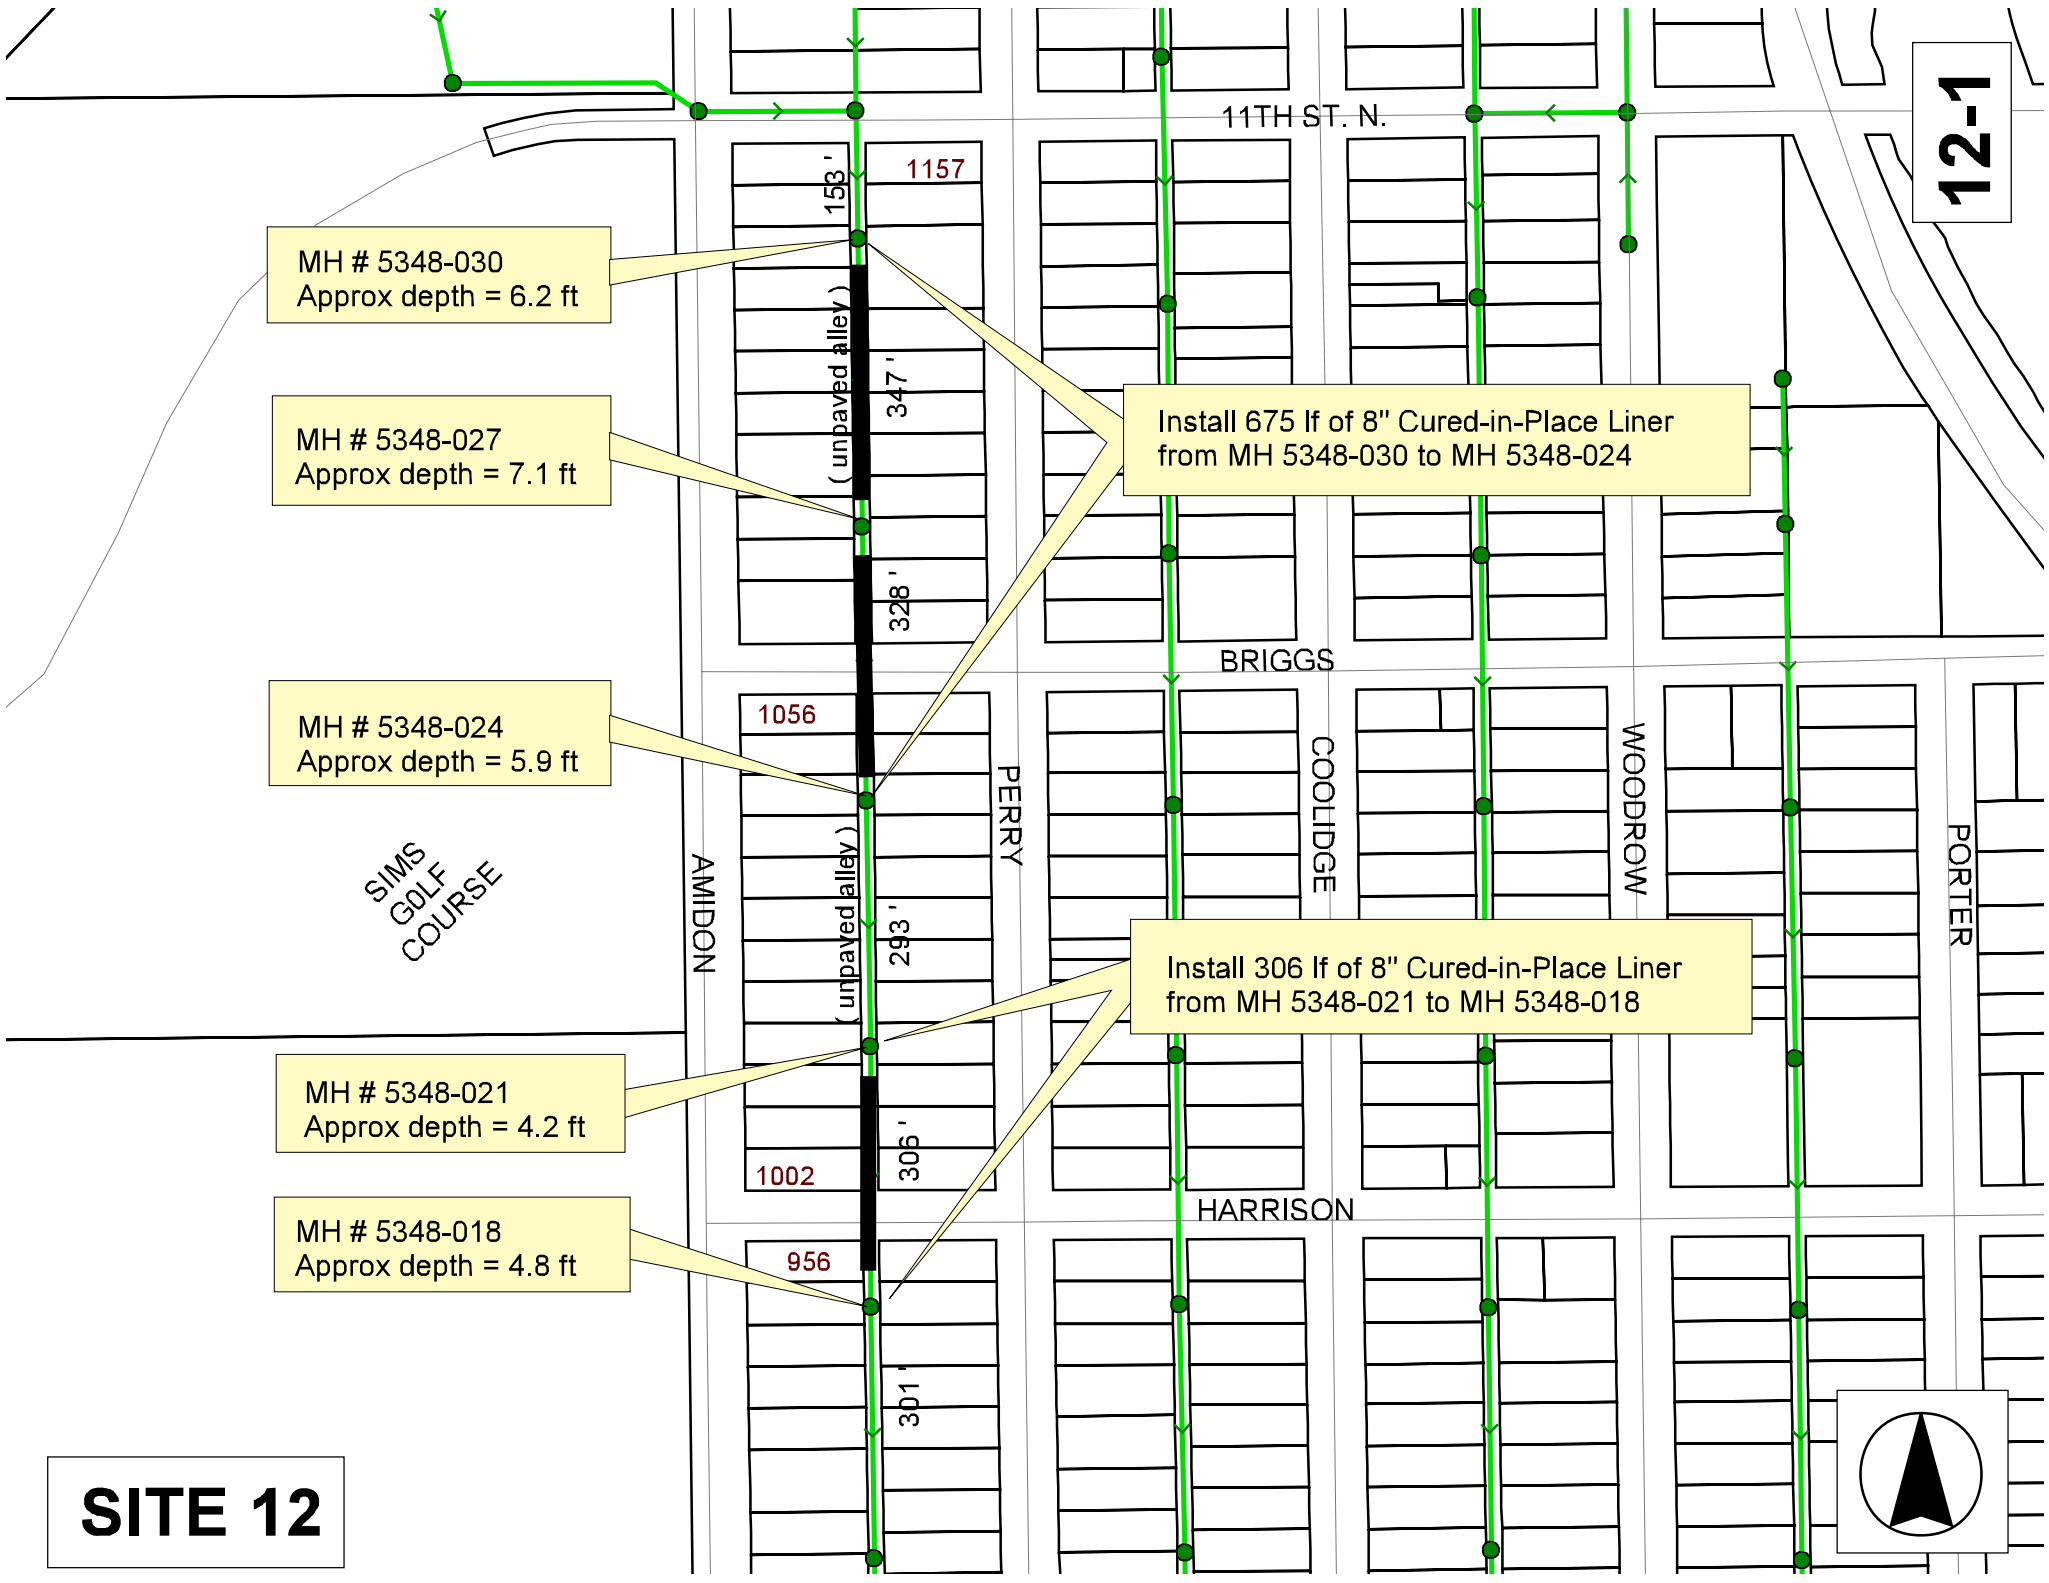
MH # 5348-030
Approx depth = 6.2 ft

MH # 5348-027
Approx depth = 7.1 ft

MH # 5348-024
Approx depth = 5.9 ft

MH # 5348-021
Approx depth = 4.2 ft

MH # 5348-018
Approx depth = 4.8 ft
