Point Repair:
Remove and replace 110 lf of 8" pipe, from MH 5847-030 to 110 lf east of MH 5847-030. Includes removal of existing concrete encasement and cut-off wall (cannot verify if there is a cut-off wall at this site / no available microfilm records)

5805 E. Central

Television Inspection Master Report

US Manhole: 5847-039 5818 AVALON RD Date Insp: 5/2/2007 Basin: E04G
DS Manhole: 5847-030 435 N BROOKSIDE PKWY Dir Televised: Upstream To Downstream

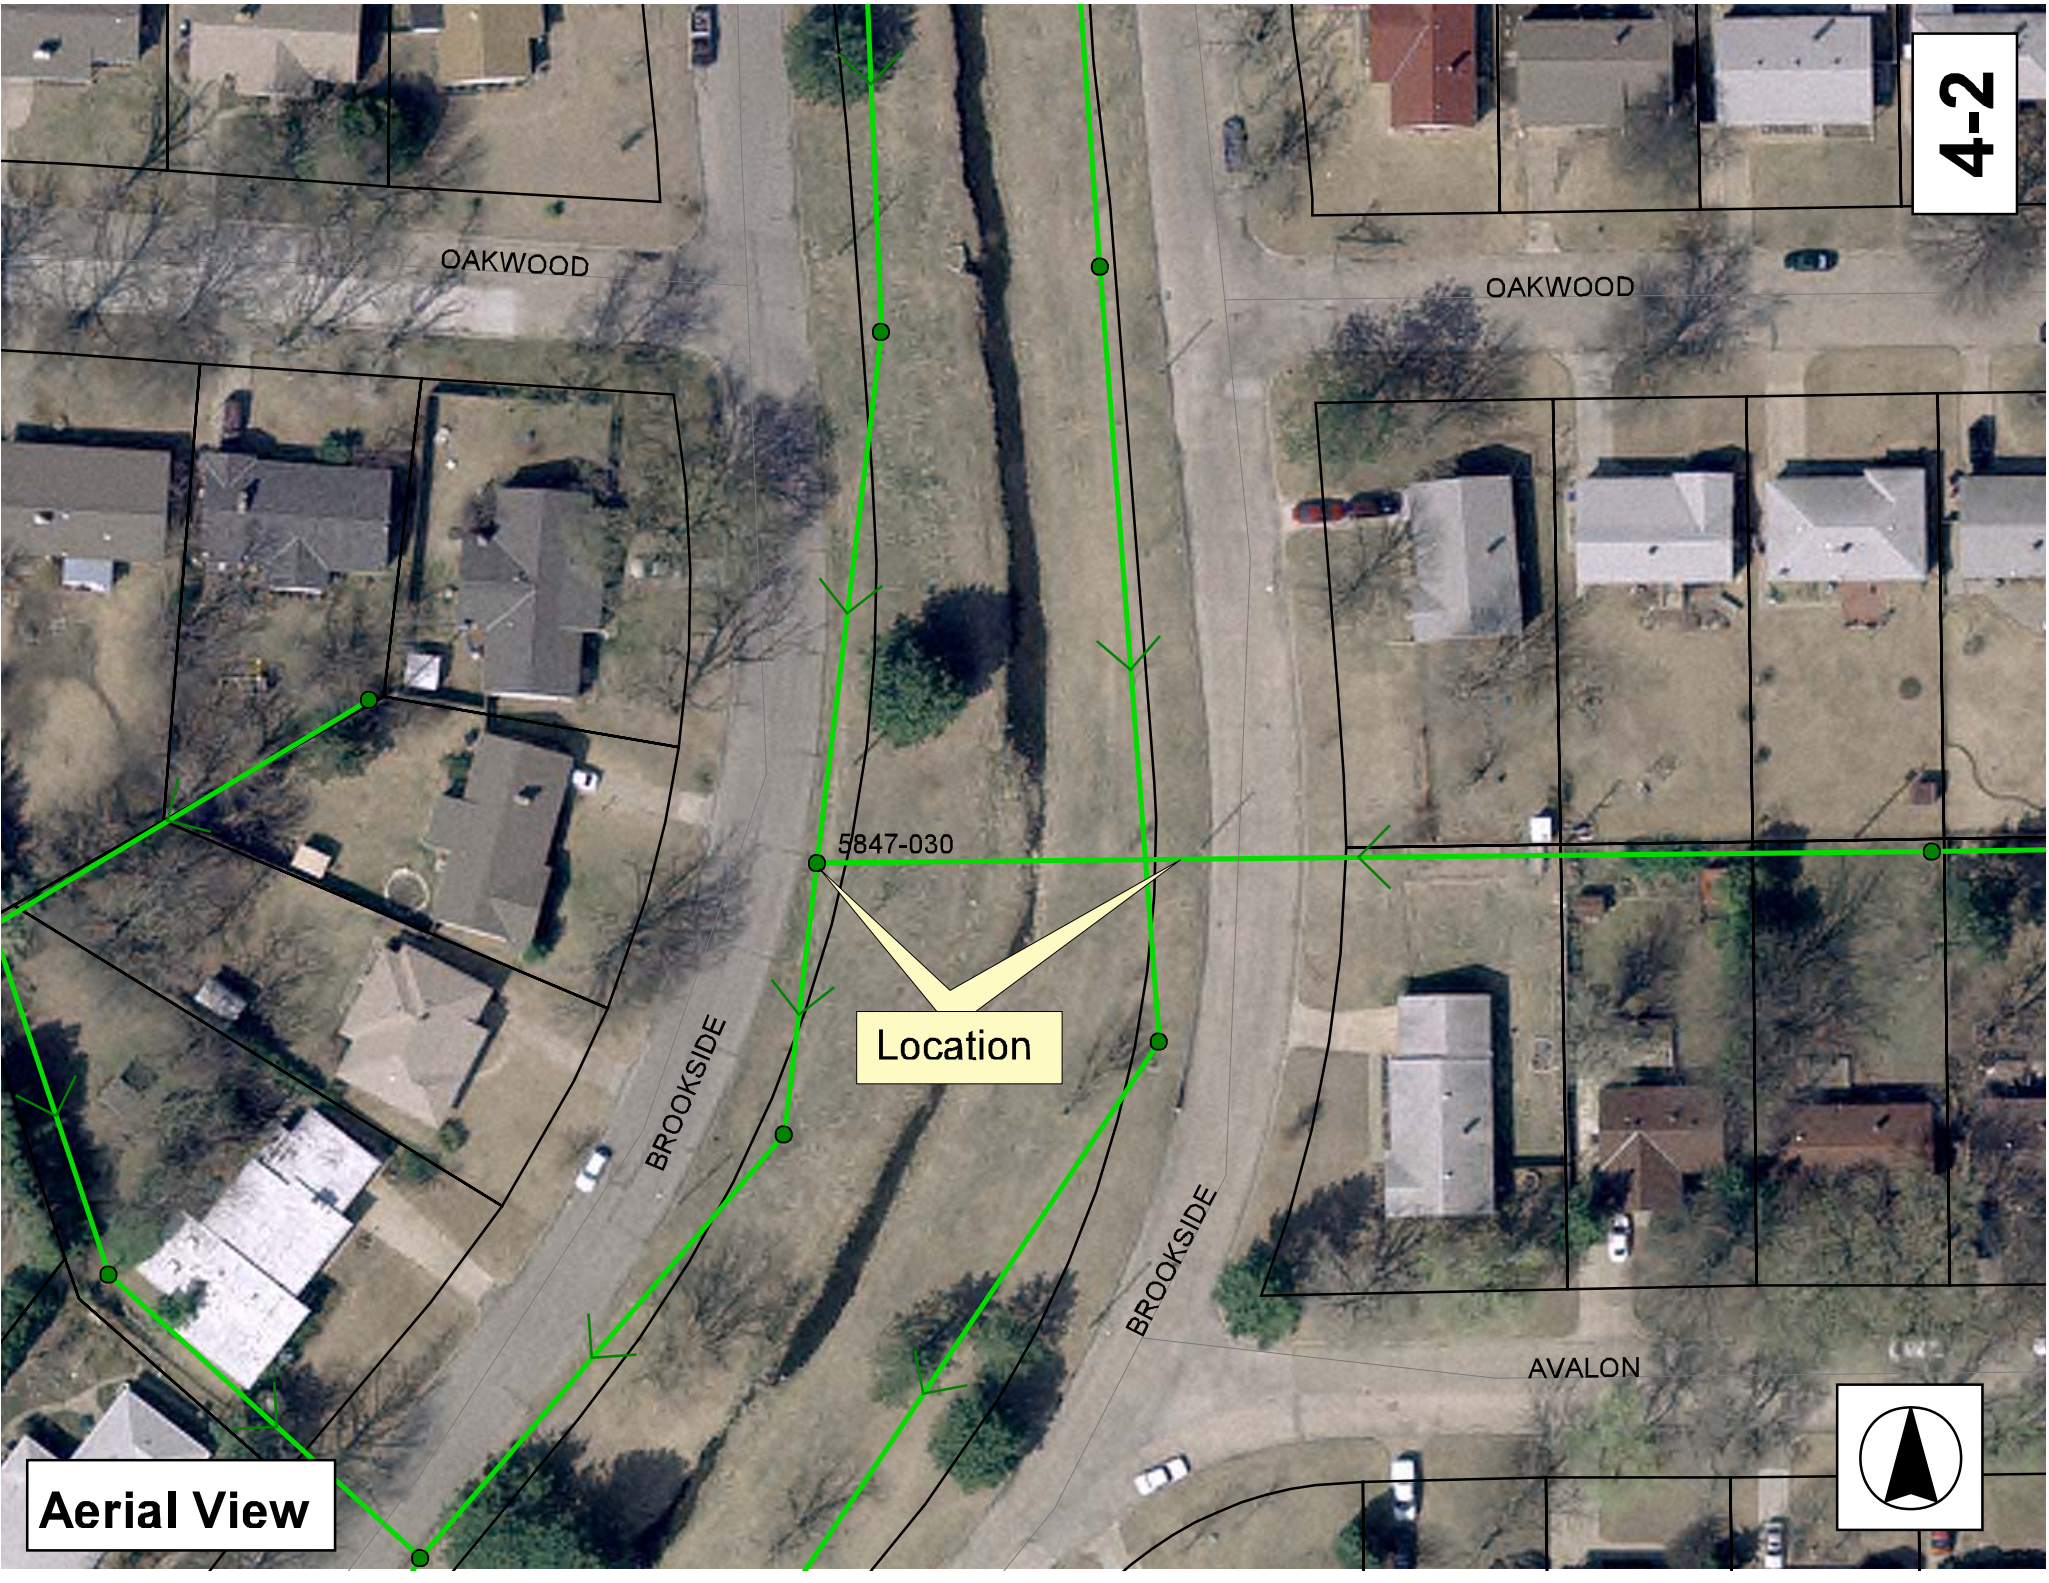
Aerial View

MH # 5847-030
Replace Manhole Frame & Cover
Approx MH depth = 11.1 ft

Construct Outside Drop (for line coming into manhole from the east)

Install Concrete Encasement with Cut-Off Wall:
Install a 15 ft wide encasement/cut-off wall, centered on the creek (see detail sheet)

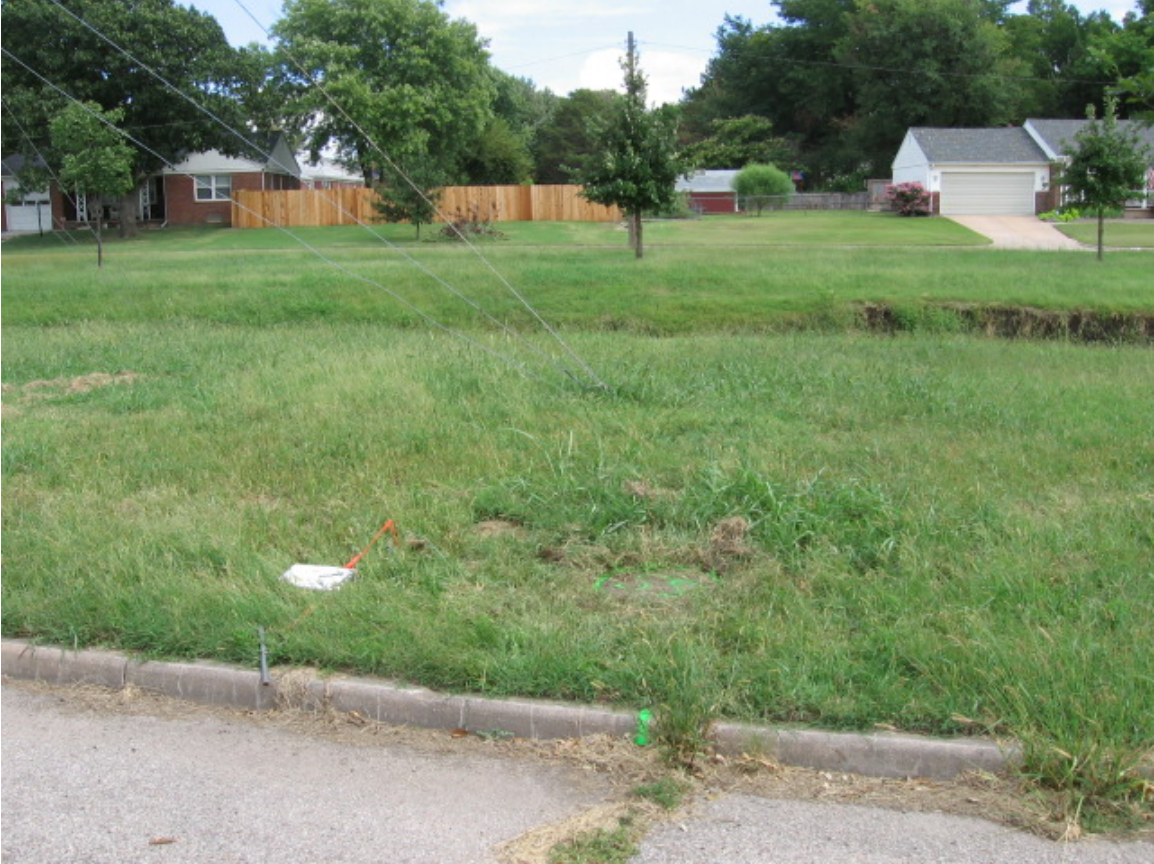
Standing in Brookside Street (west of the ditch), looking east. Manhole 5847-030 is painted there in the grass, just east of the curb line.

If the oak tree on the east side of the ditch has not been removed by the time construction is ready to begin, please contact LaDonna at 316-268-4555.
