Remove and replace 20 lf of Concrete Driveway:  
 ' 9 lf at 2755 S. Greenwood  
 ' 11 lf at 2754 S. Greenwood

Remove and replace 439 lf of 8" pipe from MH 5544-372 to MH 5544-370

Sheet 11 of 24

# Television Inspection Master Report

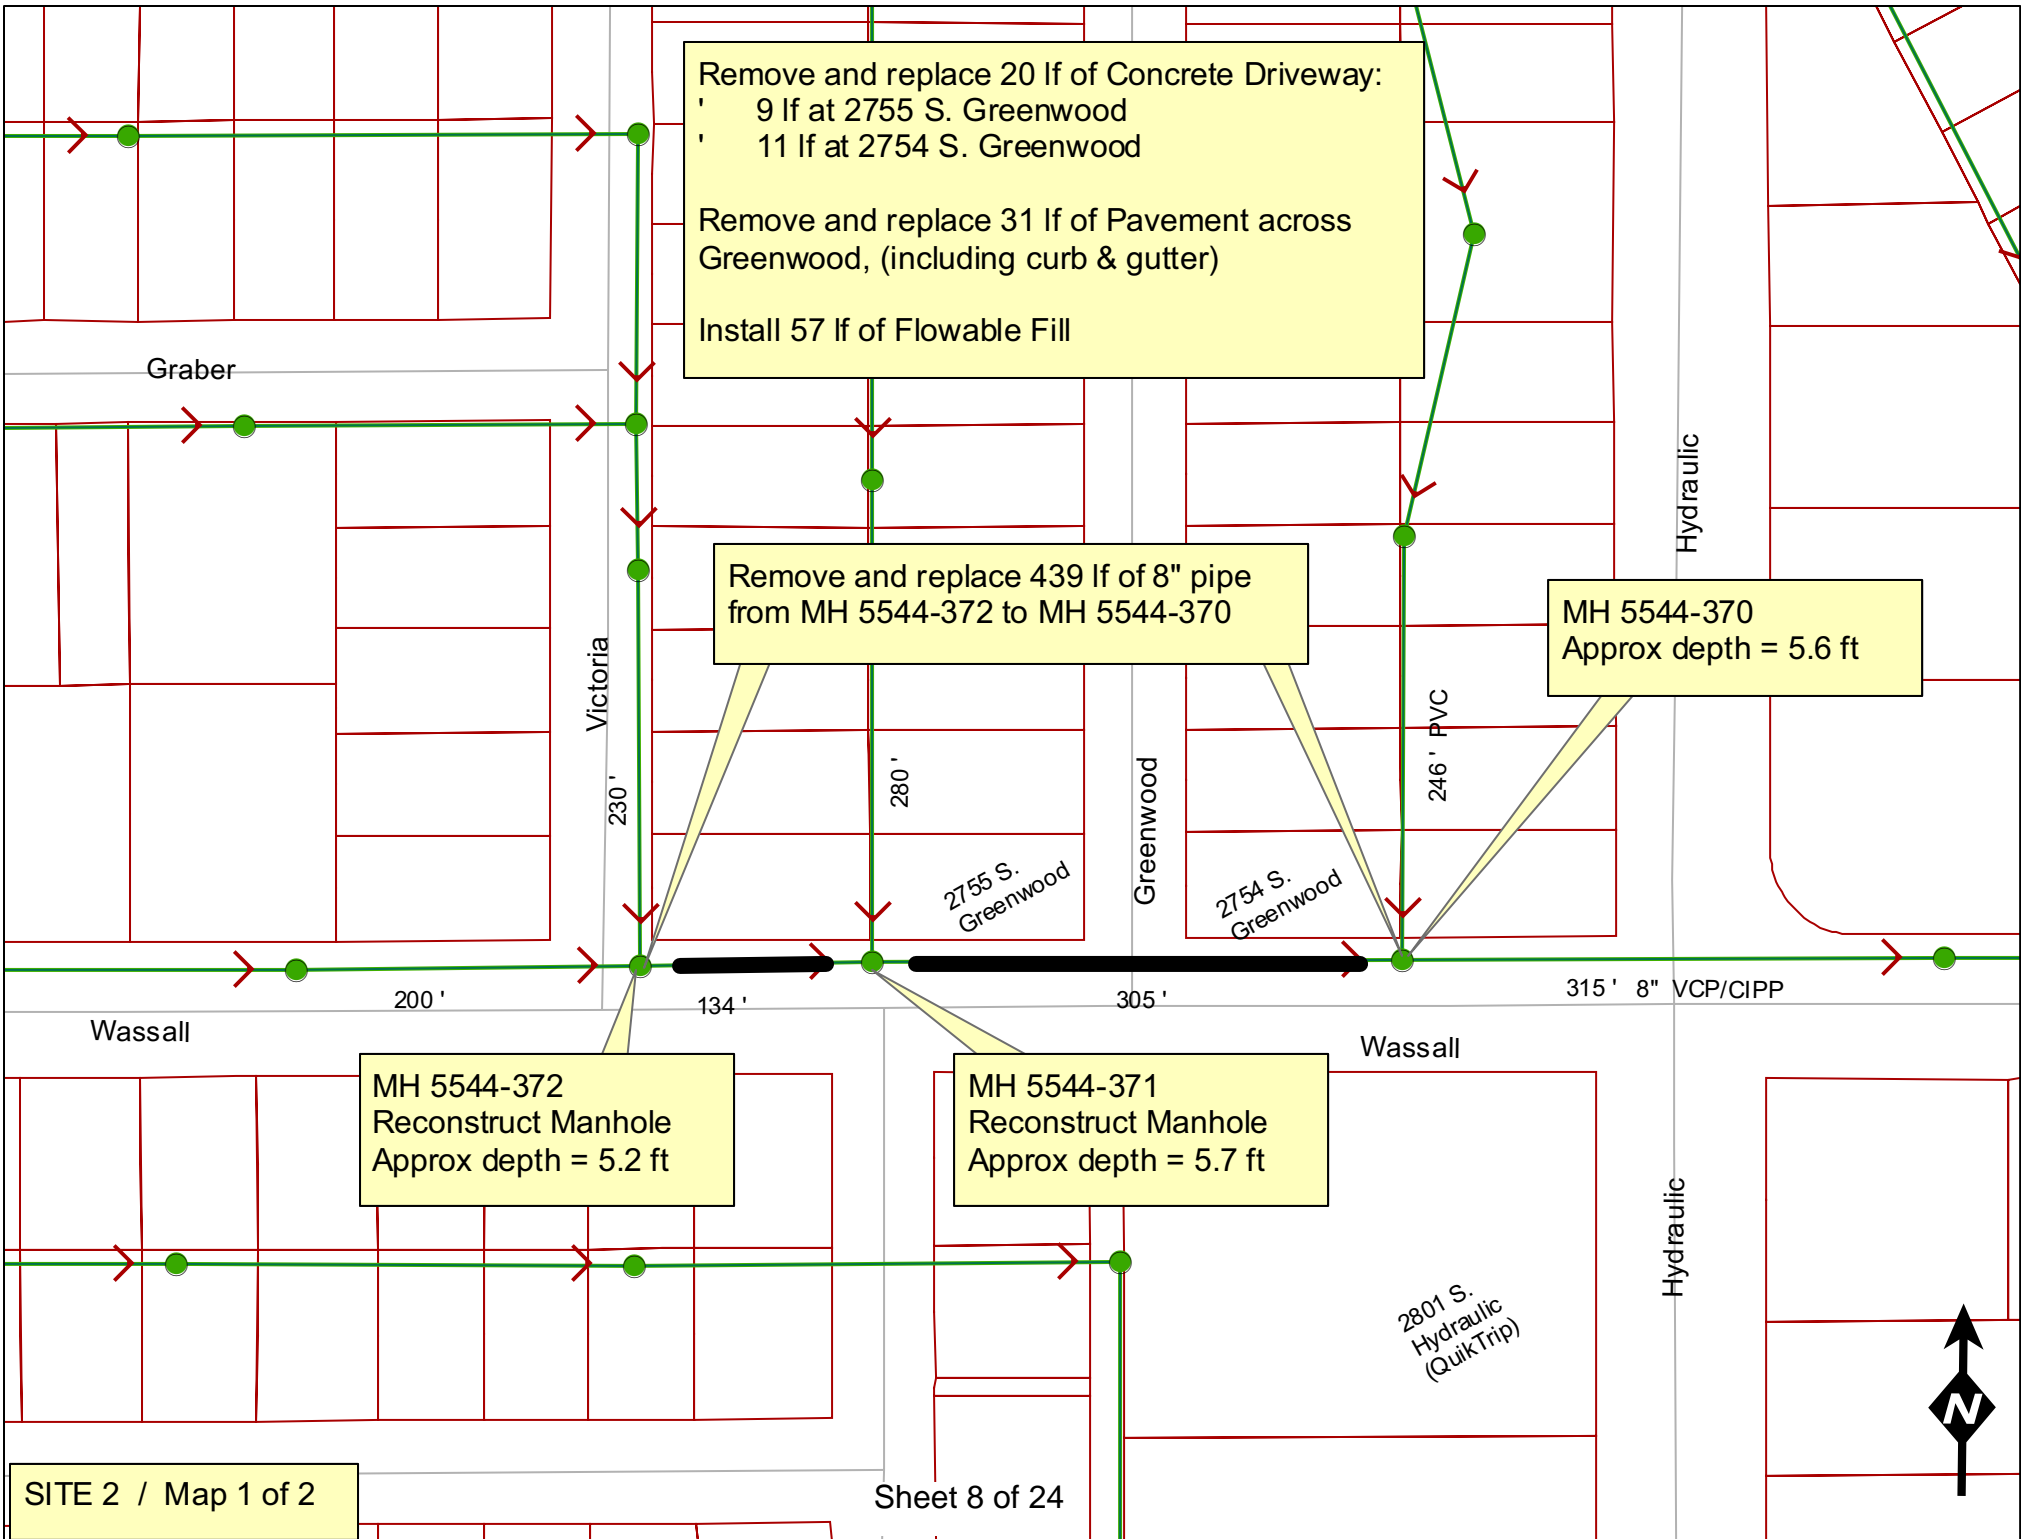
MH 5544-370  
 Approx depth = 5.6 ft

MH 5544-372  
 Reconstruct Manhole  
 Approx depth = 5.2 ft

MH 5544-371  
 Reconstruct Manhole  
 Approx depth = 5.7 ft

MH 5544-377  
Reconstruct Manhole  
Approx depth = 4.3 ft

MH 5544-376  
Reconstruct Manhole  
Approx depth = 5.2 ft

Remove and replace 31 lf of Pavement across Greenwood, (including curb & gutter)

Install 57 lf of Flowable Fill

Point Repair: Remove and replace 23 lf of 8" pipe, from MH 5544-376, going 24 ft to the west (see tv log / includes tap replacements)

Point Repair: Remove and replace 10 lf of 8" pipe, from 45' to 55' east of MH 5544-377 (see tv log / includes tap replacements)
