2011 SANITARY SEWER RECONSTRUCTION PHASE 4

OCA # 620580 / 468-84778
(East of Meridian, South of 13th Street North)

Television Inspection Master Report

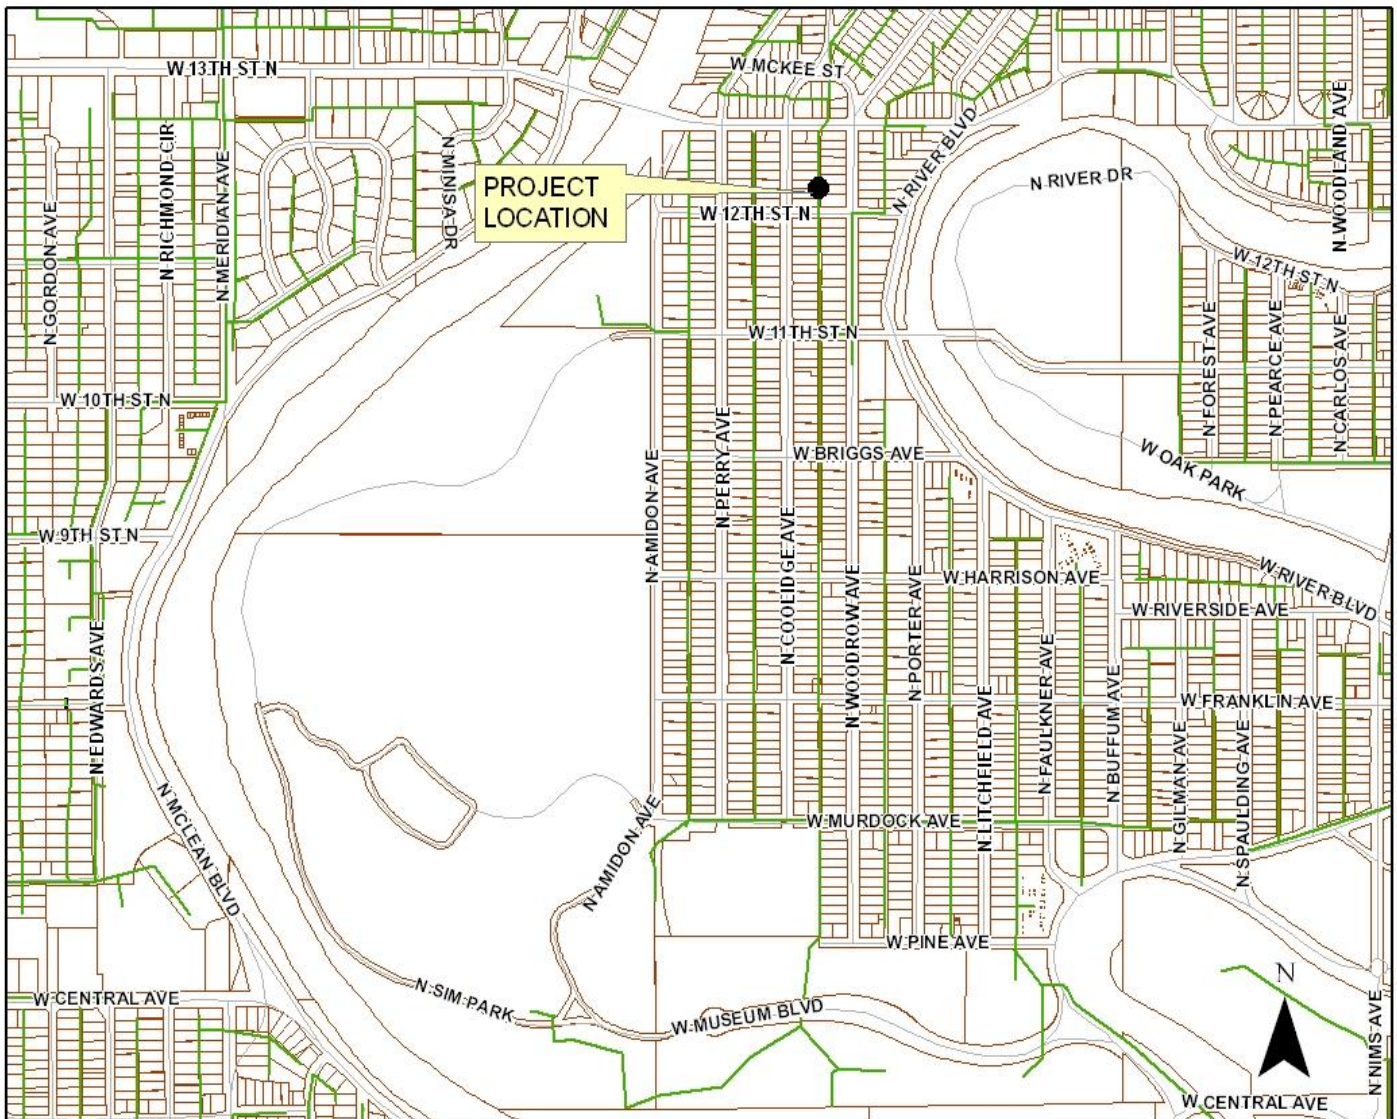
MH # 5348-123
Approx depth = 7.1 ft

MH # 5348-120
Reconstruct Manhole
Approx depth = 7.9 ft

MH # 5348-117
Reconstruct Manhole
Approx depth = 8.6 ft

Remove 363 lf of 8" Pipe
Install 363 lf of 8" Pipe

Point Repair: Remove and replace
40 lf of pipe, from MH 5348-117 to
40 lf north, including two Service
Connections (see tv log)
