SITE 3

Video Inspection Master Report

US Structure: 4848-186 9127 W 10TH ST N Date Insp: 4/28/2009 Basin: W06A
 DS Structure: 4848-185 1111 N WESTFIELD ST Dir Televised: Downstream To Upstream

Project No. : K-068 Dia: 8 Material: VCP Length: 233.0 Slope: 0.400

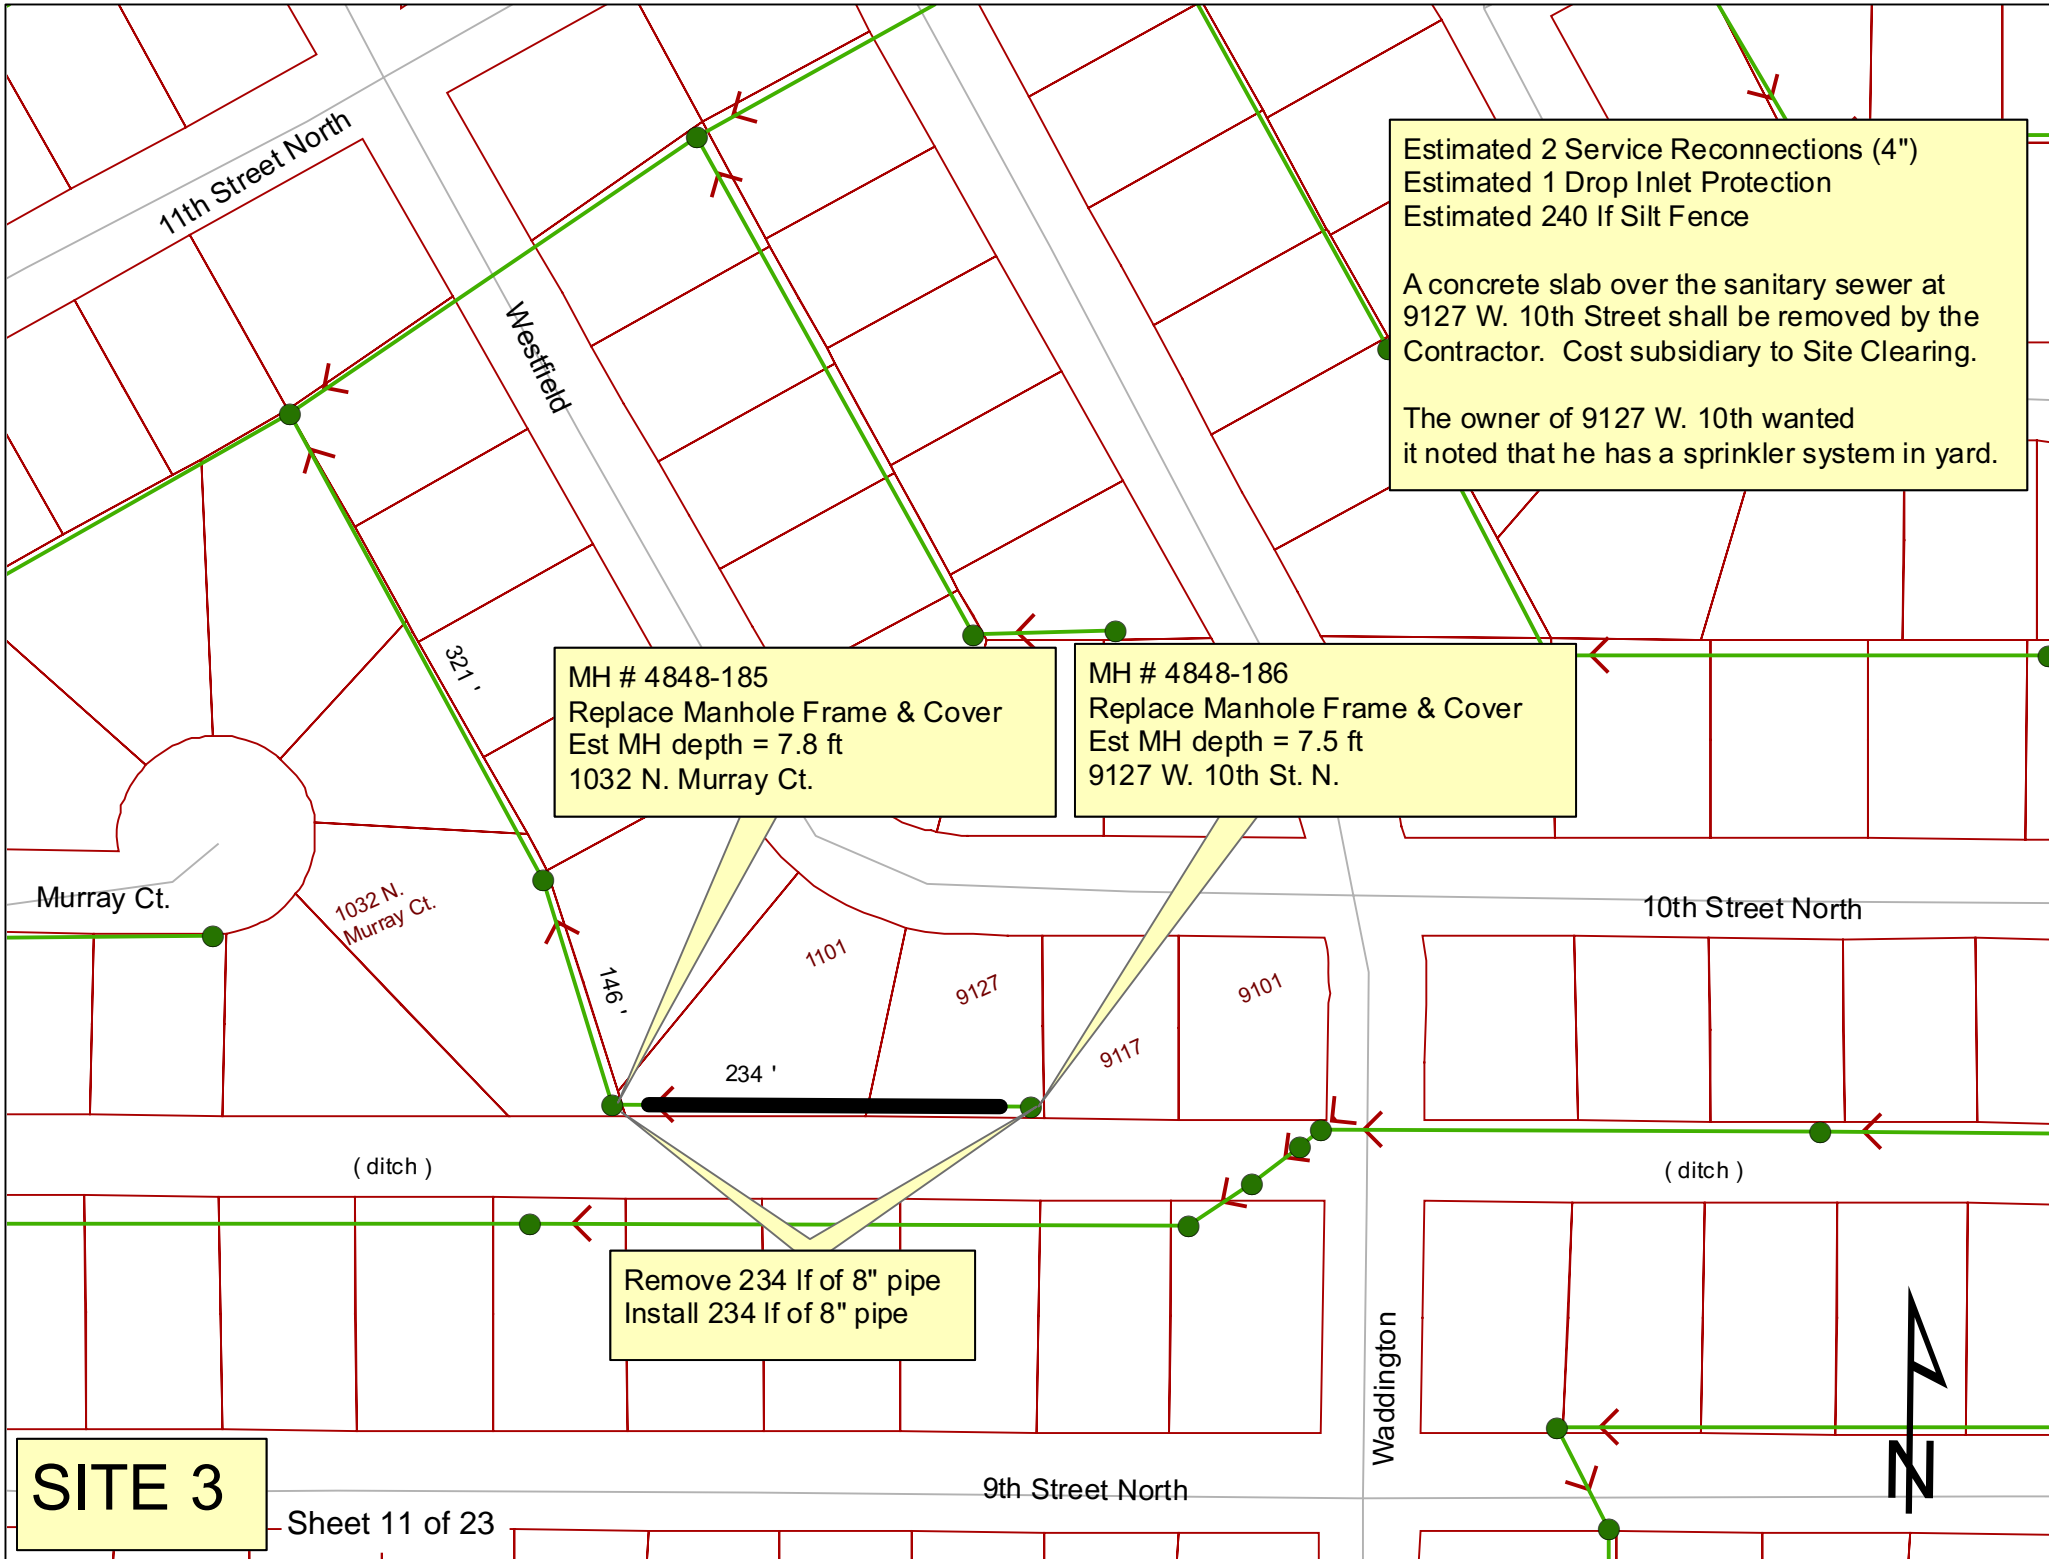
MH # 4848-185
 Replace Manhole Frame & Cover
 Est MH depth = 7.8 ft
 1032 N. Murray Ct.

MH # 4848-186
 Replace Manhole Frame & Cover
 Est MH depth = 7.5 ft
 9127 W. 10th St. N.

Remove 234 lf of 8" pipe
 Install 234 lf of 8" pipe

Pipe is "roller coaster" and not on grade. Most every joint is offset.

A concrete slab over the sanitary sewer at 9127 W. 10th Street shall be removed by the Contractor. Cost subsidiary to Site Clearing.

The owner of 9127 W. 10th wanted it noted that he has a sprinkler system in yard.

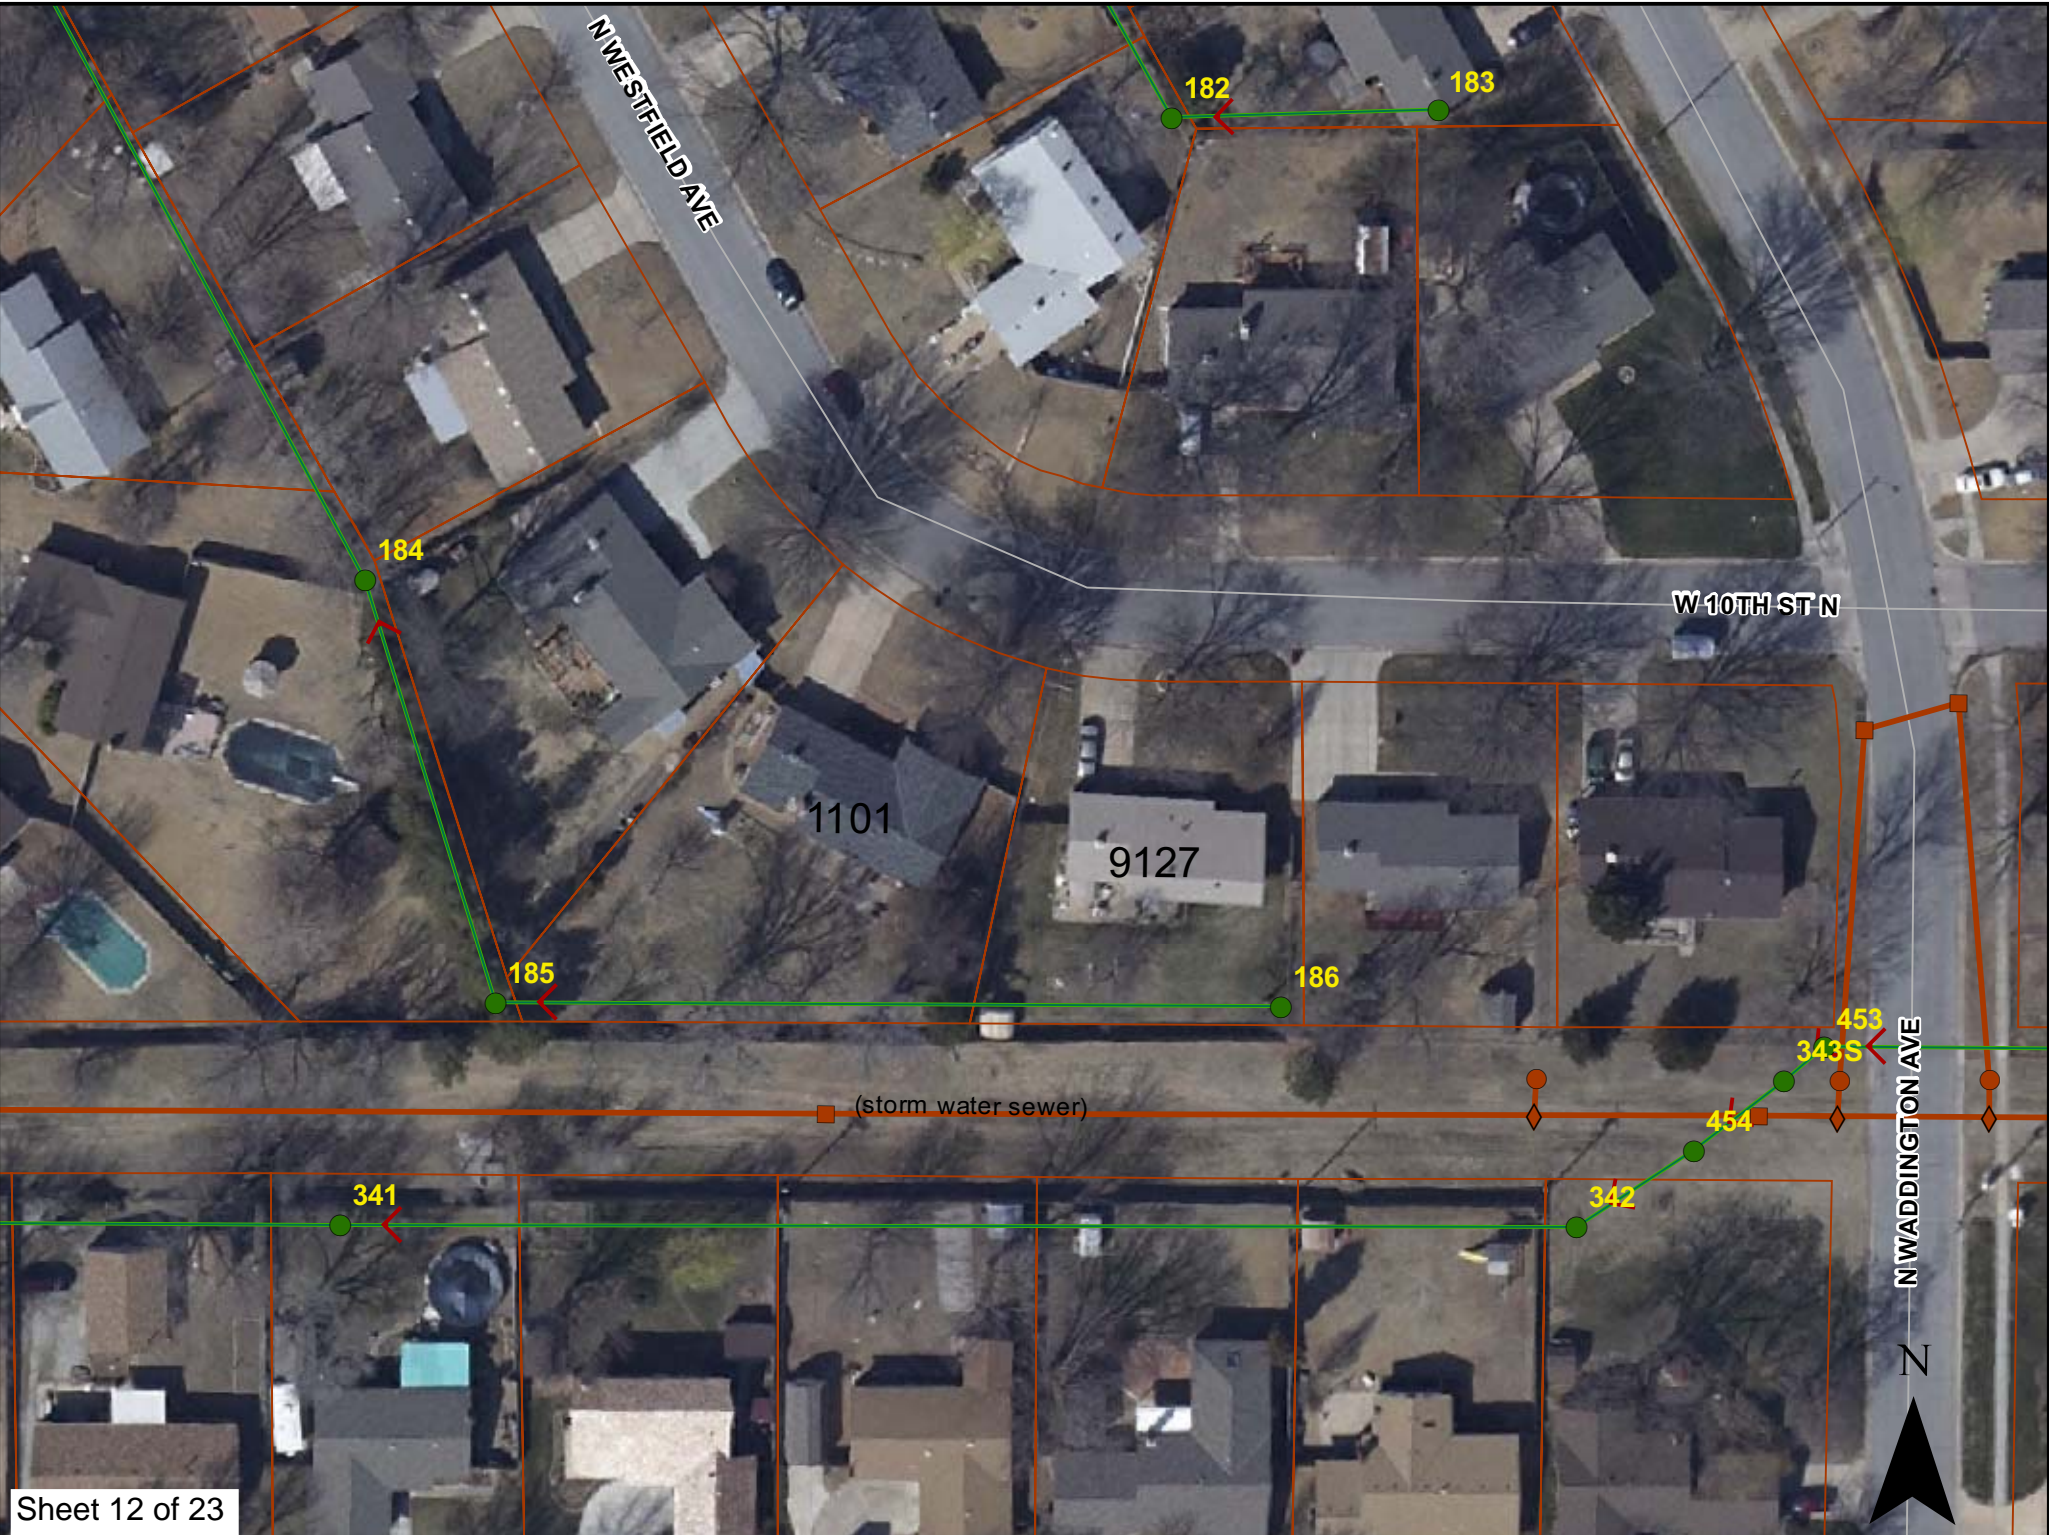
Obs. #	VTR Counter	Distance	Location	Description	Rating	Obsrvd (gpm)	Ratings			Remain (gpm)
							Est. (gpm)	Struct	Clean	
1		0.0	TV Against the Flow	4848-185 DS Manhole	1		0.000	0	0	0.000
2		0.0	Joint	Offset	2		0.000	0	0	0.000
3		6.8		Broken Pipe	4		0.030	78	0	0.030
4		8.1	Joint	Offset	5		0.060	100	0	0.060
5		10.4		Sag	4		0.000	10	0	0.000
6		16.8	Joint	Offset	4		0.030	60	0	0.030
(the pipe from 8' to 16' sits lower than the rest of the pipe)										
7		21.0		Sag	1		0.000	1	0	0.000
8		21.9		Sag	3		0.000	5	0	0.000
9		22.6		Sag	1		0.000	1	0	0.000
10		24.4	Joint	Offset	2		0.000	0	0	0.000
11		40.3	Joint	Offset	3		0.010	20	0	0.010
12		44.4	Joint	Offset	3		0.010	20	0	0.010
13		48.6	Joint	Offset	3		0.010	20	0	0.010
14		49.1		Sag	3		0.000	5	0	0.000
15		51.6		Sag	1		0.000	1	0	0.000
16		56.4	Joint	Offset	3		0.010	20	0	0.010
17		60.5	Joint	Offset	3		0.010	20	0	0.010
18		64.5	Joint	Offset	2		0.000	0	0	0.000
19		66.5		Sag	3		0.000	5	0	0.000

20		68.6	Joint	Offset	2		0.000	0	0	0.000
21		70.0	1101 S WESTFIELD AVE?	Wye Service (ball of roots / could this be abandoned?)	3		0.000	2	0	0.000
22		71.1		Sag	1		0.000	1	0	0.000
23		78.6	Joint	Offset	3		0.010	20	0	0.010
24		79.2		Crack-Horizontal	3		0.004	5	0	0.004
25		89.7	1101 S WESTFIELD AVE	Break-In Conn (PVC service connected to VCP wye)	2		0.002	0	0	0.002
26		94.6	Joint	Offset	2		0.000	0	0	0.000
27		102.8	Joint	Offset	3		0.010	20	0	0.010
28		114.8	Joint	Offset	2		0.000	0	0	0.000
29		118.7	Joint	Offset	3		0.010	20	0	0.010
30		122.8		Roots	3		0.008	5	8	0.008
31		123.0	Joint	(fairly severe) Offset	3		0.010	20	0	0.010
32		127.1	Joint	Offset	2		0.000	0	0	0.000

33	151.3	Joint		Offset	3	0.010	20	0	0.010	
34	163.4	Joint		Offset	2	0.000	0	0	0.000	
35	165.1		Wye Service / sealed off		1	0.000	0	0	0.000	
36	165.2	Joint		Offset	3	0.010	20	0	0.010	
37	173.4	Joint		Offset	2	0.000	0	0	0.000	
38	181.4	Joint		Offset	3	0.010	20	0	0.010	
39	189.4	Joint		Offset	2	0.000	0	0	0.000	
40	197.5	Joint		Offset	3	0.010	20	0	0.010	
41	209.5	Joint		Offset	2	0.000	0	0	0.000	
42	217.6	Joint		Offset	3	0.010	20	0	0.010	
(this is a high point / pipe appears to be way lower on both sides of this joint)										
43	221.9	Joint		Offset	2	0.000	0	0	0.000	
44	222.3		Crack-Horizontal		3	0.004	5	0	0.004	
45	225.3	9127 E 10TH ST N		Break-In Conn	4	0.008	60	0	0.008	
(this tap sits in a sag / water level is half way up on the service opening)										
46	225.6			Broken Pipe	4	0.030	78	0	0.030	
47	235.9	9117 E 10TH ST N		MH TAP / Break-In Conn	1	0.001	0	0	0.001	
48	235.9		4848-186 US Manhole		4	0.000	0	0	0.000

At 9127 W. 10th Street, there is a small shed on a concrete slab over the top of the sanitary sewer line. The owner has agreed to move his shed, but removal of the small concrete slab will be the responsibility of the Contractor.

The owner of 9127 wanted it noted that he has a sprinkler system in his back yard. 4/2/12 -LML
