**SITE 7**

Sheet 20 of 32

# Video Inspection Master Report

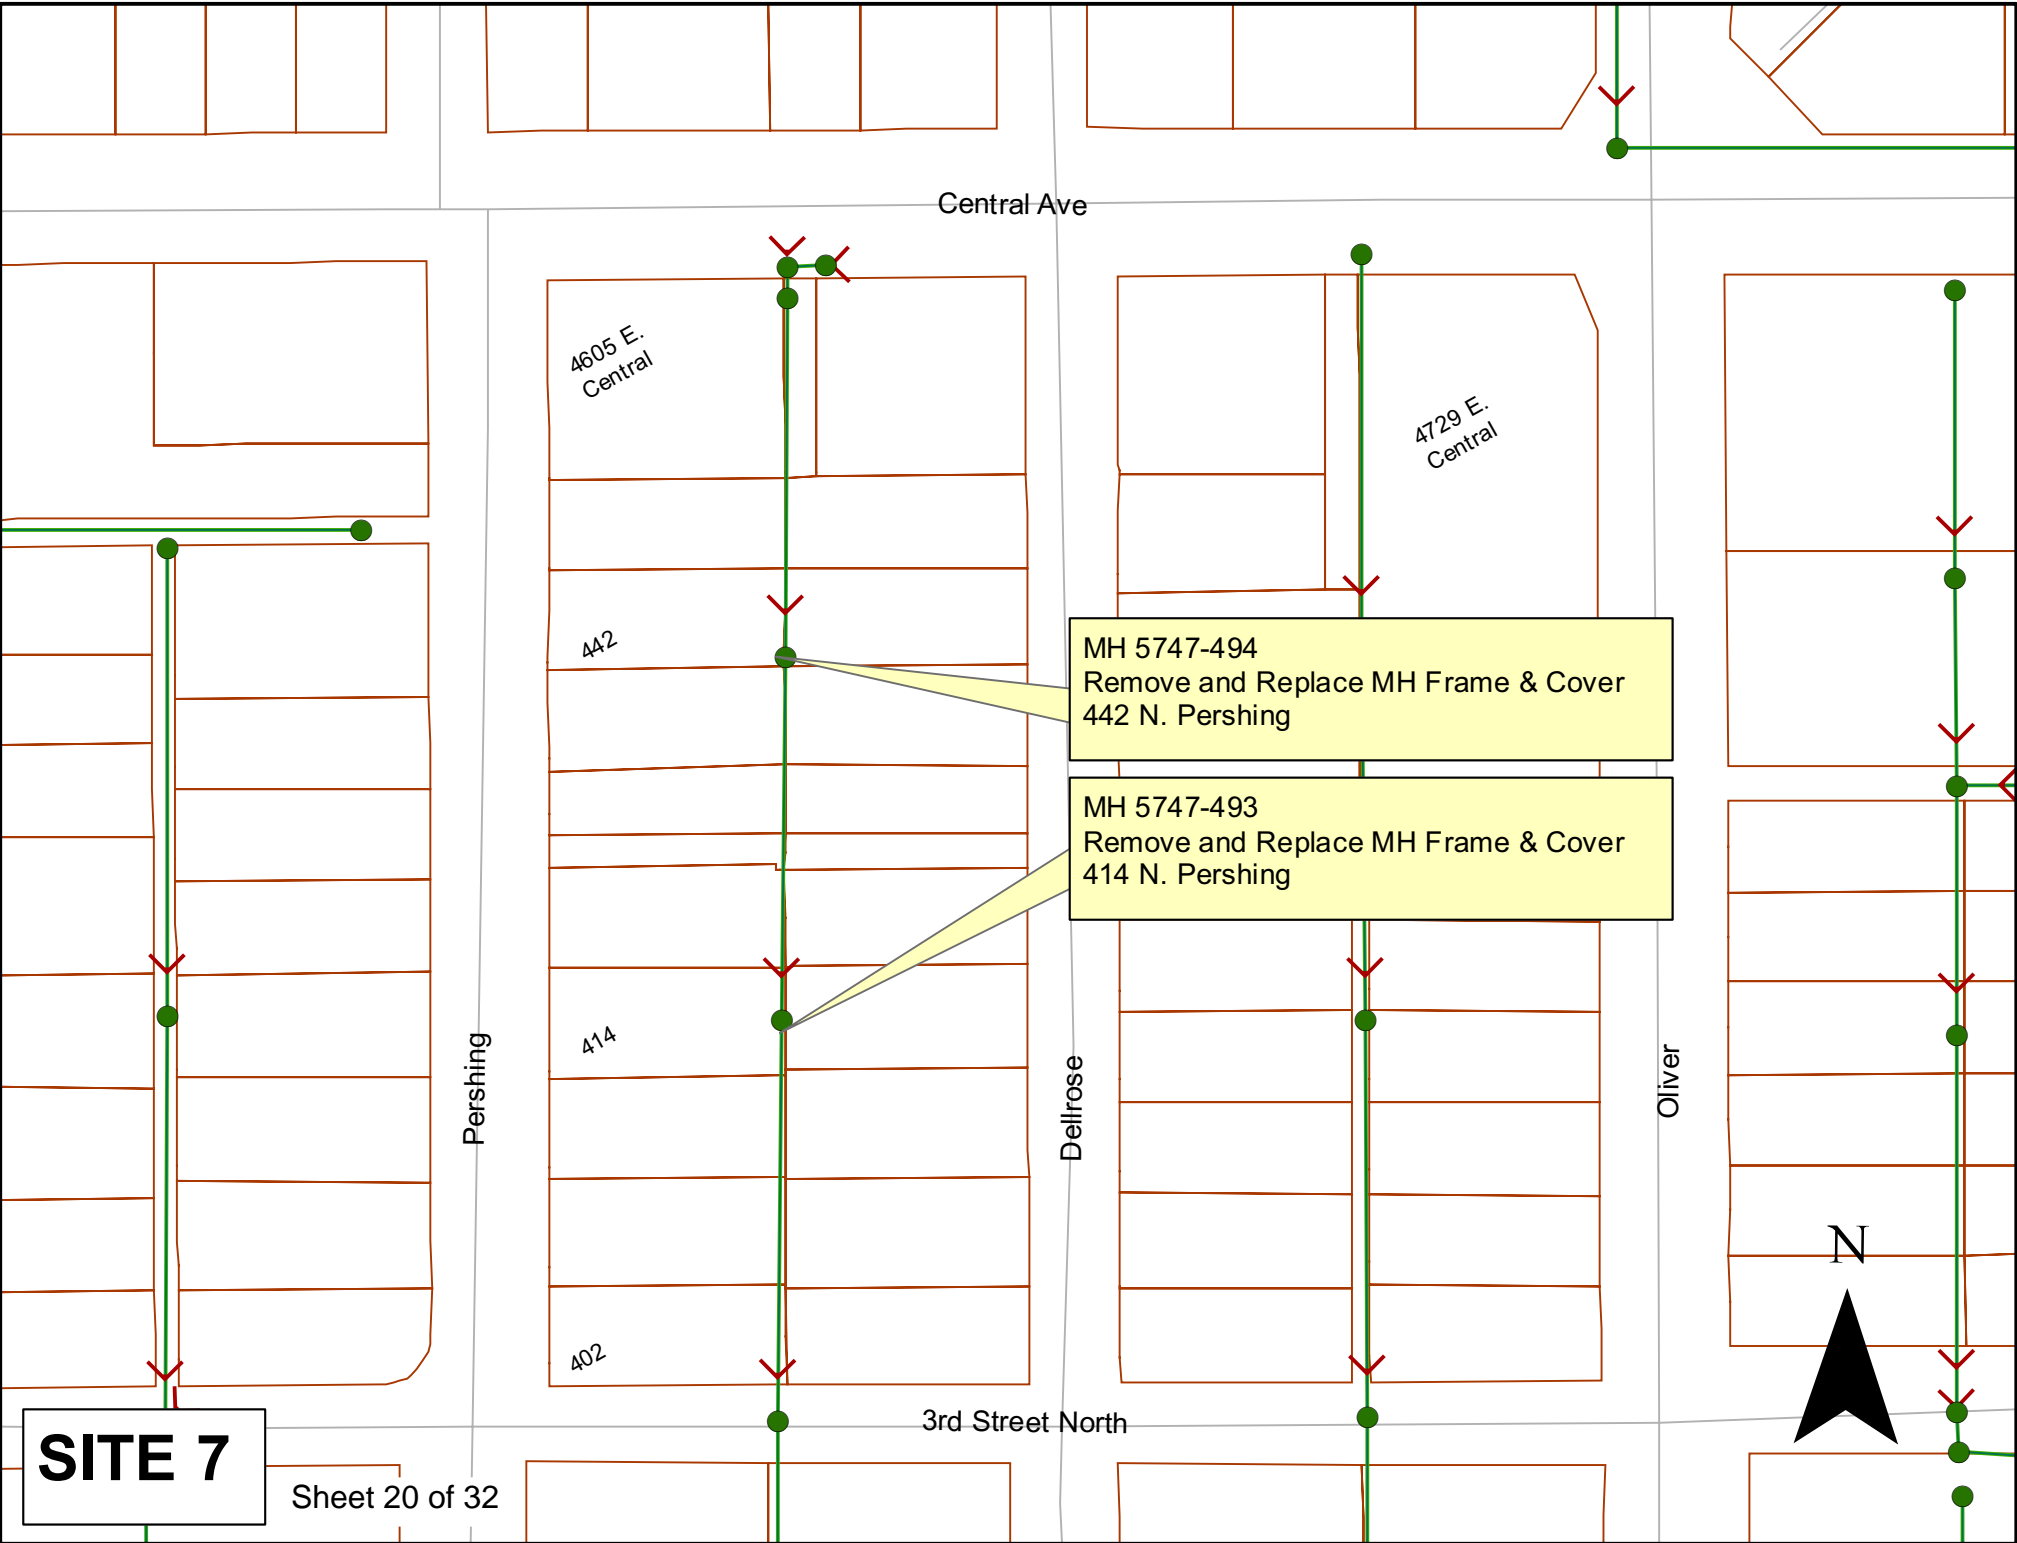
MH 5747-494  
Remove and Replace MH Frame & Cover  
442 N. Pershing

MH 5747-493  
Remove and Replace MH Frame & Cover  
414 N. Pershing

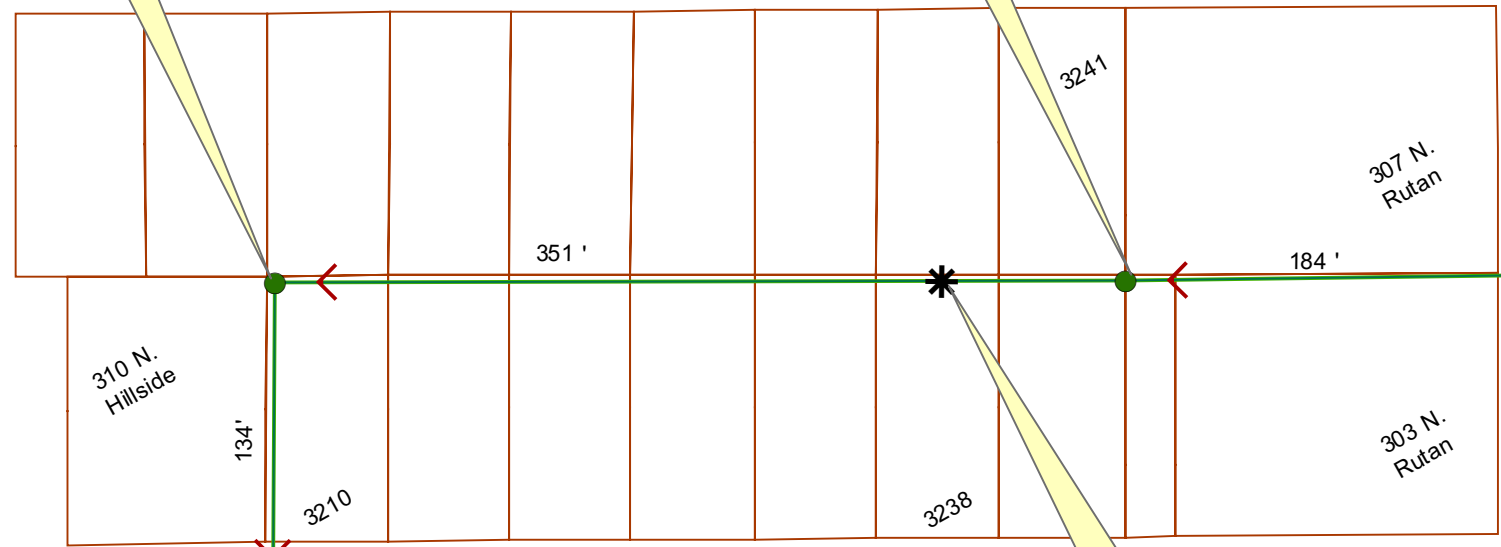
**SITE 8**

MH 5747-615  
Remove and Replace MH Frame & Cover  
3210 E. 2nd Street N.  
Approx MH depth = 6.7 ft

MH 5747-618  
3241 E. Chatfield  
Estimated MH depth = 8.5 ft

17		<b>77.6</b>		<b>Tap for 3238 E. 2<sup>nd</sup> / pipe missing / dirt showing / packed with roots</b>						
18		<b>78.4</b>		<b>Broken pipe</b>						
<b><u>NEEDS REPLACED FROM PVC AT 69 FEET TO 87 FEET</u></b>										
19		92.6		Sealed off wye						
20		95.4		Sealed off wye						
21		101.7		Roots						
22		109.3		Roots						
23		115.8		Sealed off wye						
24		118.4		Sealed off wye						
25		119.3		Tap for 3225 E. Chatfield / roots

Point Repair: Remove and replace 18 lf of pipe, from existing PVC located at 69 ft west of MH 5747-618, to a point 87 ft west of MH 5747-618. Includes 4" tap replacement for 3238 E. 2nd St. N. (See tv log)

Estimated 20 lf Silt Fence
