SITE 5

SHEET 21 OF 55

Video Inspection Master Report

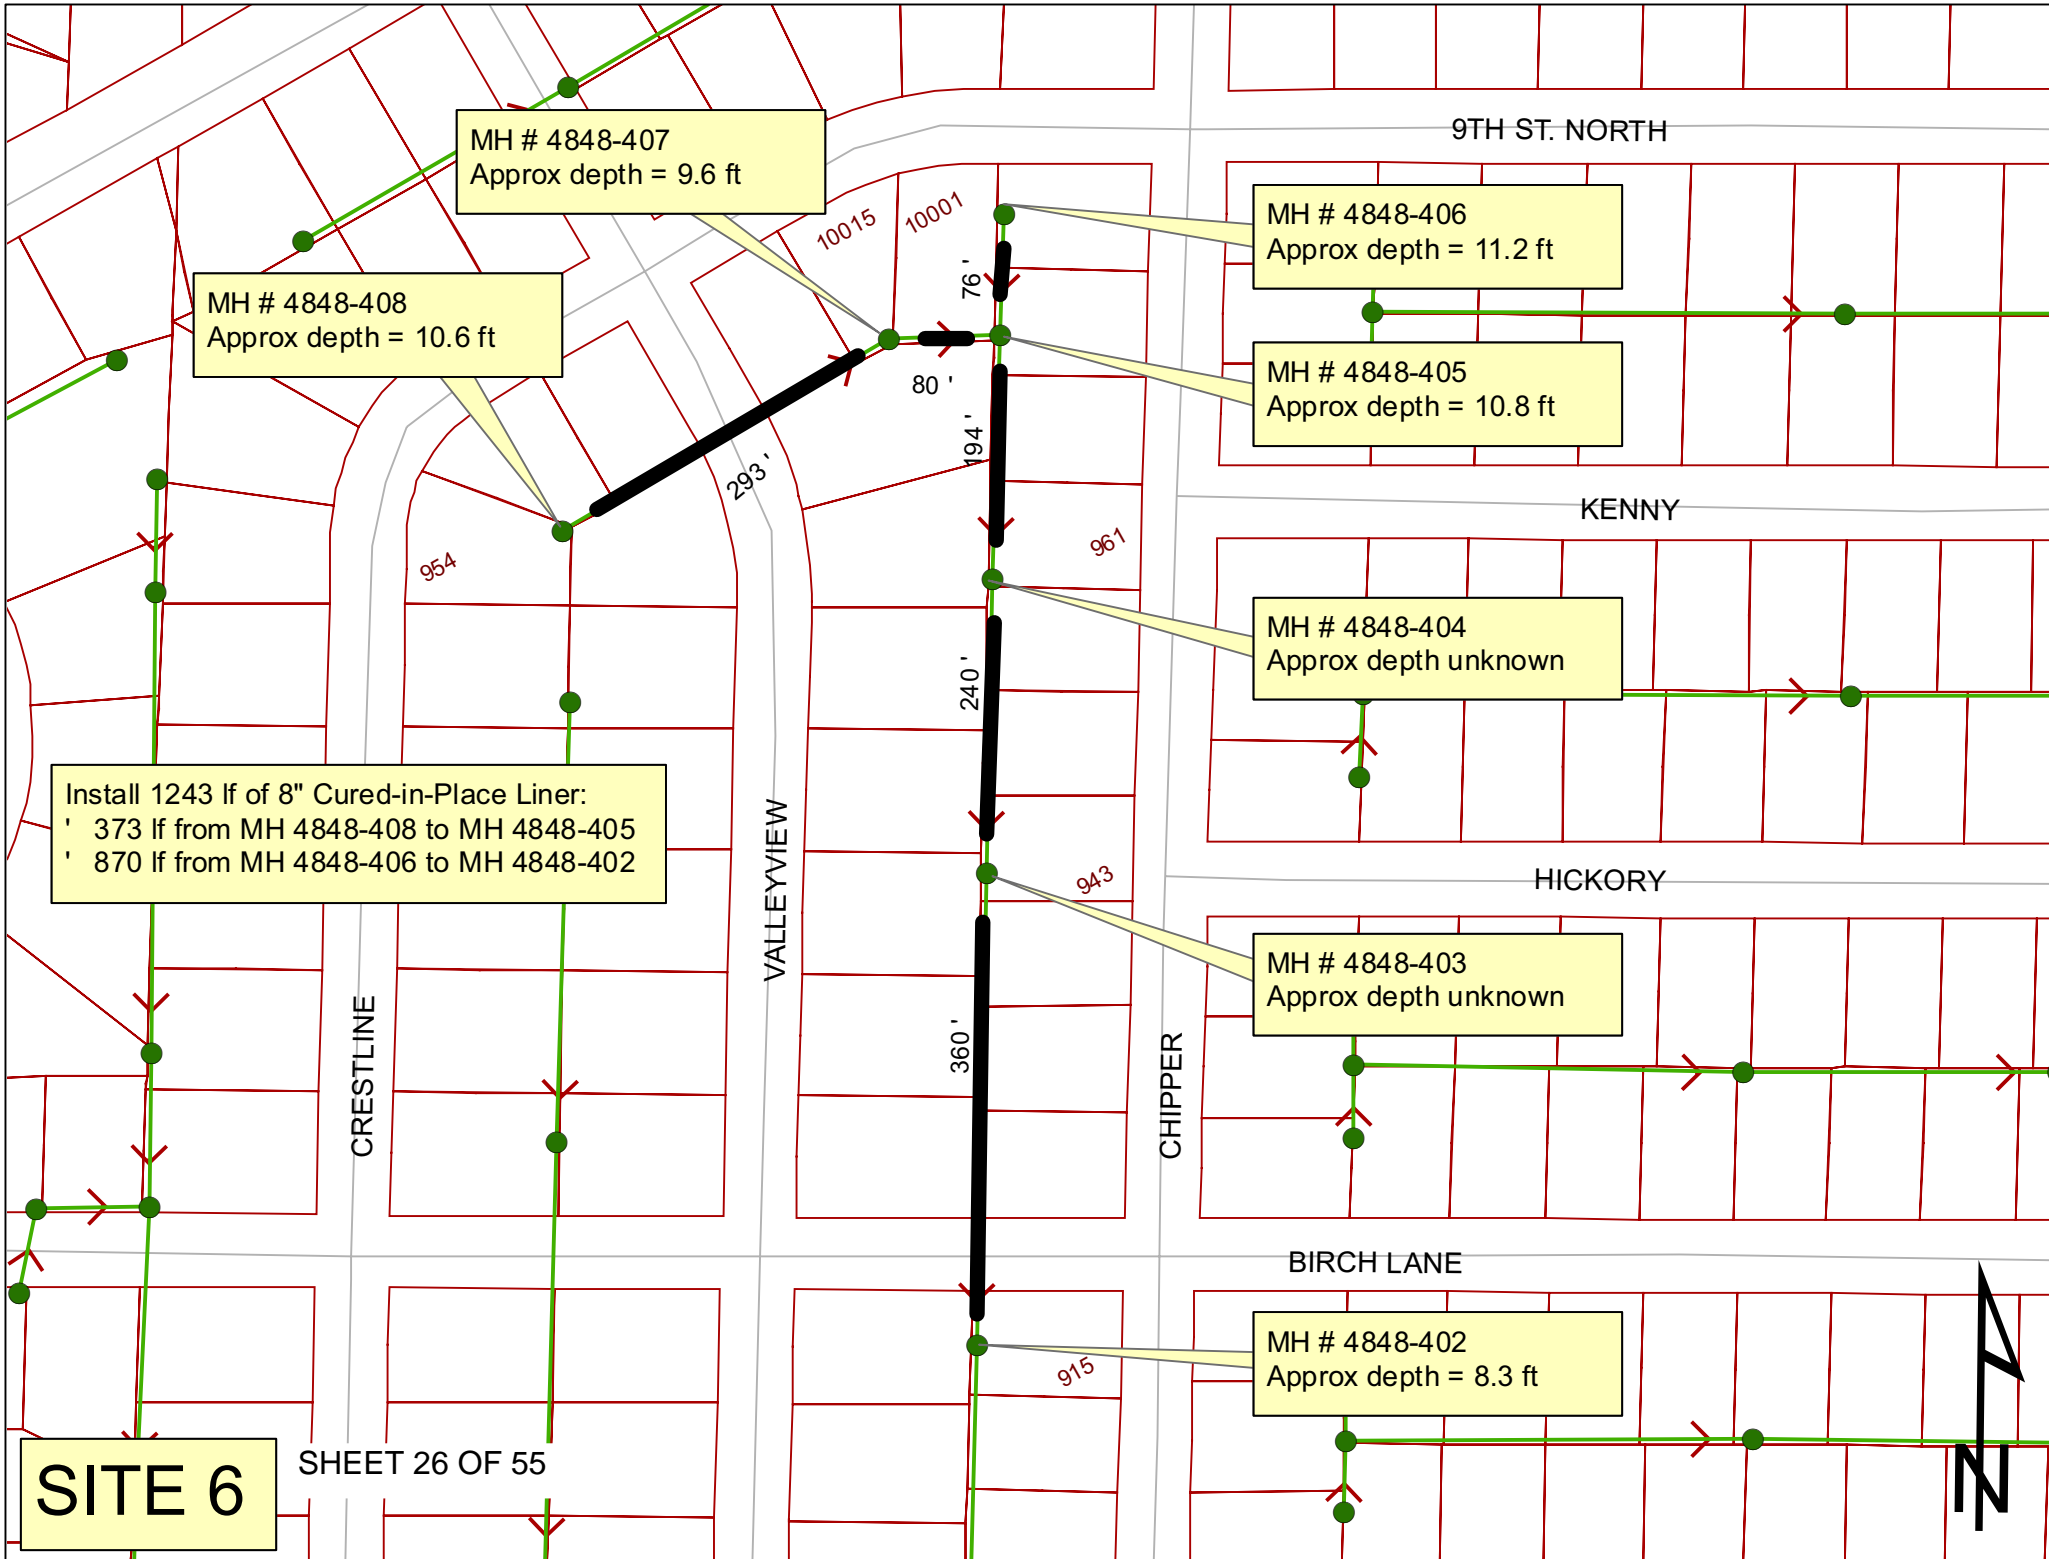
SITE 6

MH # 4848-407
Approx depth = 9.6 ft

MH # 4848-408
Approx depth = 10.6 ft

MH # 4848-406
Approx depth = 11.2 ft

MH # 4848-405
Approx depth = 10.8 ft

MH # 4848-404
Approx depth unknown

MH # 4848-403
Approx depth unknown

MH # 4848-402
Approx depth = 8.3 ft

Install 1243 lf of 8" Cured-in-Place Liner:
 ' 373 lf from MH 4848-408 to MH 4848-405
 ' 870 lf from MH 4848-406 to MH 4848-402

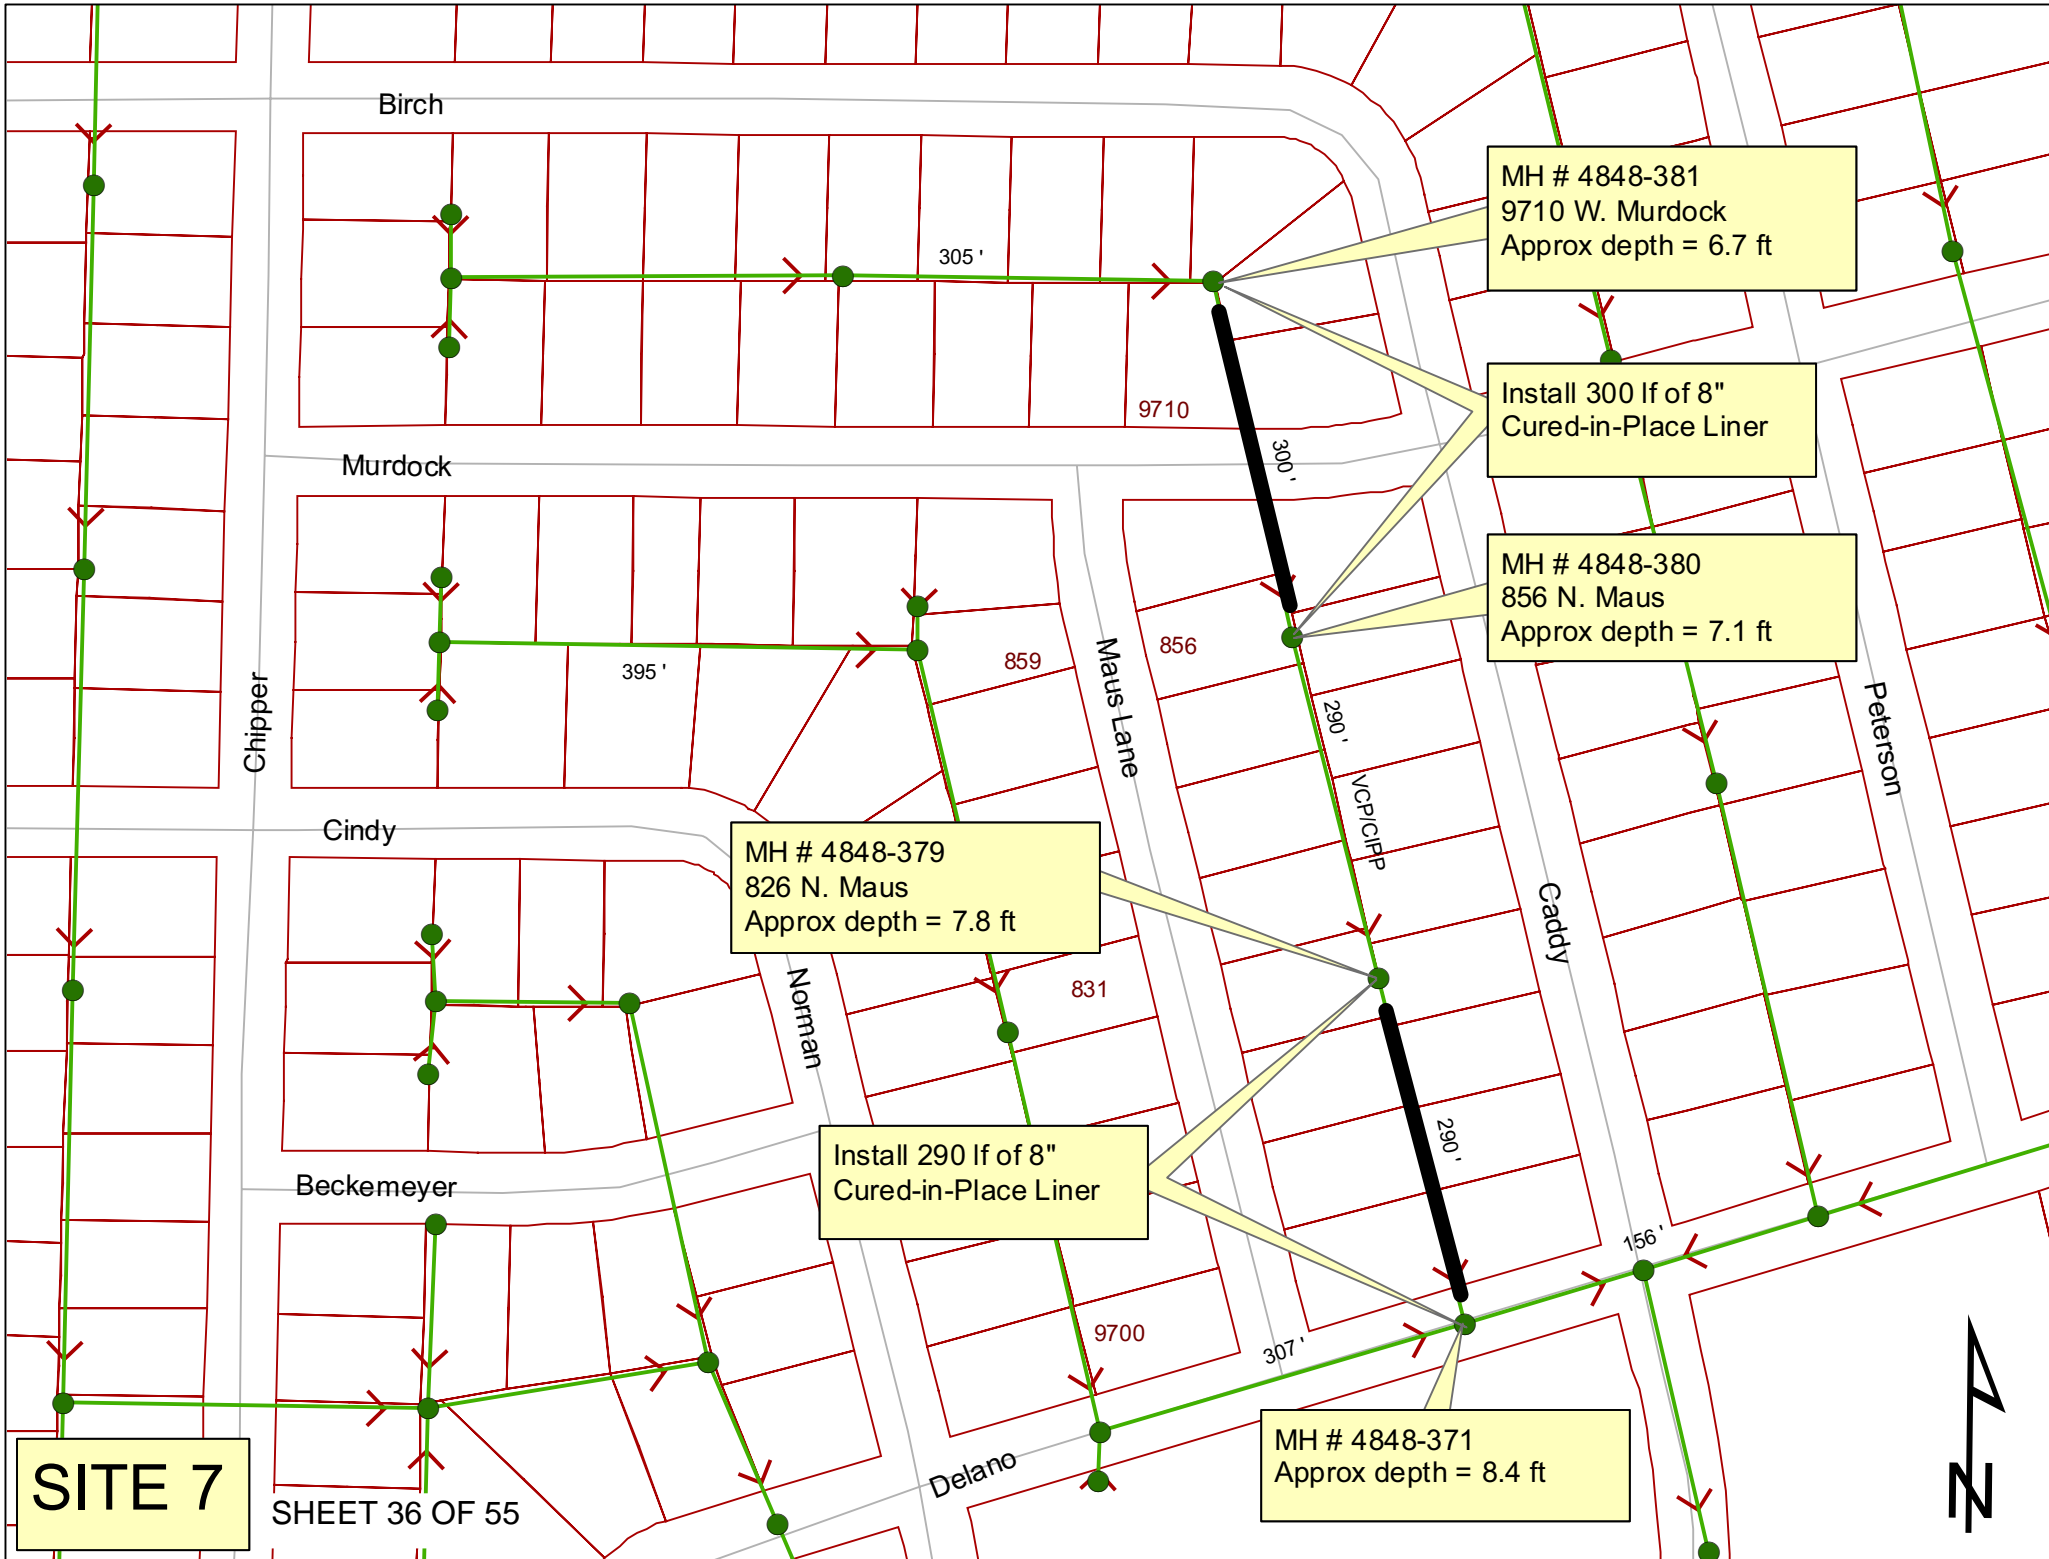
SITE 7

MH # 4848-381
9710 W. Murdock
Approx depth = 6.7 ft

MH # 4848-380
856 N. Maus
Approx depth = 7.1 ft

MH # 4848-379
826 N. Maus
Approx depth = 7.8 ft

MH # 4848-371
Approx depth = 8.4 ft

Install 300 lf of 8"
Cured-in-Place Liner

Install 290 lf of 8"
Cured-in-Place Liner
