2012 Sanitary Sewer Reconstruction
Phase 9
OCA 620607 / 468-84854

Video Inspection Master Report

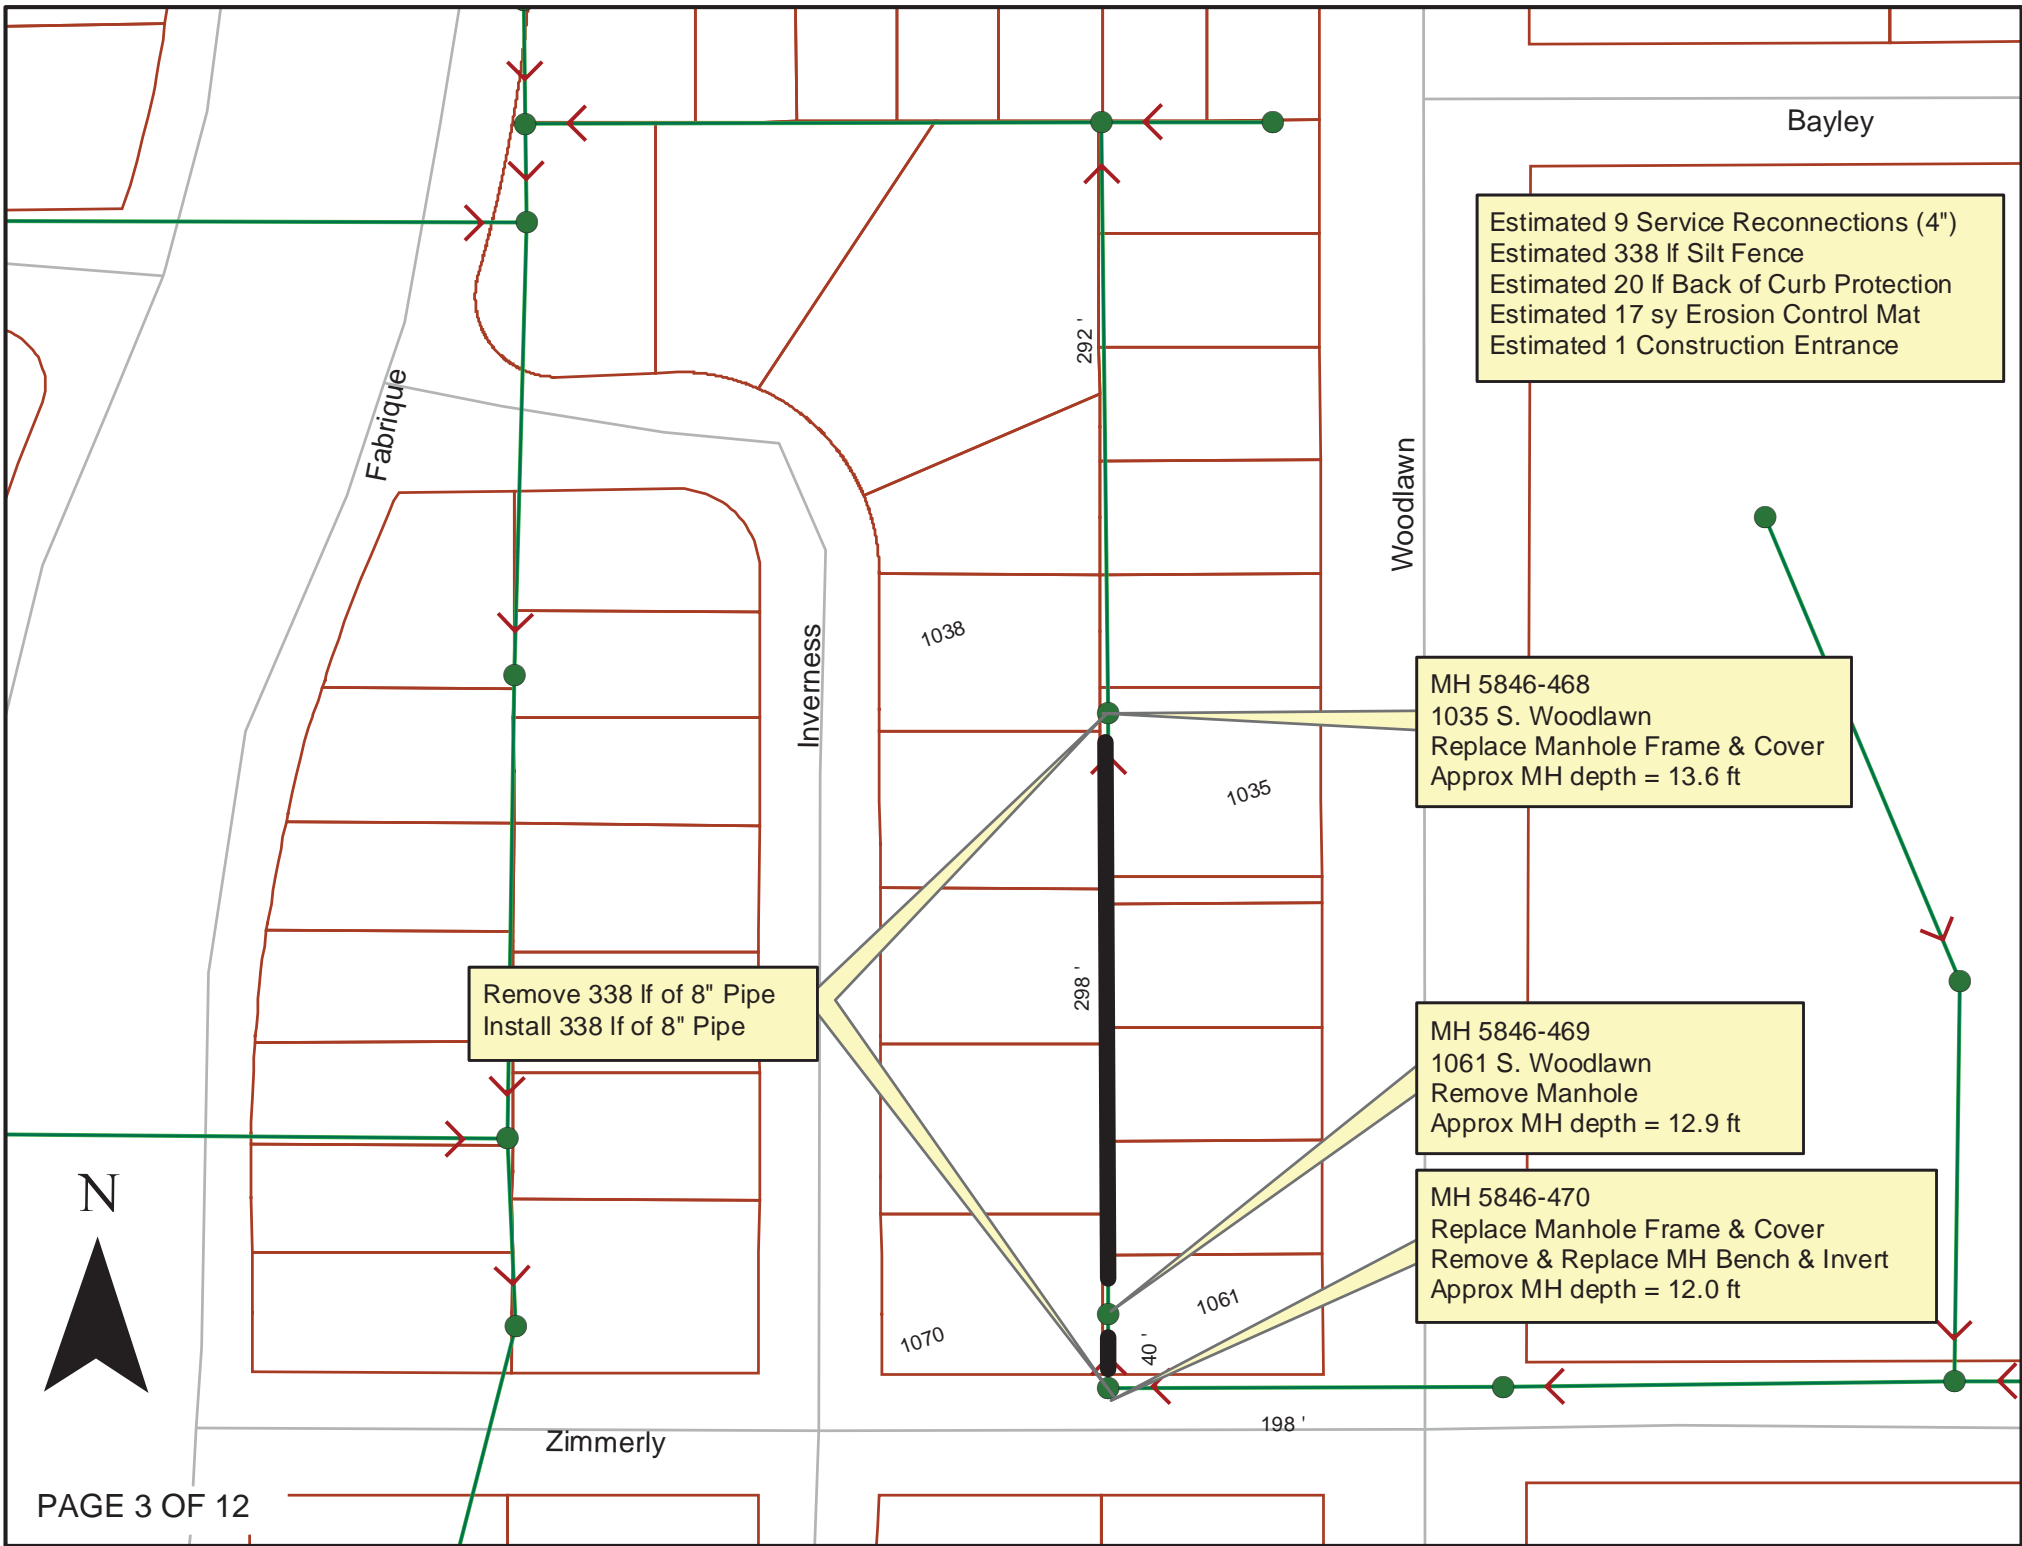
MH 5846-468
 1035 S. Woodlawn
 Replace Manhole Frame & Cover
 Approx MH depth = 13.6 ft

MH 5846-469
 1061 S. Woodlawn
 Remove Manhole
 Approx MH depth = 12.9 ft

MH 5846-470
 Replace Manhole Frame & Cover
 Remove & Replace MH Bench & Invert
 Approx MH depth = 12.0 ft

Remove 338 lf of 8" Pipe
 Install 338 lf of 8" Pipe
