Install 487 lf of 8" Cured-in-Place Liner

SITE 7

Video Inspection Master Report

US Structure: 5747-623 311 N. Clifton Date Insp: 4/13/2012 Basin: EC02A
 DS Structure: 5747-620 307 N RUTAN ST Dir Televised: Downstream To Upstream

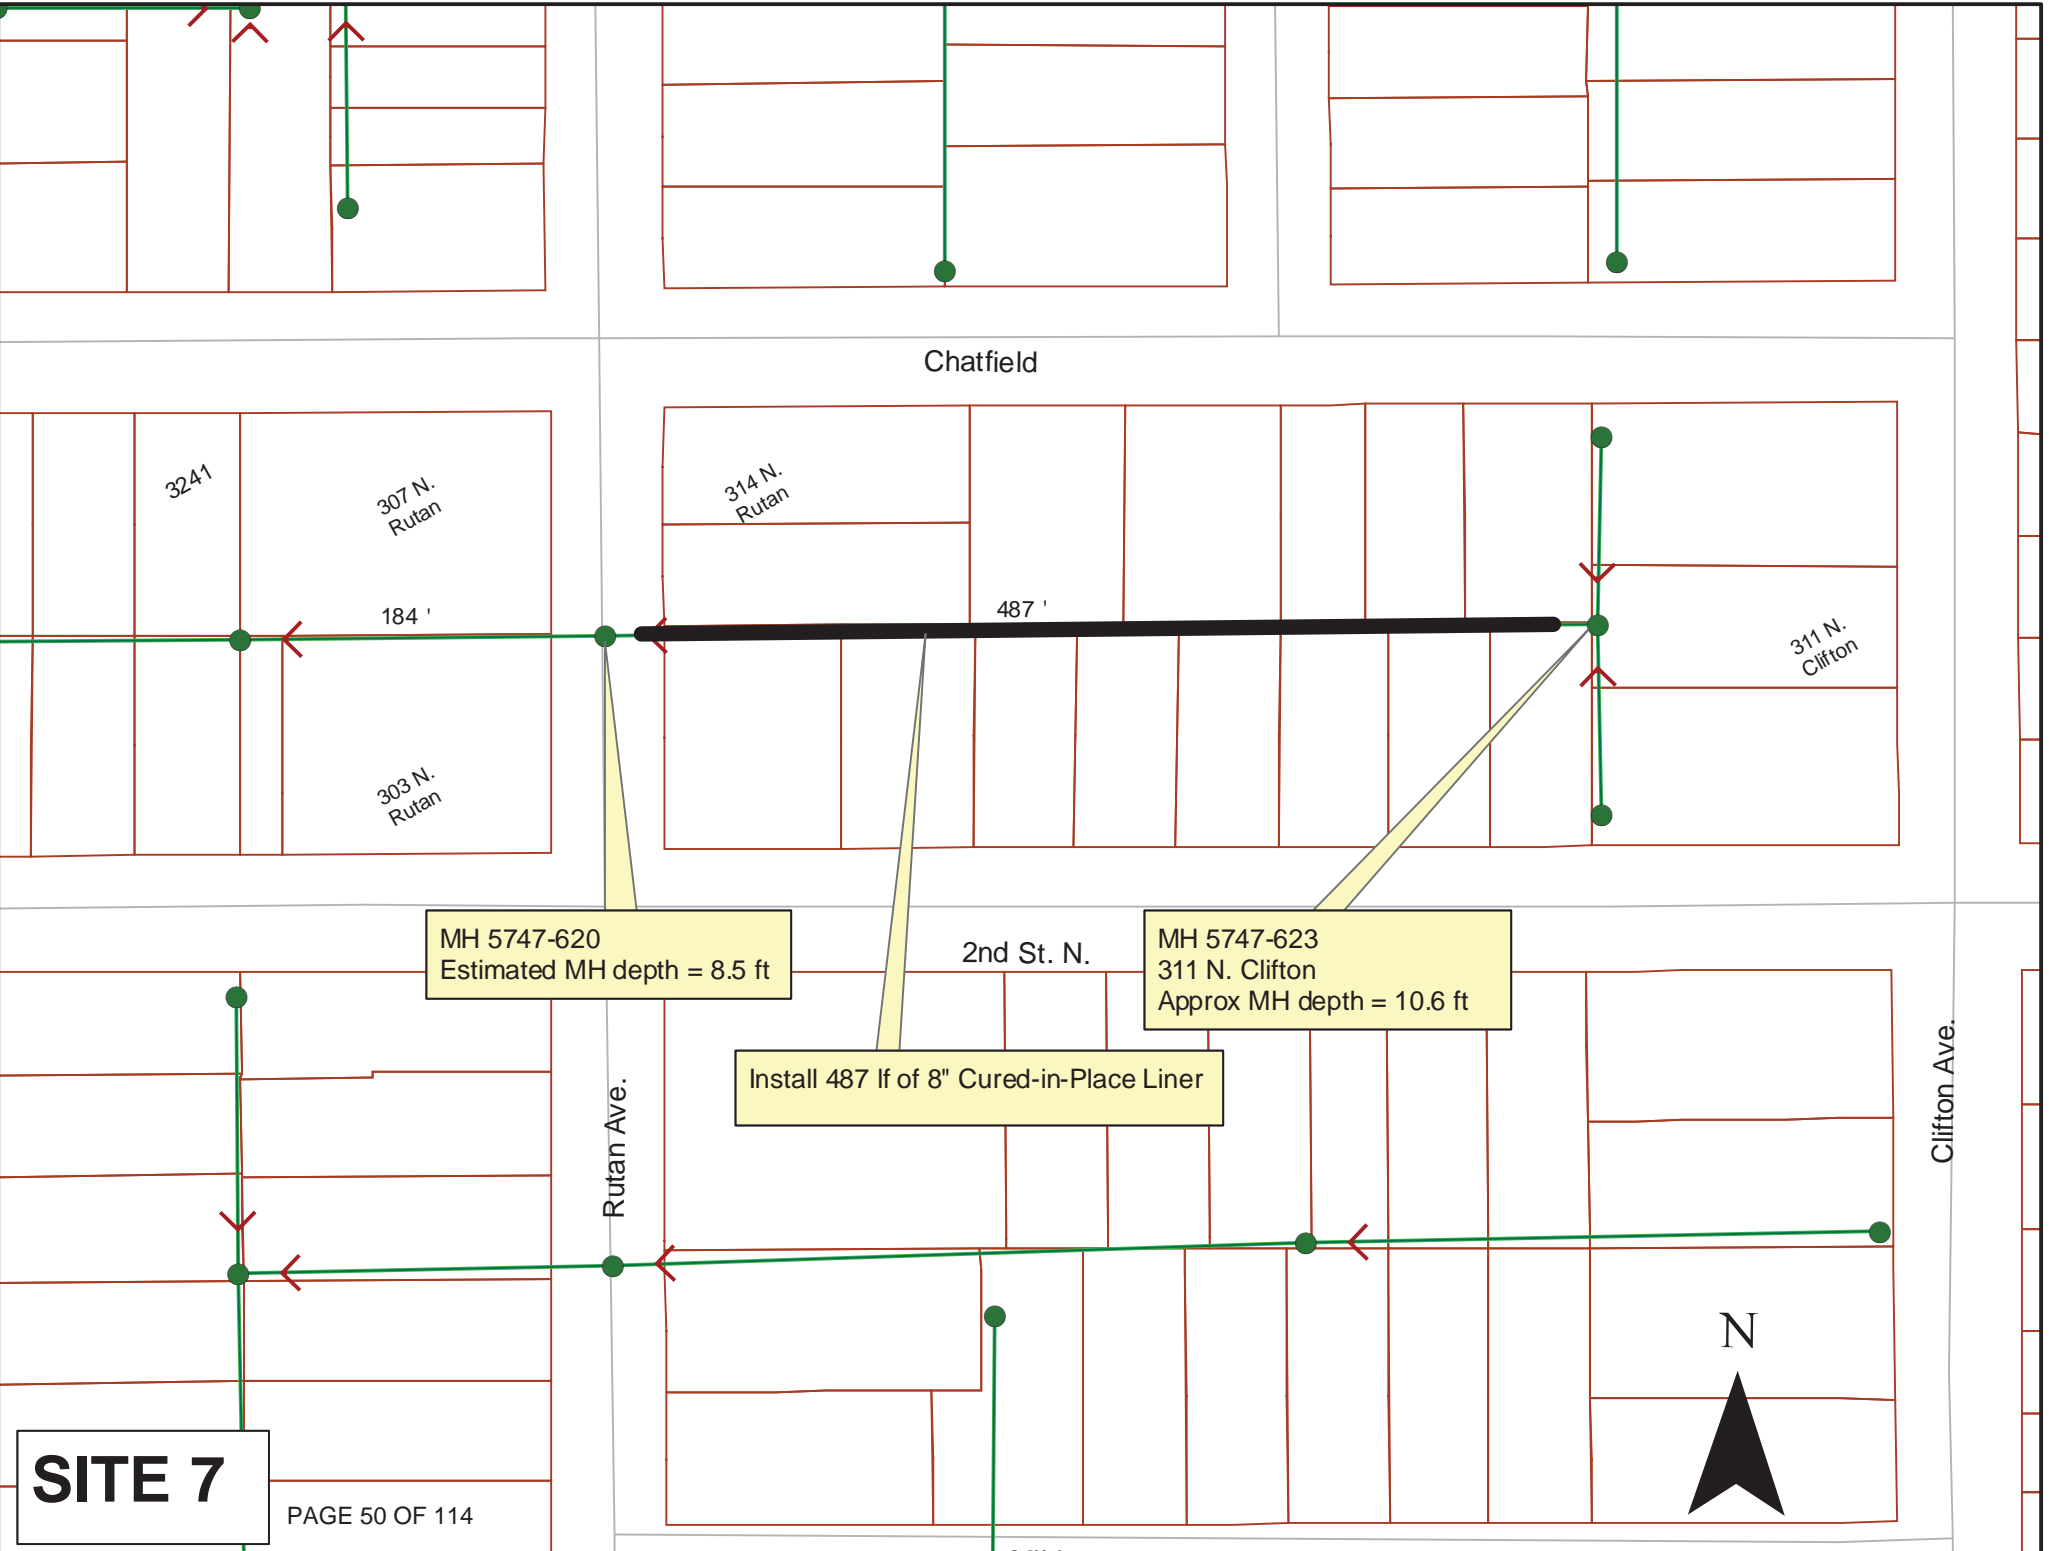
MH 5747-620
Estimated MH depth = 8.5 ft

MH 5747-623
311 N. Clifton
Approx MH depth = 10.6 ft
