Install 585 lf of 8" Cured-in-Place Limer
from MH 5846-257 to MH 5846-230

SITE 11

Video Inspection Master Report

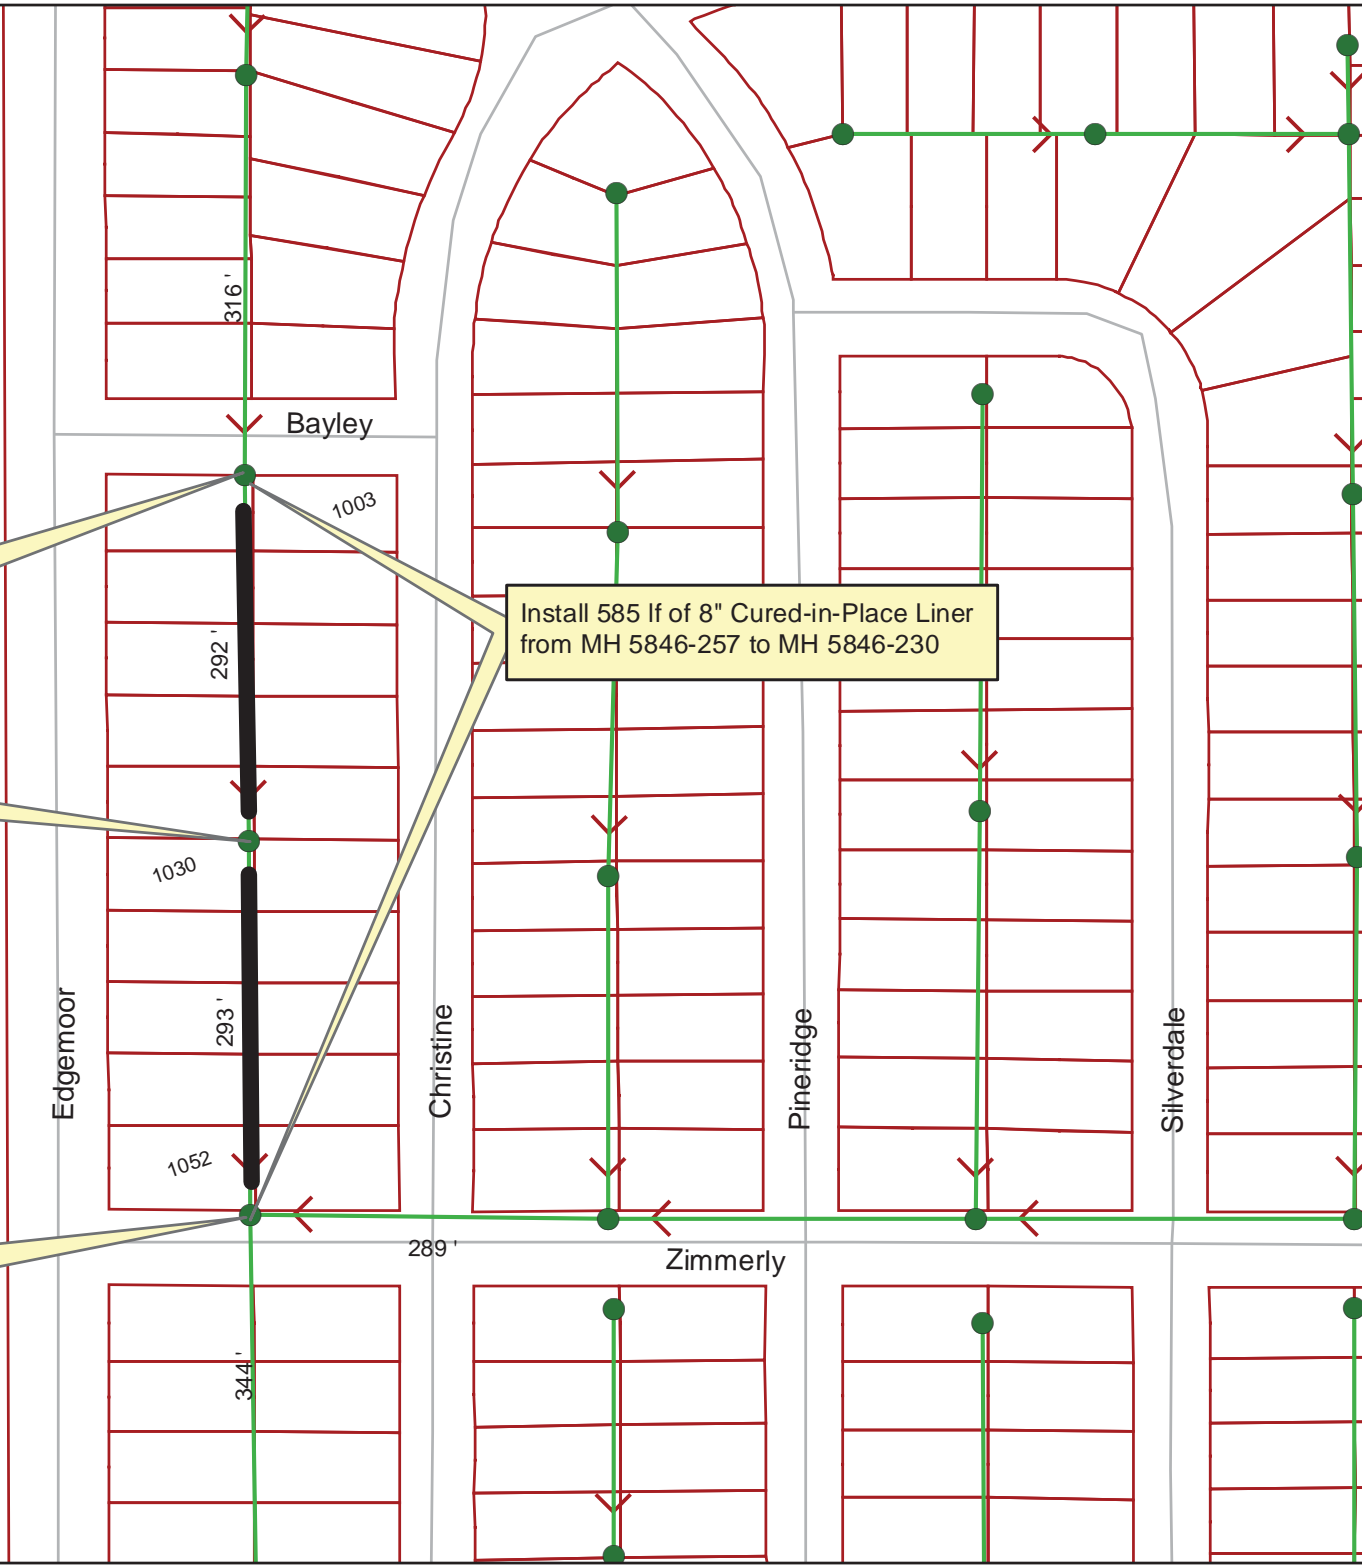
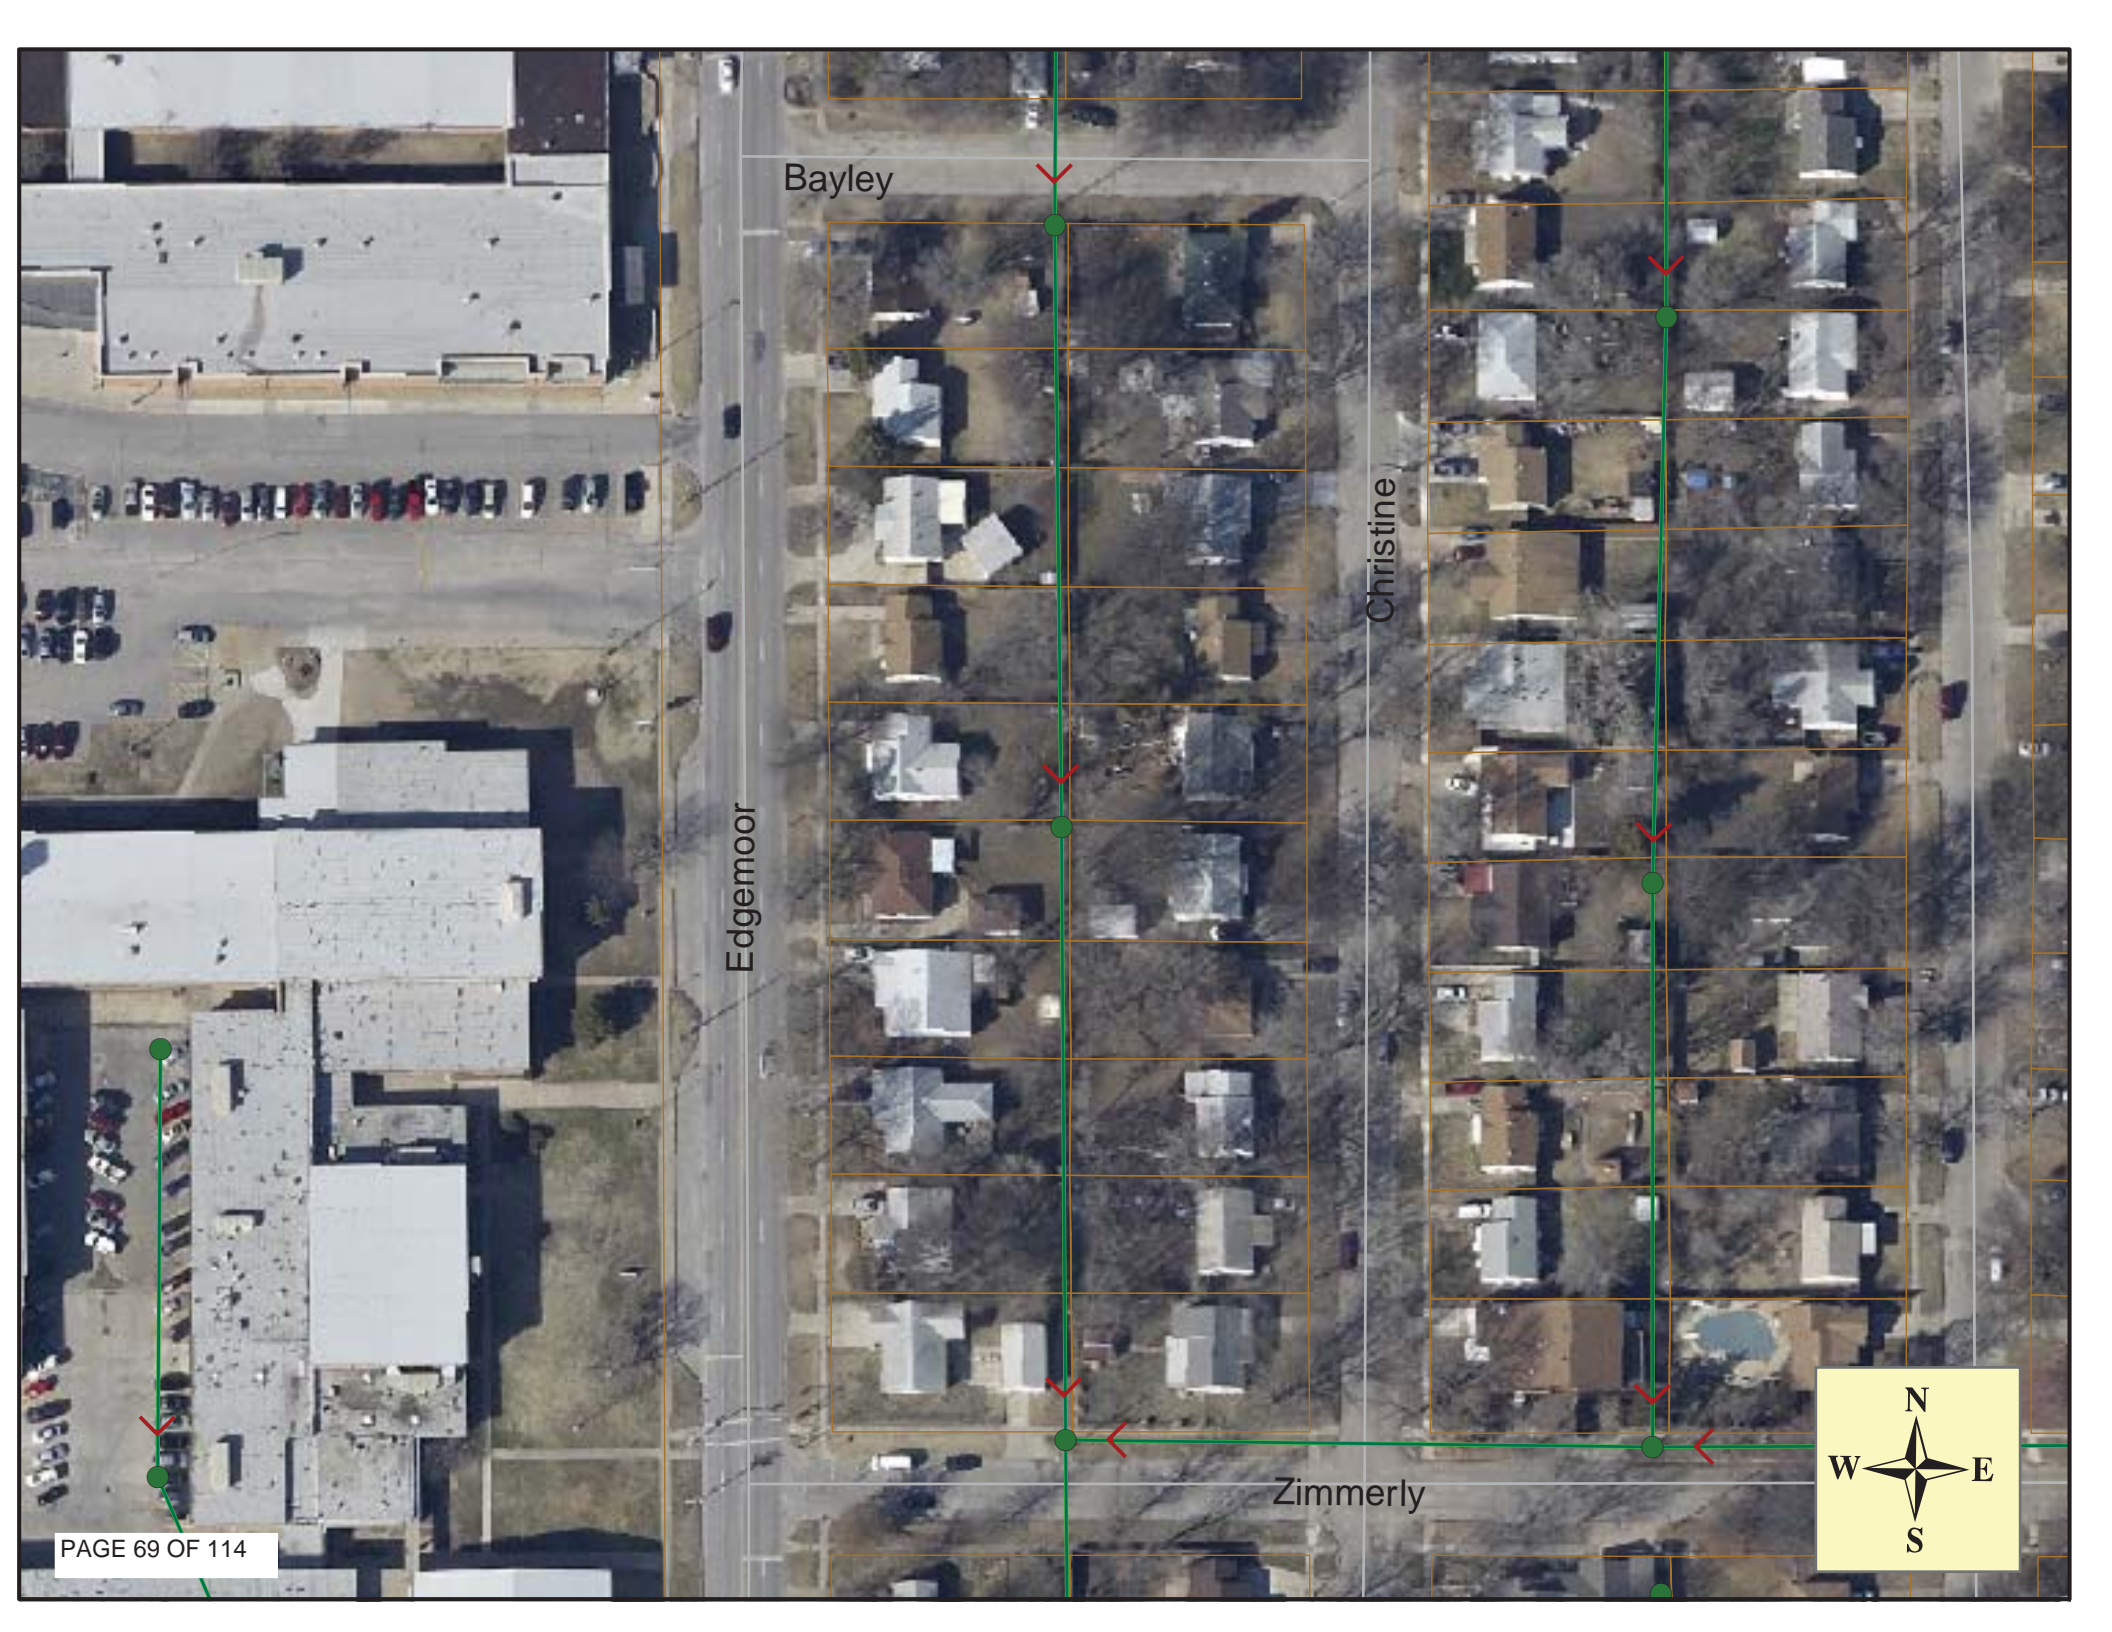
MH # 5846-257
Approx depth = 11.4 ft

MH # 5846-256
1030 S. Edgemoor
Approx depth = 10.9 ft

MH # 5846-230
(outside drop on pipe from north)
(pipe depth not measured)
Approx MH depth = 15.3 ft

Lines have horizontal cracks and roots at joints.
