**SITE 1**

# Television Inspection Master Report

US Structure: 5348-251      1318 W MURDOCK ST      Date Insp: 6/21/2010      Basin: C03E  
 DS Structure: 5348-001      1312 W MURDOCK ST      Dir Televised: Upstream To Downstream

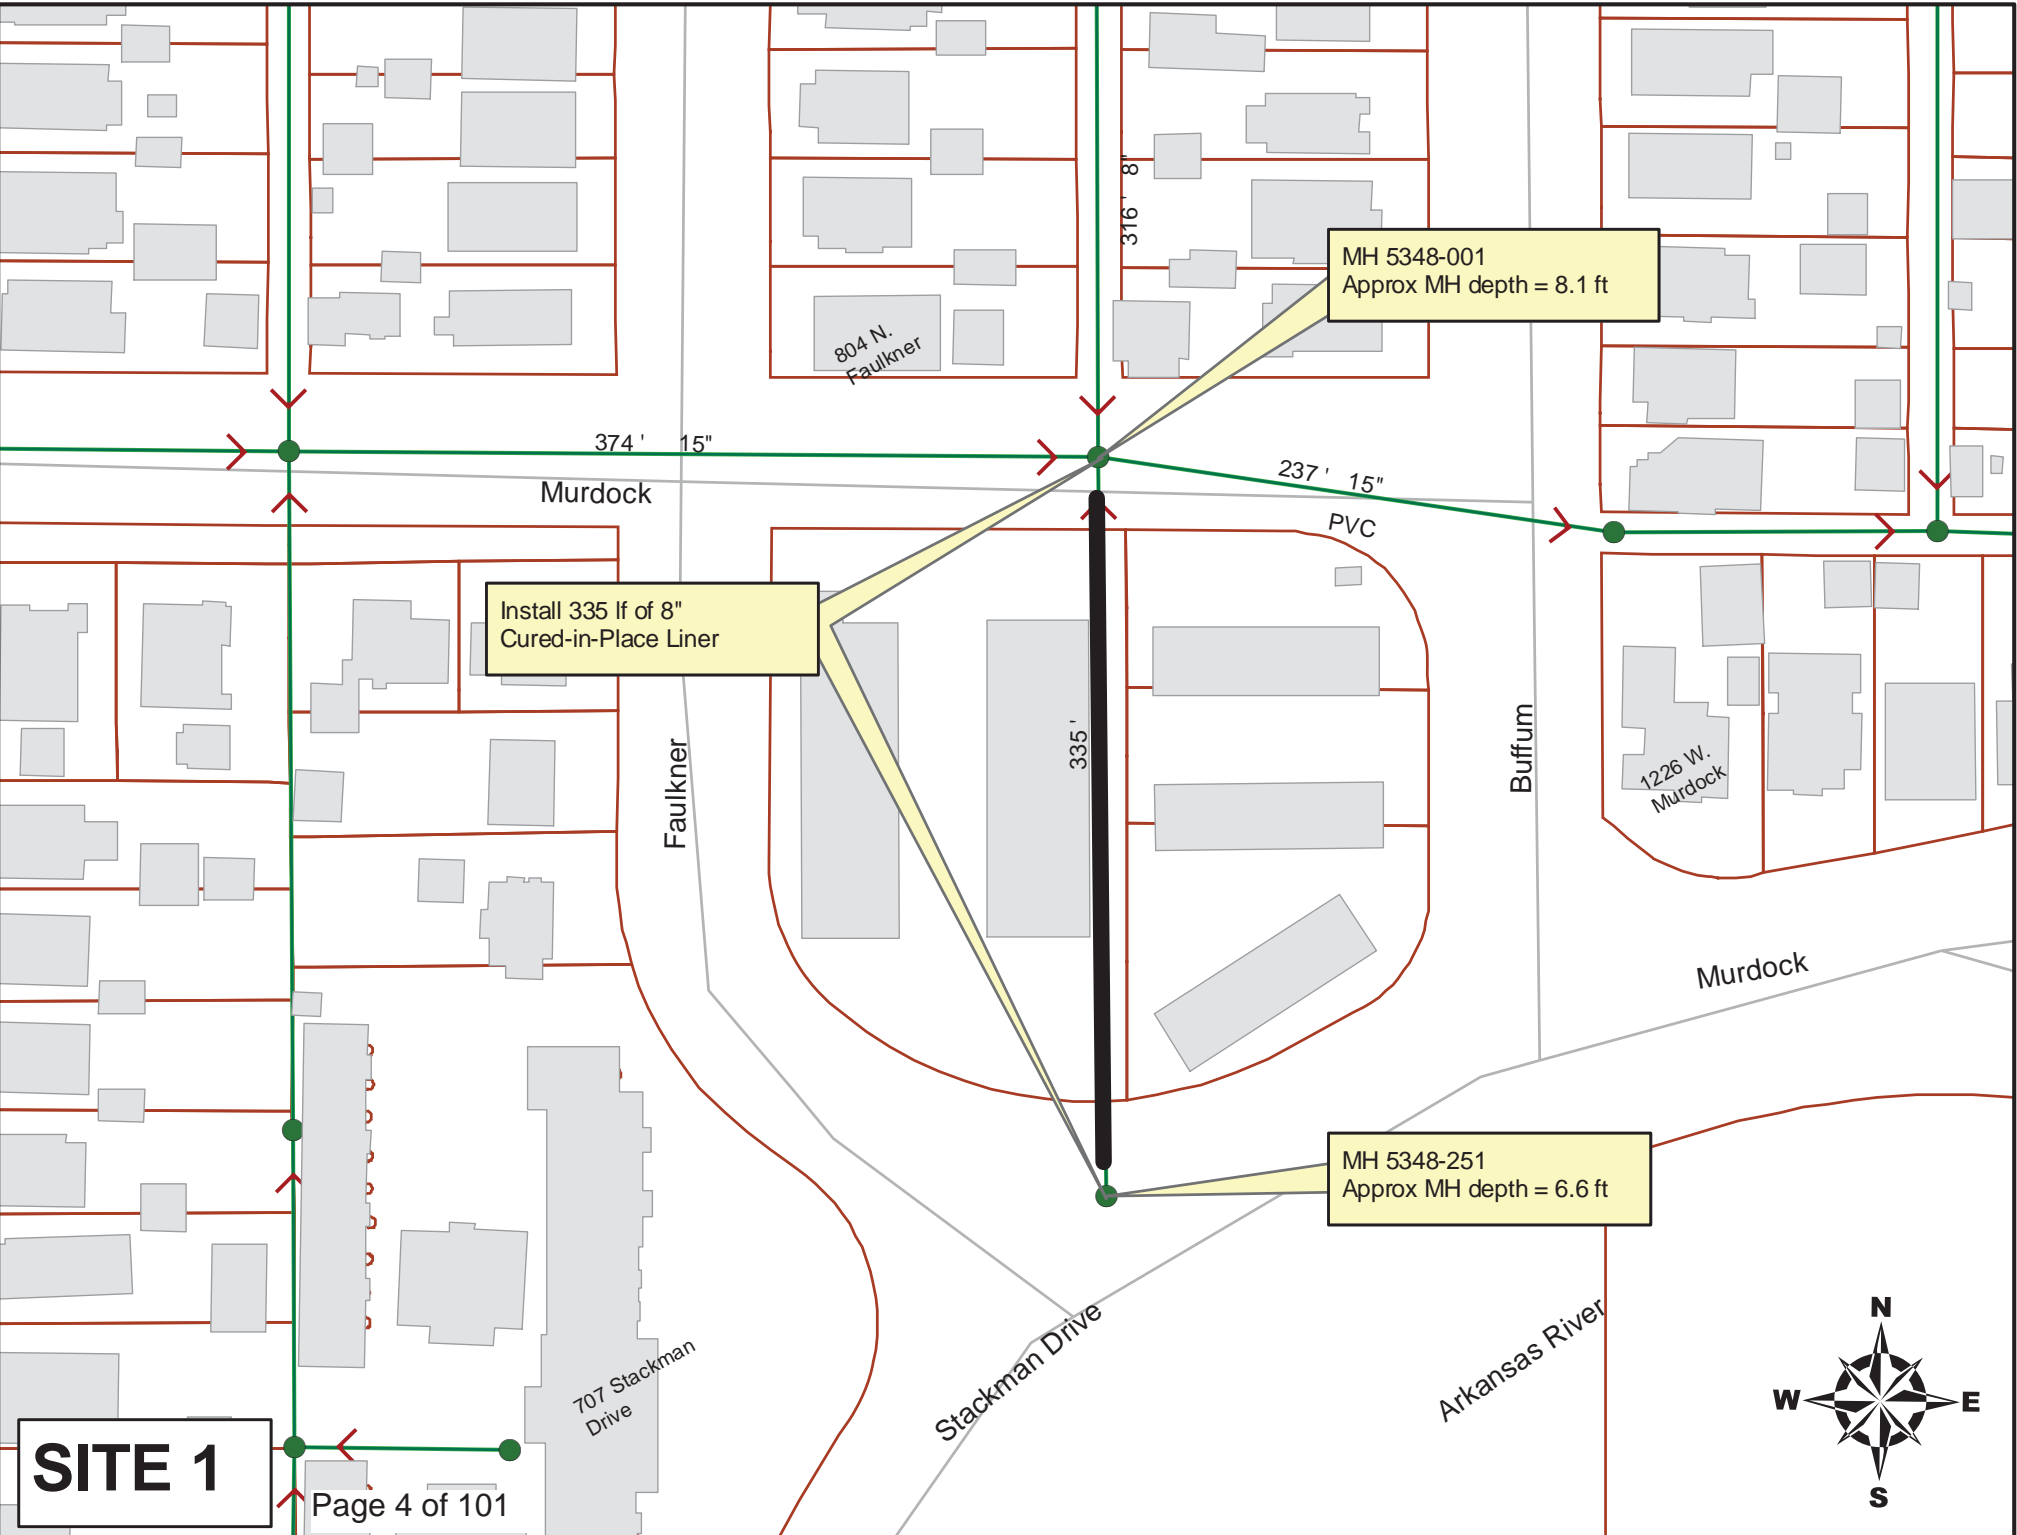
MH 5348-001  
Approx MH depth = 8.1 ft

MH 5348-251  
Approx MH depth = 6.6 ft

Comments: 118 FEET PIPE NEEDS REPAIR, 118 FEET OH NEEDS REPAIR, 184 FEET PIPE NEEDS REPAIR, LINE HAS LOTS OF CRACKS NEEDS REHABED.

Install 335 lf of 8"  
Cured-in-Place Liner
