**SITE 13**

# Video Inspection Master Report

US Structure: 5744-309                      2573 S ROOSEVELT ST                      Date Insp: 7/23/2012                      Basin: C01C  
 DS Structure: 5744-308                      2621 S ROOSEVELT ST                      Dir Televised: Upstream To Downstream

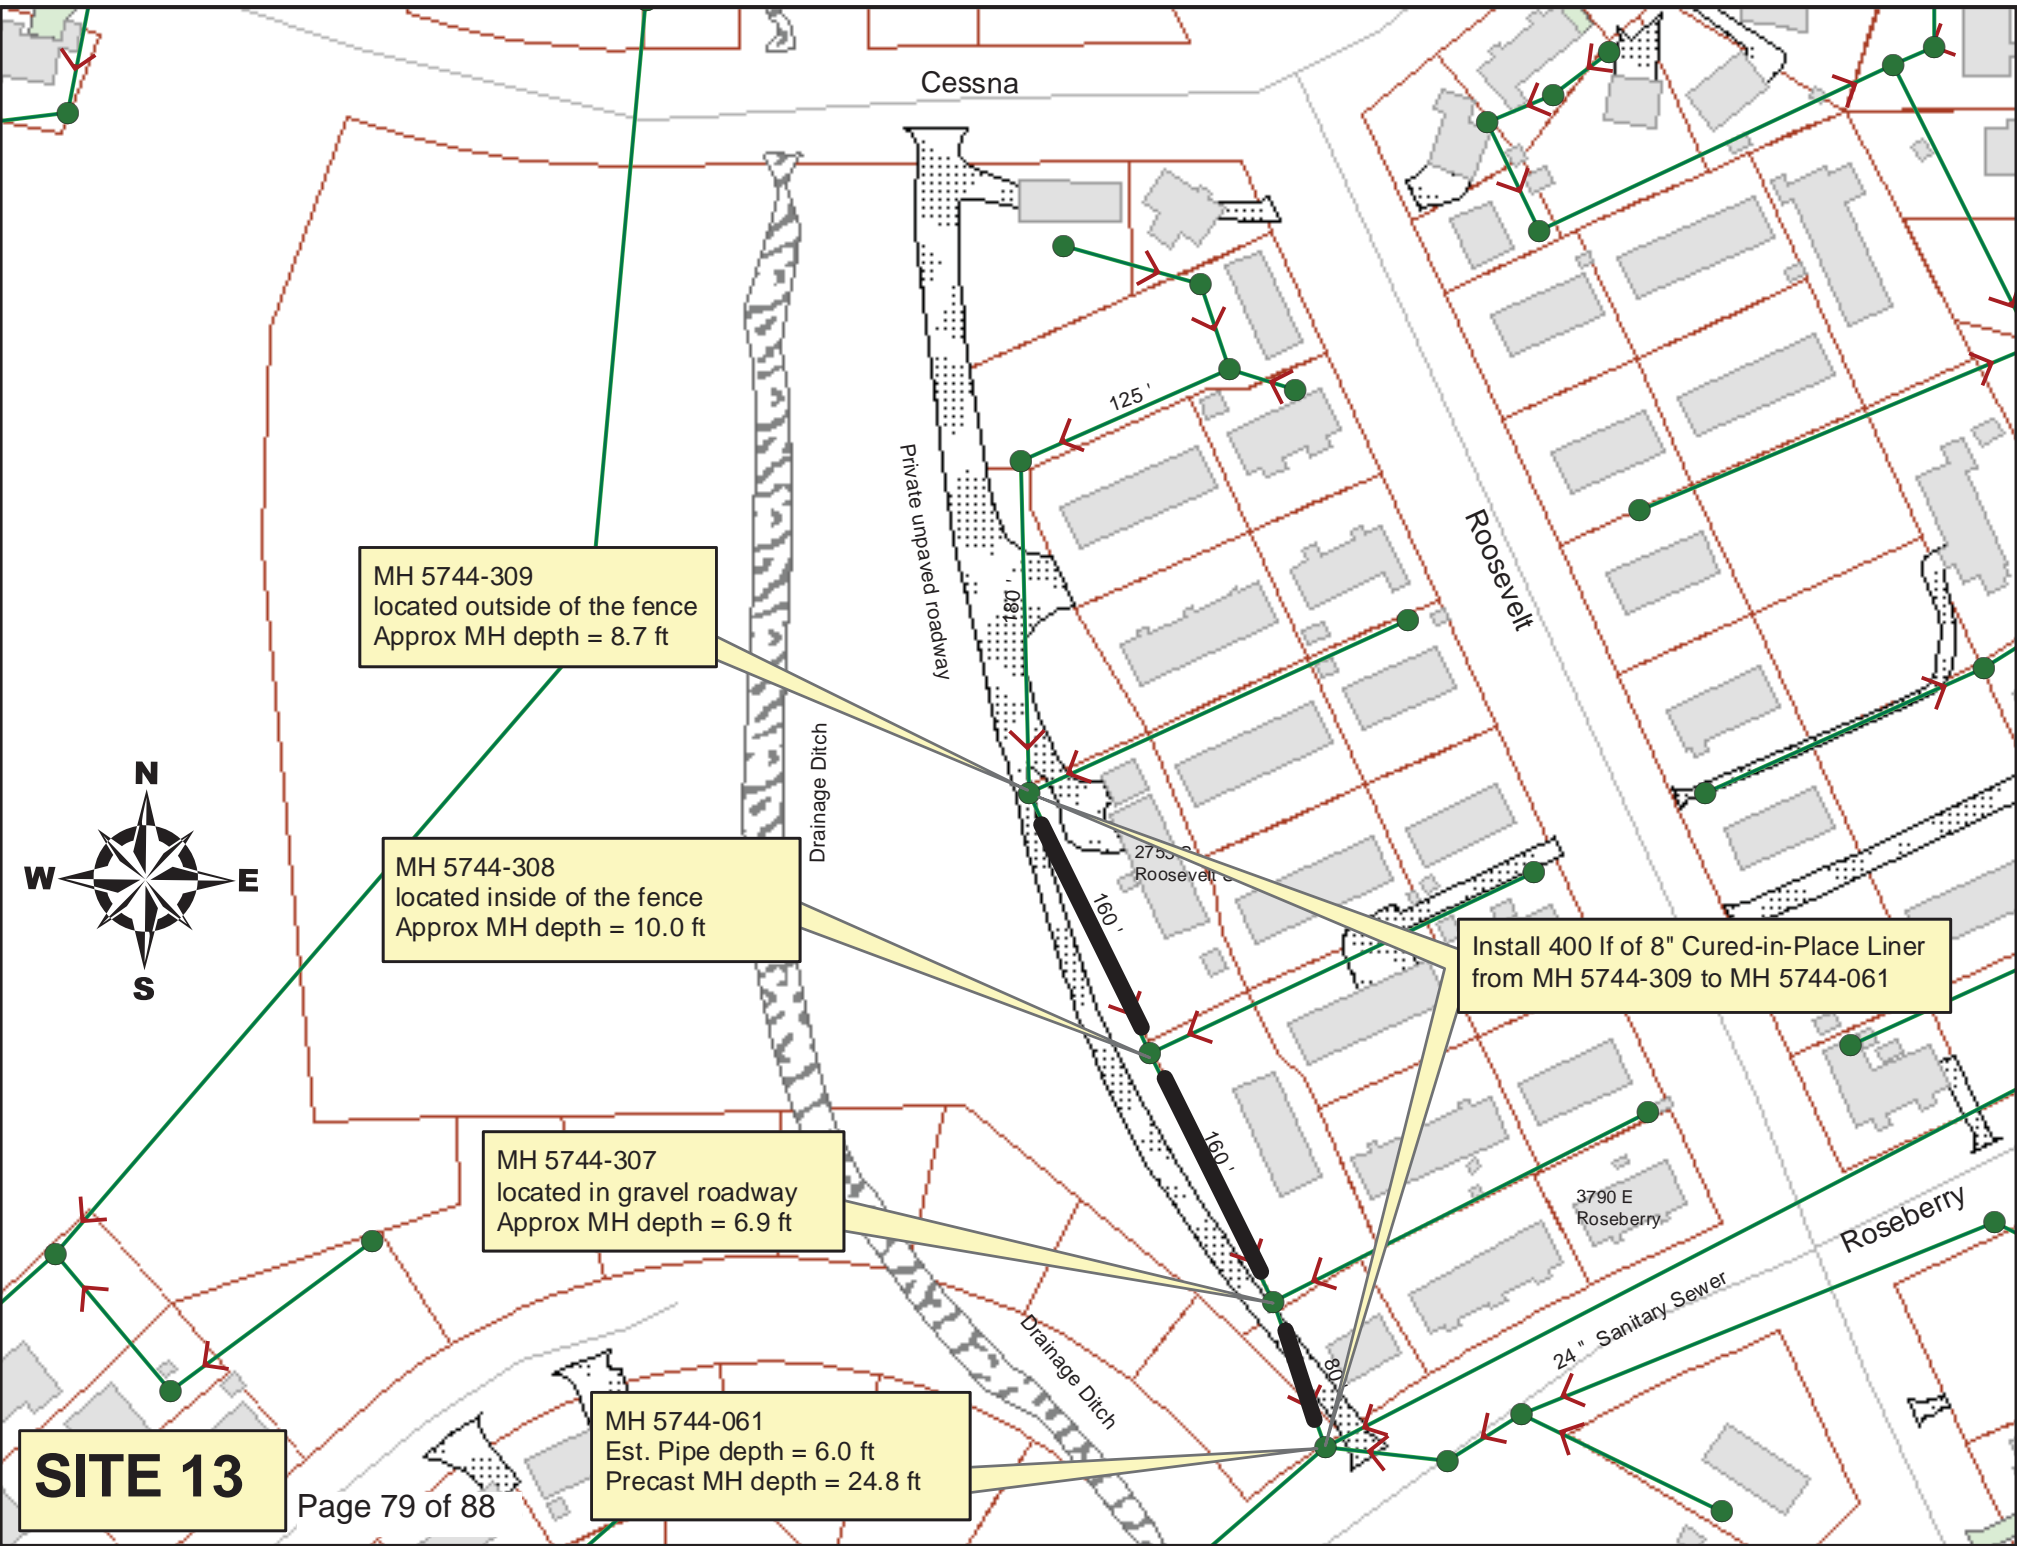
MH 5744-309  
 located outside of the fence  
 Approx MH depth = 8.7 ft

MH 5744-308  
 located inside of the fence  
 Approx MH depth = 10.0 ft

MH 5744-307  
 located in gravel roadway  
 Approx MH depth = 6.9 ft

MH 5744-061  
 Est. Pipe depth = 6.0 ft  
 Precast MH depth = 24.8 ft

Install 400 lf of 8" Cured-in-Place Liner  
 from MH 5744-309 to MH 5744-061
