Remove and replace 986 lf of 8" pipe from MH 5445-277 to MH 5445-271

SITE 1

Video Inspection Master Report

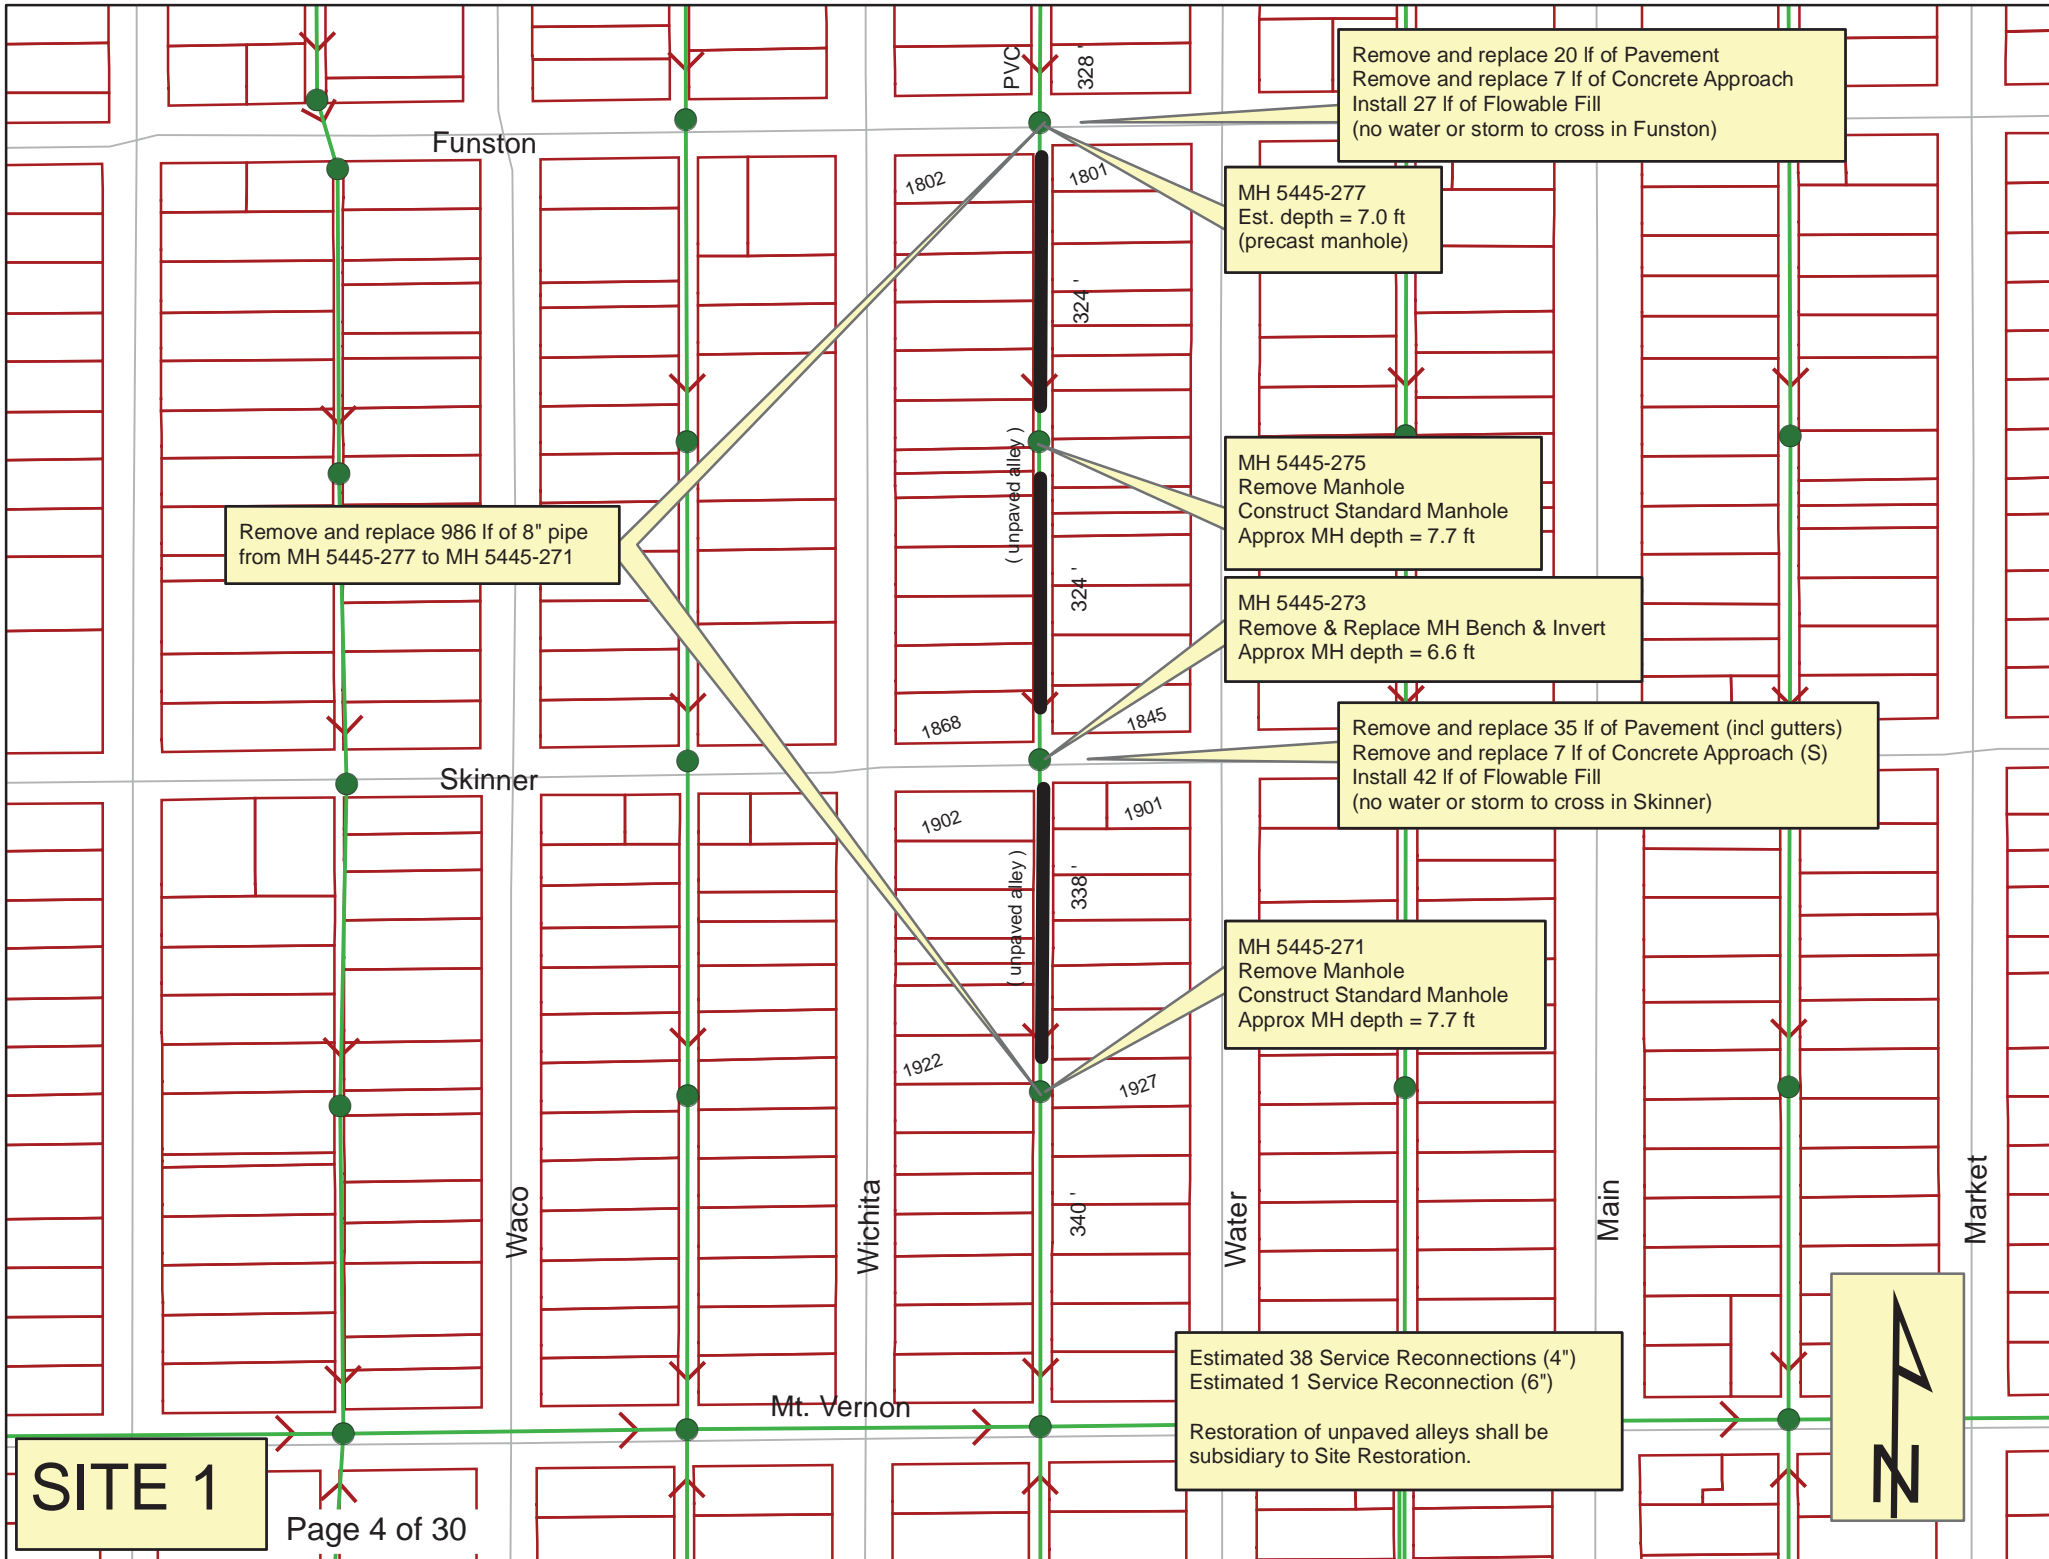
MH 5445-277
Est. depth = 7.0 ft
(precast manhole)

MH 5445-275
Remove Manhole
Construct Standard Manhole
Approx MH depth = 7.7 ft

MH 5445-273
Remove & Replace MH Bench & Invert
Approx MH depth = 6.6 ft

MH 5445-271
Remove Manhole
Construct Standard Manhole
Approx MH depth = 7.7 ft

Remove and replace 20 lf of Pavement
Remove and replace 7 lf of Concrete Approach
Install 27 lf of Flowable Fill
(no water or storm to cross in Funston)

Remove and replace 35 lf of Pavement (incl gutters)
Remove and replace 7 lf of Concrete Approach (S)
Install 42 lf of Flowable Fill
(no water or storm to cross in Skinner)

Estimated 38 Service Reconnections (4")
Estimated 1 Service Reconnection (6")

Restoration of unpaved alleys shall be subsidiary to Site Restoration.
