**SITE 2**

## Video Inspection Master Report

US Structure: 5445-348                      2055 S BROADWAY AVE                      Date Insp: 9/22/2010                      Basin: C05D  
 Dir Televised: Upstream To Downstream

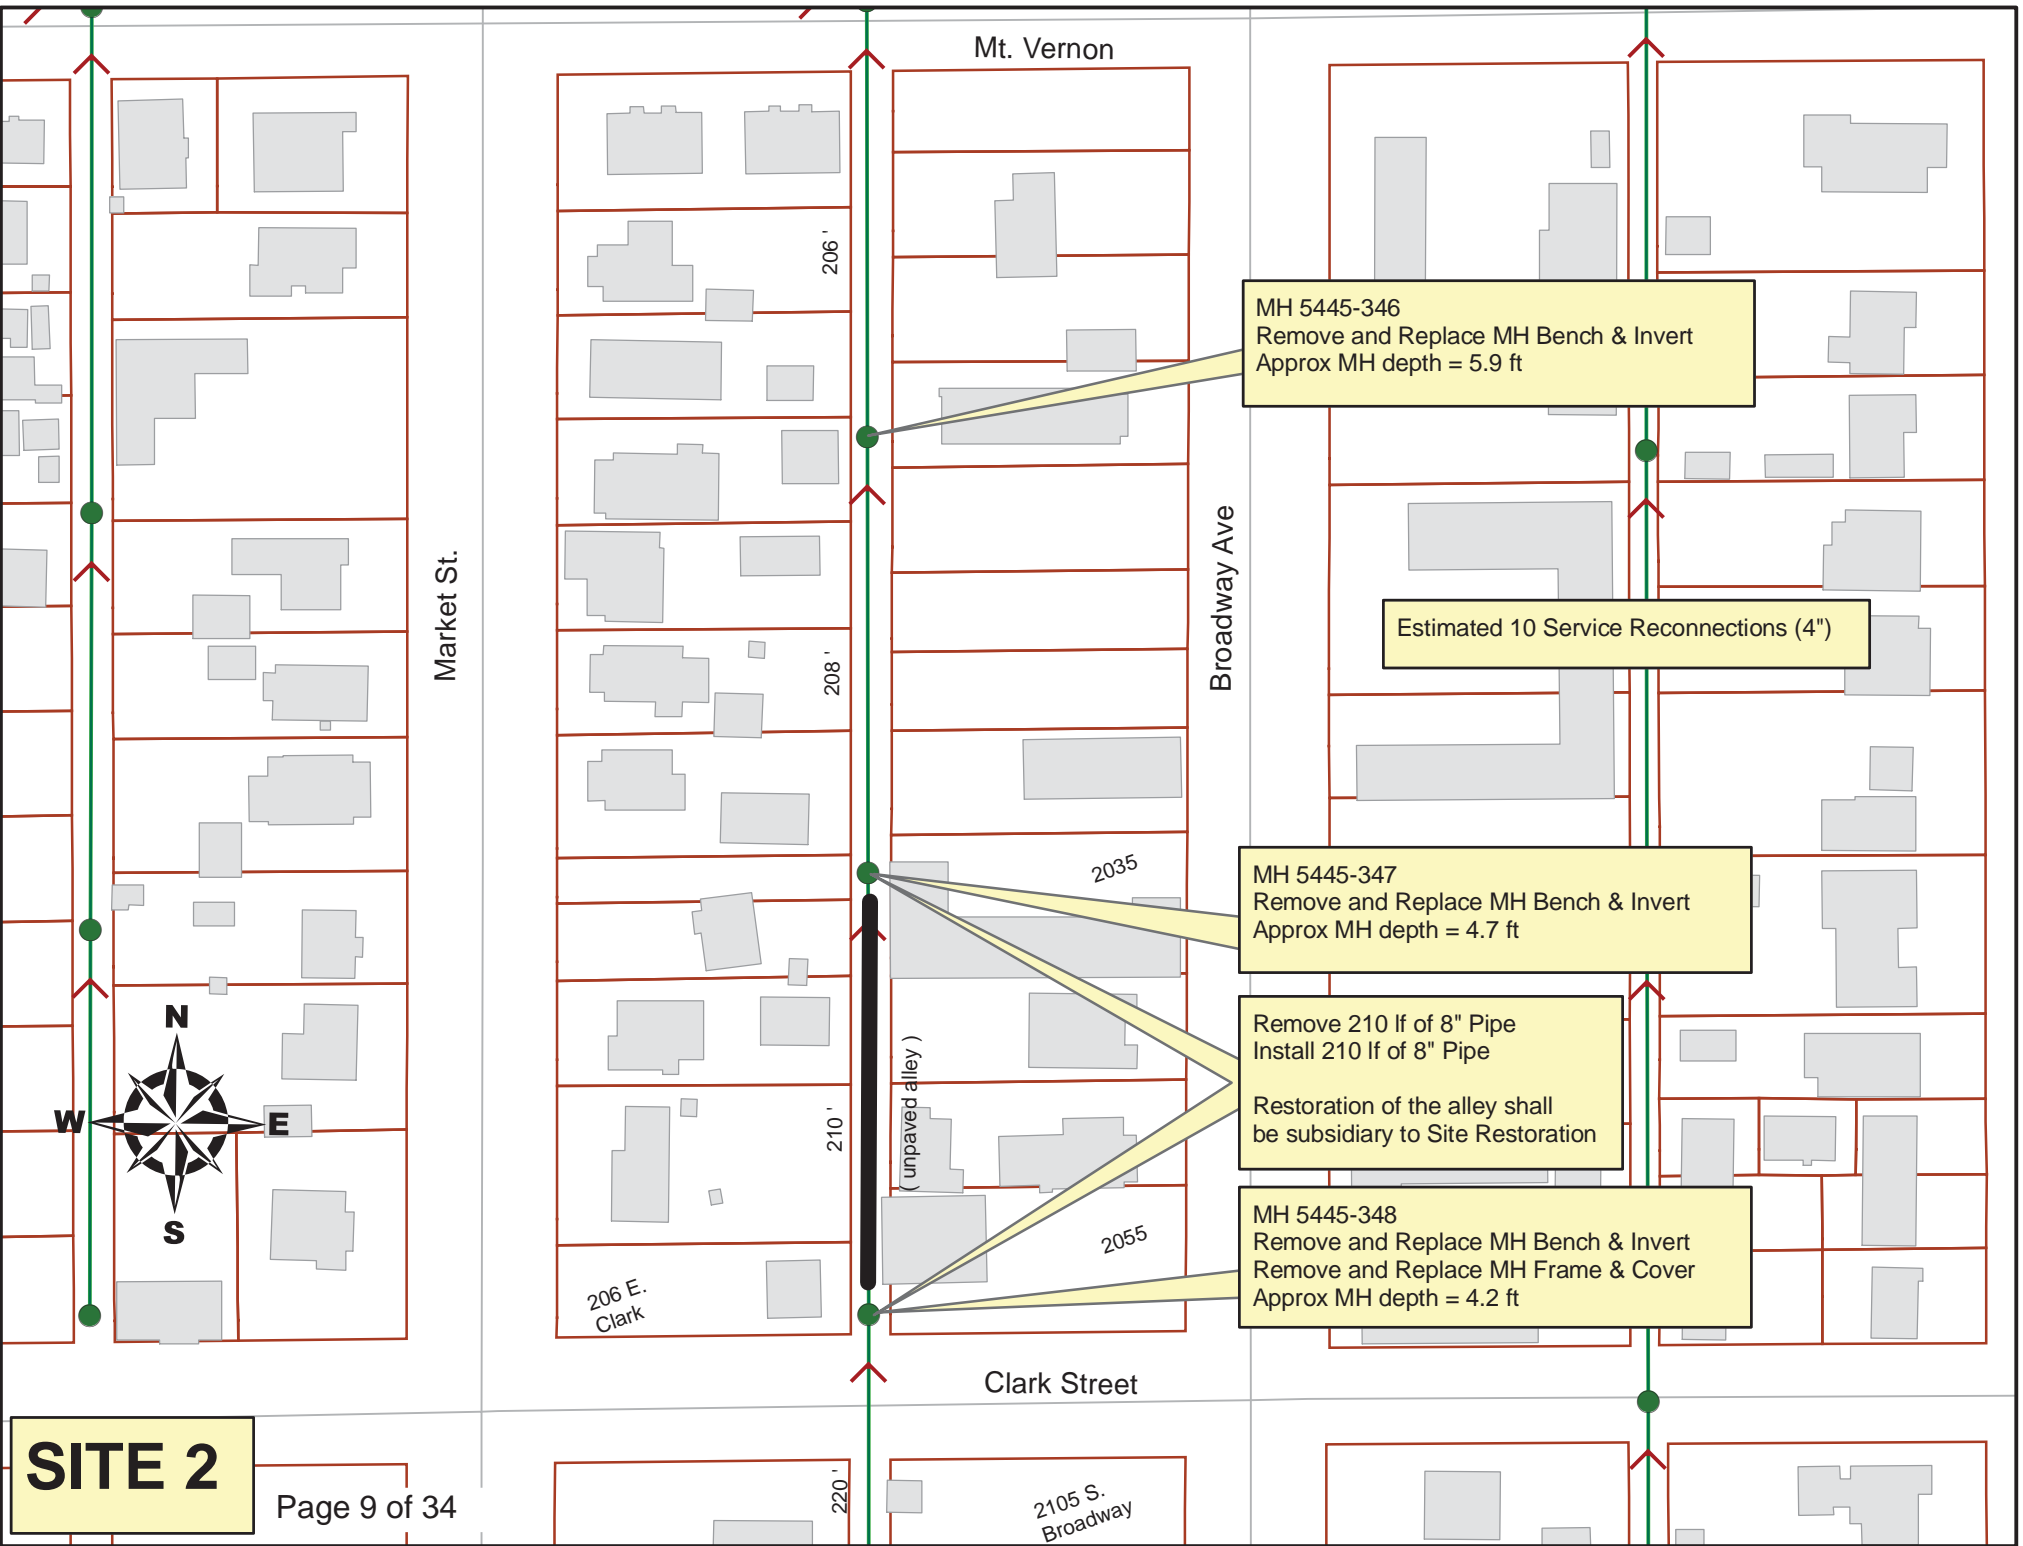
MH 5445-346  
Remove and Replace MH Bench & Invert  
Approx MH depth = 5.9 ft

MH 5445-347  
Remove and Replace MH Bench & Invert  
Approx MH depth = 4.7 ft

MH 5445-348  
Remove and Replace MH Bench & Invert  
Remove and Replace MH Frame & Cover  
Approx MH depth = 4.2 ft

Remove 210 lf of 8" Pipe  
Install 210 lf of 8" Pipe  
Restoration of the alley shall be subsidiary to Site Restoration
