**SITE 5**

## Video Inspection Master Report

US Structure: 6047-225                      220 S BONNIE BRAE ST                      Date Insp: 2/10/2010                      Basin: E01G2  
 DS Structure: 6047-224                      238 S BONNIE BRAE ST                      Dir Televised: Upstream To Downstream

Project No. : G-164                      Dia/Ht: 8                      Material: VCP                      Length: 315.0

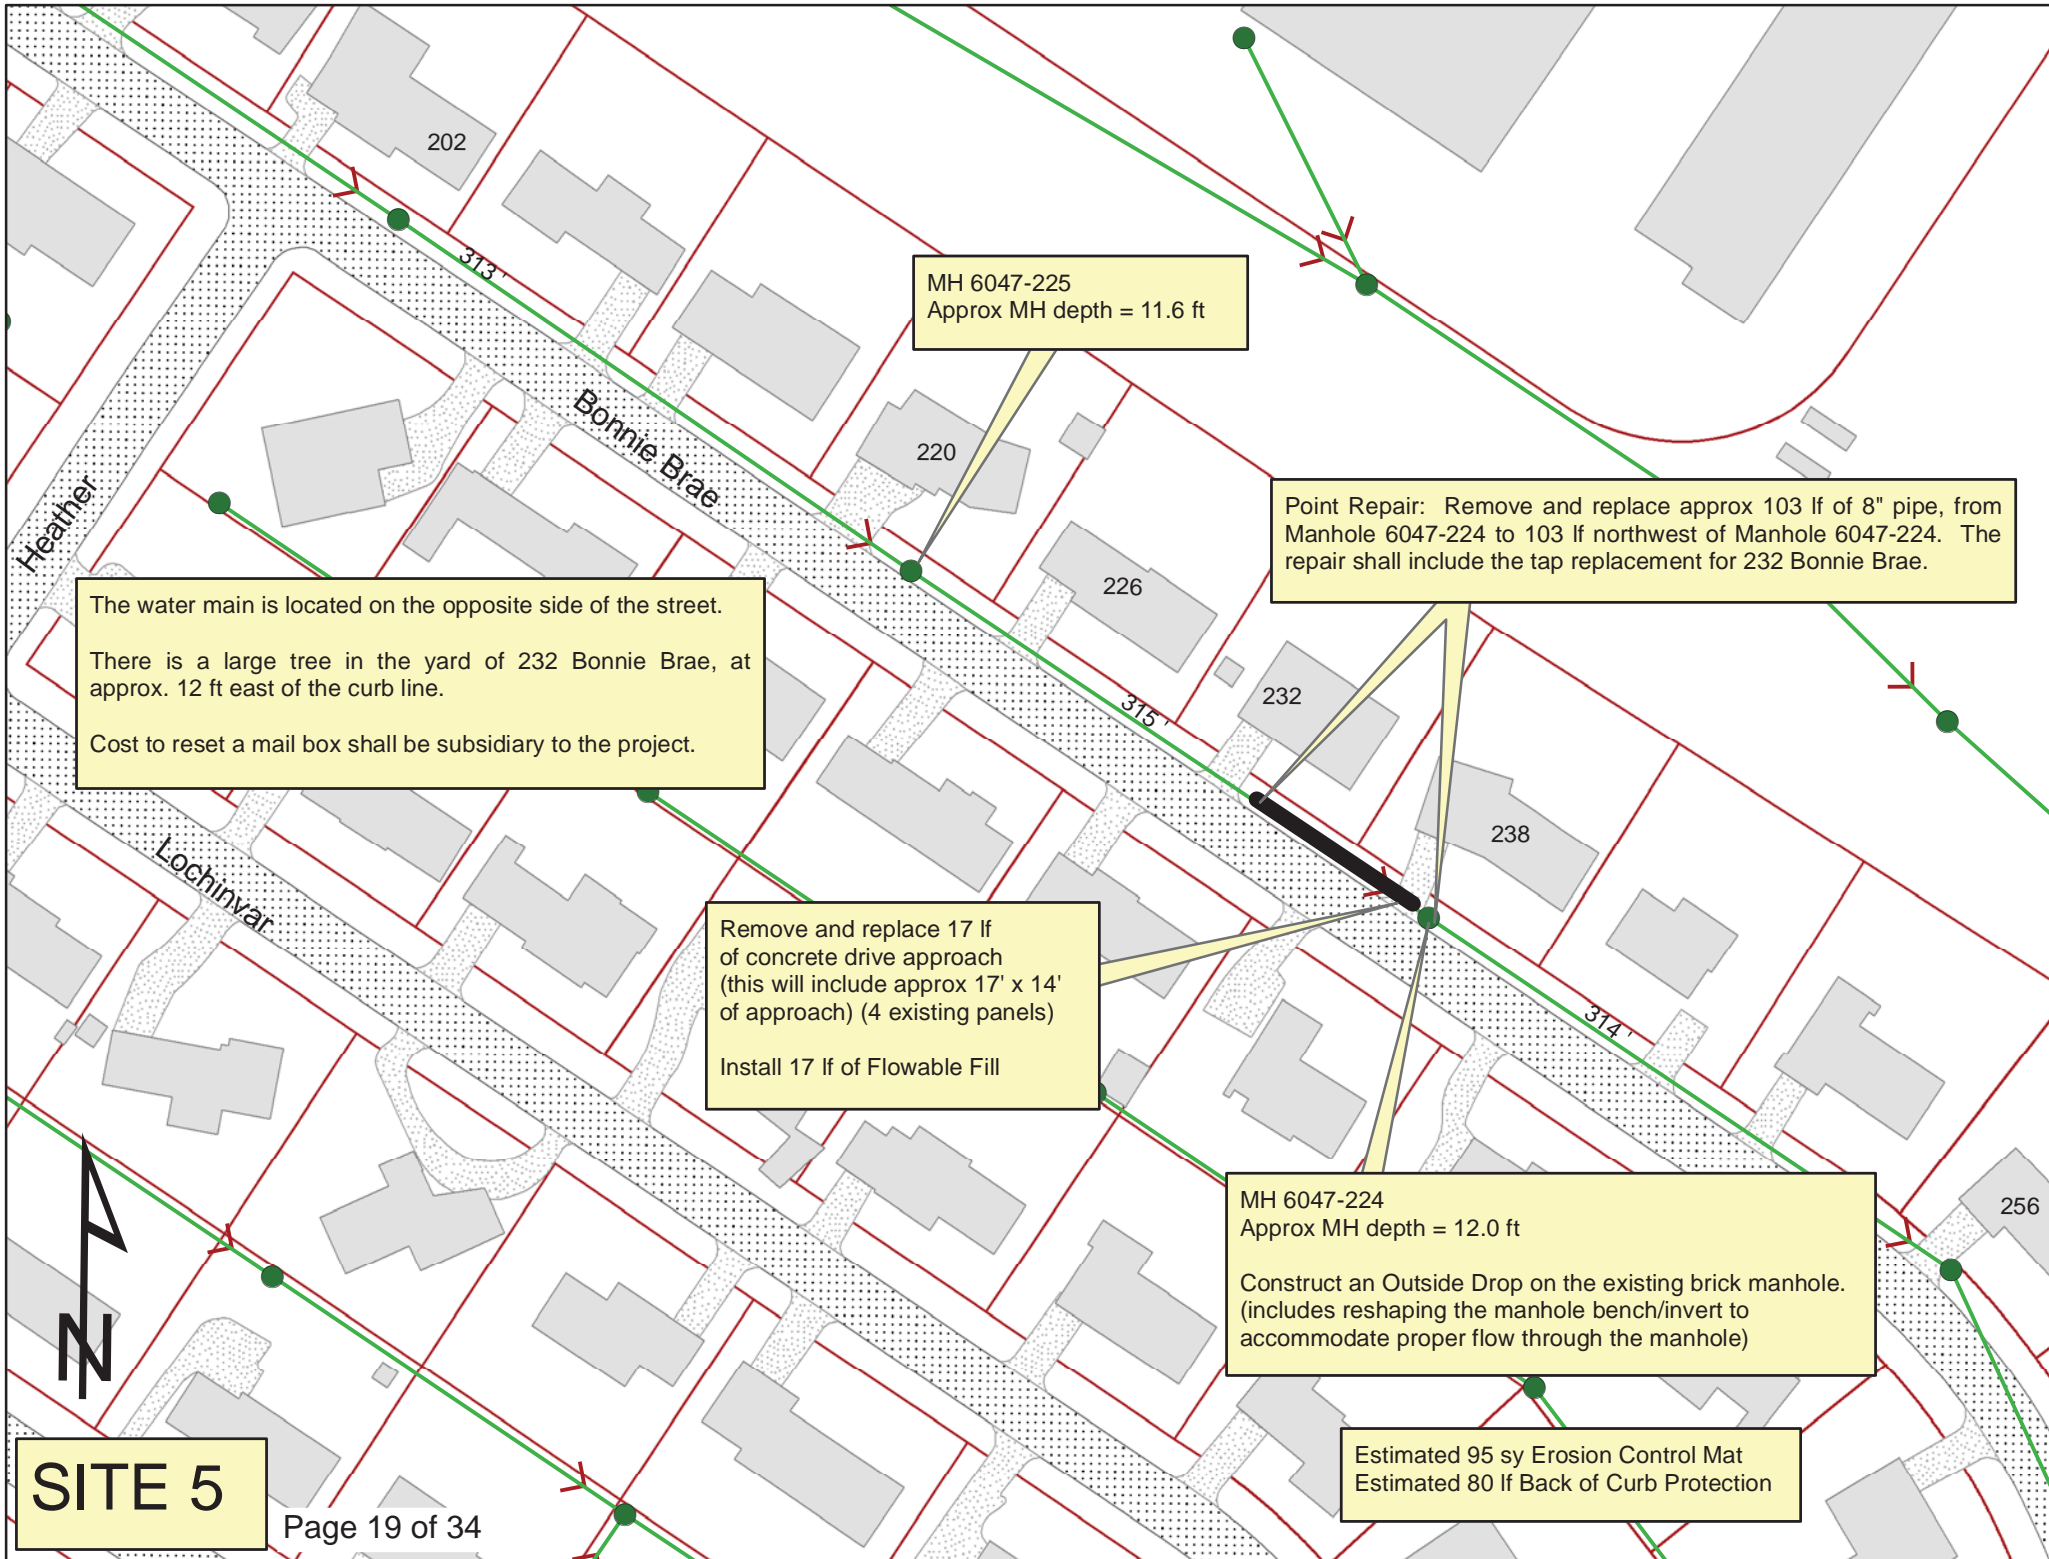
MH 6047-225  
Approx MH depth = 11.6 ft

The water main is located on the opposite side of the street.  
There is a large tree in the yard of 232 Bonnie Brae, at approx. 12 ft east of the curb line.  
Cost to reset a mail box shall be subsidiary to the project.

MH 6047-224  
Approx MH depth = 12.0 ft  
Construct an Outside Drop on the existing brick manhole. (includes reshaping the manhole bench/invert to accommodate proper flow through the manhole)

Point Repair: Remove and replace approx 103 lf of 8" pipe, from Manhole 6047-224 to 103 lf northwest of Manhole 6047-224. The repair shall include the tap replacement for 232 Bonnie Brae.

Remove and replace 17 lf of concrete drive approach (this will include approx 17' x 14' of approach) (4 existing panels)  
Install 17 lf of Flowable Fill

Estimated 95 sy Erosion Control Mat  
Estimated 80 lf Back of Curb Protection

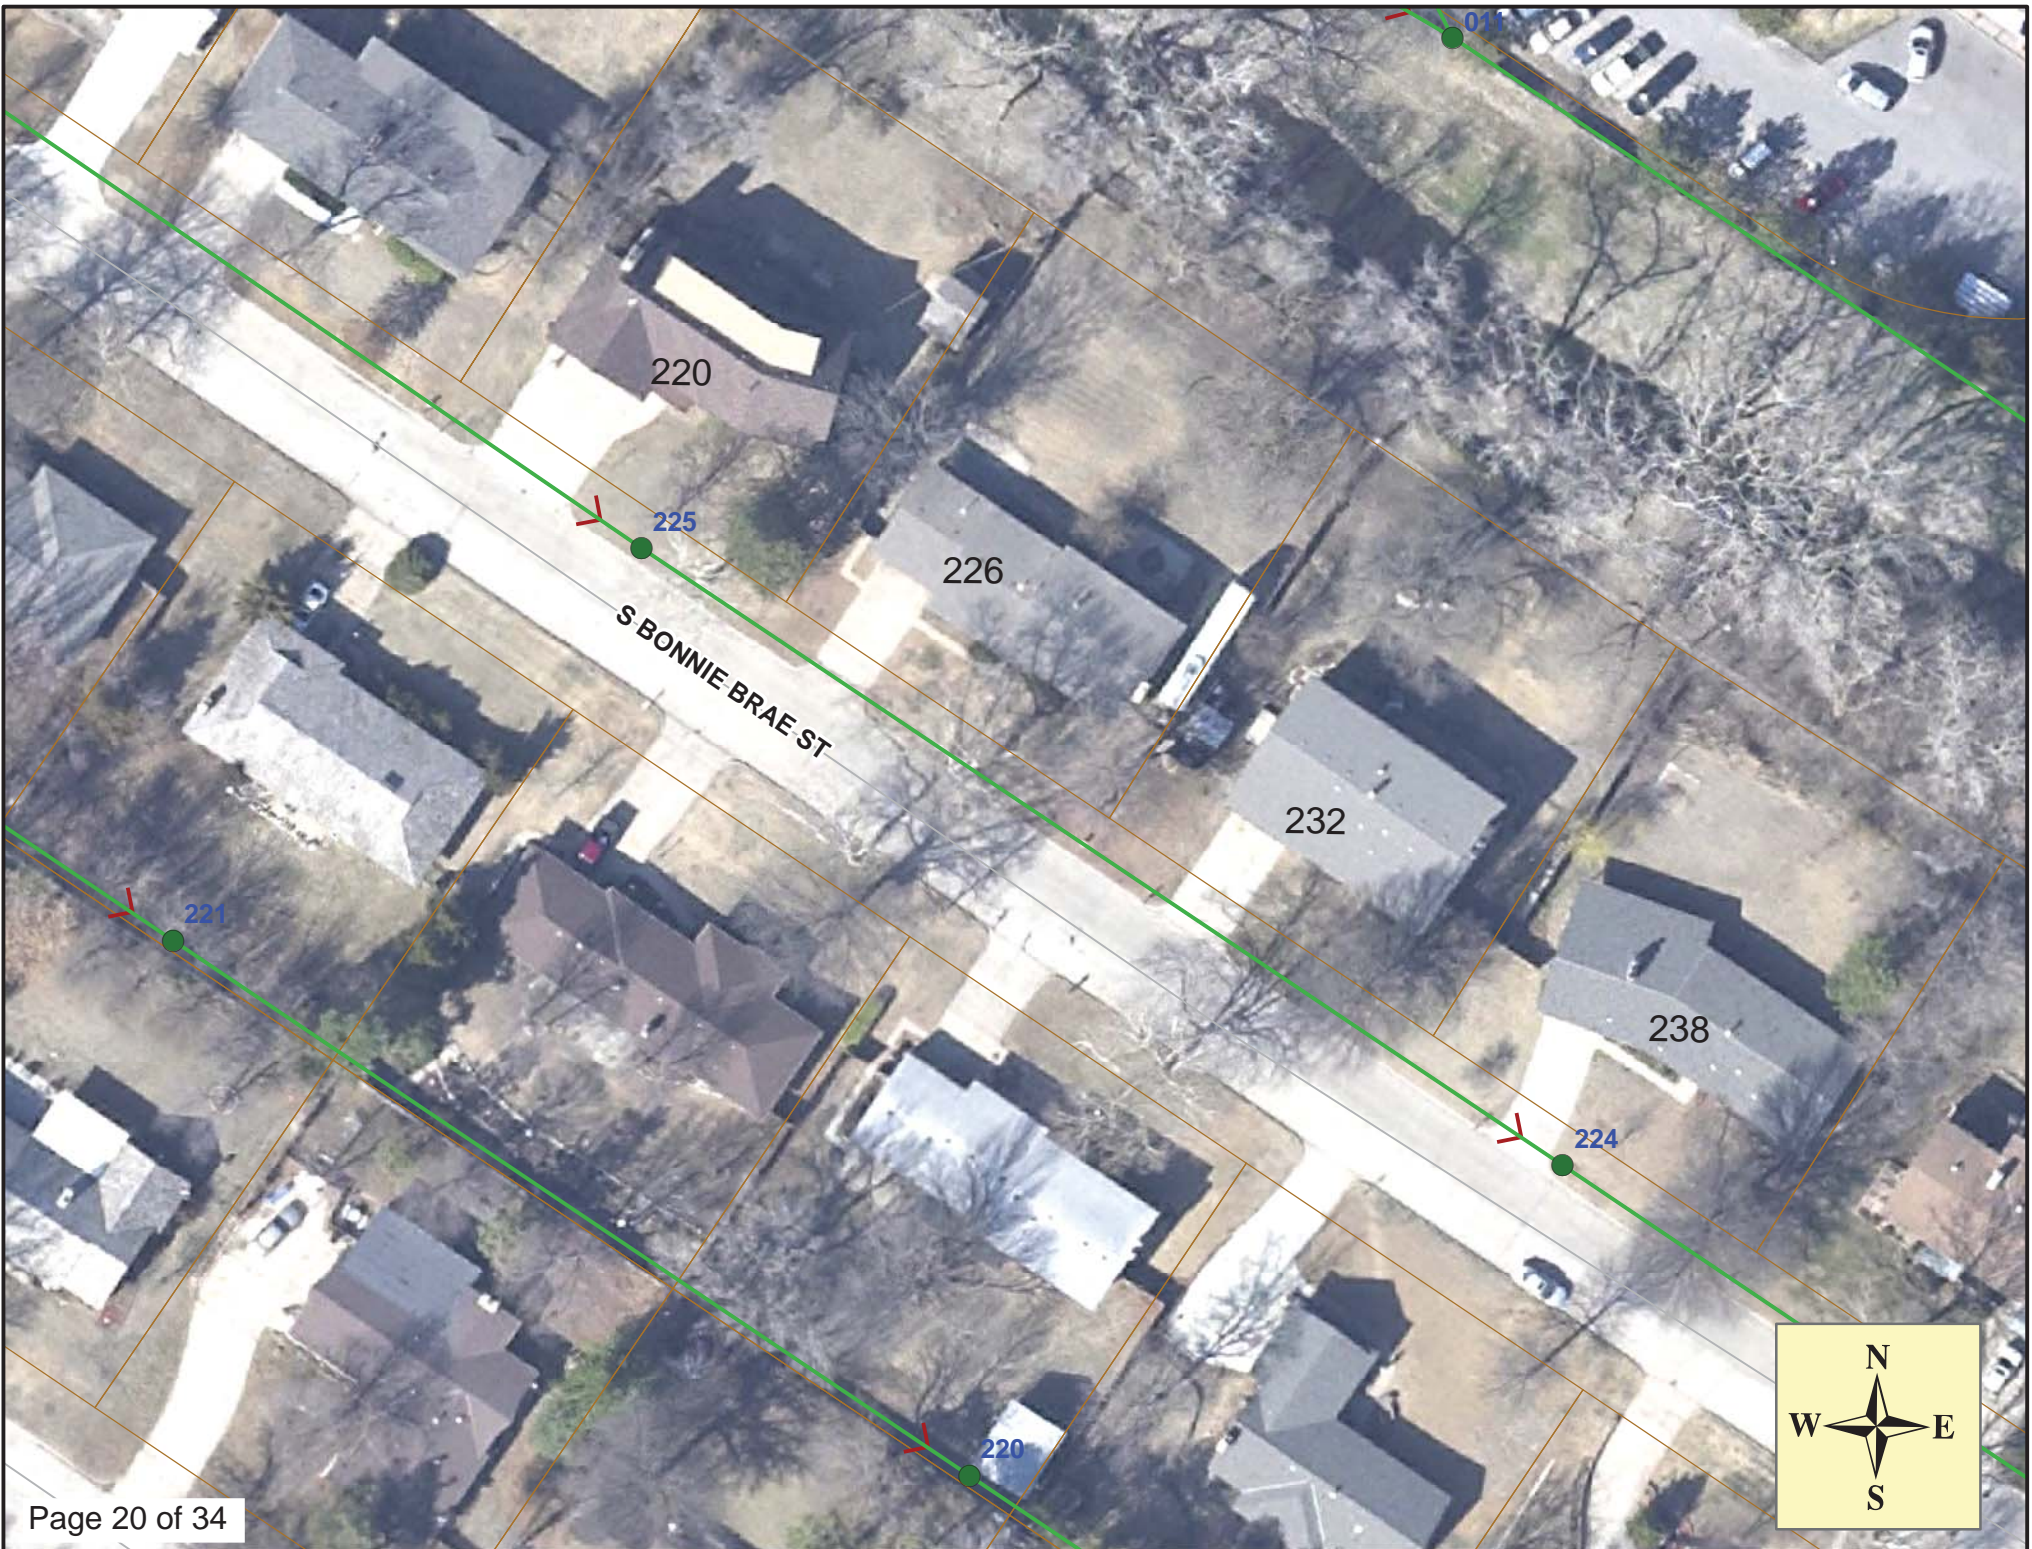
Shifted pipe in invert. Pipe in very poor condition and cannot be lined. -LML

Pipe is out of round and camera cannot pass. Pipe is shifted. -LML  
Incomplete televising -LML

**Need to replace the downstream 103 lf of pipe. From the downstream manhole, to and including the tap for 232 Bonnie Brae.**
