SITE 6

Video Inspection Master Report

US Structure: 5449-501 216 W 15TH ST N Date Insp: 12/2/2010 Basin: C03D
 DS Structure: 5449-500 219 W 15TH ST N Dir Televised: Upstream To Downstream

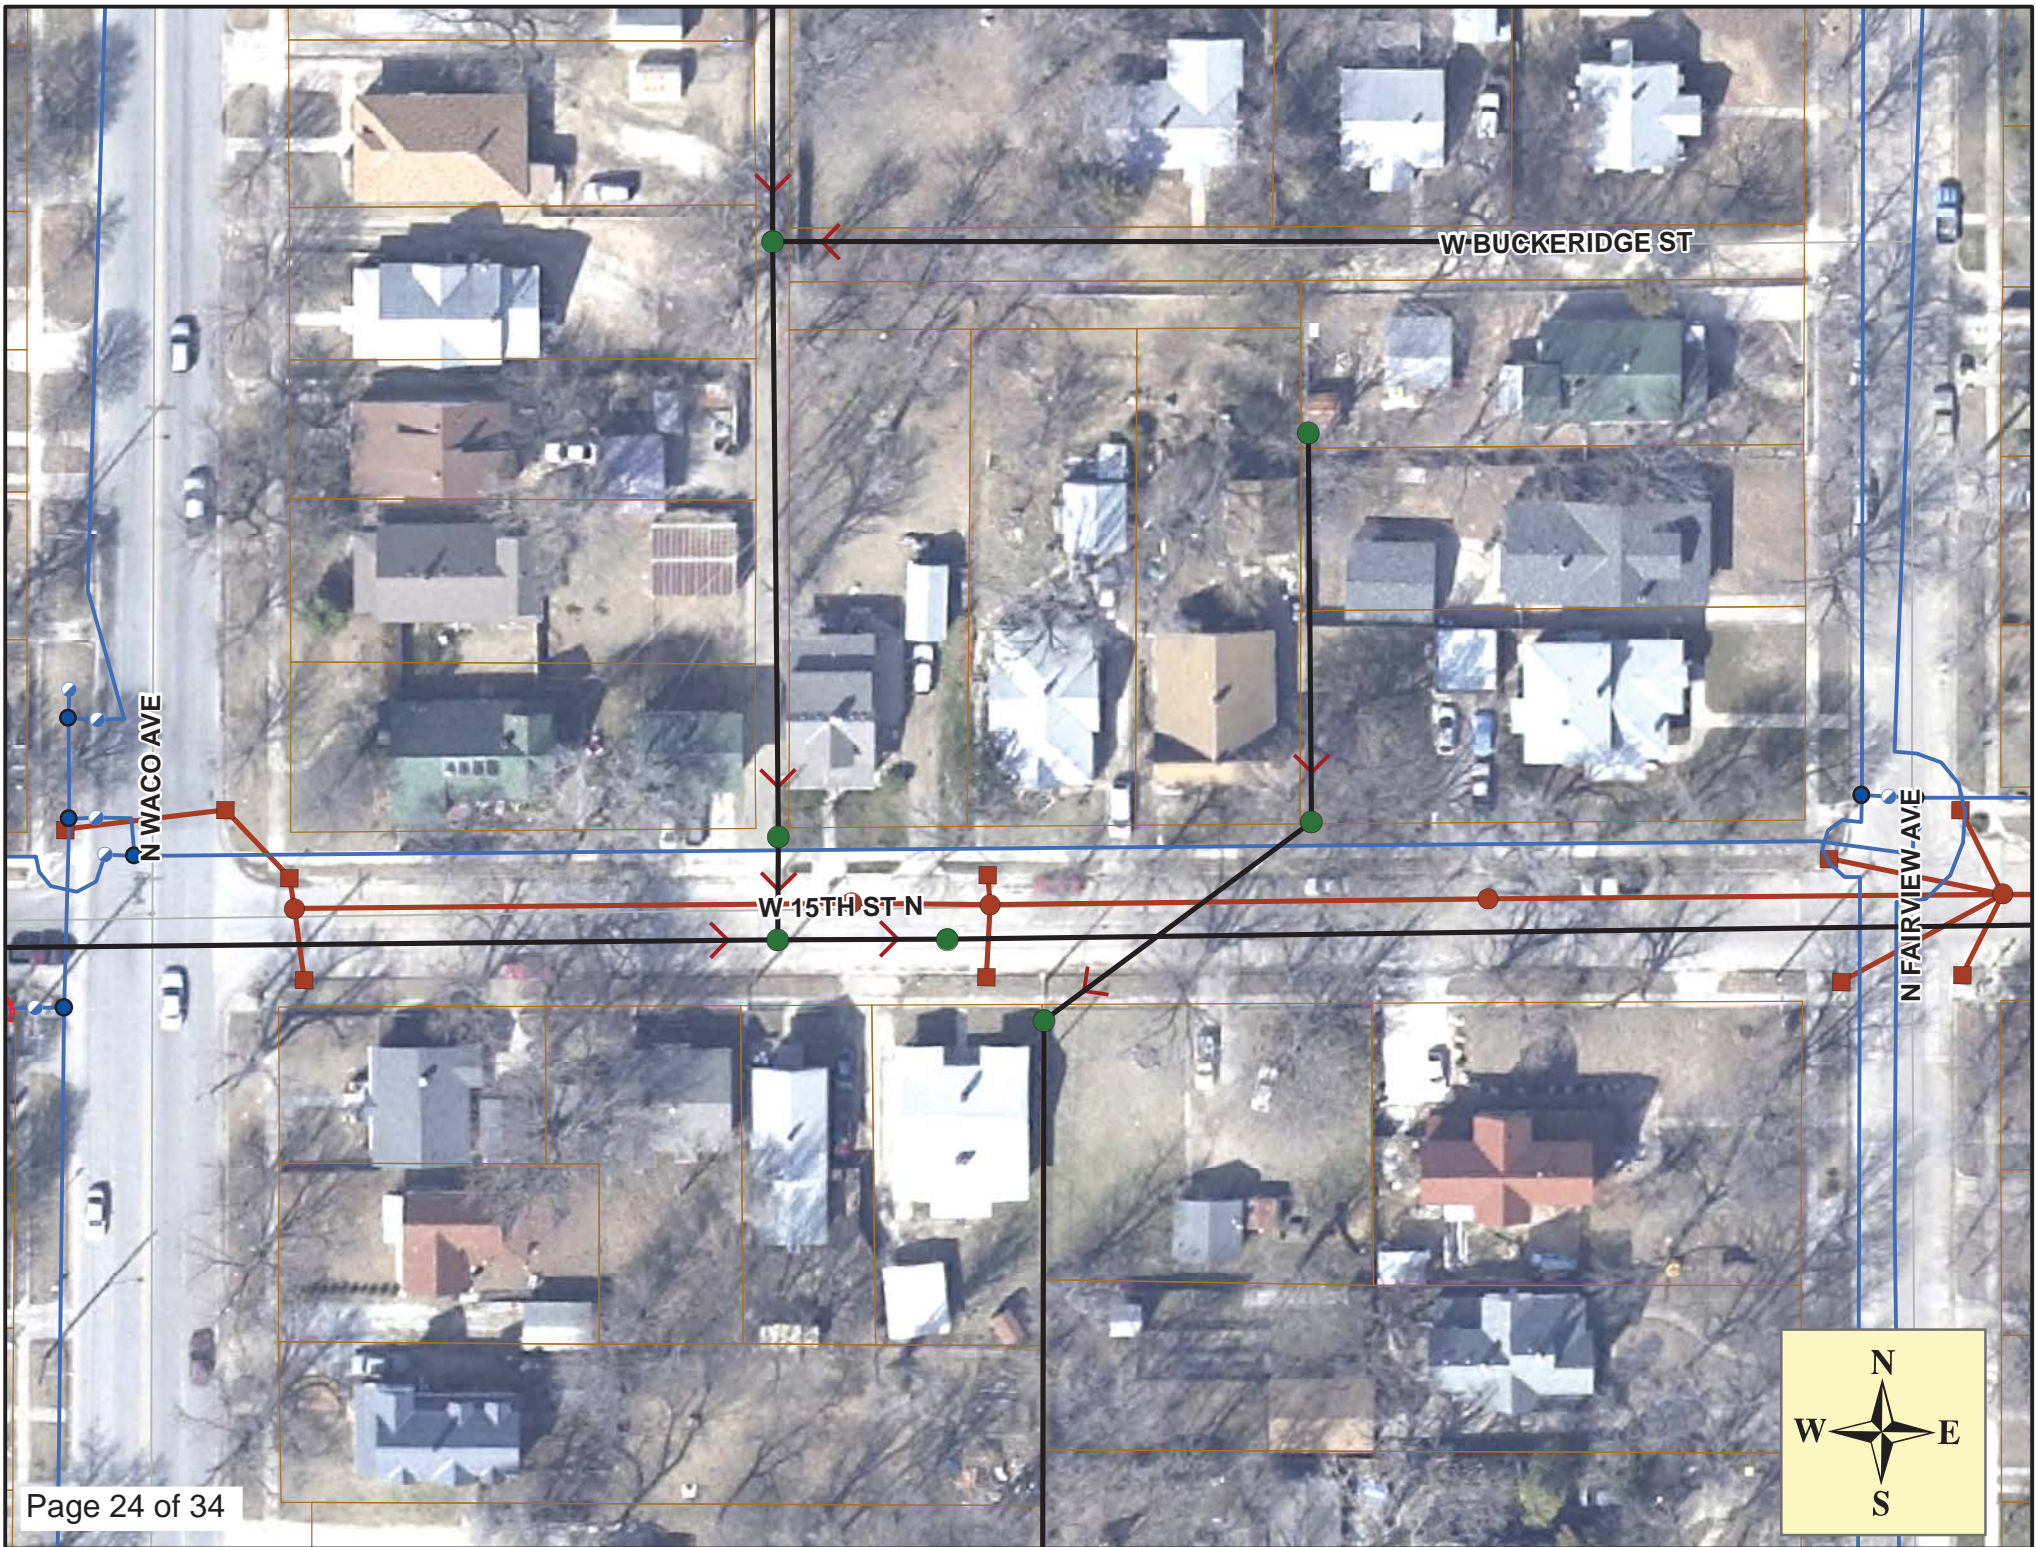
MH 5449-501
Approx MH depth = 3.1 ft

Caution: 8" PVC water main
(located below the sanitary sewer)

Caution: 10" VCP storm water main
(located just below the sanitary sewer)

MH 5449-500
Remove Manhole
Construct Shallow Manhole
Approx MH depth = 3.9 ft

Remove 98 lf of 6" Pipe
Install 98 lf of 8" Pipe
(from MH 5449-501 to MH 5449-500)

Remove & replace approx
50 lf of Pavement (incl curb/gutter)

Remove 20 lf of Reinforced Concrete Encasement (6" pipe)
Install 20 lf of Reinforced Concrete Encasement (8" pipe)
(at water line crossing)

Install 90 lf of Fill Sand (flushed & vibrated) (approx.)

The cost to remove and replace concrete sidewalks (both sides of the street) and a portion of the concrete approach for 216 W. 15th Street North shall be subsidiary to the project. Contractor may follow the same diagonal patch for the prior concrete replacement that was done when the sanitary sewer was encased.
