SITE 1

Video Inspection Master Report

US Structure: 5549-522

DS Structure: 5549-517

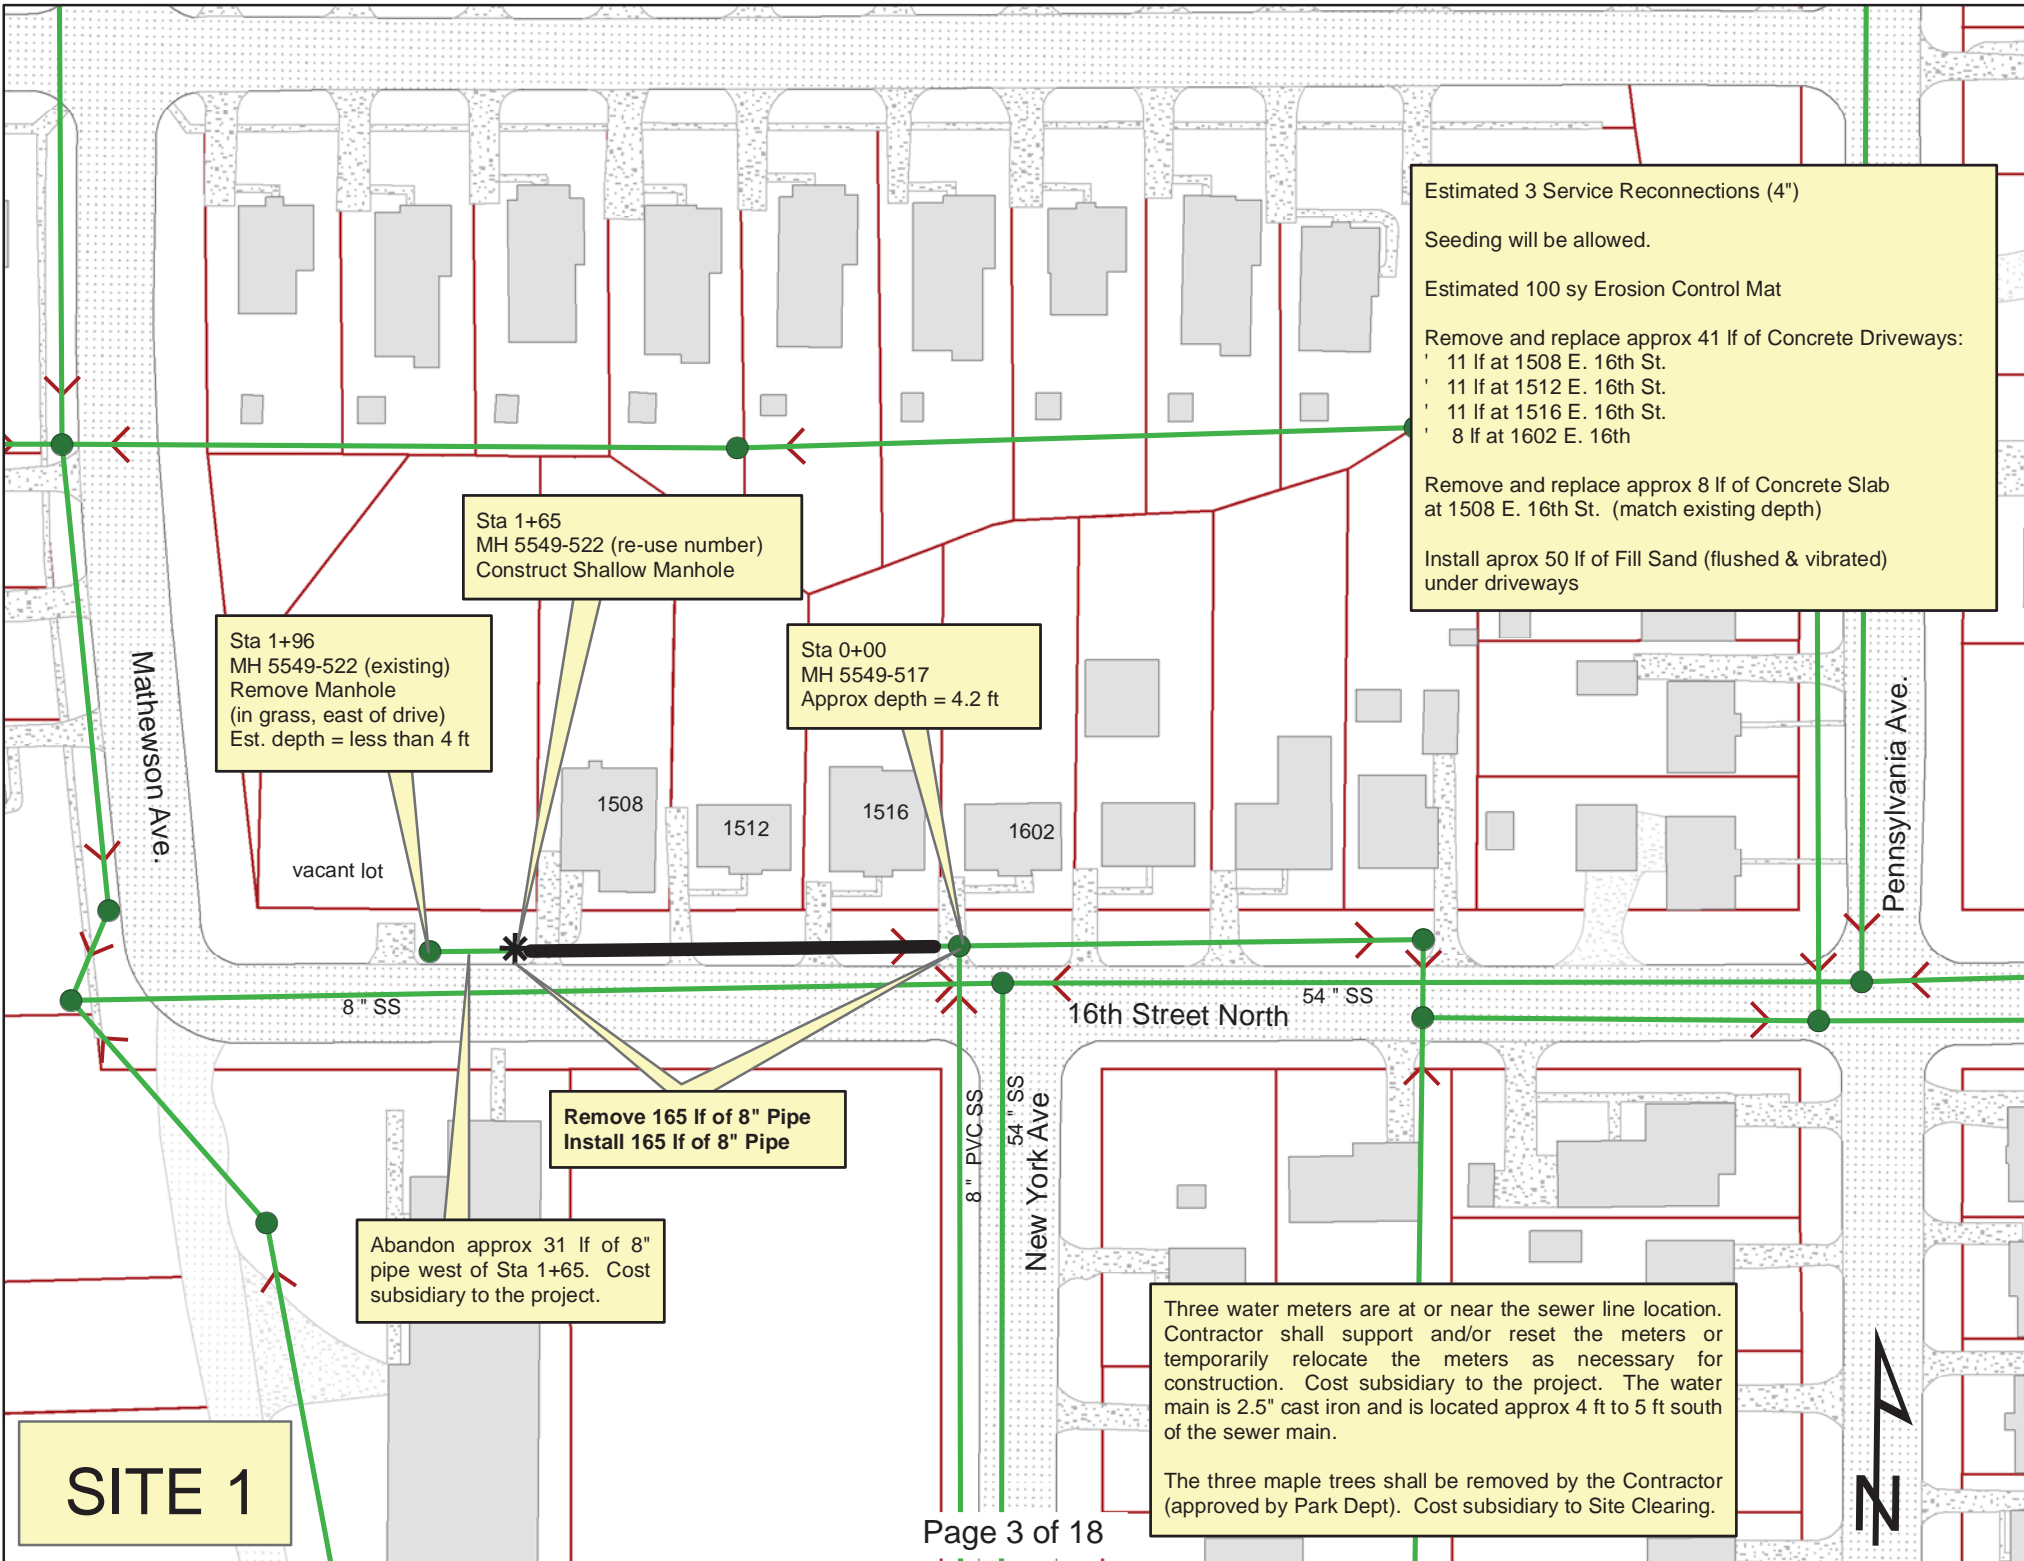
Three water meters are at or near the sewer line location. Contractor shall support and/or reset the meters or temporarily relocate the meters as necessary for construction. Cost subsidiary to the project. The water main is 2.5" cast iron and is located approx 4 ft to 5 ft south of the sewer main.

| Obs. # | VTR Counter | Distance | Location | Description | Rating | Obsrvd (gpm) | Ratings | | | |
|---|---|---|---|---|---|---|---|---|---|---|
| | | 190.0 | Offset Joint / Pipe Missing | (right outside of manhole wall) | | | | | | |

Remove and replace approx 41 lf of Concrete Driveways:

Remove and replace approx 8 lf of Concrete Slab at 1508 E. 16th St. (match existing depth)

Install aprox 50 lf of Fill Sand (flushed & vibrated) under driveways

Sta 1+65
MH 5549-522 (re-use number)
Construct Shallow Manhole

Sta 1+96
MH 5549-522 (existing)
Remove Manhole
(in grass, east of drive)
Est. depth = less than 4 ft

Remove 165 lf of 8" Pipe
Install 165 lf of 8" Pipe

Abandon approx 31 lf of 8" pipe west of Sta 1+65. Cost subsidiary to the project.

The three maple trees shall be removed by the Contractor (approved by Park Dept). Cost subsidiary to Site Clearing.
