**SITE 1**

Sheet 3 of 23

# Video Inspection Master Report

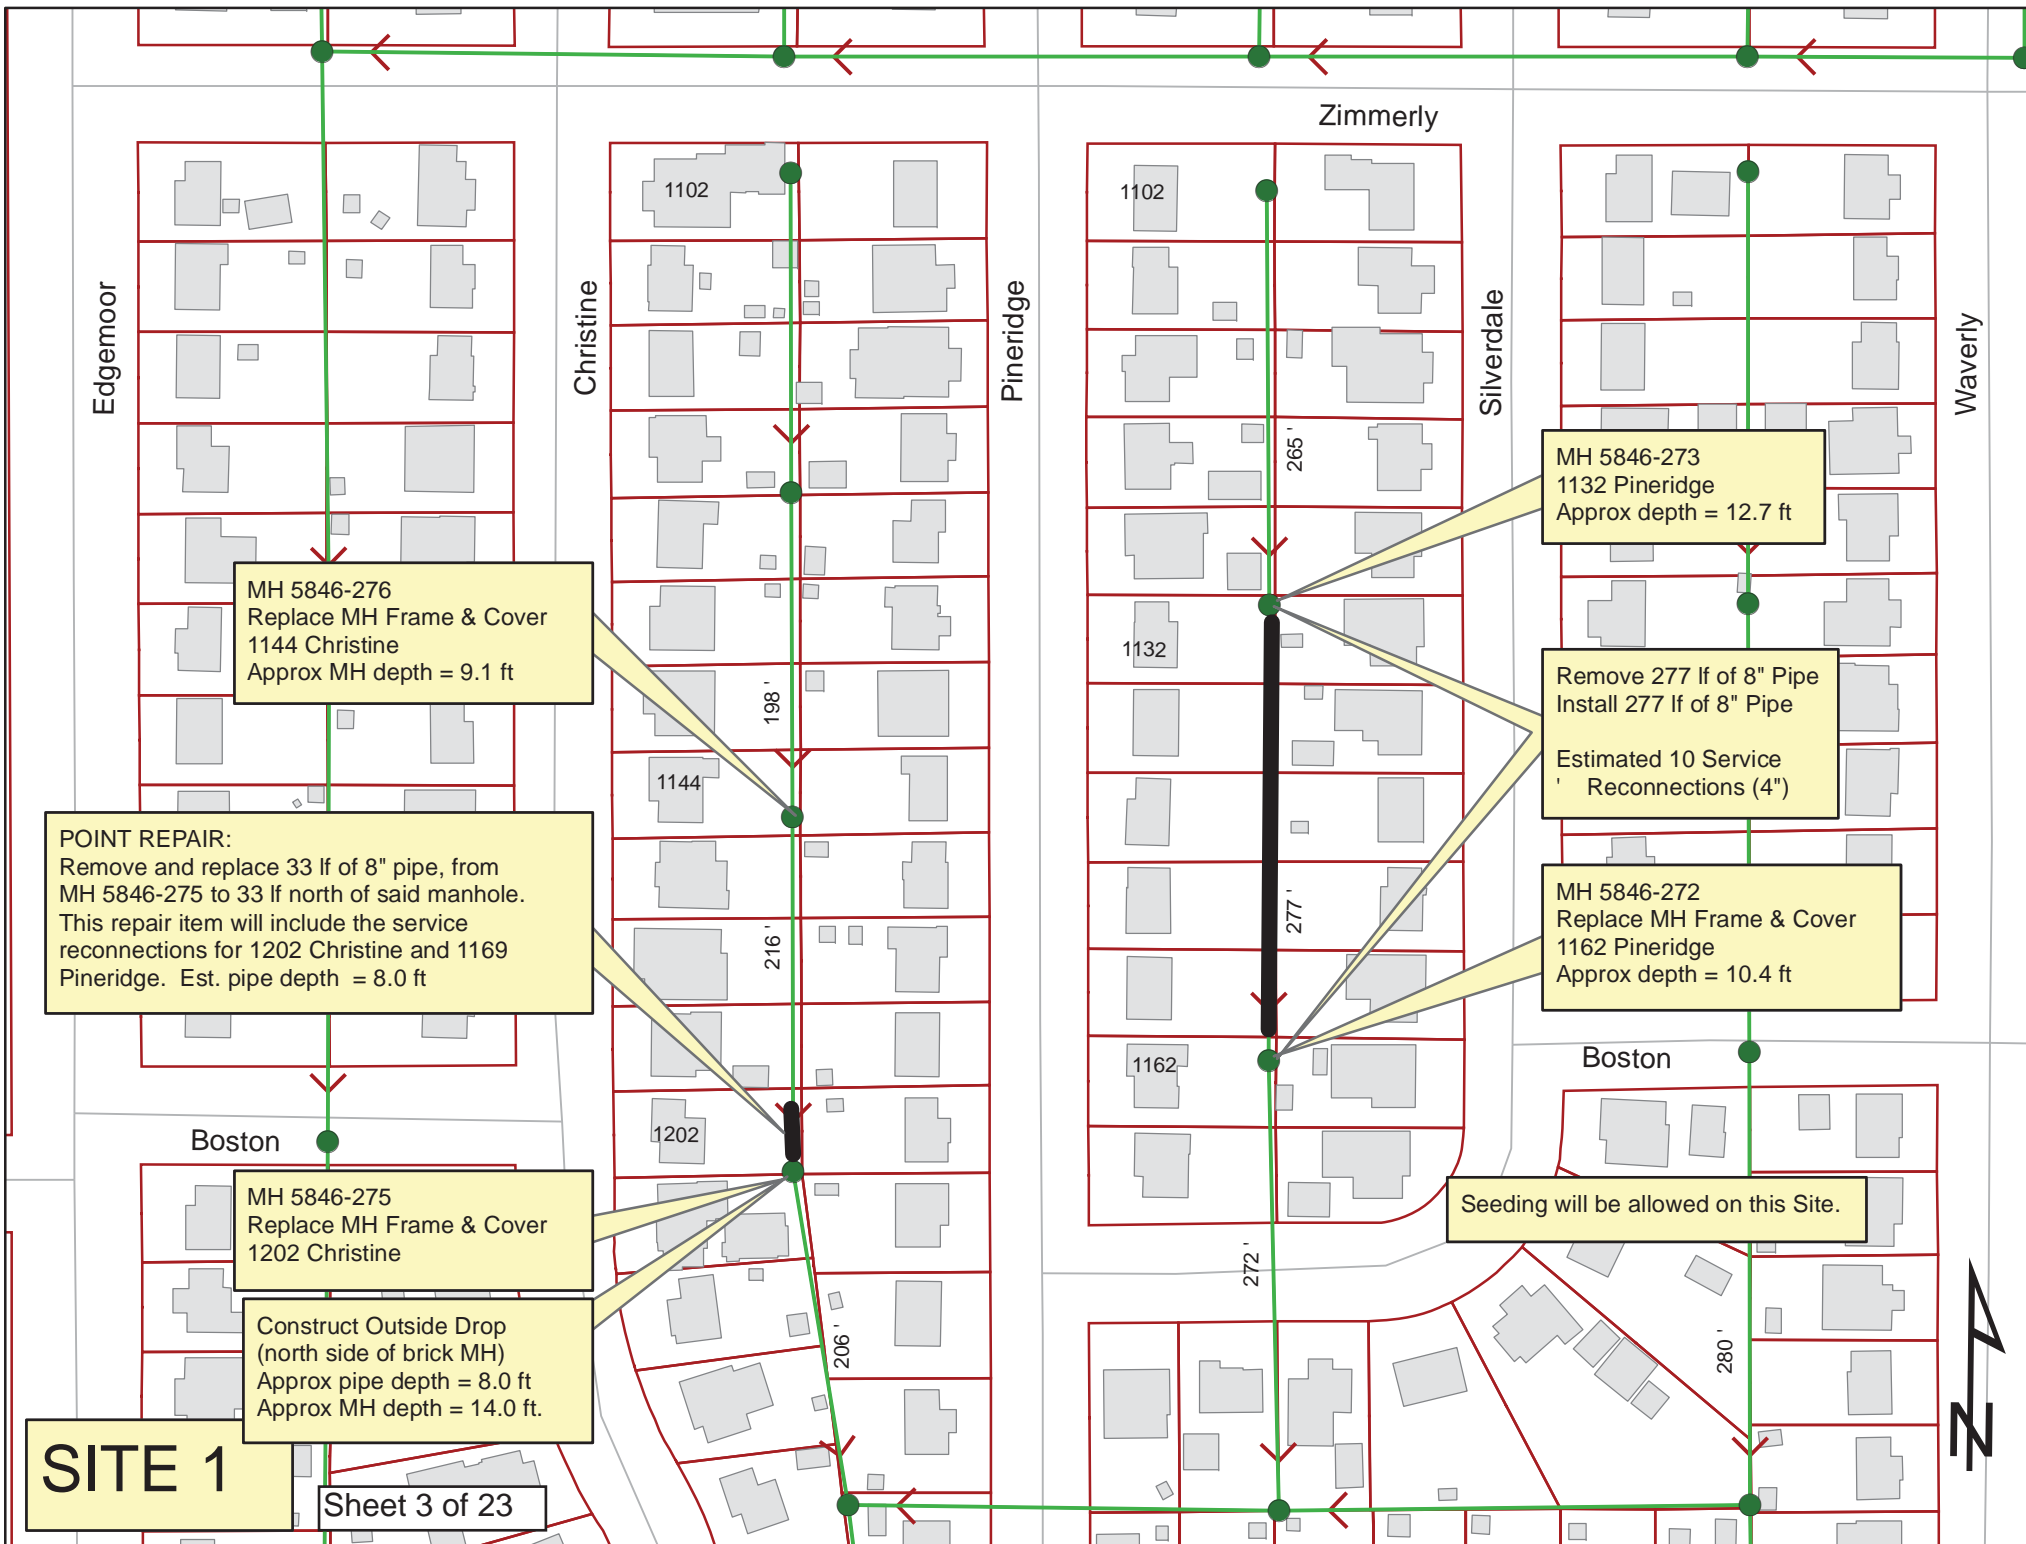
MH 5846-276  
 Replace MH Frame & Cover  
 1144 Christine  
 Approx MH depth = 9.1 ft

MH 5846-275  
 Replace MH Frame & Cover  
 1202 Christine

Construct Outside Drop  
 (north side of brick MH)  
 Approx pipe depth = 8.0 ft  
 Approx MH depth = 14.0 ft.

MH 5846-273  
 1132 Pineridge  
 Approx depth = 12.7 ft

MH 5846-272  
 Replace MH Frame & Cover  
 1162 Pineridge  
 Approx depth = 10.4 ft

**Comment:** BROKEN PIPE THROUGH OUT LINE NEEDS REHAB.

Pipe condition is too poor for liner installation. Needs replaced.  
 Area also has a history of high maintenance during rainfall. - LML

**POINT REPAIR:**  
 Remove and replace 33 lf of 8" pipe, from  
 MH 5846-275 to 33 lf north of said manhole.  
 This repair item will include the service  
 reconNECTIONS for 1202 Christine and 1169  
 Pineridge. Est. pipe depth = 8.0 ft

Remove 277 lf of 8" Pipe  
 Install 277 lf of 8" Pipe  
 Estimated 10 Service  
 ReconNECTIONS (4")

POINT REPAIR NEEDED: Replace the downstream 33 feet of pipe, from approx 182' to the downstream manhole. Replace two service connections. Construct an outside drop. -LML

The pipe is scheduled for CIPP installation and this repair needs to be completed prior to CIPP. -LML
