SITE 2

Sheet 9 of 23

Video Inspection Master Report

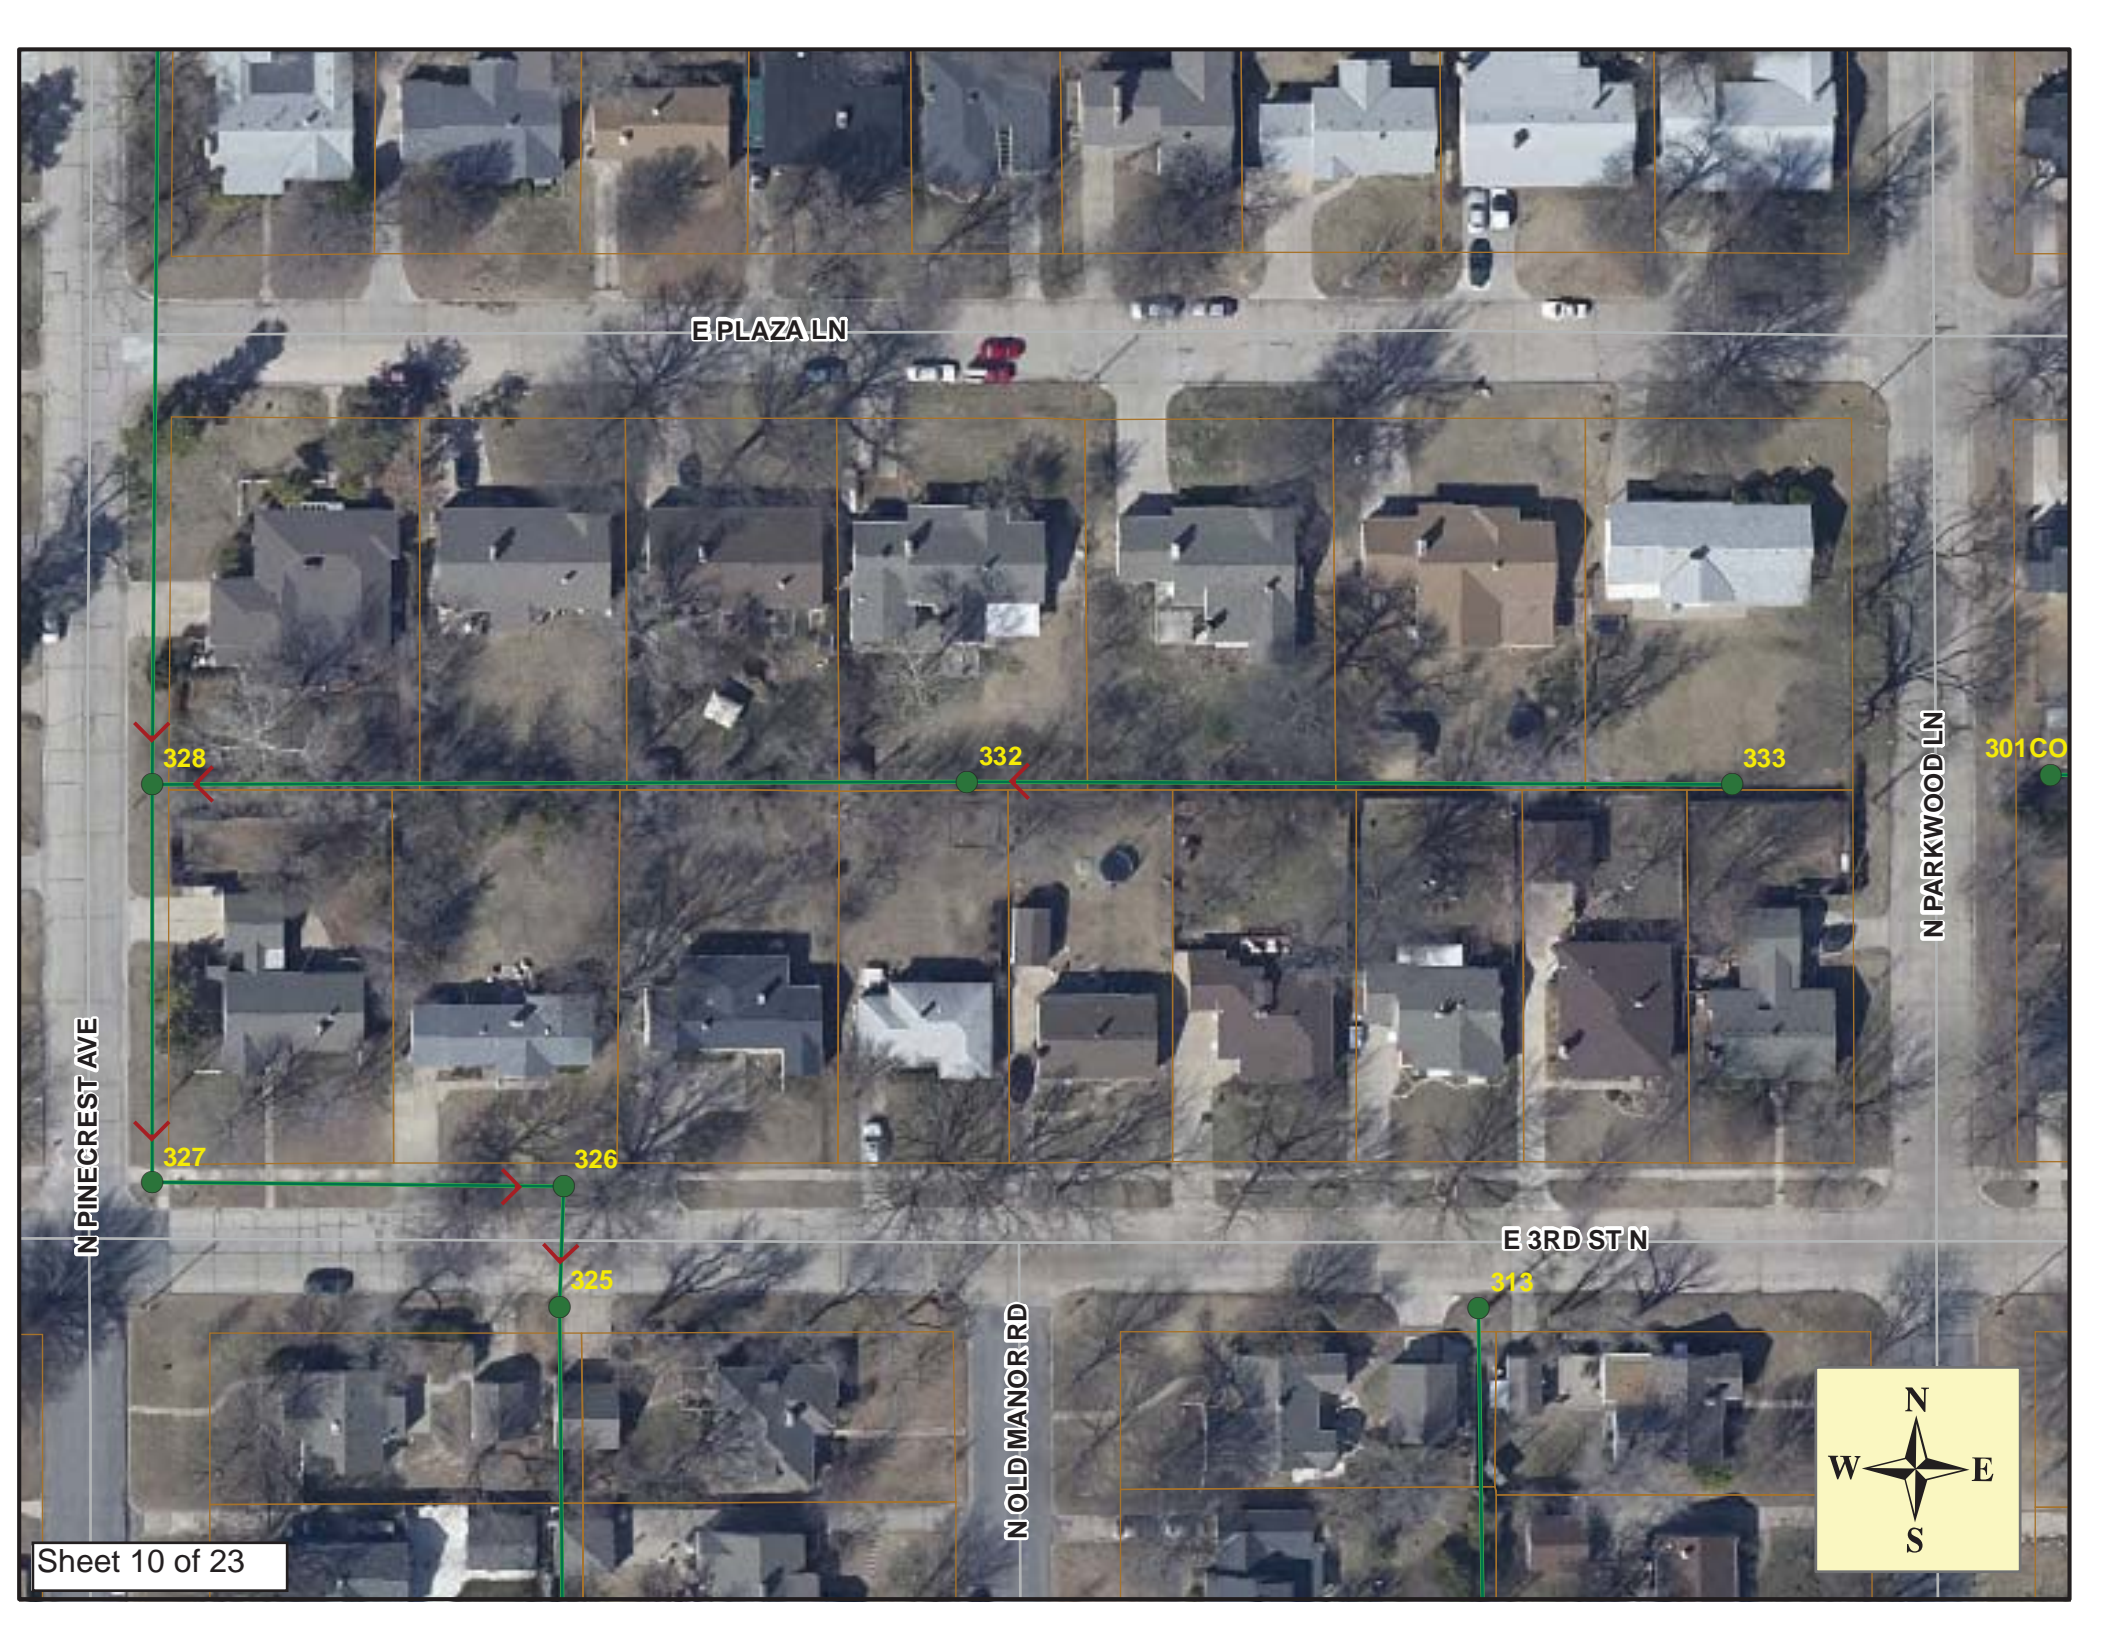
MH 5847-328
5225 E Plaza
Approx depth = 8.5 ft

MH 5847-332
Replace MH Frame & Cover
Construct Outside Drop
5225 E Plaza
Approx depth = 12.5 ft

MH 5847-333
5321 E Plaza
Est. depth = 12.0 ft

Remove 571 lf of 8" Pipe
Install 571 lf of 8" Pipe

Estimated 16 Service Reconnections (4")
Estimated 20 lf Silt Fence
Estimated 20 sy Erosion Control Mat
Estimated 1 Construction Entrance
