**SITE 3**

Sheet 15 of 23

## Video Inspection Master Report

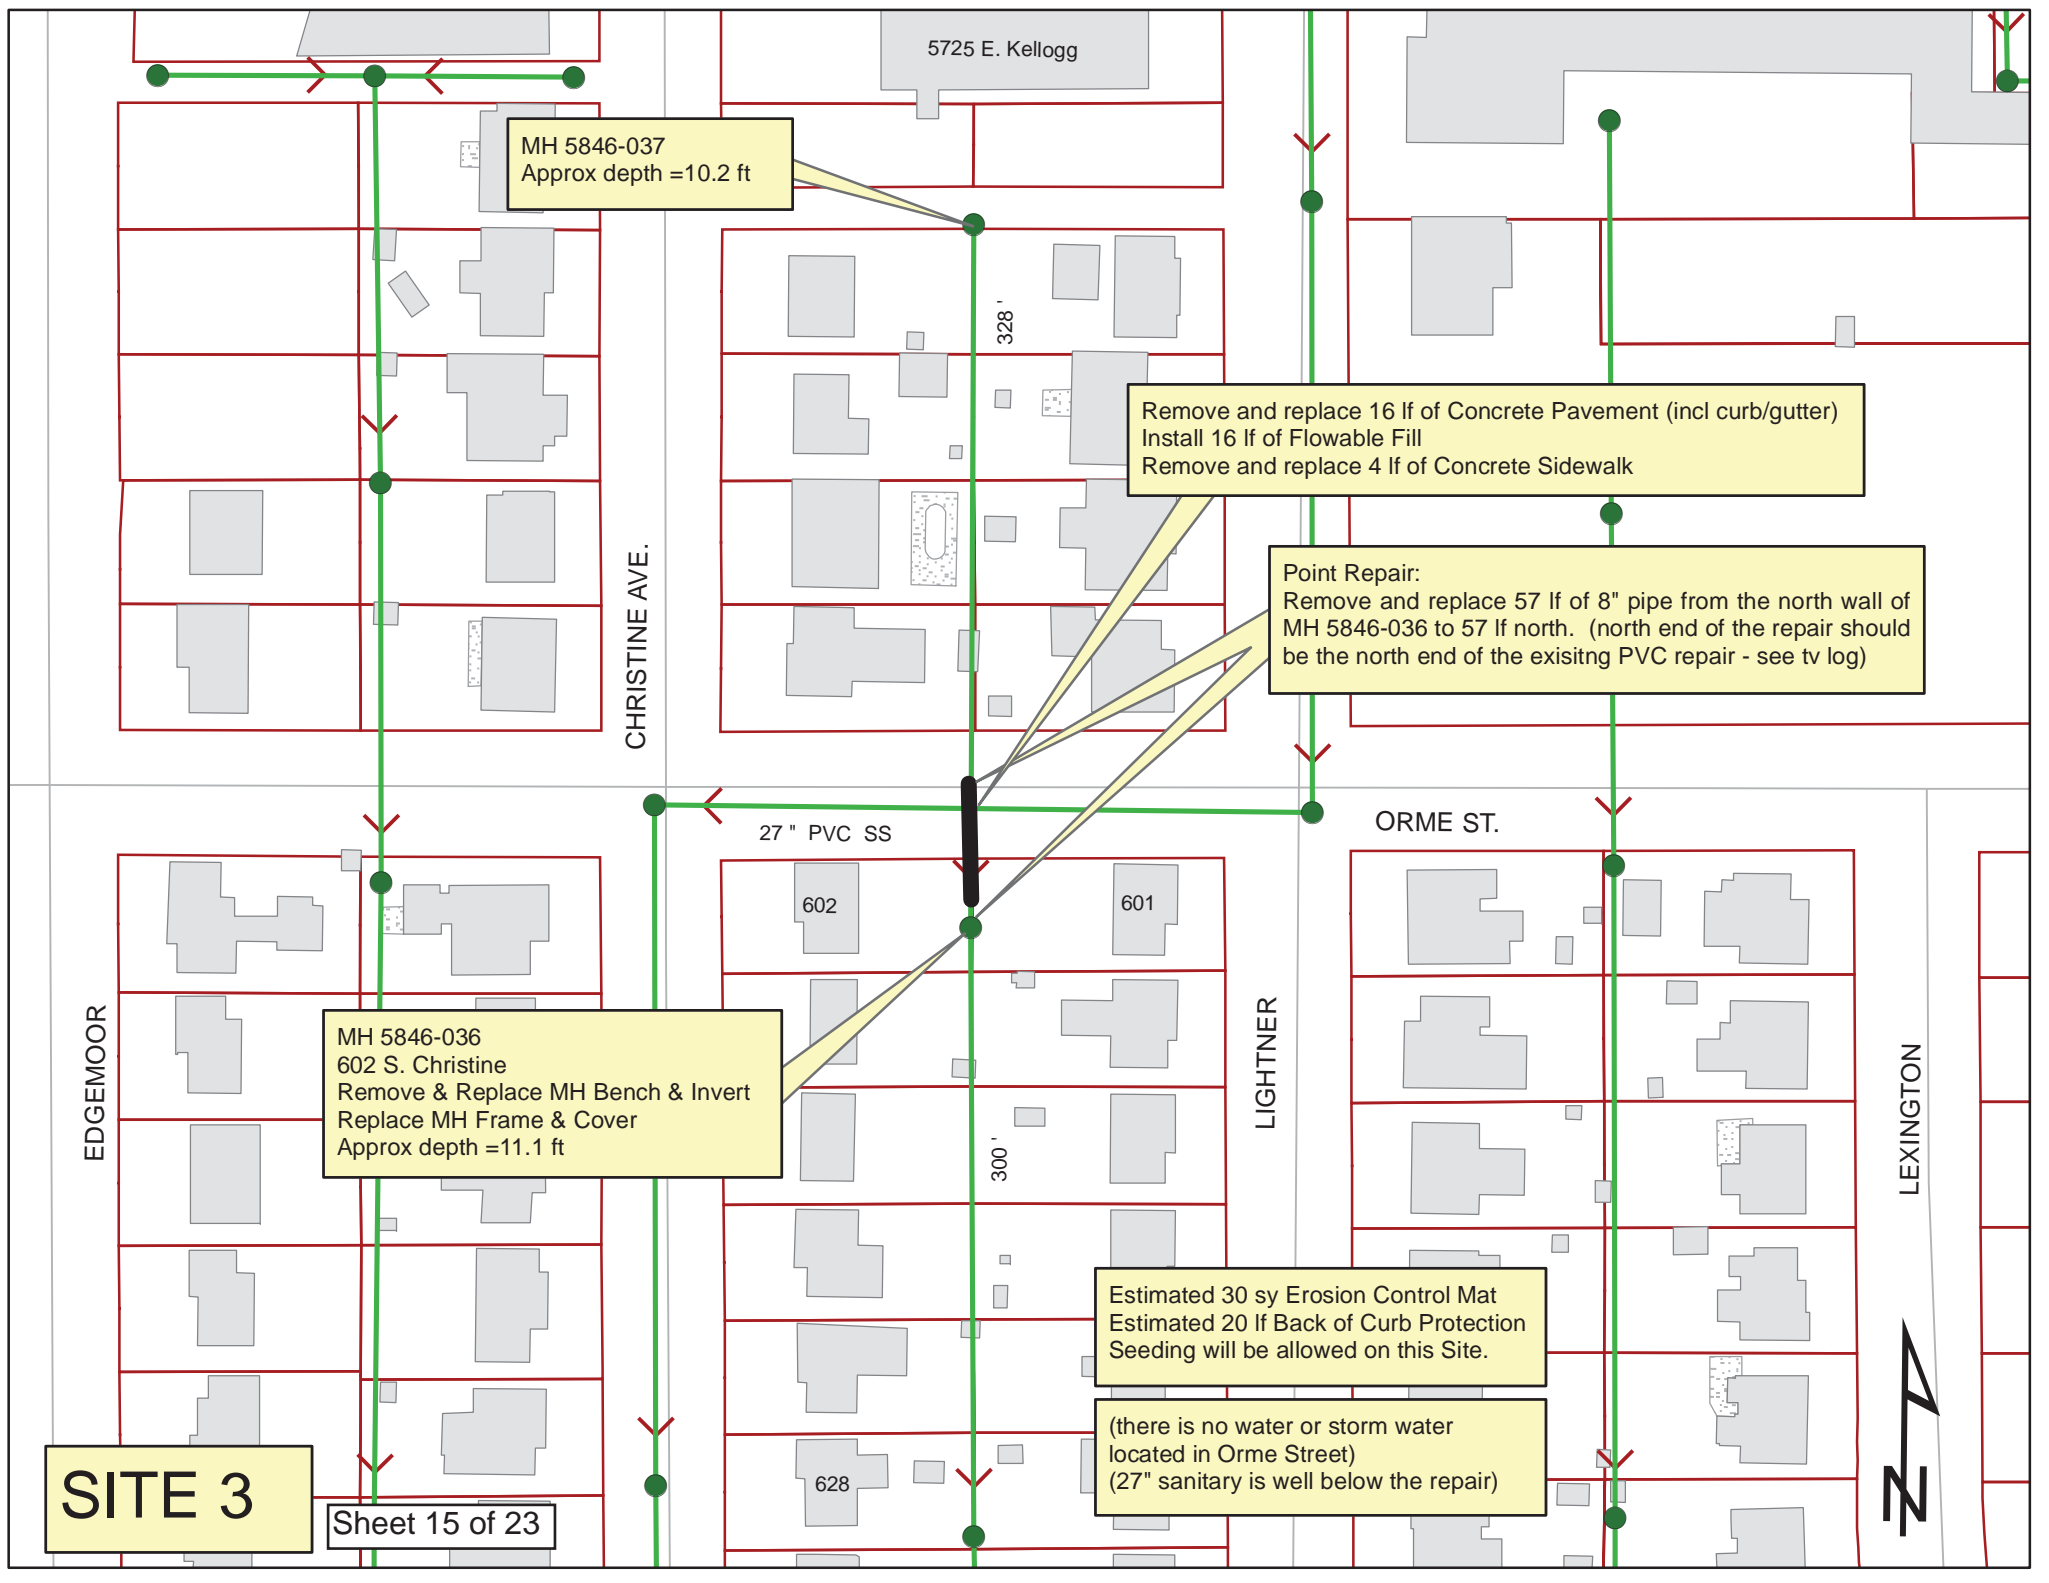
MH 5846-037  
Approx depth =10.2 ft

MH 5846-036  
602 S. Christine  
Remove & Replace MH Bench & Invert  
Replace MH Frame & Cover  
Approx depth =11.1 ft

(there is no water or storm water  
located in Orme Street)  
(27" sanitary is well below the repair)

Remove and replace 16 lf of Concrete Pavement (incl curb/gutter)  
Install 16 lf of Flowable Fill  
Remove and replace 4 lf of Concrete Sidewalk

Point Repair:  
Remove and replace 57 lf of 8" pipe from the north wall of  
MH 5846-036 to 57 lf north. (north end of the repair should  
be the north end of the existing PVC repair - see tv log)

Estimated 30 sy Erosion Control Mat  
Estimated 20 lf Back of Curb Protection  
Seeding will be allowed on this Site.
