**SITE 1**

# Video Inspection Master Report

US Structure: 5445-350                      2122 S MARKET AVE ST                      Date Insp: 9/21/2010                      Basin: C05D  
 DS Structure: 5445-382                      2122 S MARKET ST                      Dir Televised: Upstream To Downstream

**SITE 2**

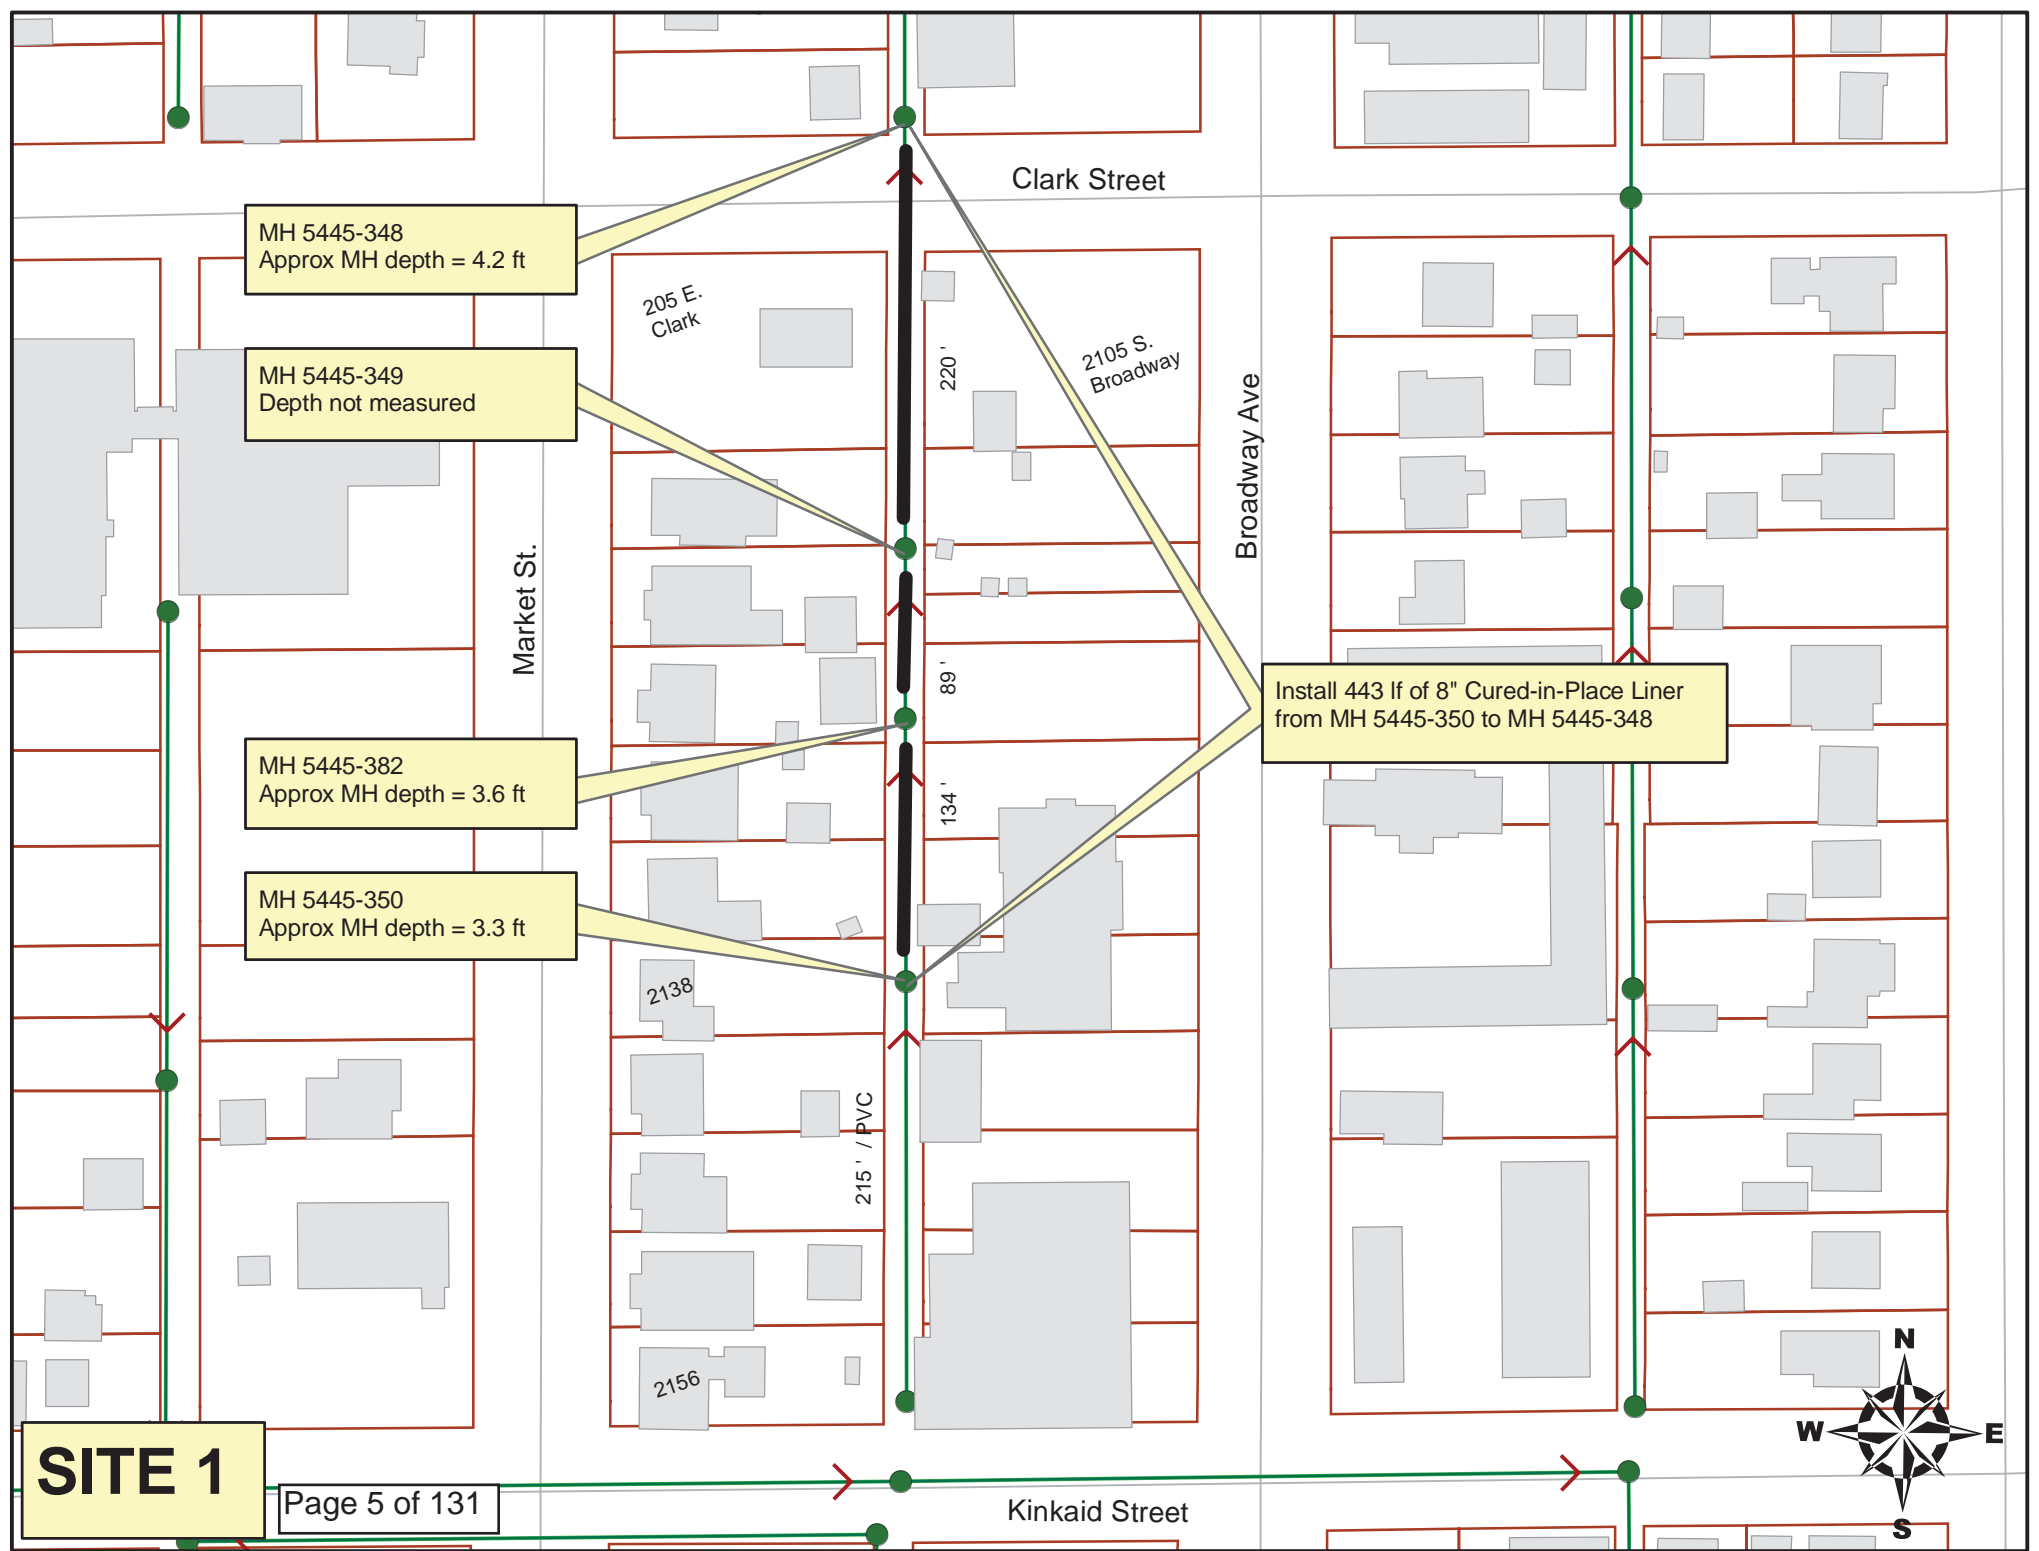
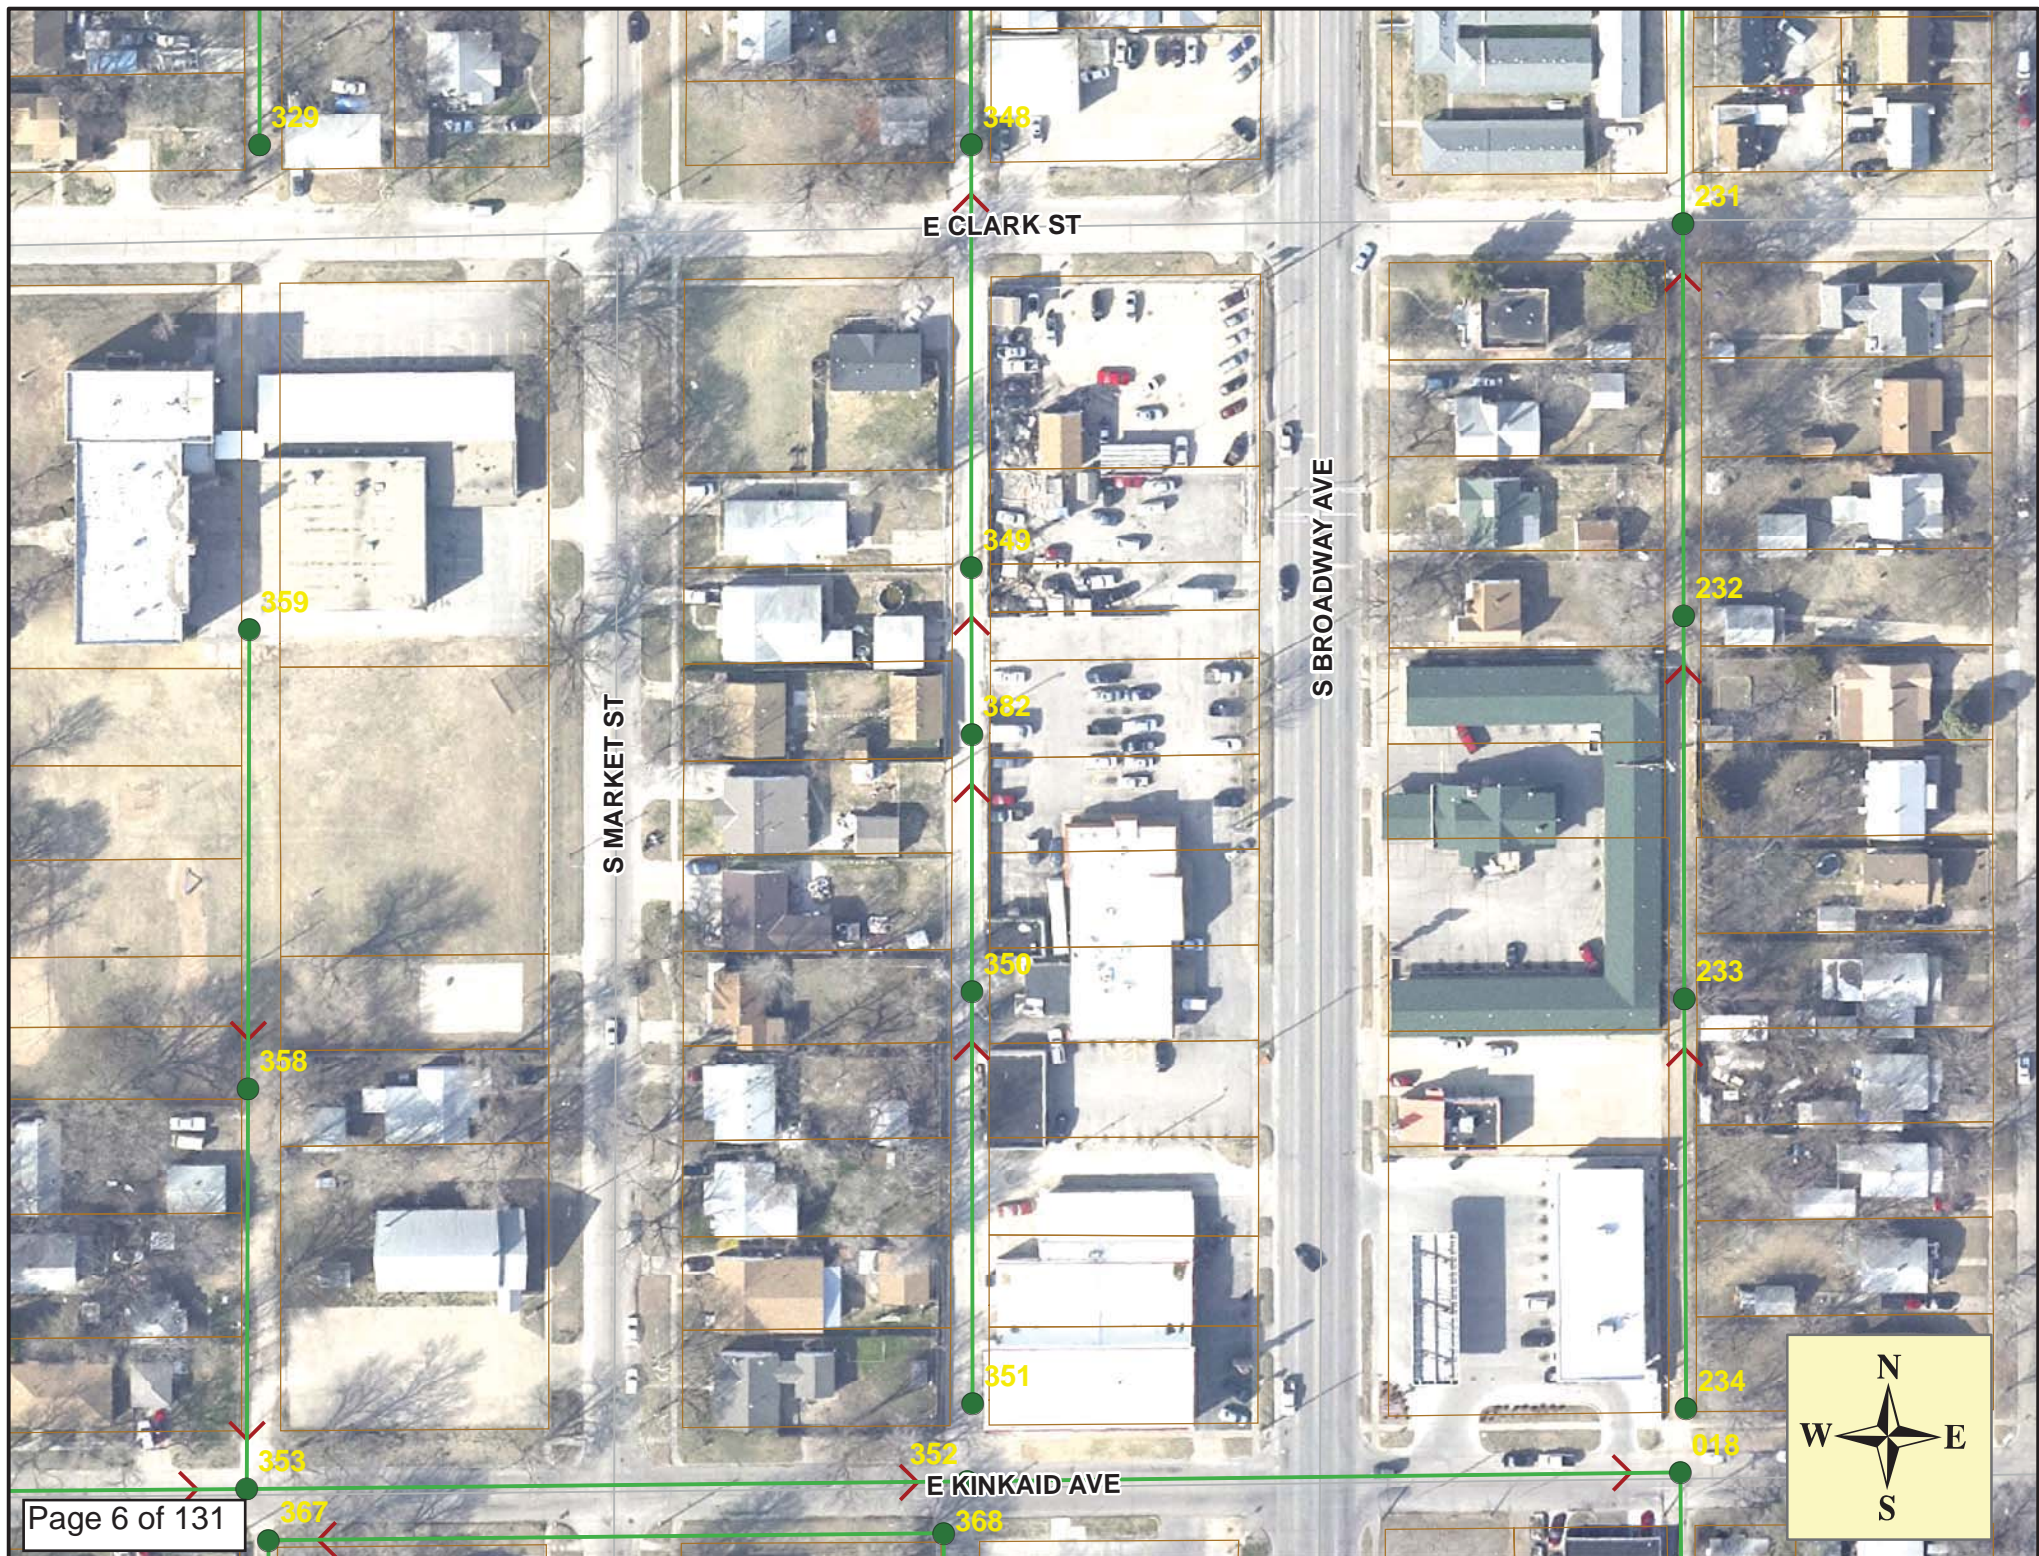
MH 5445-348  
Approx MH depth = 4.2 ft

MH 5445-349  
Depth not measured

MH 5445-382  
Approx MH depth = 3.6 ft

MH 5445-350  
Approx MH depth = 3.3 ft

Install 443 lf of 8" Cured-in-Place Liner  
from MH 5445-350 to MH 5445-348

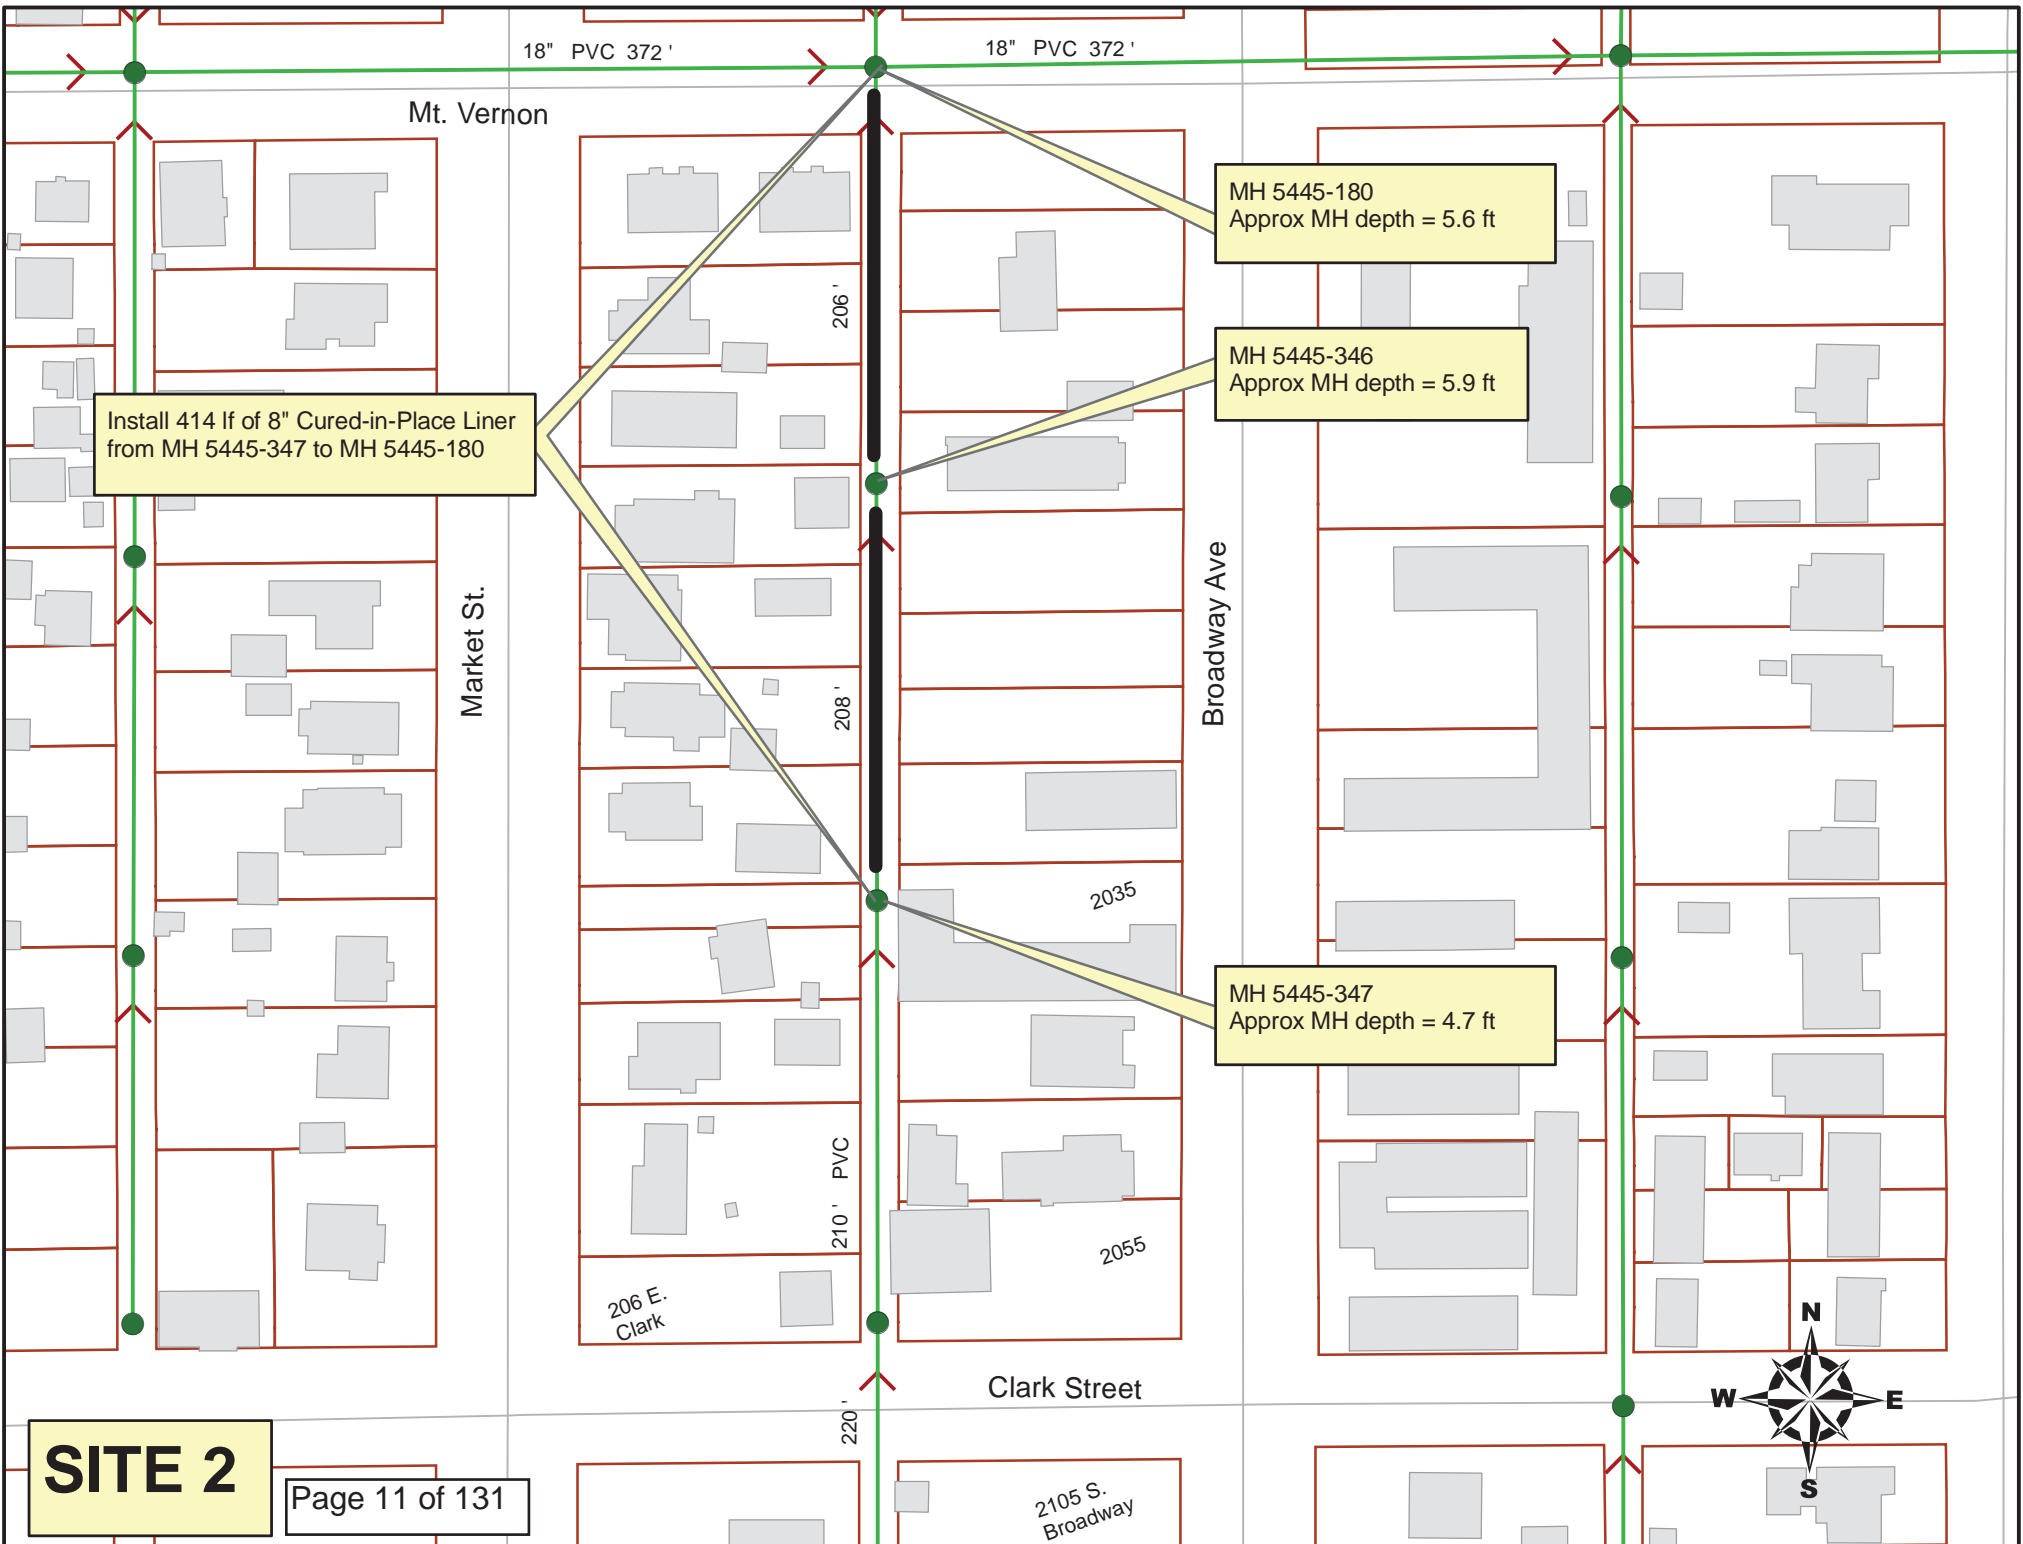
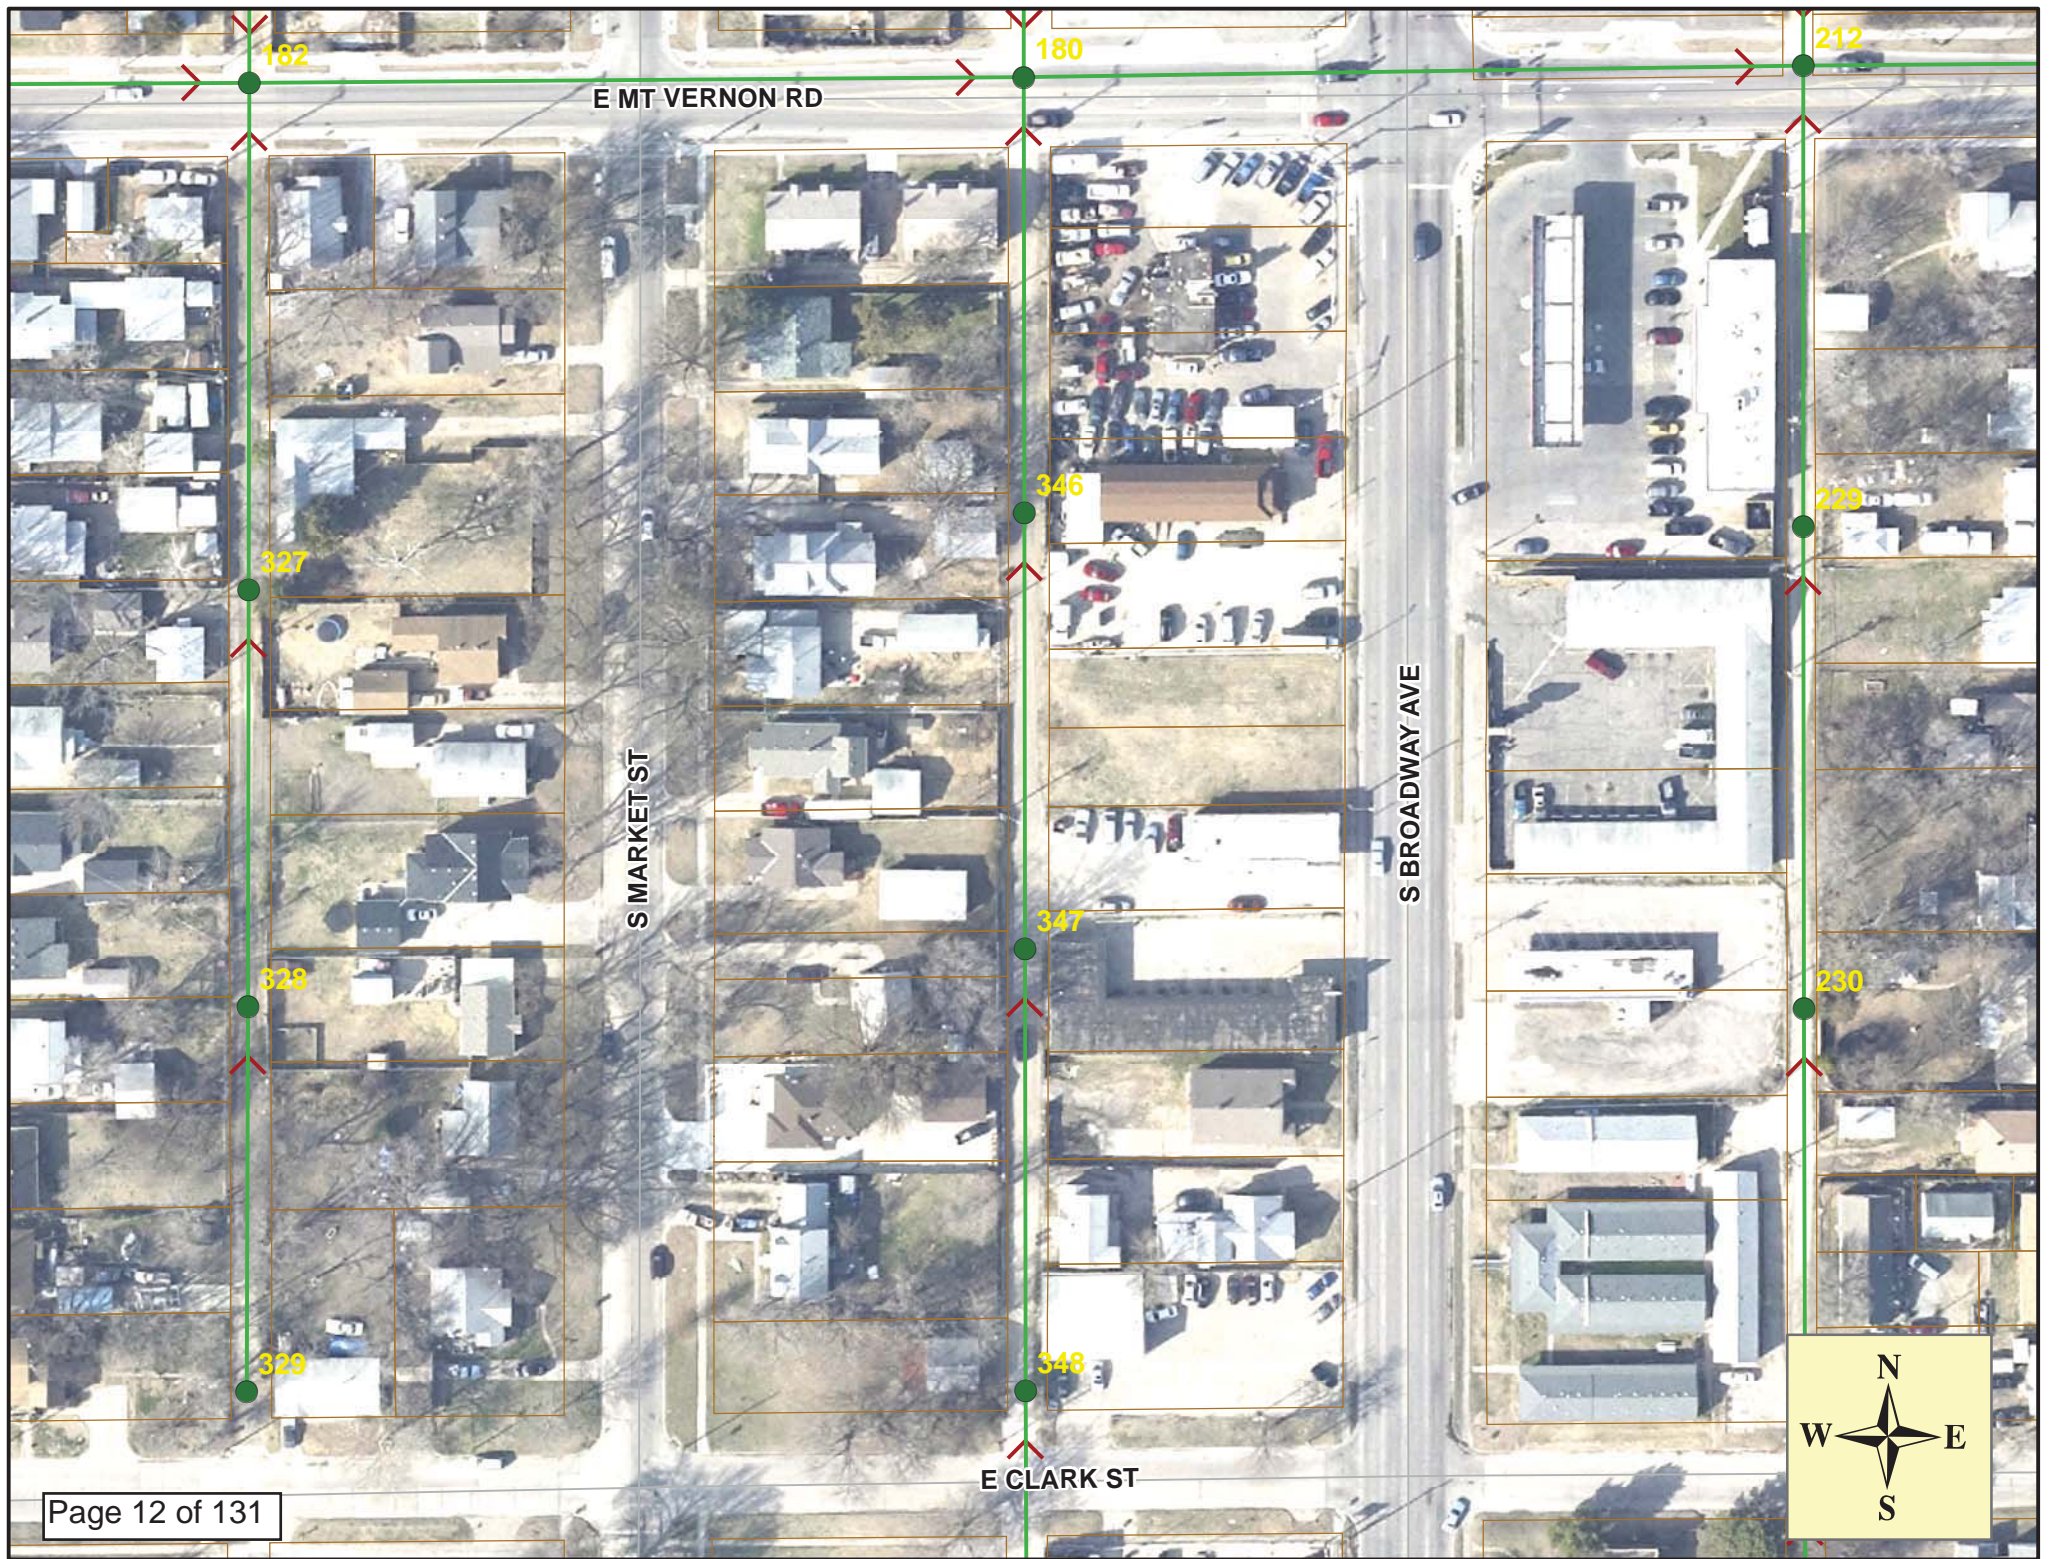
MH 5445-180  
Approx MH depth = 5.6 ft

MH 5445-346  
Approx MH depth = 5.9 ft

MH 5445-347  
Approx MH depth = 4.7 ft

Install 414 lf of 8" Cured-in-Place Liner from MH 5445-347 to MH 5445-180
