SITE 9

Video Inspection Master Report

SITE 10

Page 72 of 131

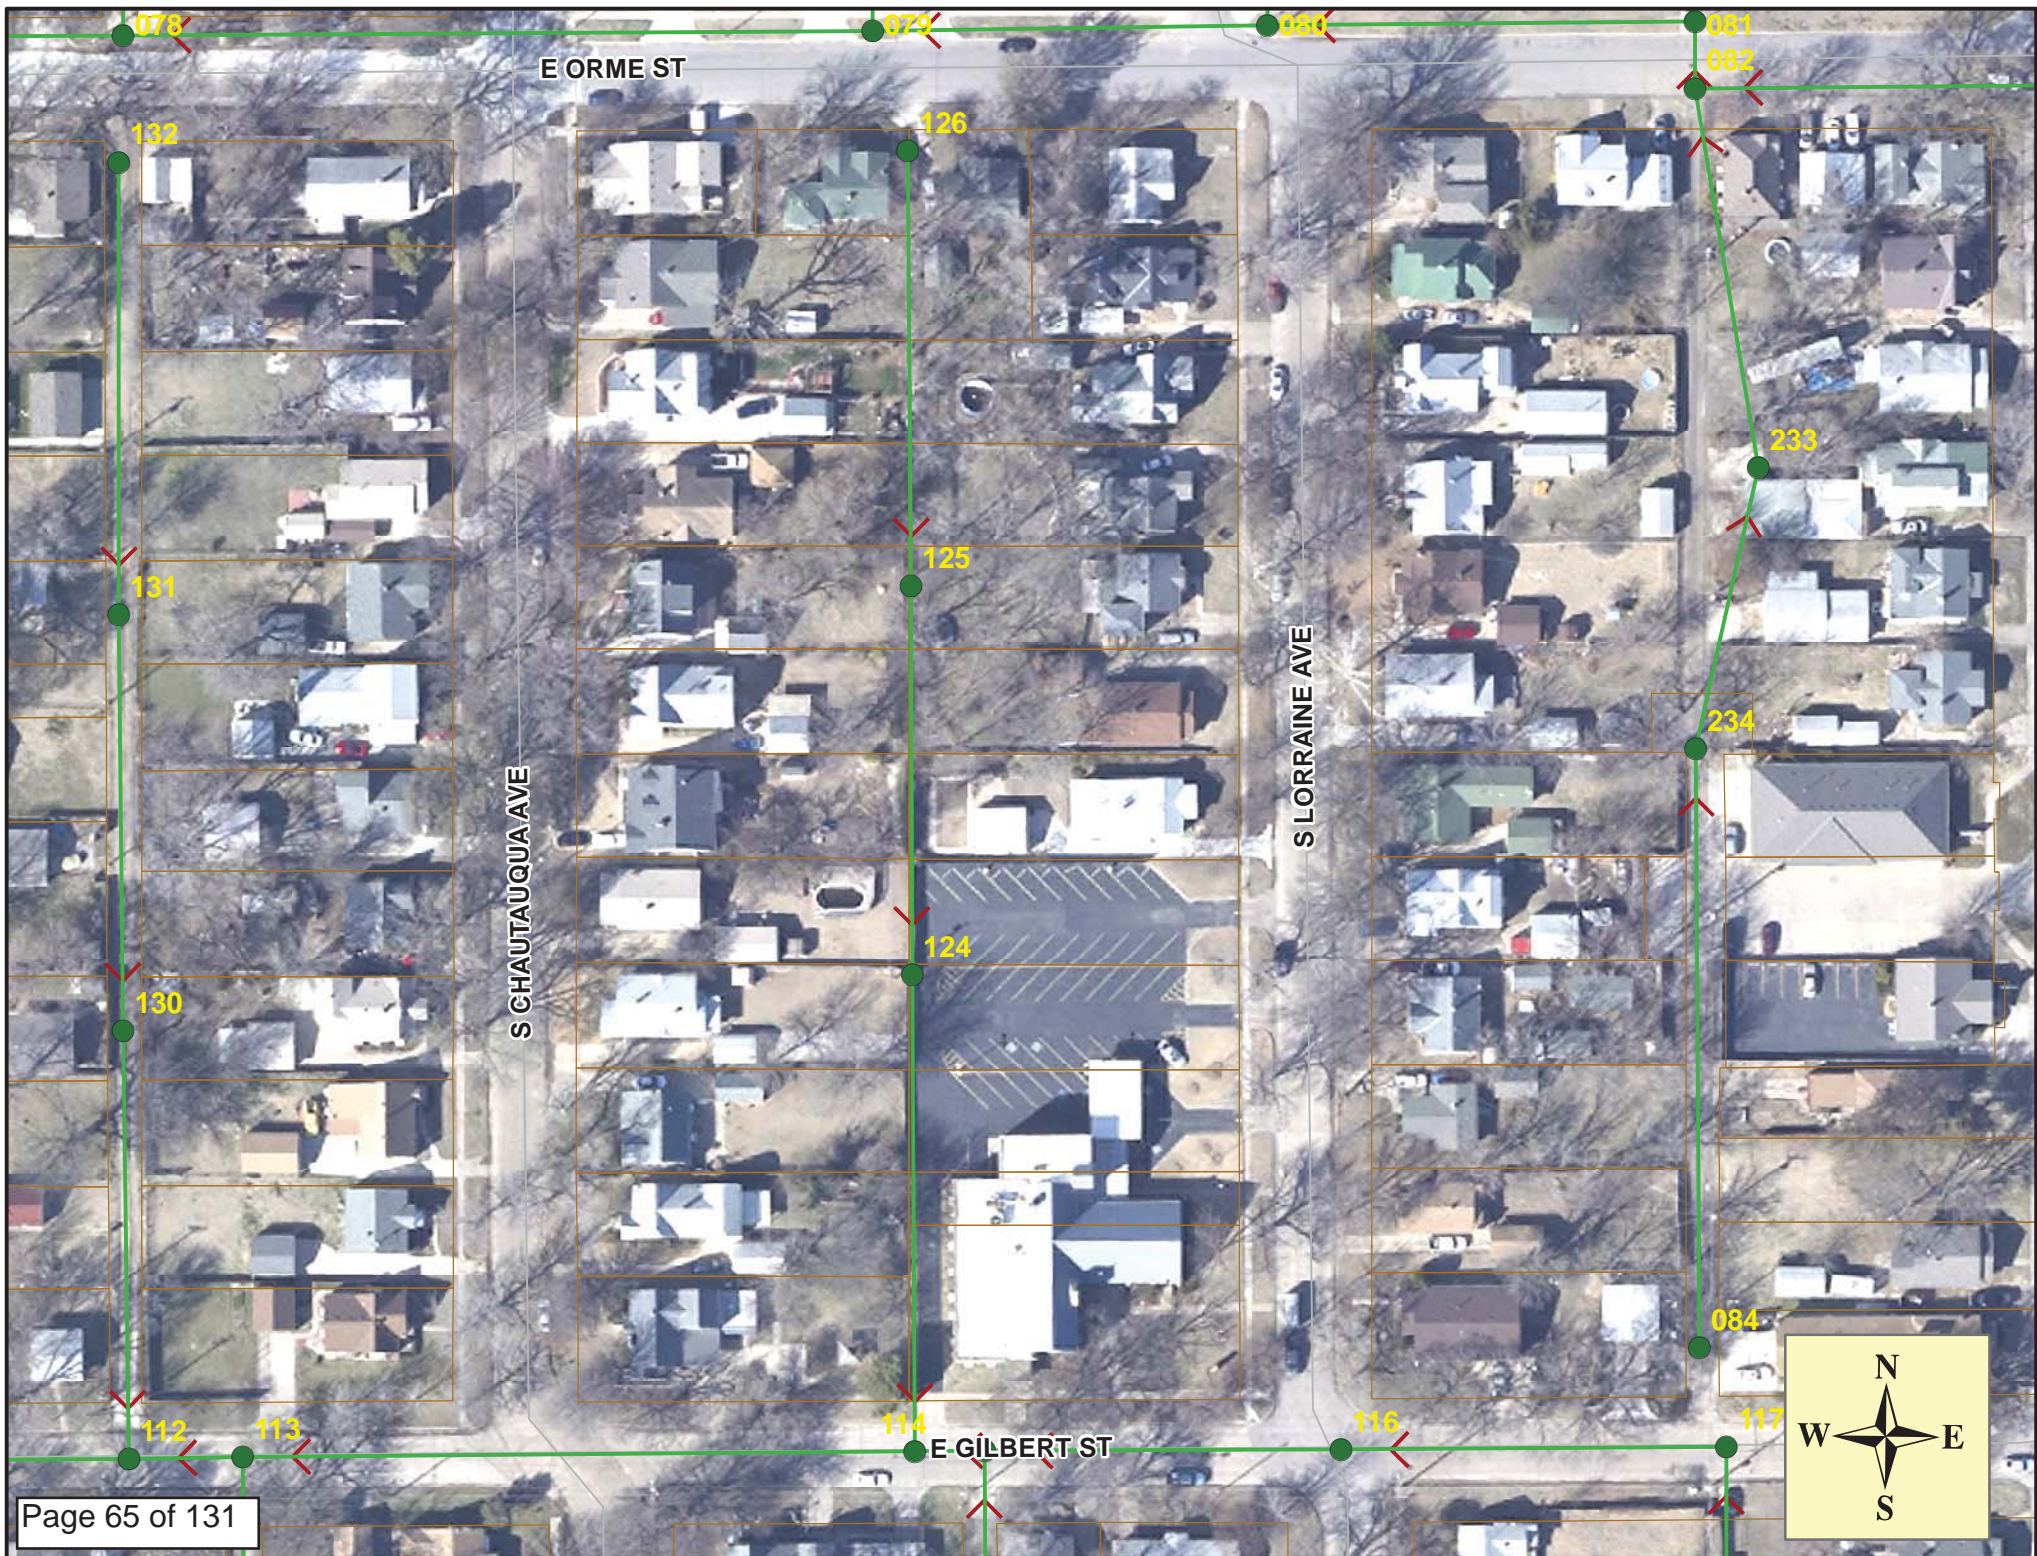
Obs. #	VTR Counter	Distance	Location	Description	Rating	Obsrvd (gpm)	Ratings			Remain (gpm)
							Est. (gpm)	Struct	Clean	
1		0.0	5646-126	US Manhole	1	0.000	0	0	0.000	
2		16.5		Sealed Off Wye	1	0.000	0	0	0.000	
3		18.8	3015 E ORME	Wye Service	5	0.000	400	0	0.000	
				(connection repaired by Sewer Maintenance since this televising)						
5		19.8		Crack-Radial	3	0.004	5	0	0.004	
6		31.2	3019 E ORME	Break-In Conn	5	0.010	400	0	0.010	
				(connection repaired by Sewer Maintenance since this televising)						
7		34.2	602 S CHAURAUQUA	Break-In Conn	5	0.010	400	0	0.010	
				(connection repaired by Sewer Maintenance since this televising)(main is 7.5' deep)						
8		37.5		Roots	2	0.004	2	4	0.004	
9		39.8		Roots	2	0.004	2	4	0.004	
10		40.4	604 S CHUAUTAUQUA	Break-In Conn / roots	5	0.010	400	0	0.010	
11		41.6		Sealed Off Wye	1	0.000	0	0	0.000	
12		42.5		Roots	2	0.004	2	4	0.004	
13		43.8		Sealed Off Wye	1	0.000	0	0	0.000

14		45.2		Roots	2	0.004	2	4	0.004	
15		47.5		Broken Pipe	4	0.030	78	0	0.030	
16		48.7	607 S LORRAINE	Break-In Conn / roots	5	0.010	400	0	0.010	
17		52.5		Roots	1	0.002	1	1	0.002	
18		66.9		Sealed Off Wye	1	0.000	0	0	0.000	
19		67.4		Roots	2	0.004	2	4	0.004	
20		68.5	616 S CHAUTAUQUA	Wye Service / roots	5	0.000	400	0	0.000	
21		76.7	611 S LORRAINE	Break-In Conn / roots	4	0.008	60	0	0.008	
22		80.4		Crack-Radial	2	0.002	2	0	0.002	
23		92.2		Sealed Off Wye	1	0.000	0	0	0.000	
24		94.6		Sealed Off Wye	1	0.000	0	0	0.000	
25		95.3		Crack-Radial	2	0.002	2	0	0.002	
26		100.4		Crack-Radial	4	0.008	10	0	0.008	
27		102.8		Crack-Radial	3	0.004	5	0	0.004	
28		105.7		Crack-Radial	3	0.004	5	0	0.004	
29		115.9		Sealed Off Wye	1	0.000	0	0	0.000	
30		118.4	615 S LORRAINE	Break-In Conn	4	0.008	60	0	0.008	
				(connection repaired by Sewer Maintenance since this televising)

31	119.8	618 S CHAUTAUQUA	Wye Service	3	0.000	2	0	0.000
		(connection repaired by Sewer Maintenance since this televising)						
32	128.3		Crack-Radial	2	0.002	2	0	0.002
33	130.5		Crack-Radial	3	0.004	5	0	0.004
34	135.9		Crack-Radial	1	0.001	1	0	0.001
35	142.4		Sealed Off Wye	1	0.000	0	0	0.000
36	144.8		Sealed Off Wye	1	0.000	0	0	0.000
37	153.4		Crack-Radial	3	0.004	5	0	0.004
38	155.9		Crack-Radial	1	0.001	1	0	0.001
39	158.4		Crack-Radial	3	0.004	5	0	0.004
40	161.1		Crack-Radial	3	0.004	5	0	0.004
41	163.4		Crack-Radial	2	0.002	2	0	0.002
42	165.9		Crack-Radial	2	0.002	2	0	0.002
43	167.7		Sealed Off Wye	1	0.000	0	0	0.000
44	168.5		Crack-Radial	3	0.004	5	0	0.004
45	170.1		Sealed Off Wye	1	0.000	0	0	0.000
46	176.2		Crack-Radial	2	0.002	2	0	0.002
47	178.6		Crack-Radial	2	0.002	2	0	0.002
48	183.6		Crack-Radial	3	0.004	5	0	0.004
49	193.0	621 S LORRAINE	Wye Service / roots	5	0.000	400	0	0.000
50	194.8	622 S CHAUTAUQUA	Wye Service / roots	5	0.000	400	0	0.000

51	198.6		Crack-Radial	3	0.004	5	0	0.004
52	201.2		Crack-Radial	3	0.004	5	0	0.004
53	203.9		Crack-Radial	3	0.004	5	0	0.004
54	209.0	5646-125	DS Manhole	1	0.000	0	0	0.000

Obs. #	VTR Counter	Distance	Location	Description	Rating	Obsrvd (gpm)	Ratings			Remain (gpm)
							Est. (gpm)	Struct	Clean	
1		0.0	5646-125	US Manhole	1		0.000	0	0	0.000
2		7.1	621 S LORRAINE	Break-In Conn	2		0.002	0	0	0.002
3		9.3		Crack-Radial	4		0.008	10	0	0.008
4		10.5	622 S CHAUTAUQUA	Wye Service	5		0.000	400	0	0.000
(connection repaired by Sewer Maintenance since this televising)(8.6' deep)										
6		11.9		Crack-Radial	4		0.008	10	0	0.008
7		16.8		Crack-Radial	4		0.008	10	0	0.008
8		19.3		Crack-Radial	3		0.004	5	0	0.004
9		21.9		Crack-Radial	3		0.004	5	0	0.004
10		27.0		Crack-Radial	3		0.004	5	0	0.004
11		31.9		Crack-Radial	3		0.004	5	0	0.004
12		33.6		Sealed Off Wye	1		0.000	0	0	0.000
13		34.3		Crack-Radial	3		0.004	5	0	0.004
14		35.8		Sealed Off Wye	1		0.000	0	0	0.000
15		36.8		Crack-Radial	2		0.002	2	0	0.002
16		39.5		Crack-Radial	2		0.002	2	0	0.002
17		44.5		Crack-Radial	2		0.002	2	0	0.002
18		47.0		Crack-Radial	3		0.004	5	0	0.004

19		57.9	627 S LORRAINE	Wye Service / roots	5		0.000	400	0	0.000
20		60.4		Sealed Off Wye	1		0.000	0	0	0.000
21		64.6	628 S CHAUTAUQUA	Break-In Conn	3		0.004	2	0	0.004
(connection repaired by Sewer Maintenance since this televising)										
22		72.1		Crack-Radial	3		0.004	5	0	0.004
23		83.2		Sealed Off Wye	1		0.000	0	0	0.000
24		85.1		Sealed Off Wye	1		0.000	0	0	0.000
25		94.9		Crack-Radial	2		0.002	2	0	0.002
26		100.0		Crack-Radial	3		0.004	5	0	0.004
27		109.4	633 S LORRAINE	Wye Service	1		0.000	0	0	0.000
28		110.3	634 S CHAUTAUQUA	Break-In Conn	2		0.002	0	0	0.002
(connection repaired by Sewer Maintenance since this televising)										
29		112.7		Crack-Radial	3		0.004	5	0	0.004
30		115.2		Crack-Radial	3		0.004	5	0	0.004

31	117.7		Crack-Radial	3	0.004	5	0	0.004
32	122.9		Crack-Radial	3	0.004	5	0	0.004
33	134.4		Sealed Off Wye	1	0.000	0	0	0.000
34	135.9		Crack-Radial	2	0.002	2	0	0.002
35	136.6	638 S CHAUTAUQUA	Wye Service	1	0.000	0	0	0.000
36	137.9		Crack-Radial	3	0.004	5	0	0.004
37	148.0		Crack-Radial	2	0.002	2	0	0.002
38	158.5		Sealed Off Wye	1	0.000	0	0	0.000
39	161.6		Sealed Off Wye	1	0.000	0	0	0.000
40	183.8		Break-In Conn	1	0.001	0	0	0.001
41	185.8		Crack-Radial	3	0.004	5	0	0.004
42	187.7		Sealed Off Wye	1	0.000	0	0	0.000
43	195.9		Crack-Radial	3	0.004	5	0	0.004
44	198.0	642 S CHAUTAUQUA	Break-In Conn	1	0.001	0	0	0.001
45	199.0		Broken Pipe	5	0.060	100	0	0.060
46	203.8	5646-124	DS Manhole	1	0.000	0	0	0.000

Obs. #	VTR Counter	Distance	Location	Description	Rating	Obsrvd (gpm)	Ratings			Remain (gpm)
							Est. (gpm)	Struct	Clean	
1		0.0	5646-124	US Manhole	1	0.000	0	0	0.000	
2		7.1		Wye Service / possibly abandoned	2	0.000	0	0	0.000	
3		9.6		Sealed Off Wye	1	0.000	0	0	0.000	
4		10.2		Crack-Radial	3	0.004	5	0	0.004	
5		13.0		Crack-Radial	3	0.004	5	0	0.004	
6		25.5		Crack-Radial	3	0.004	5	0	0.004	
7		28.2		Crack-Radial	3	0.004	5	0	0.004	
8		32.4		Sealed Off Wye	1	0.000	0	0	0.000	
9		32.9		Crack-Radial	3	0.004	5	0	0.004	
10		35.1		Sealed Off Wye	1	0.000	0	0	0.000	
11		43.2		Crack-Radial	3	0.004	5	0	0.004	
12		48.3		Crack-Radial	3	0.004	5	0	0.004	
13		53.3		Crack-Radial	2	0.002	2	0	0.002	
14		57.6		Wye Service / possibly abandoned	1	0.000	0	0	0.000	
15		58.3		Crack-Radial	3	0.004	5	0	0.004	
16		60.3		Sealed Off Wye	1	0.000	0	0	0.000	
17		63.5		Crack-Radial	3	0.004	5	0	0.004	
18		66.1		Crack-Radial	3	0.004	5	0	0.004

19		69.0		Crack-Radial	2	0.002	2	0	0.002	
20		71.2		Crack-Radial	3	0.004	5	0	0.004	
21		78.7		Crack-Radial	2	0.002	2	0	0.002	
22		82.6		Sealed Off Wye	1	0.000	0	0	0.000	
23		84.8	648 S CHAUTAUQUA	Break-In Conn	1	0.001	0	0	0.001	
				(connection repaired by Sewer Maintenance since this televising)						
24		88.7		Crack-Radial	3	0.004	5	0	0.004	
25		96.5		Crack-Radial	3	0.004	5	0	0.004	
26		107.0	655 S LORRAINE	Wye Service	1	0.000	0	0	0.000	
27		110.9		Sealed Off Wye	1	0.000	0	0	0.000	
28		112.4	654 S CHAUTAUQUA	Wye Service	3	0.000	2	0	0.000	
				(connection repaired by Sewer Maintenance since this televising)						
29		114.3		Crack-Radial	4	0.008	10	0	0.008	
30		129.3		Crack-Radial	3	0.004	5	0	0.004	
31		133.8	655 S LORRAINE	Wye Service	1	0.000	0	0	0.000

32	136.0		Sealed Off Wye	1	0.000	0	0	0.000
33	142.1		Crack-Radial	3	0.004	5	0	0.004
34	144.5		Crack-Radial	3	0.004	5	0	0.004
35	152.2		Crack-Radial	2	0.002	2	0	0.002
36	154.6		Crack-Radial	1	0.001	1	0	0.001
37	159.0		Sealed Off Wye	1	0.000	0	0	0.000
38	161.4		Sealed Off Wye	1	0.000	0	0	0.000
39	162.3	656 S CHAUTAUQUA	Break-In Conn	4	0.008	60	0	0.008
		(connection repaired by Sewer Maintenance since this televising)						
40	177.4		Crack-Radial	4	0.008	10	0	0.008
41	184.2		Sealed Off Wye	1	0.000	0	0	0.000
42	185.0		Crack-Radial	3	0.004	5	0	0.004
43	186.6		Sealed Off Wye	1	0.000	0	0	0.000
44	187.4		Crack-Radial	3	0.004	5	0	0.004
45	190.0		Crack-Radial	3	0.004	5	0	0.004
46	192.4		Crack-Radial	3	0.004	5	0	0.004
47	202.6		Crack-Radial	3	0.004	5	0	0.004
48	205.2		Crack-Radial	3	0.004	5	0	0.004
49	210.0		Crack-Radial	3	0.004	5	0	0.004
50	213.5	5646-114	DS Manhole	1	0.000	0	0	0.000

The video recording stopped at 112 ft and the remainder was not available for inspection by office staff. -LML

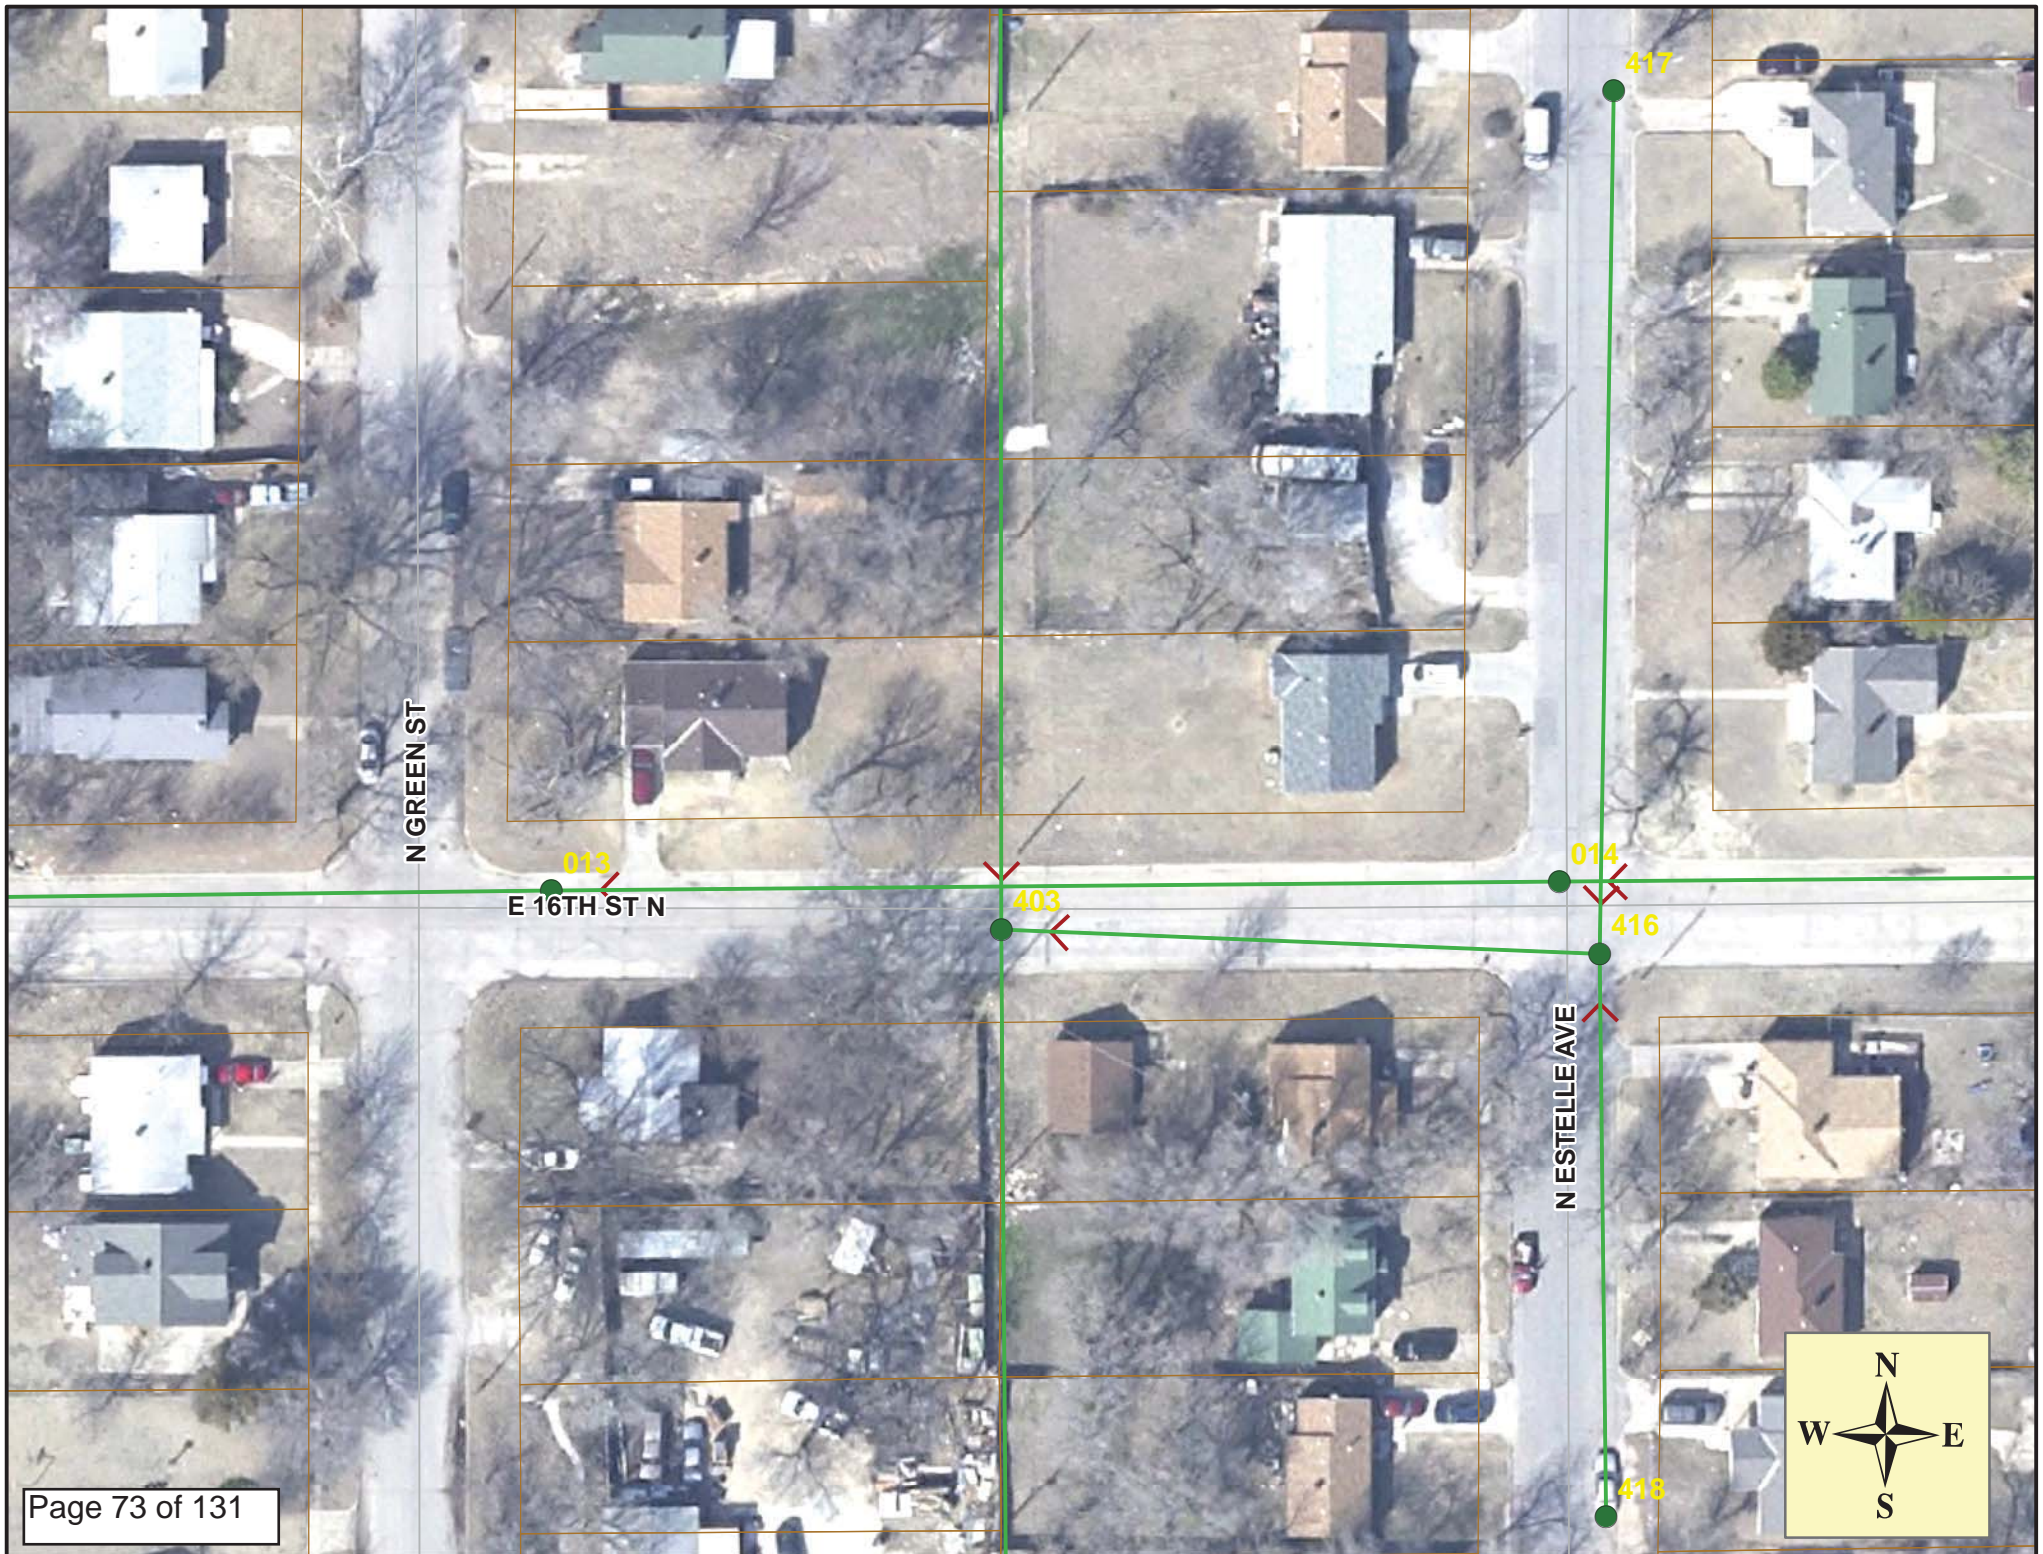
MH 5649-403
Approx depth = 9.6 ft

MH 5649-416
Approx depth = 8.5 ft

Obs. #	VTR Counter	Distance	Location	Description	Rating	Obsrvd (gpm)	Ratings		Remain (gpm)
							Est. (gpm)	Struct Clean	
1		0.8		5649-416 US Manhole	1				
2		0.0	Joint	Offset	3				
3		0.0	Joint	Offset	3				
4		1.0		Crack-Radial	3				
5		7.4		Crack-Radial	3				
6		9.6	Joint	Offset	2				
7		12.4		Crack-Radial	2				
8		17.0		Crack-Radial	2				
9		19.7		Crack-Radial	3				
10		22.0	Joint	Offset	2				
11		24.7		Crack-Radial	3				
12		27.1	Joint	Offset	3				
13		29.8	Joint	Offset	2				
14		32.3	Joint	Offset	2				
15		32.3		Roots	3				
16		34.8		Crack-Radial	2				
17		34.8	Joint	Offset	2				
18		39.7	Joint	Offset	3				
19		42.2		Crack-Radial	3				
20		49.7	Joint	Offset	3				
21		52.4		Crack-Radial	2				
22		55.0		Crack-Radial	2				
23		57.1	Joint	Offset	3				
24		60.0		Crack-Radial	2				
25		62.2		Crack-Radial	3				
26		64.6	Joint	Offset	3				
27		67.4		Crack-Radial	2				
28		69.7	Joint	Offset	2				
29		77.1	Joint	Offset	3

30		81.7		Crack-Horizontal	2				
31		82.1	Joint	Offset	3				
32		82.5		Crack-Radial	3				
33		84.9		Crack-Radial	2				
34		87.2		Crack-Radial	2				
35		87.2	Joint	Offset	2				
36		94.9	Joint	Offset	3				
37		95.3		Crack-Radial	3				
38		99.7	Joint	Offset	3				
39		102.5	Joint	Offset	2				
40		107.2	Joint	Offset	2

41	110.0		Crack-Radial	2
42	114.8		Crack-Radial	2
43	117.6		Broken Pipe	2
44	124.7	Joint	Offset	3
45	124.8		Crack-Radial	2
46	135.0		Crack-Radial	3
47	137.2	Joint	Offset	2
48	139.9		Crack-Radial	3
49	142.3	Joint	Offset	2
50	147.4	Joint	Offset	2
51	147.6		Crack-Radial	3
52	149.8	Joint	Offset	2
53	152.2	Joint	Offset	2
54	157.3		Crack-Radial	2
55	159.6	Joint	Offset	2
56	162.4	Joint	Offset	3
57	164.7	Joint	Offset	3
58	165.1		Crack-Radial	3
59	167.3	Offset Joint with cracks OK to install CIPP - LML	Broken Pipe	5
60	169.6	5649-403	DS Manhole	3

No taps on the line.
 Line has a history of high maintenance.
 -LML

Install 170 lf of 8"
Cured-in-Place Liner
