Install 633 lf of 8" Cured-in-Place Liner
from MH 5846-259 to MH 5846-257

SITE 11

Video Inspection Master Report

SITE 12

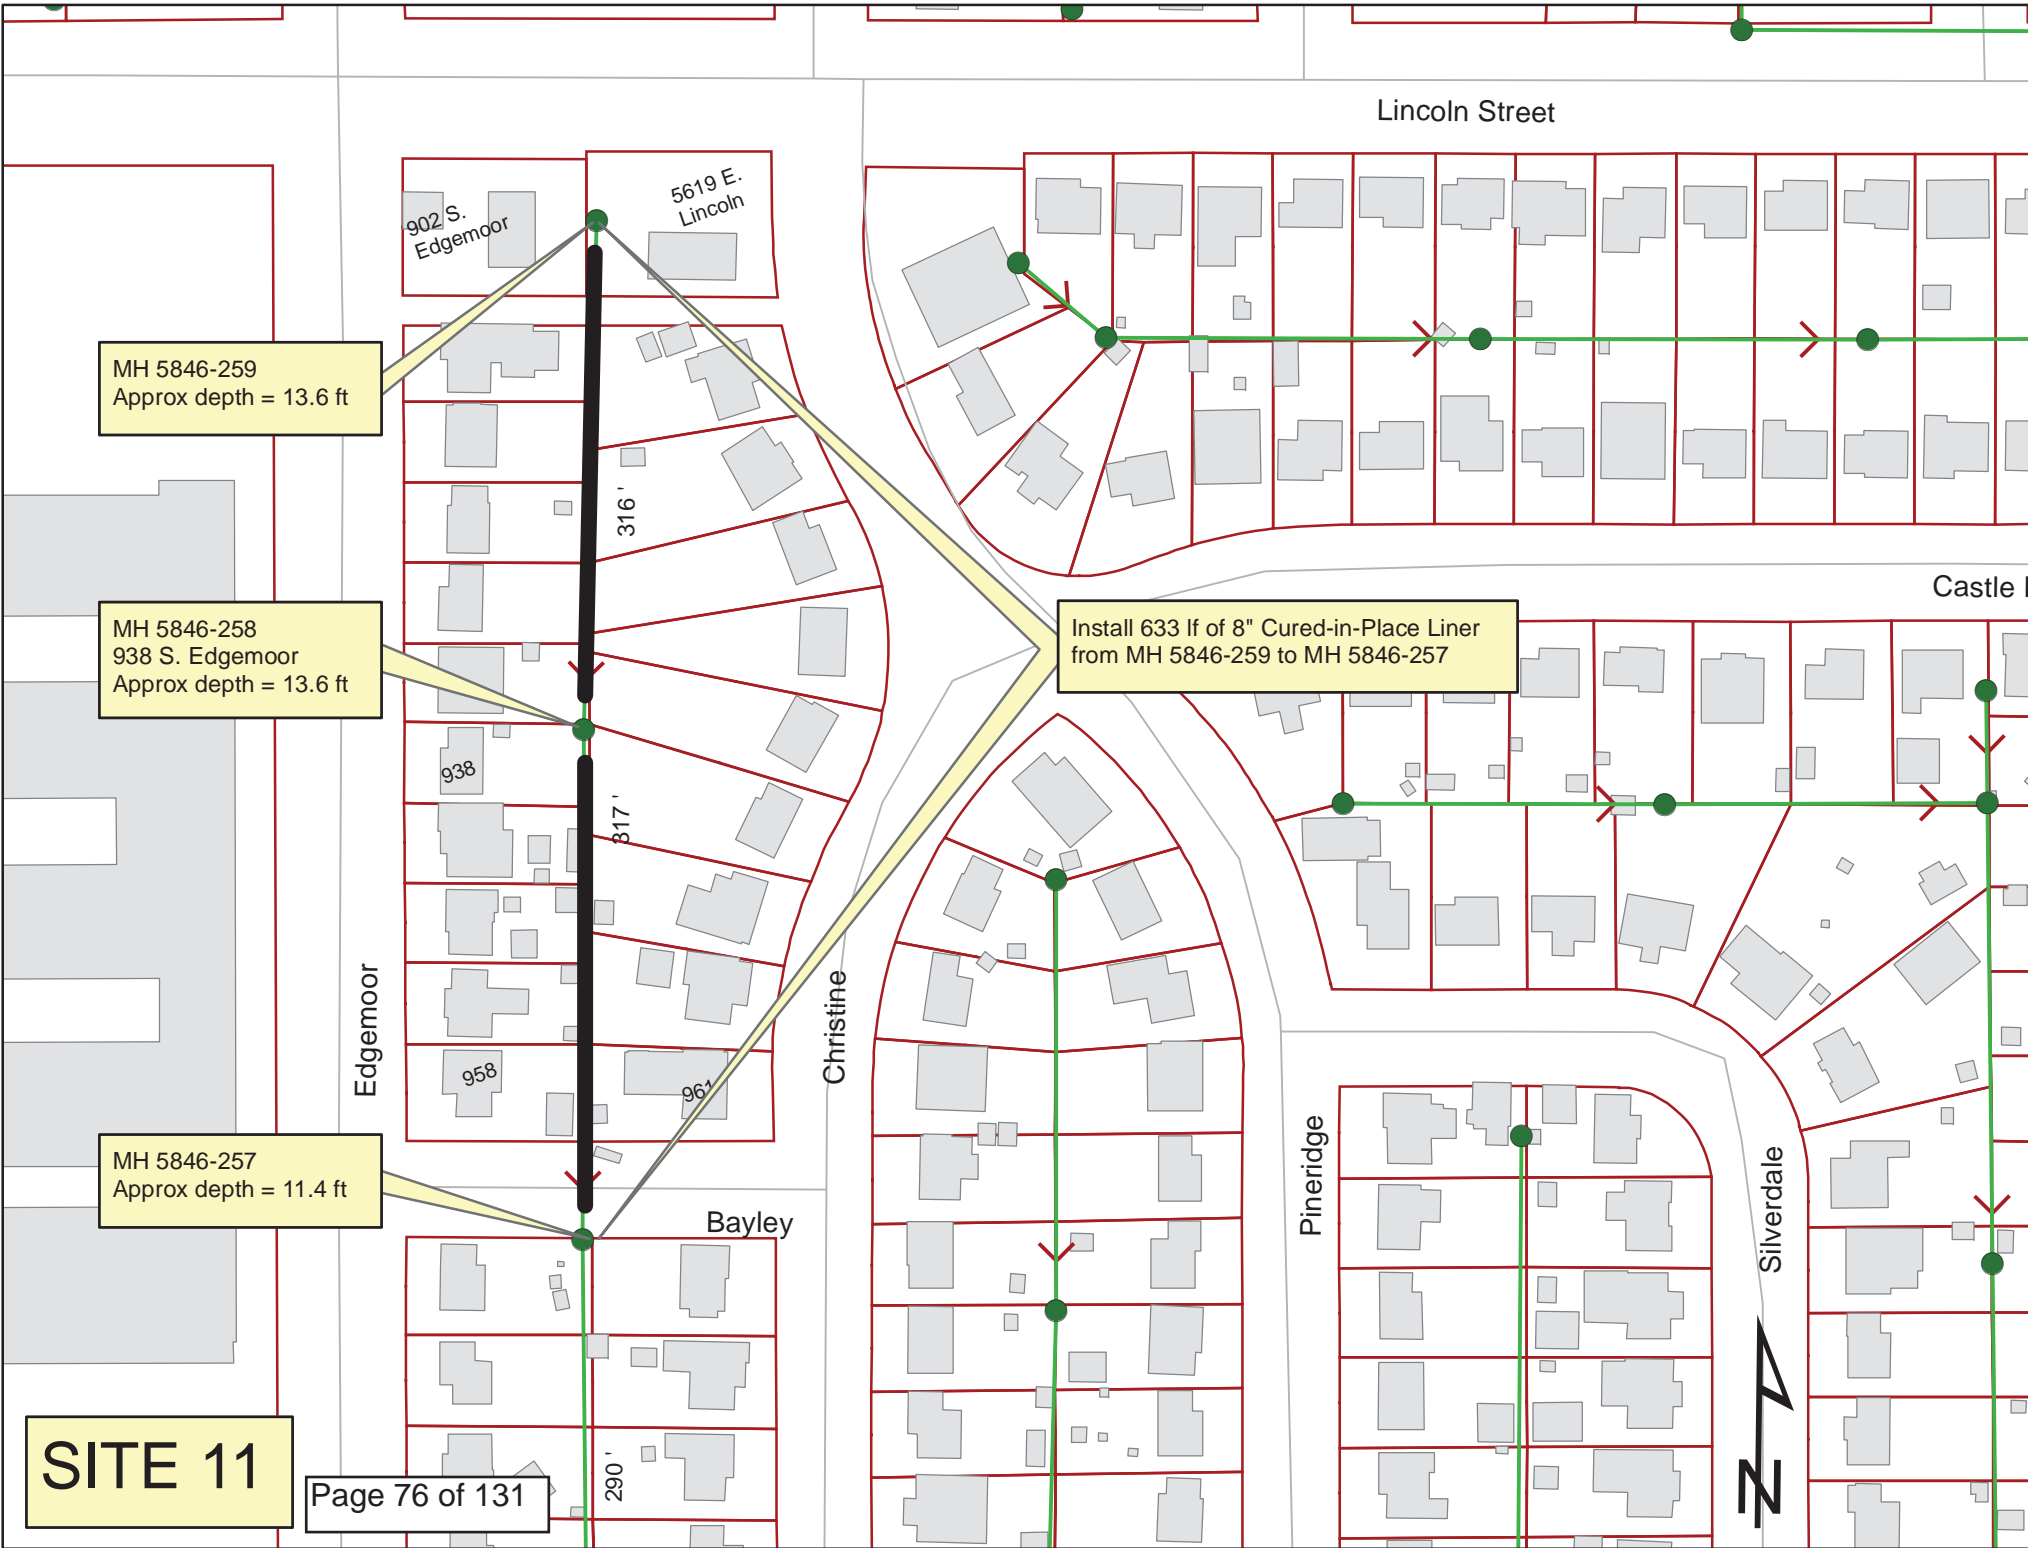
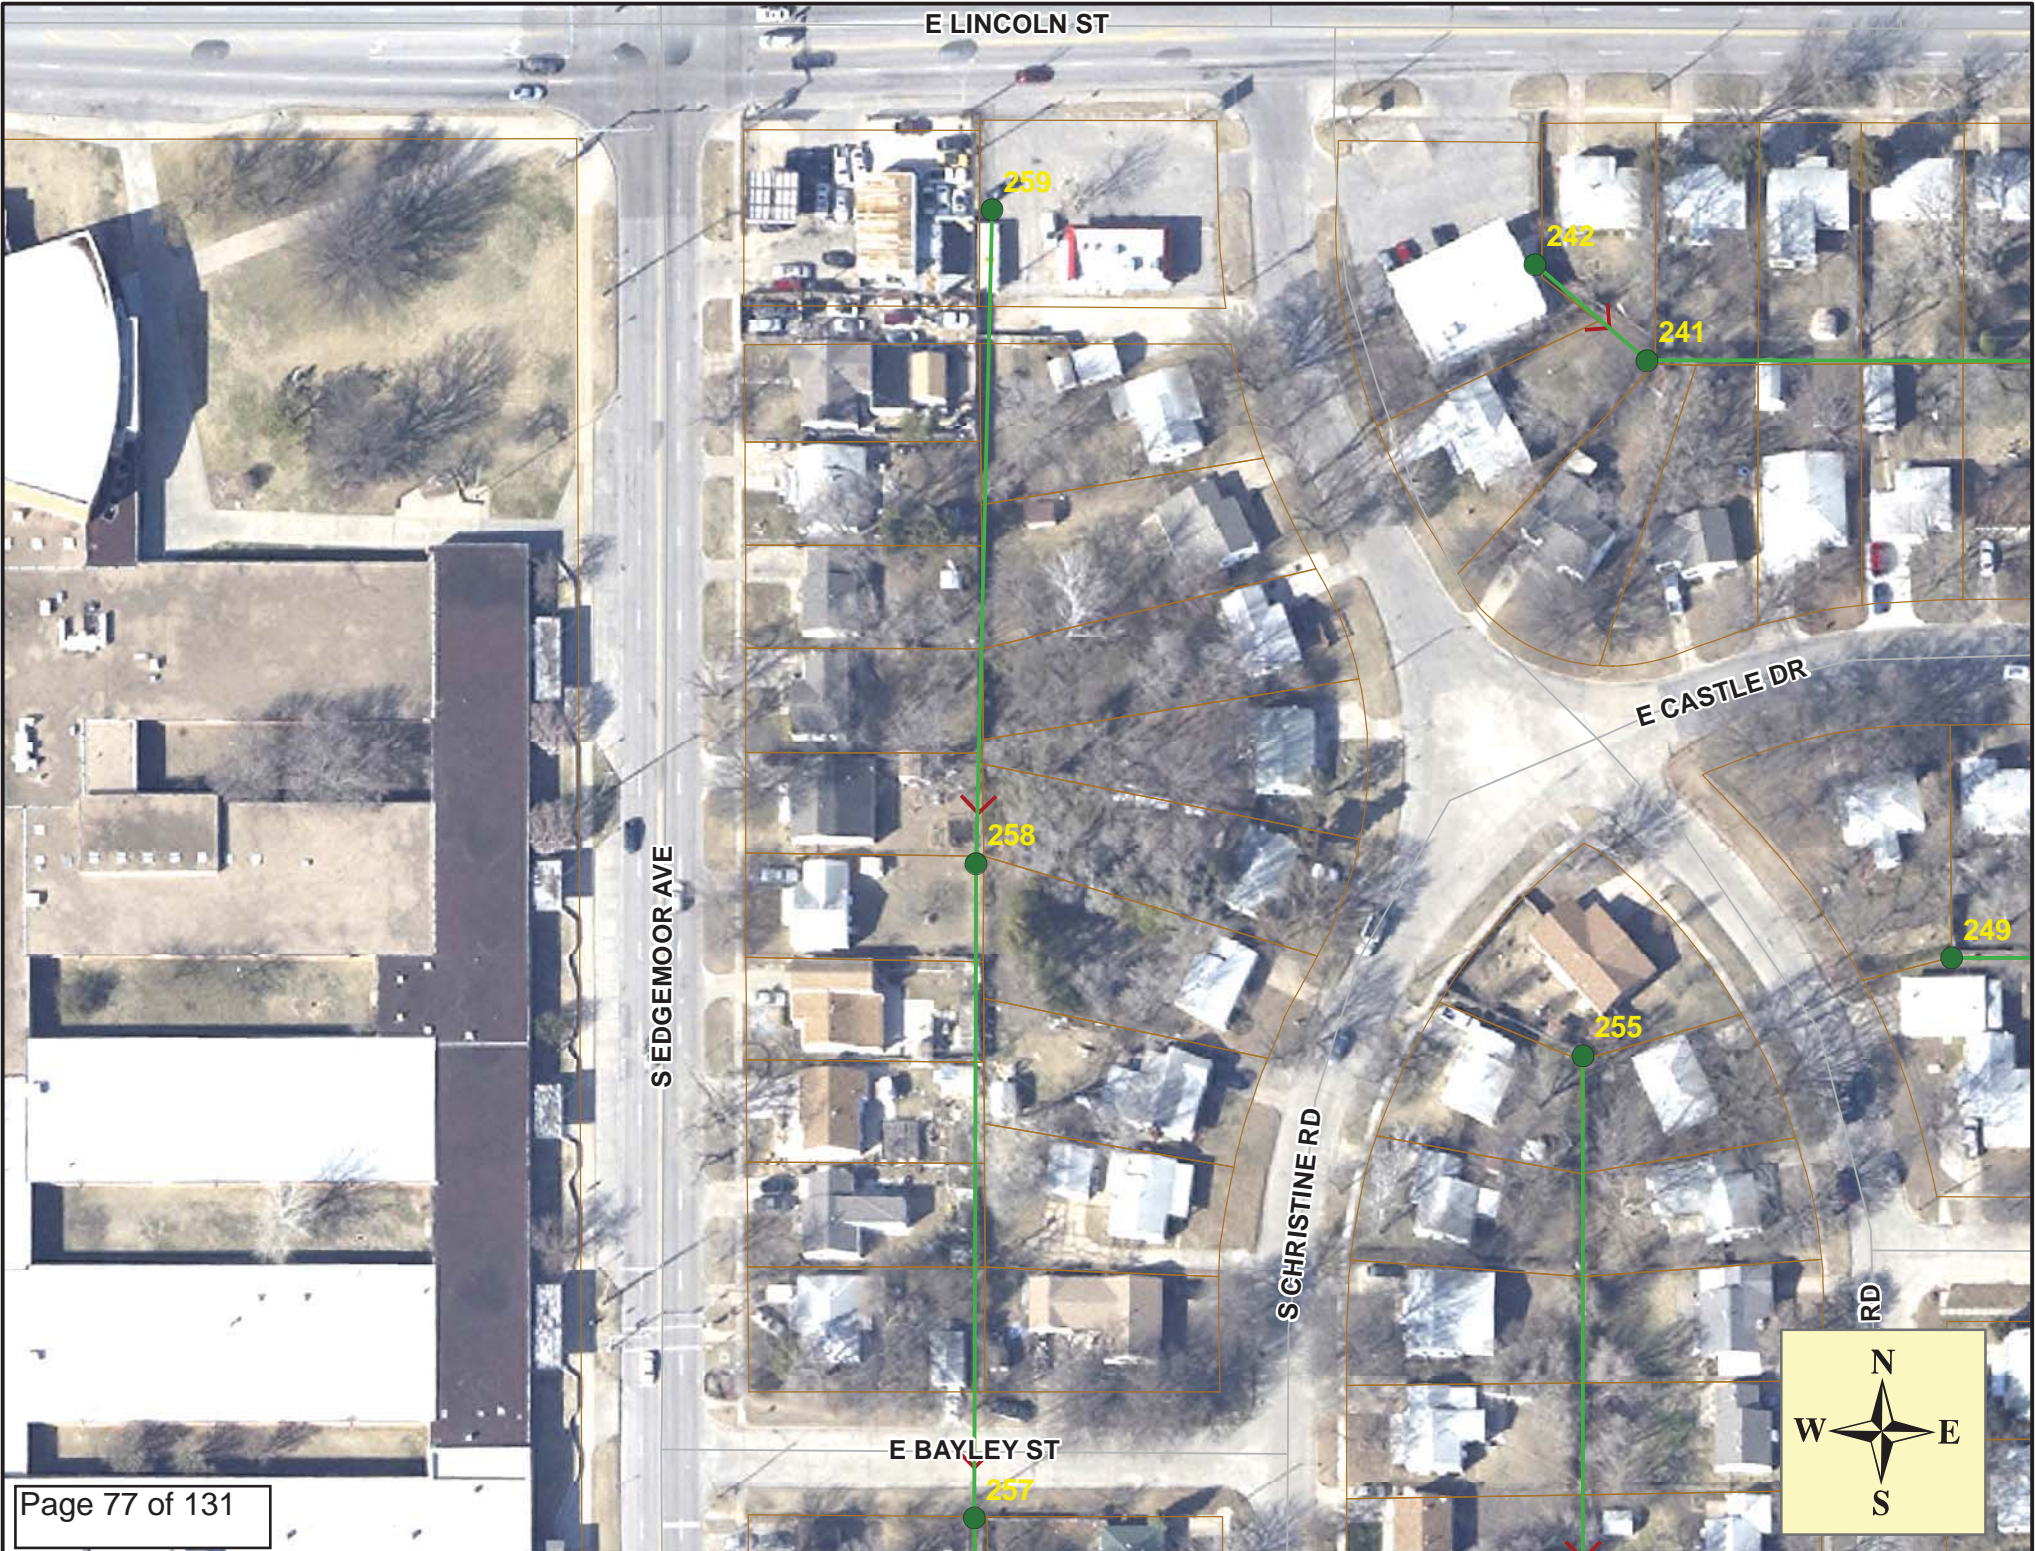
MH 5846-259
Approx depth = 13.6 ft

MH 5846-258
938 S. Edgemoor
Approx depth = 13.6 ft

MH 5846-257
Approx depth = 11.4 ft

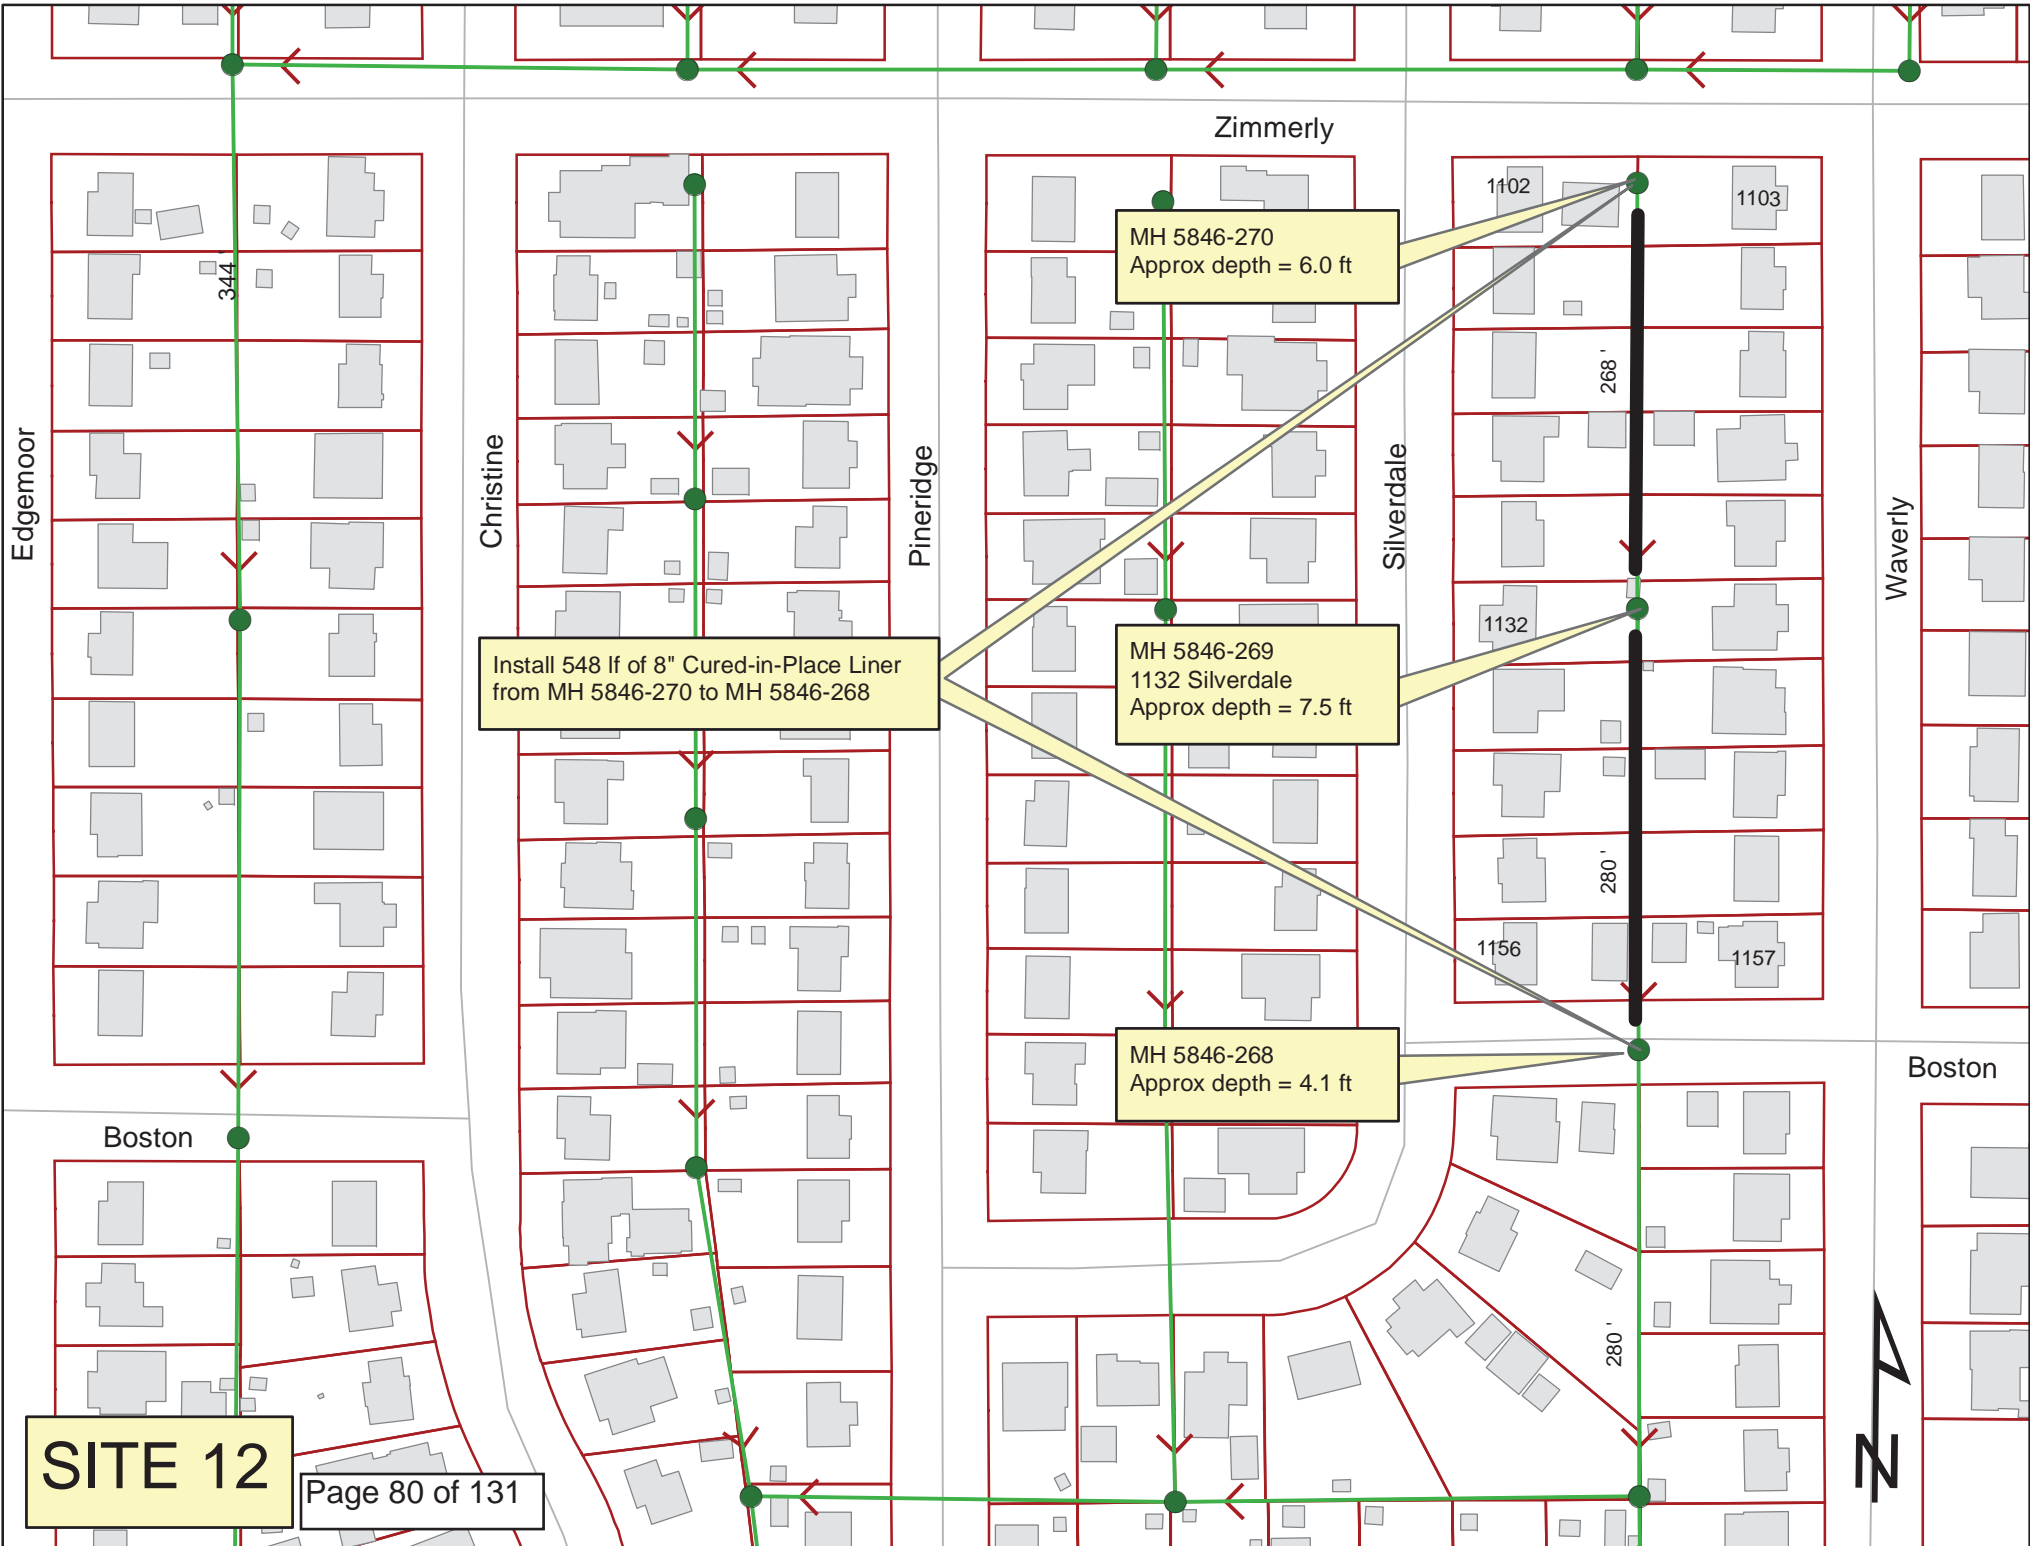
MH 5846-270
Approx depth = 6.0 ft

MH 5846-269
1132 Silverdale
Approx depth = 7.5 ft

MH 5846-268
Approx depth = 4.1 ft

Install 548 lf of 8" Cured-in-Place Liner
from MH 5846-270 to MH 5846-268
