Install 609 lf of 8" Cured-in-Place Liner from MH 5846-278 to MH 5846-275

SITE 13

Install 265 lf of 8" Cured-in-Place Liner

SITE 14

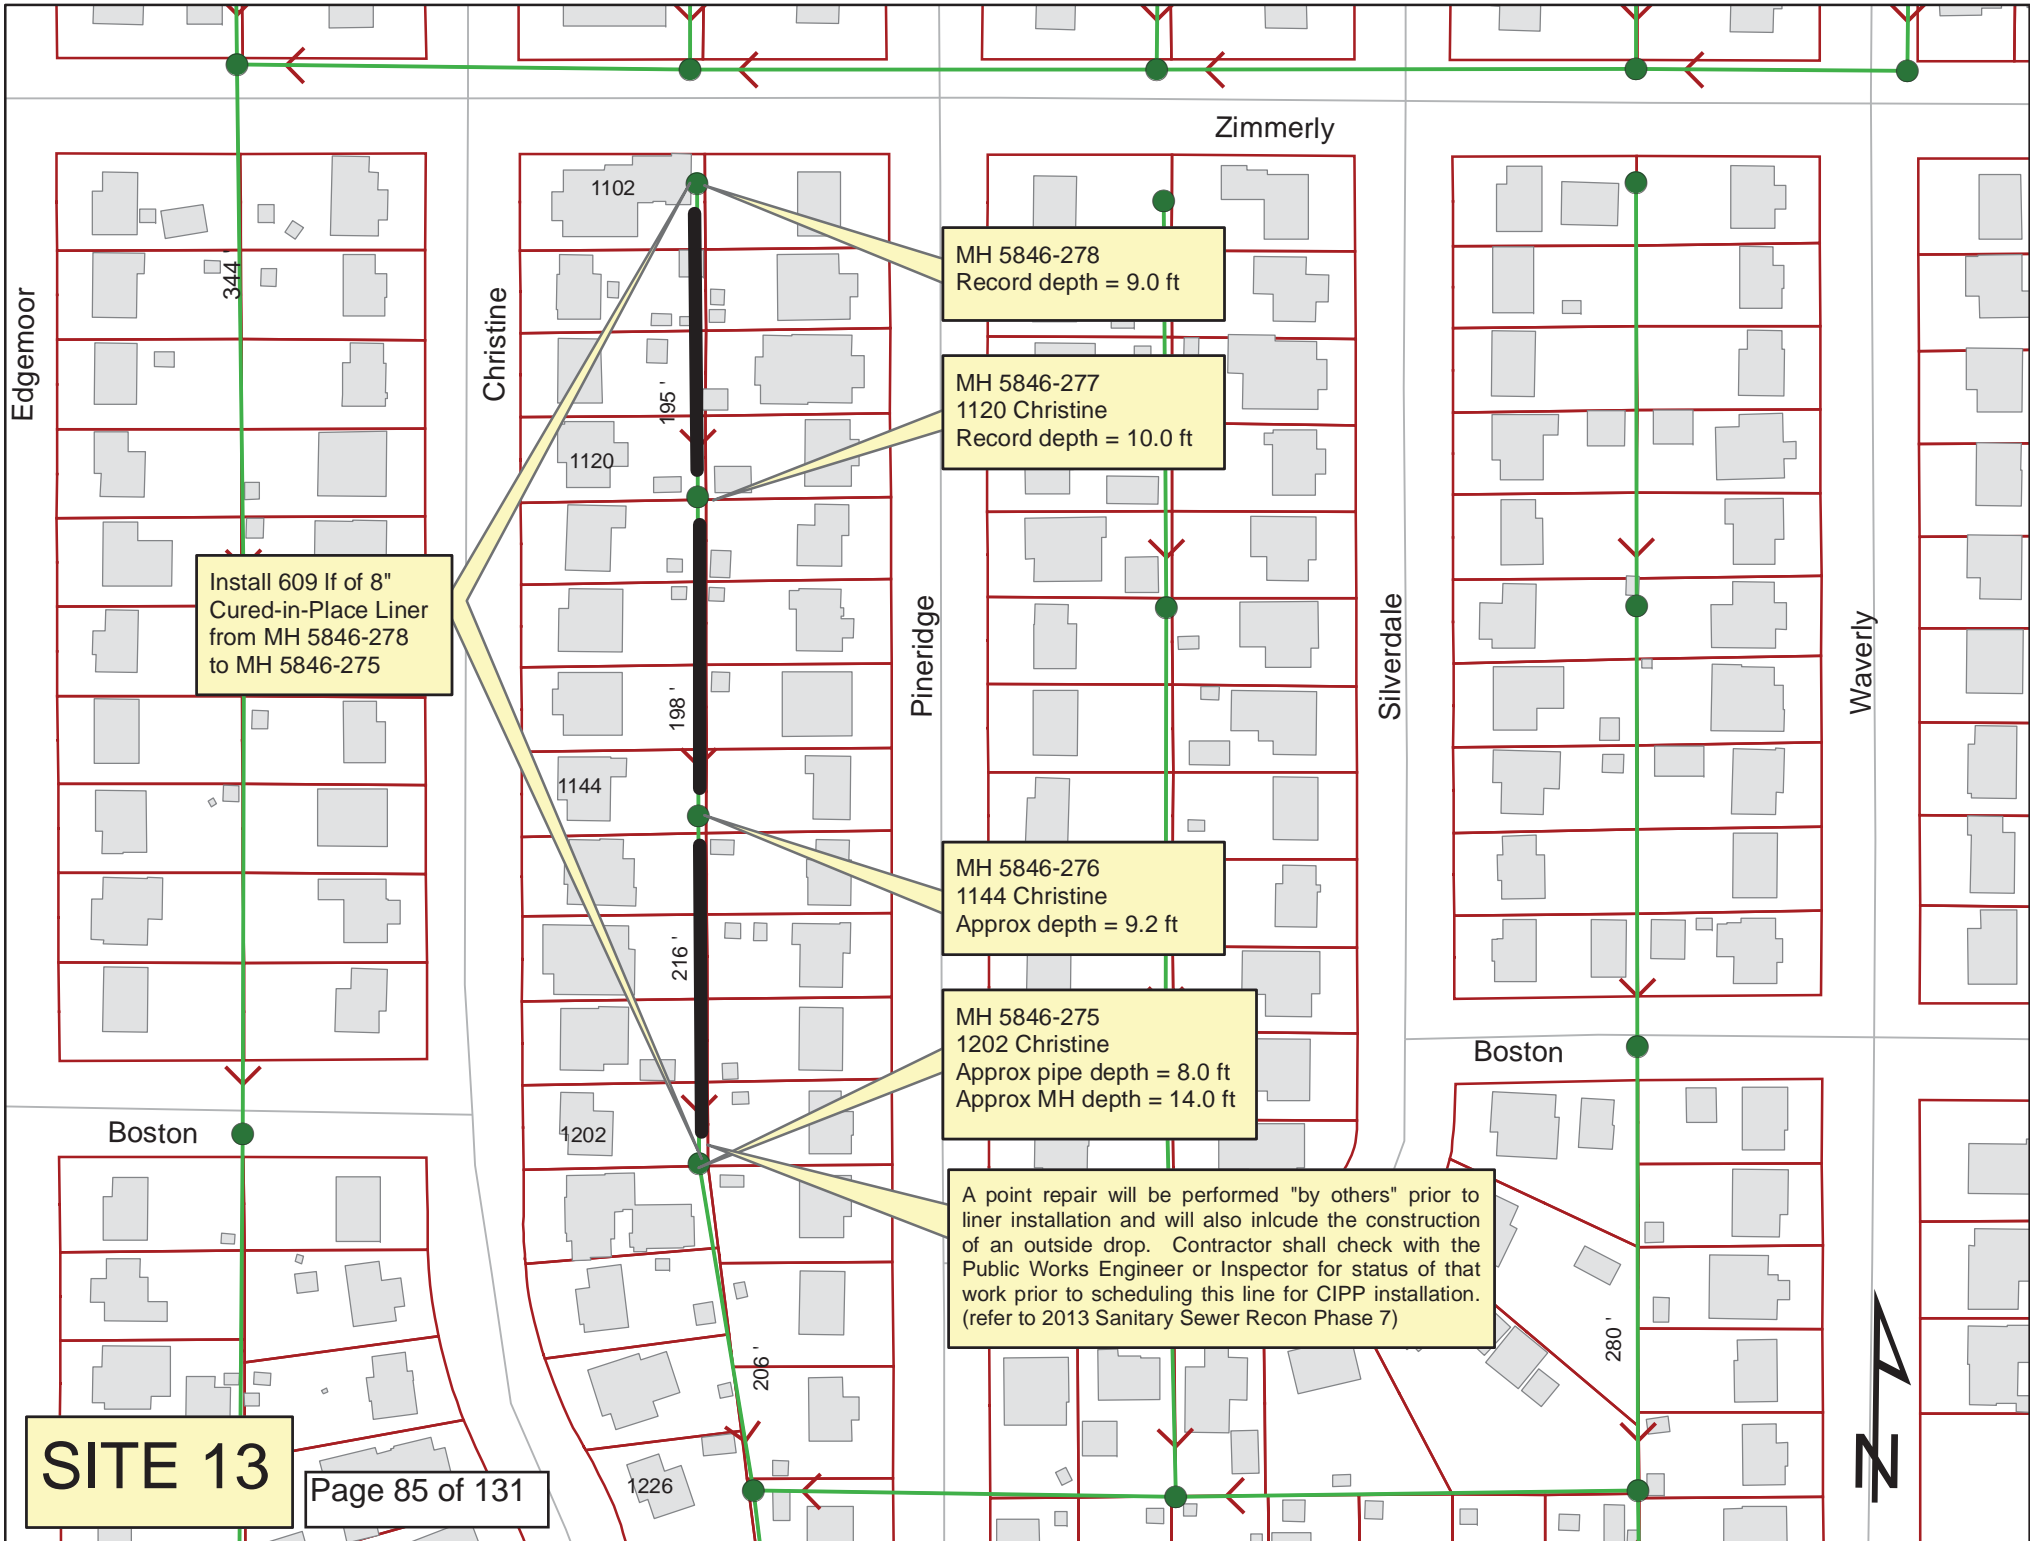
MH 5846-278
Record depth = 9.0 ft

MH 5846-277
1120 Christine
Record depth = 10.0 ft

MH 5846-276
1144 Christine
Approx depth = 9.2 ft

MH 5846-275
1202 Christine
Approx pipe depth = 8.0 ft
Approx MH depth = 14.0 ft

A point repair will be performed "by others" prior to liner installation and will also include the construction of an outside drop. Contractor shall check with the Public Works Engineer or Inspector for status of that work prior to scheduling this line for CIPP installation. (refer to 2013 Sanitary Sewer Recon Phase 7)

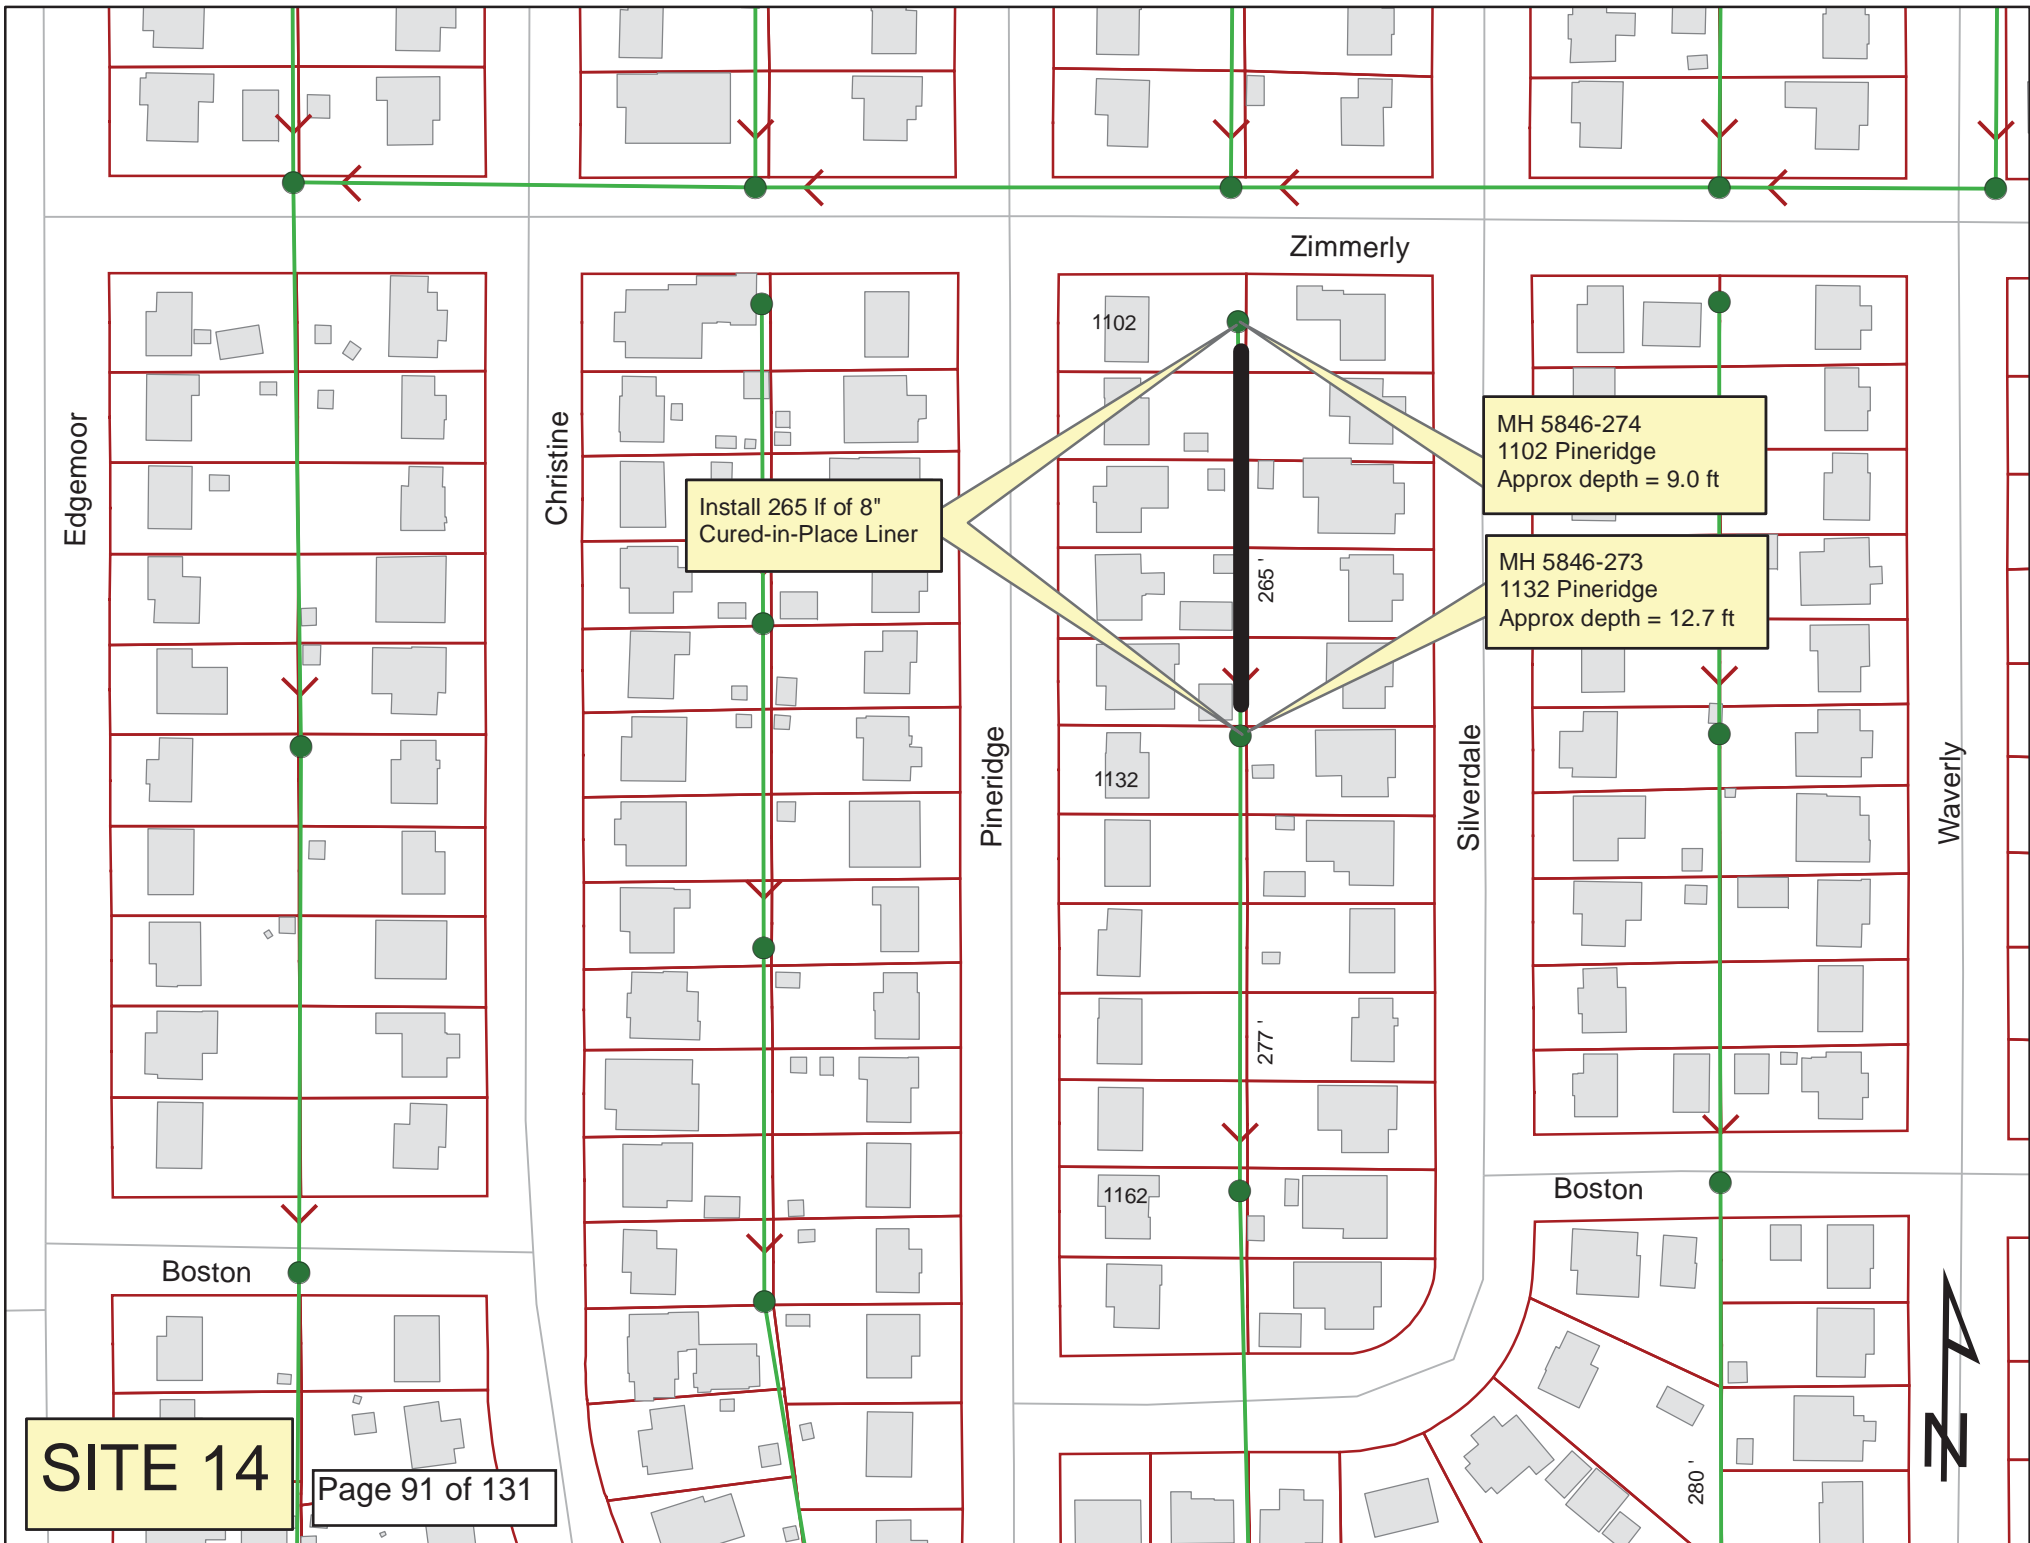
MH 5846-274
1102 Pineridge
Approx depth = 9.0 ft

MH 5846-273
1132 Pineridge
Approx depth = 12.7 ft

7-23-13: Sewer Maintenance will do a point repair on the north side of MH 5846-273. Pipe should be OK for liner installation after that. -LML

8-8-13: Sewer Maintenance has completed the repair. The next segment south of MH 5846-273 is scheduled for open cut replacement. - LML
