Install 631 lf of 8" Cured-in-Place Liner
from MH 5846-032 to MH 5846-030

SITE 19

Video Inspection Master Report

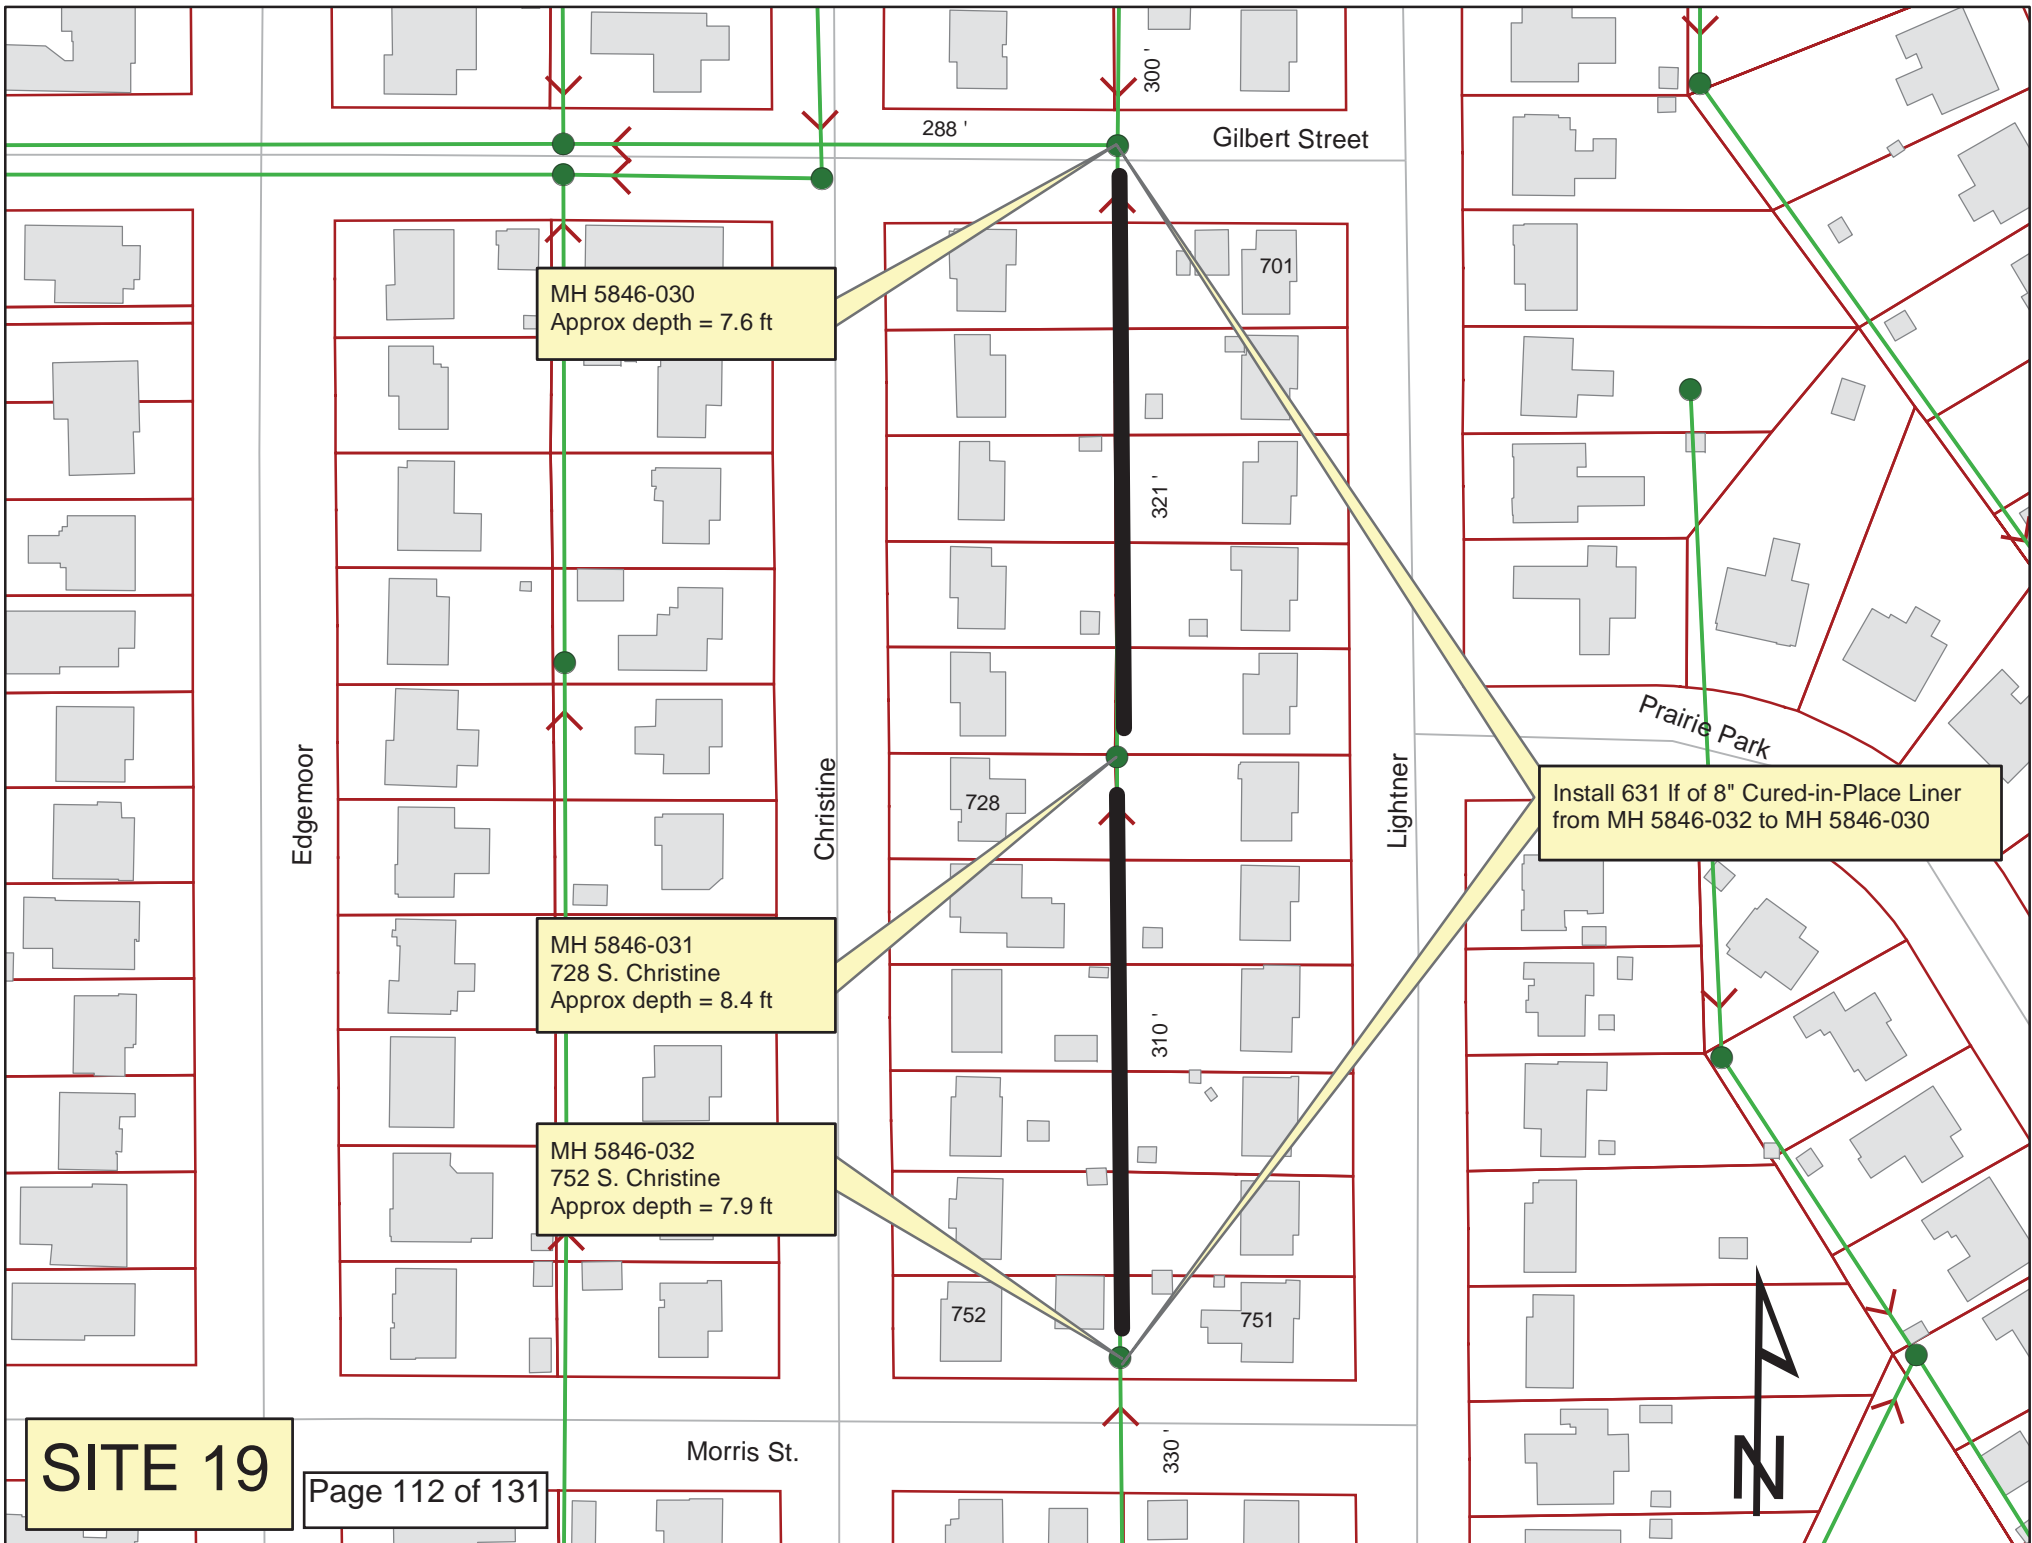
MH 5846-030
Approx depth = 7.6 ft

MH 5846-031
728 S. Christine
Approx depth = 8.4 ft

MH 5846-032
752 S. Christine
Approx depth = 7.9 ft

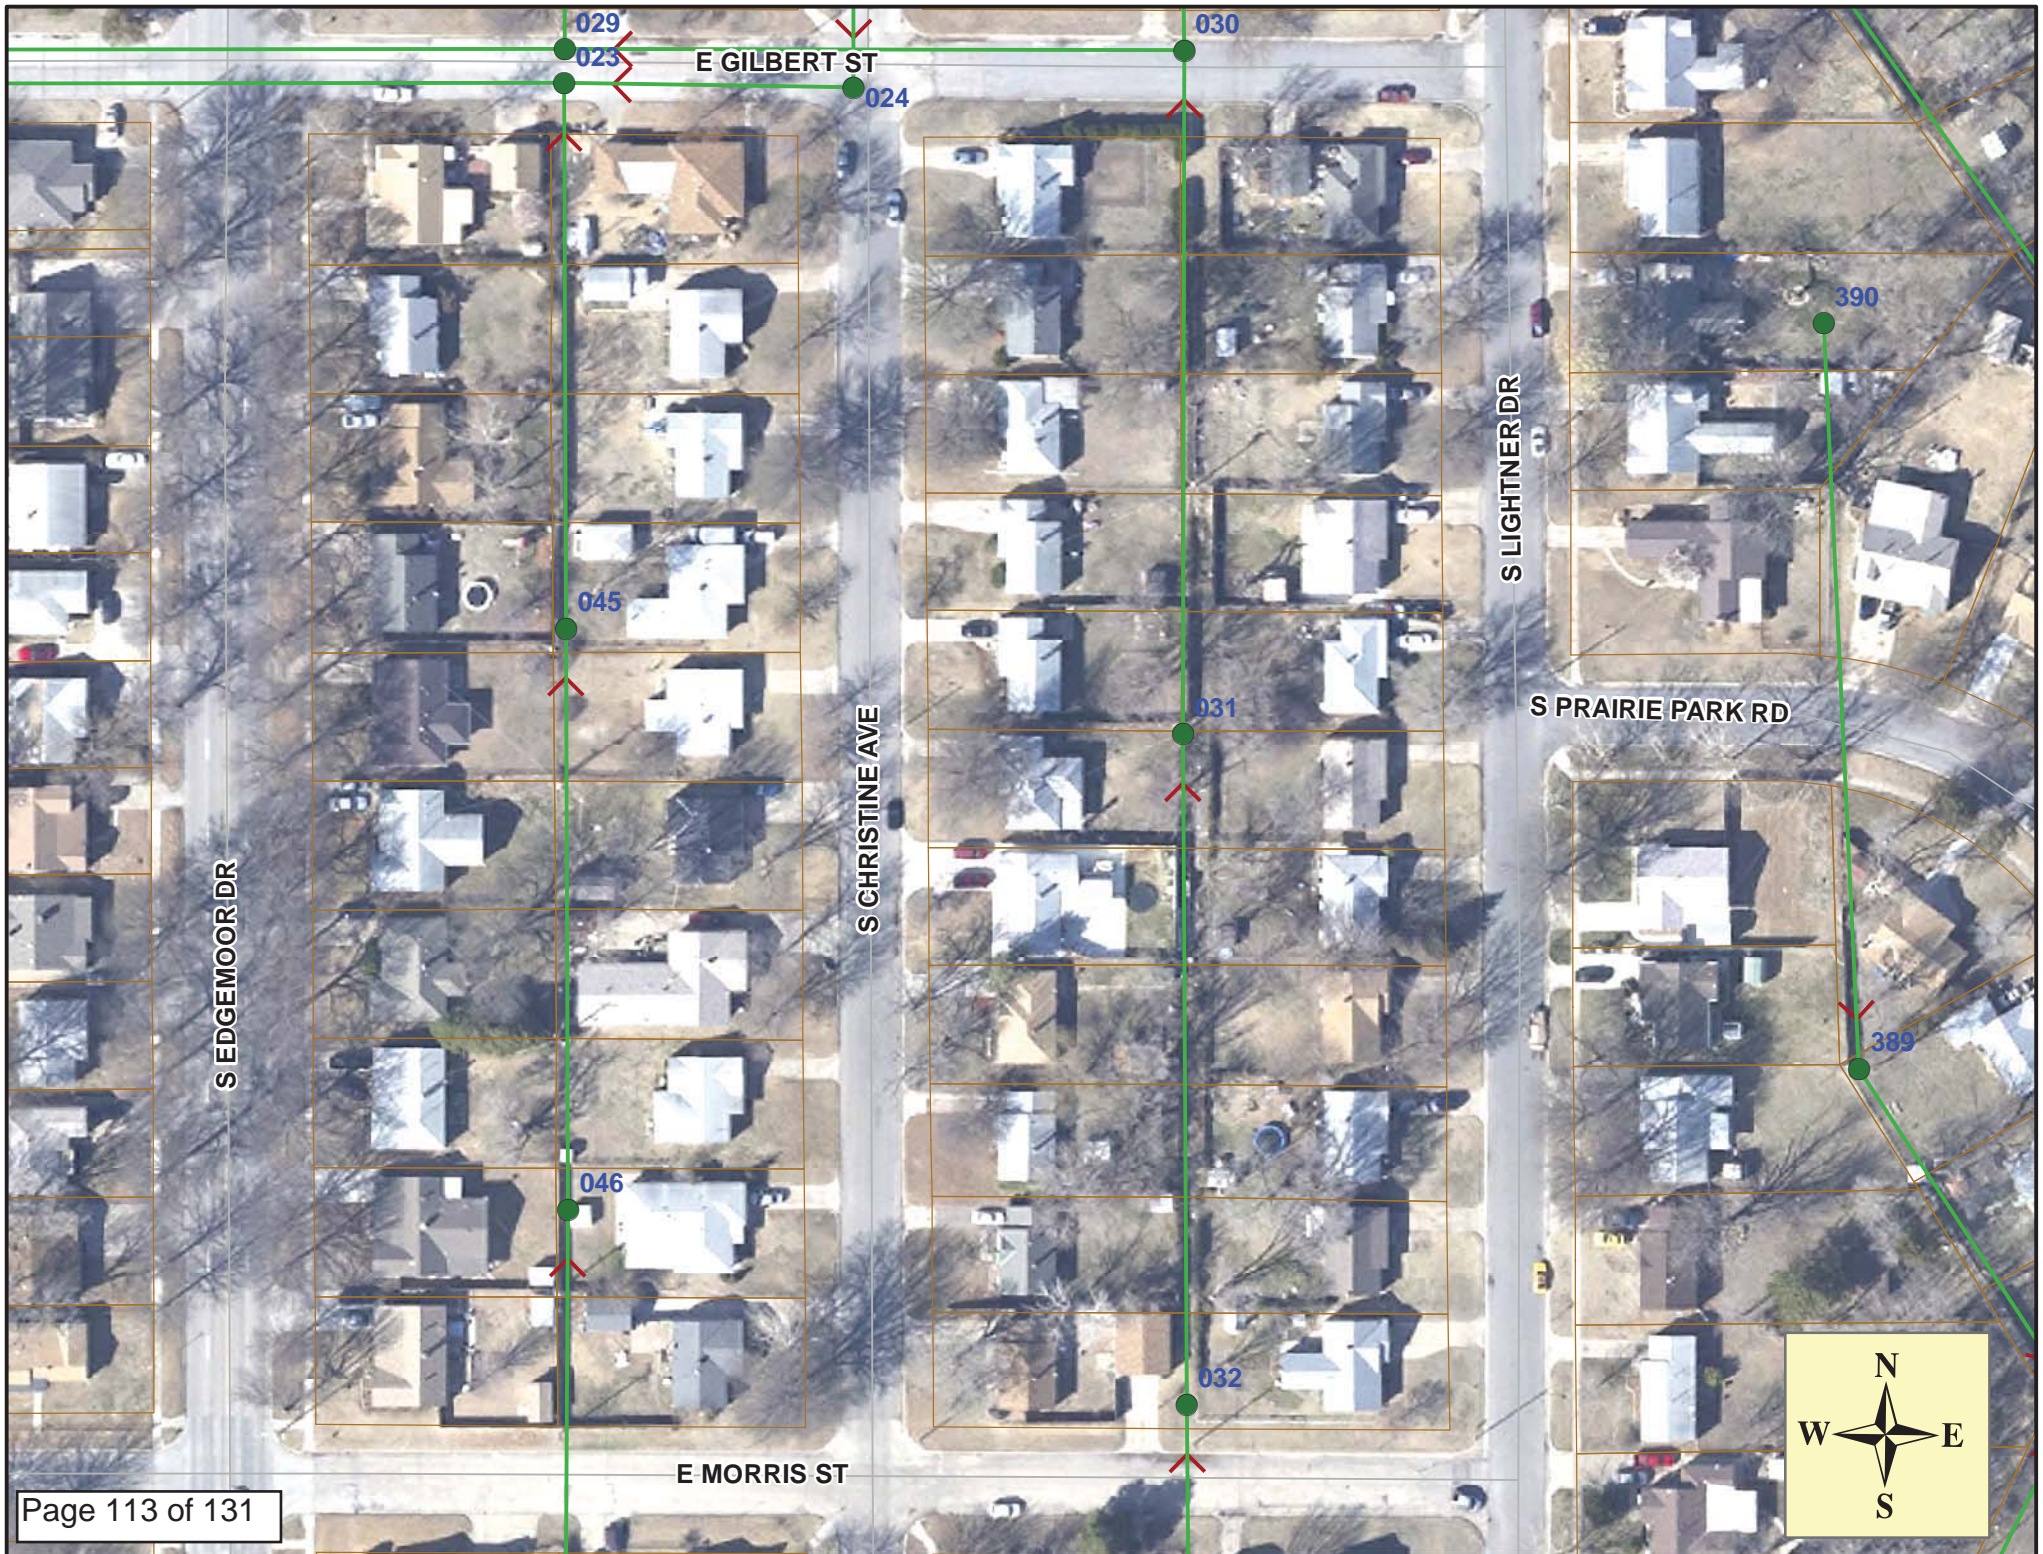
US Structure: 5846-032 752 CHRISTINE ST Date Insp: 5/5/2011 Basin: E04D
 DS Structure: 5846-031 728 CHRISTINE ST Dir Televised: Upstream To Downstream

Obs. #	VTR Counter	Distance	Location	Description	Rating	Obsrvd (gpm)	Ratings			Remain (gpm)
							Est. (gpm)	Struct	Clean	
1		0.0	5846-032	US Manhole	1	0.000	0	0	0.000	
2		2.5	752 S CHRISTINE	Break-In Conn	1	0.001	0	0	0.001	
3		30.4		Sealed Off Wye	5	0.000	0	0	0.000	
4		32.7	751 S LIGHTNER	PVC Break-In Conn	1	0.001	0	0	0.001	
5		33.1	752 S CHIRSTINE	Extended VCP Break-In Conn	5	0.010	400	0	0.010	
6		63.0		Crack-Horizontal	3	0.004	5	0	0.004	
7		65.9		Crack-Radial	3	0.004	5	0	0.004	
8		66.6		Crack-Horizontal	3	0.004	5	0	0.004	
9		82.9	748 S CHRISTINE	Wye Service	3	0.000	2	0	0.000	
10		85.9	747 S LIGHTNER	Wye Service	3	0.000	2	0	0.000	
11		109.3		Broken Pipe	4	0.030	78	0	0.030	
12		112.5		Crack-Horizontal	4	0.008	10	0	0.008	
13		115.7		Crack-Horizontal	4	0.008	10	0	0.008	
14		118.3		Crack-Horizontal	3	0.004	5	0	0.004	
15		137.0	742 S CHRISTINE	Wye Service	1	0.000	0	0	0.000	
16		138.3		Crack-Horizontal	2	0.002	2	0	0.002

17		140.1	741 S LIGHTNER	Break-In Conn	2	0.002	0	0	0.002	
18		152.1		Crack-Horizontal	3	0.004	5	0	0.004	
19		196.5	738 S CHRISTINE	Wye Service	2	0.000	0	0	0.000	
20		198.7	737 S LIGHTNER	PVC Break-In Conn	1	0.001	0	0	0.001	
21		247.0	732 S CHRISTINE	Wye Service	4	0.000	60	0	0.000	
22		250.6	731 S LIGHTNER	Wye Service	3	0.000	2	0	0.000	
23		256.0		Broken Pipe	3	0.010	60	0	0.010	
24		268.7		Roots	2	0.004	2	4	0.004	
25		269.4		Crack-Horizontal	2	0.002	2	0	0.002	
26		274.8		Roots	3	0.008	5	8	0.008	
27		283.9		Broken Pipe	2	0.008	44	0	0.008	
28		296.2		Roots	3	0.008	5	8	0.008	
29		299.2		Roots	1	0.002	1	1	0.002	
30		300.2	728 S CHRISTINE	Wye Service	3	0.000	2	0	0.000	
31		303.5	727 S LIGHTNER	Wye Service	5	0.000	400	0	0.000	
32		305.2	Offset Joint / shifted in crown	Broken Pipe	4	OK to line - LML				
33		309.0	5846-031	DS Manhole	1

Lots of cracks. Wyes have roots. Line in poor cond. - LML

US Structure: 5846-031 **728** **CHRISTINE ST** **Date Insp:** 5/9/2011 **Basin:** E04D
DS Structure: 5846-030 **651** **LIGHTNER ST** **Dir Televised:** Upstream To Downstream

Obs. #	VTR Counter	Distance	Location	Description	Rating	Obsrvd (gpm)	Ratings			Remain (gpm)
							Est. (gpm)	Struct	Clean	
1		0.0		US Manhole	1	0.000	0	0	0.000	
2		5.0		Roots	1	0.002	1	1	0.002	
3		5.8		Crack-Horizontal	2	0.002	2	0	0.002	
4		48.7	724 S CHRISTINE	packed w/roots / Wye Service	5	0.000	400	0	0.000	
5		53.1	721 S LIGHTNER	Wye Service	4	0.000	60	0	0.000	
6		105.7	720 S CHRISTINE	Wye Service	1	0.000	0	0	0.000	
7		109.0	717 S LIGHTNER	Wye Service	1	0.000	0	0	0.000	
8		160.8	714 S CHRISTINE	Break-In Conn	1	0.001	0	0	0.001	
9		164.9	711 S LIGHTNER	Wye Service	2	0.000	0	0	0.000	
10		200.9		Crack-Horizontal	2	0.002	2	0	0.002	
11		208.3		Crack-Horizontal	2	0.002	2	0	0.002	
12		213.4	Cracks in all quadrants	Broken Pipe	3	0.010	60	0	0.010	
13		216.8	708 S CHRISTINE	Break-In Conn	3	0.004	2	0	0.004	
14		219.7		Crack-Horizontal	3	0.004	5	0	0.004	
15		220.7	707 S LIGHTNER	Wye Service	1	0.000	0	0	0.000	
16		222.8		Crack-Horizontal	2	0.002	2	0	0.002

17		241.4		Broken Pipe	3	0.010	60	0	0.010	
18		244.7		Crack-Horizontal	4	0.008	10	0	0.008	
19		247.8		Crack-Horizontal	3	0.004	5	0	0.004	
20		251.2		Crack-Horizontal	3	0.004	5	0	0.004	
21		254.3		Broken Pipe	3	0.010	60	0	0.010	
22		257.0		Broken Pipe	4	0.030	78	0	0.030	
23		260.2		Broken Pipe	3	0.010	60	0	0.010	
24		263.6		Crack-Horizontal	3	0.004	5	0	0.004	
25		269.6	702 S CHRISTINE	Break-In Conn	1	0.001	0	0	0.001	
26		273.4	701 S LIGHTNER	Wye Service	4	0.000	60	0	0.000	
27		291.3		Roots	2	0.004	2	4	0.004	
28		294.3		Roots	2	0.004	2	4	0.004	
29		320.5	5846-030	DS Manhole	1	0.000	0	0	0.000

Lots of cracks not listed on this video log - LML

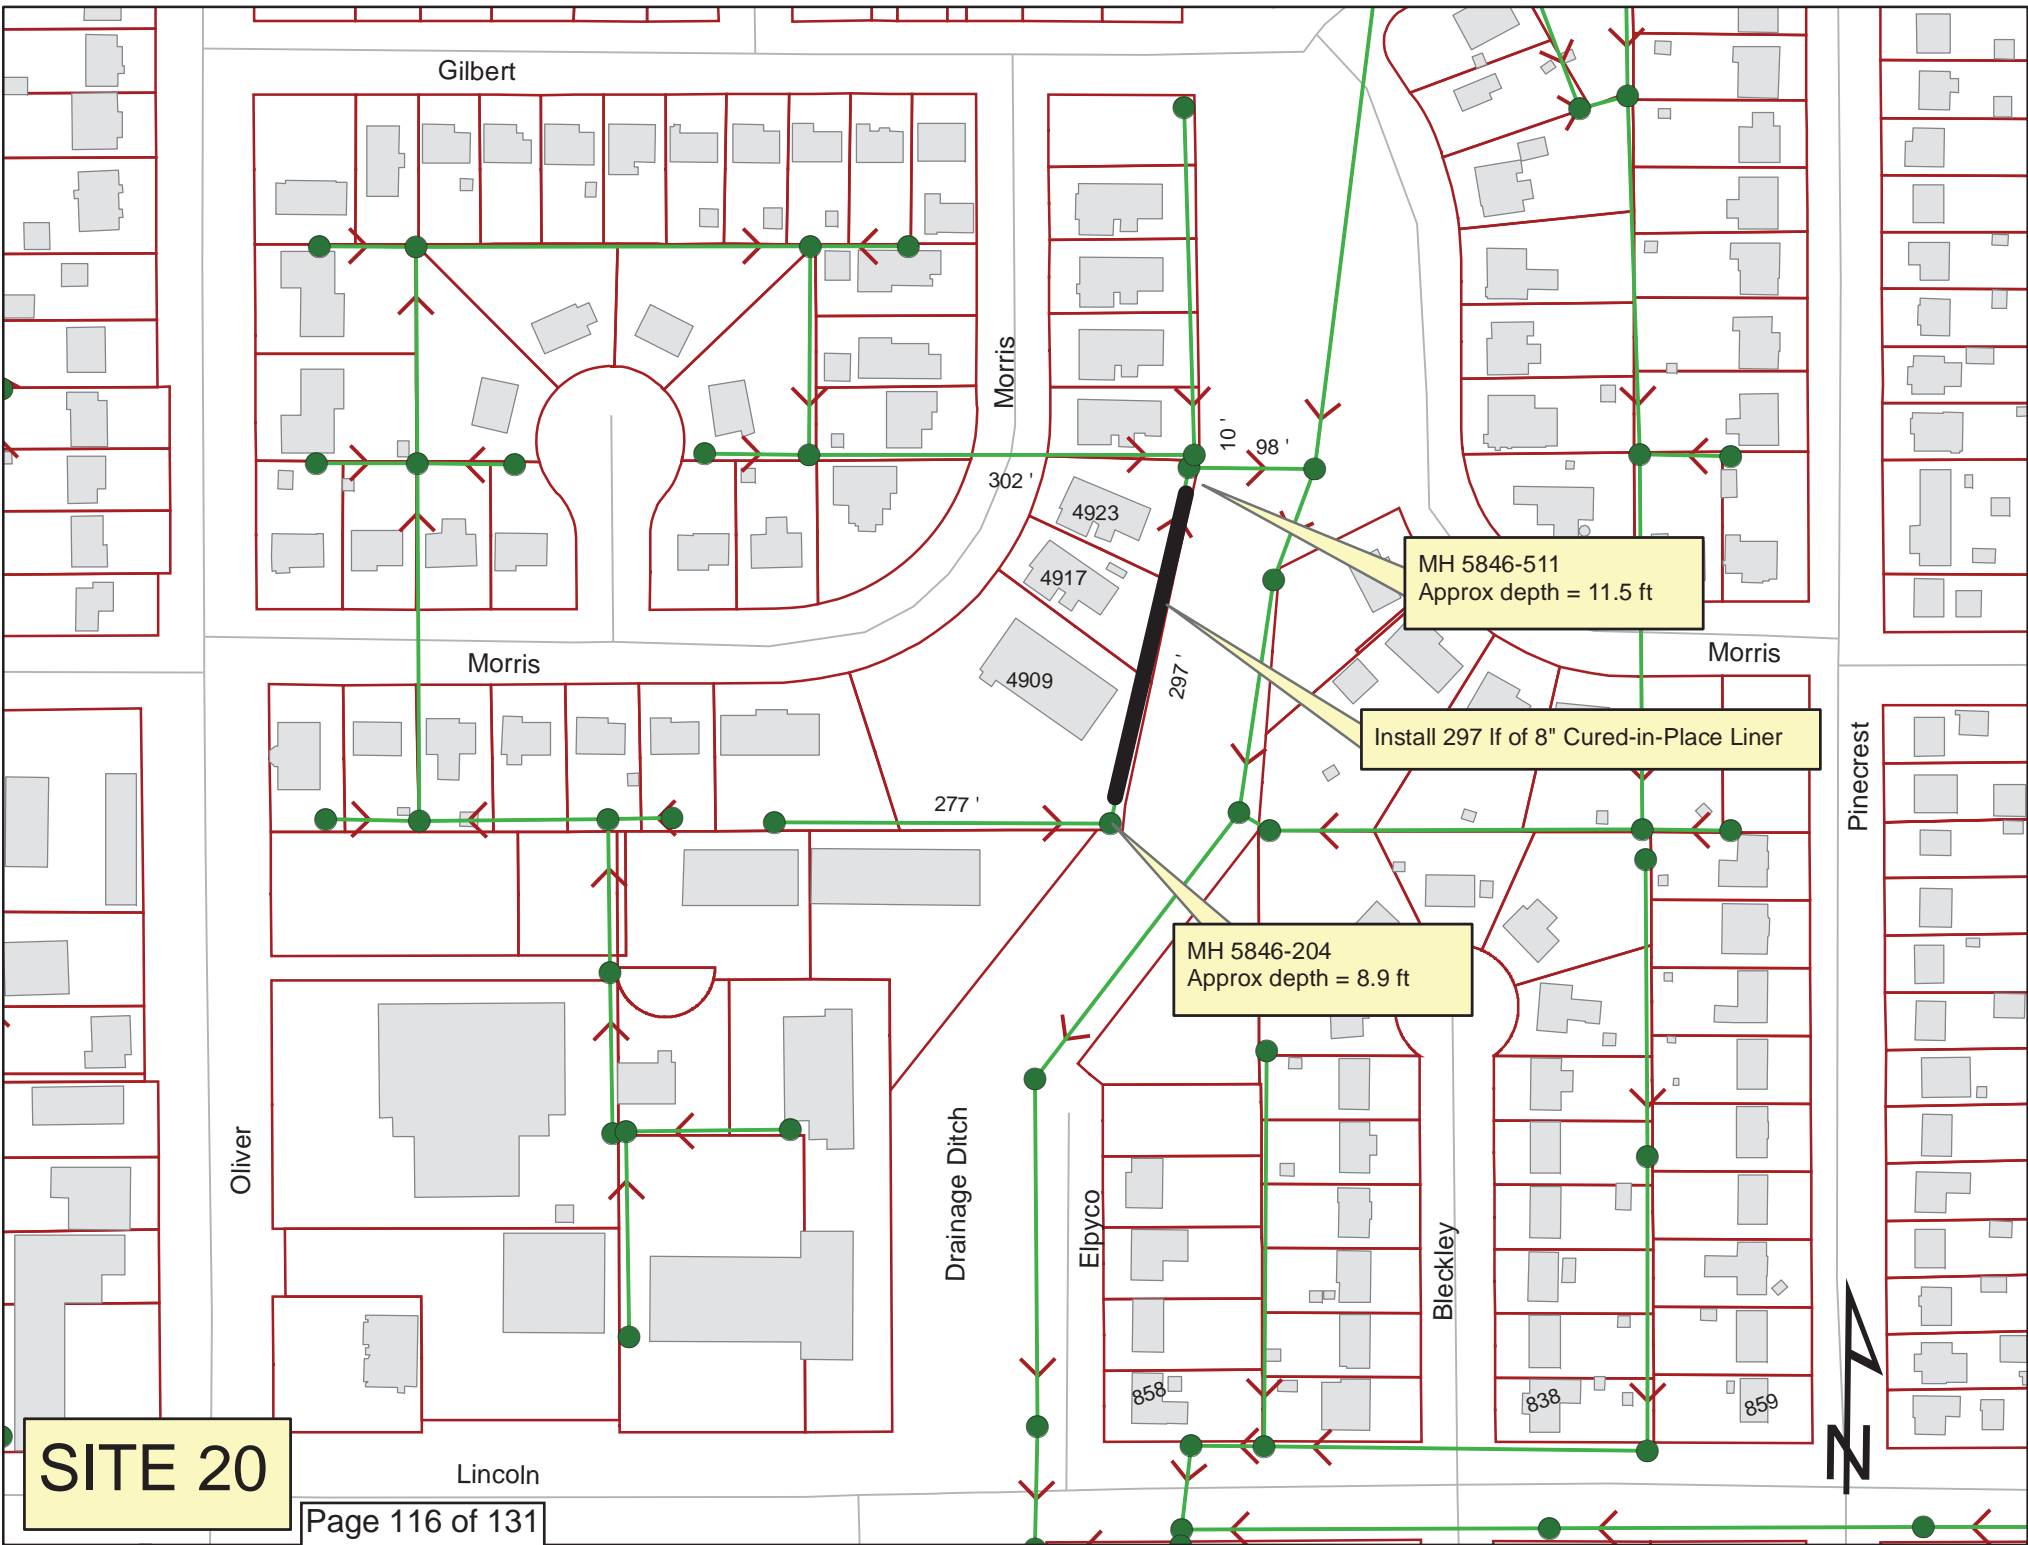
SITE 20

MH 5846-511
Approx depth = 11.5 ft

MH 5846-204
Approx depth = 8.9 ft

Install 297 lf of 8" Cured-in-Place Liner

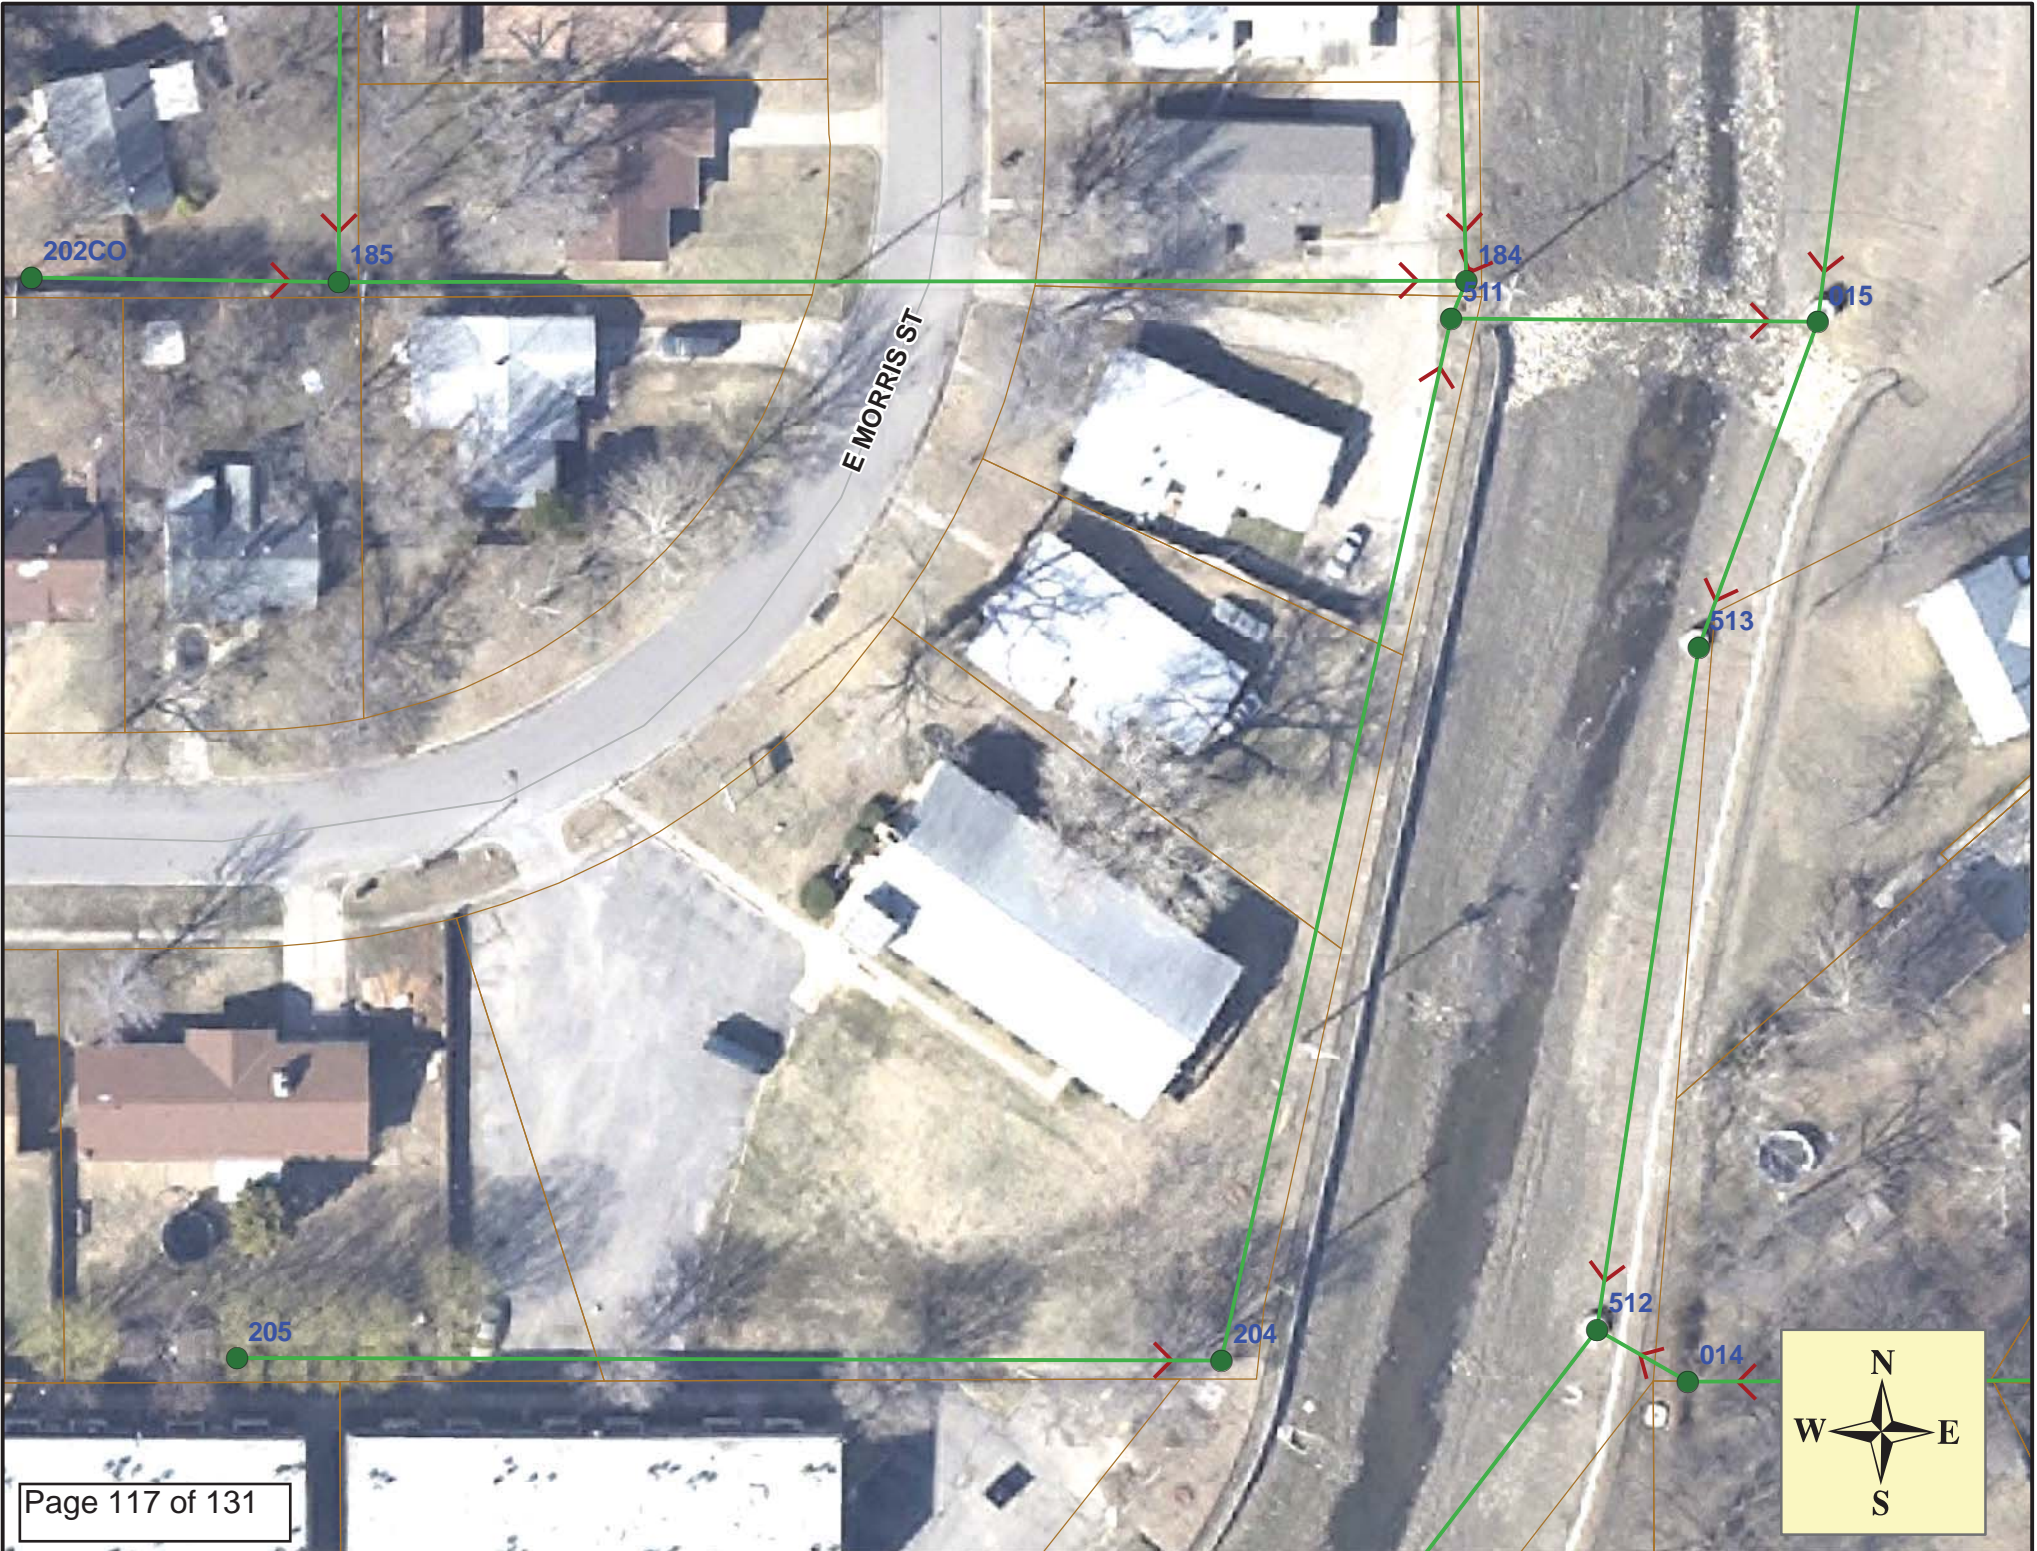
US Structure: 5846-204 4847 MORRIS ST Date Insp: 2/22/2012 Basin: E04A
 DS Structure: 5846-511 4923 E MORRIS ST Dir Televised: Downstream To Upstream

Obs. #	VTR Counter	Distance	Location	Description	Rating	Obsrvd (gpm)	Ratings		Remain (gpm)
							Est. (gpm)	Struct Clean	
1		0.0		TV against the flow Pipe begins as PVC at the manhole wall	1				
2		6.7		VCP begins / PVC ends	1				
3		18.0		Crack-Horizontal	3				
4		26.0		Crack-Horizontal	3				
5		32.8		Crack-Horizontal	3				
6		36.6	Hole in east side of pipe	Broken Pipe	4			OK to line - LML	
7		58.3	4925 E MORRIS	Wye Service	1				
8		58.4	Joint	Offset	3				
9		61.3	Joint	Offset	3				
10		77.7	Joint	Offset	3				
11		83.6	Joint	Offset	2				
12		85.6	Joint	Offset	2				
13		91.4	Joint	Offset	2				
14		95.3	Joint	Offset	2				
15		97.4	Joint	Offset	3				
16		109.3	Joint	Offset	3				
17		113.3	Joint	Offset	2				
18		115.7	Joint	Offset	3				
19		118.6	Joint	Offset	3				
20		118.9	Cracks at the joint	Broken Pipe	3				
21		121.5	Joint	Offset	3				
22		124.6	Joint	Offset	3				
23		124.6		Crack-Horizontal	2				
24		127.7	Joint	Offset	3

25		130.4	4919 E MORRIS	Wye Service	2				
26		142.2	Joint	Offset	3				
27		169.5	Joint	Offset	3				
28		172.1	Joint	Offset	2				
29		181.0	Joint	Offset	3				
30		203.0		Crack-Horizontal	3				
31		205.7		Crack-Horizontal	2				
32		208.1	Joint	Offset	3				
33		216.4	4909 E MORRIS	Break-In Conn	4				
34		296.0	5846-204	US Manhole / needs a new bench & invert - LML

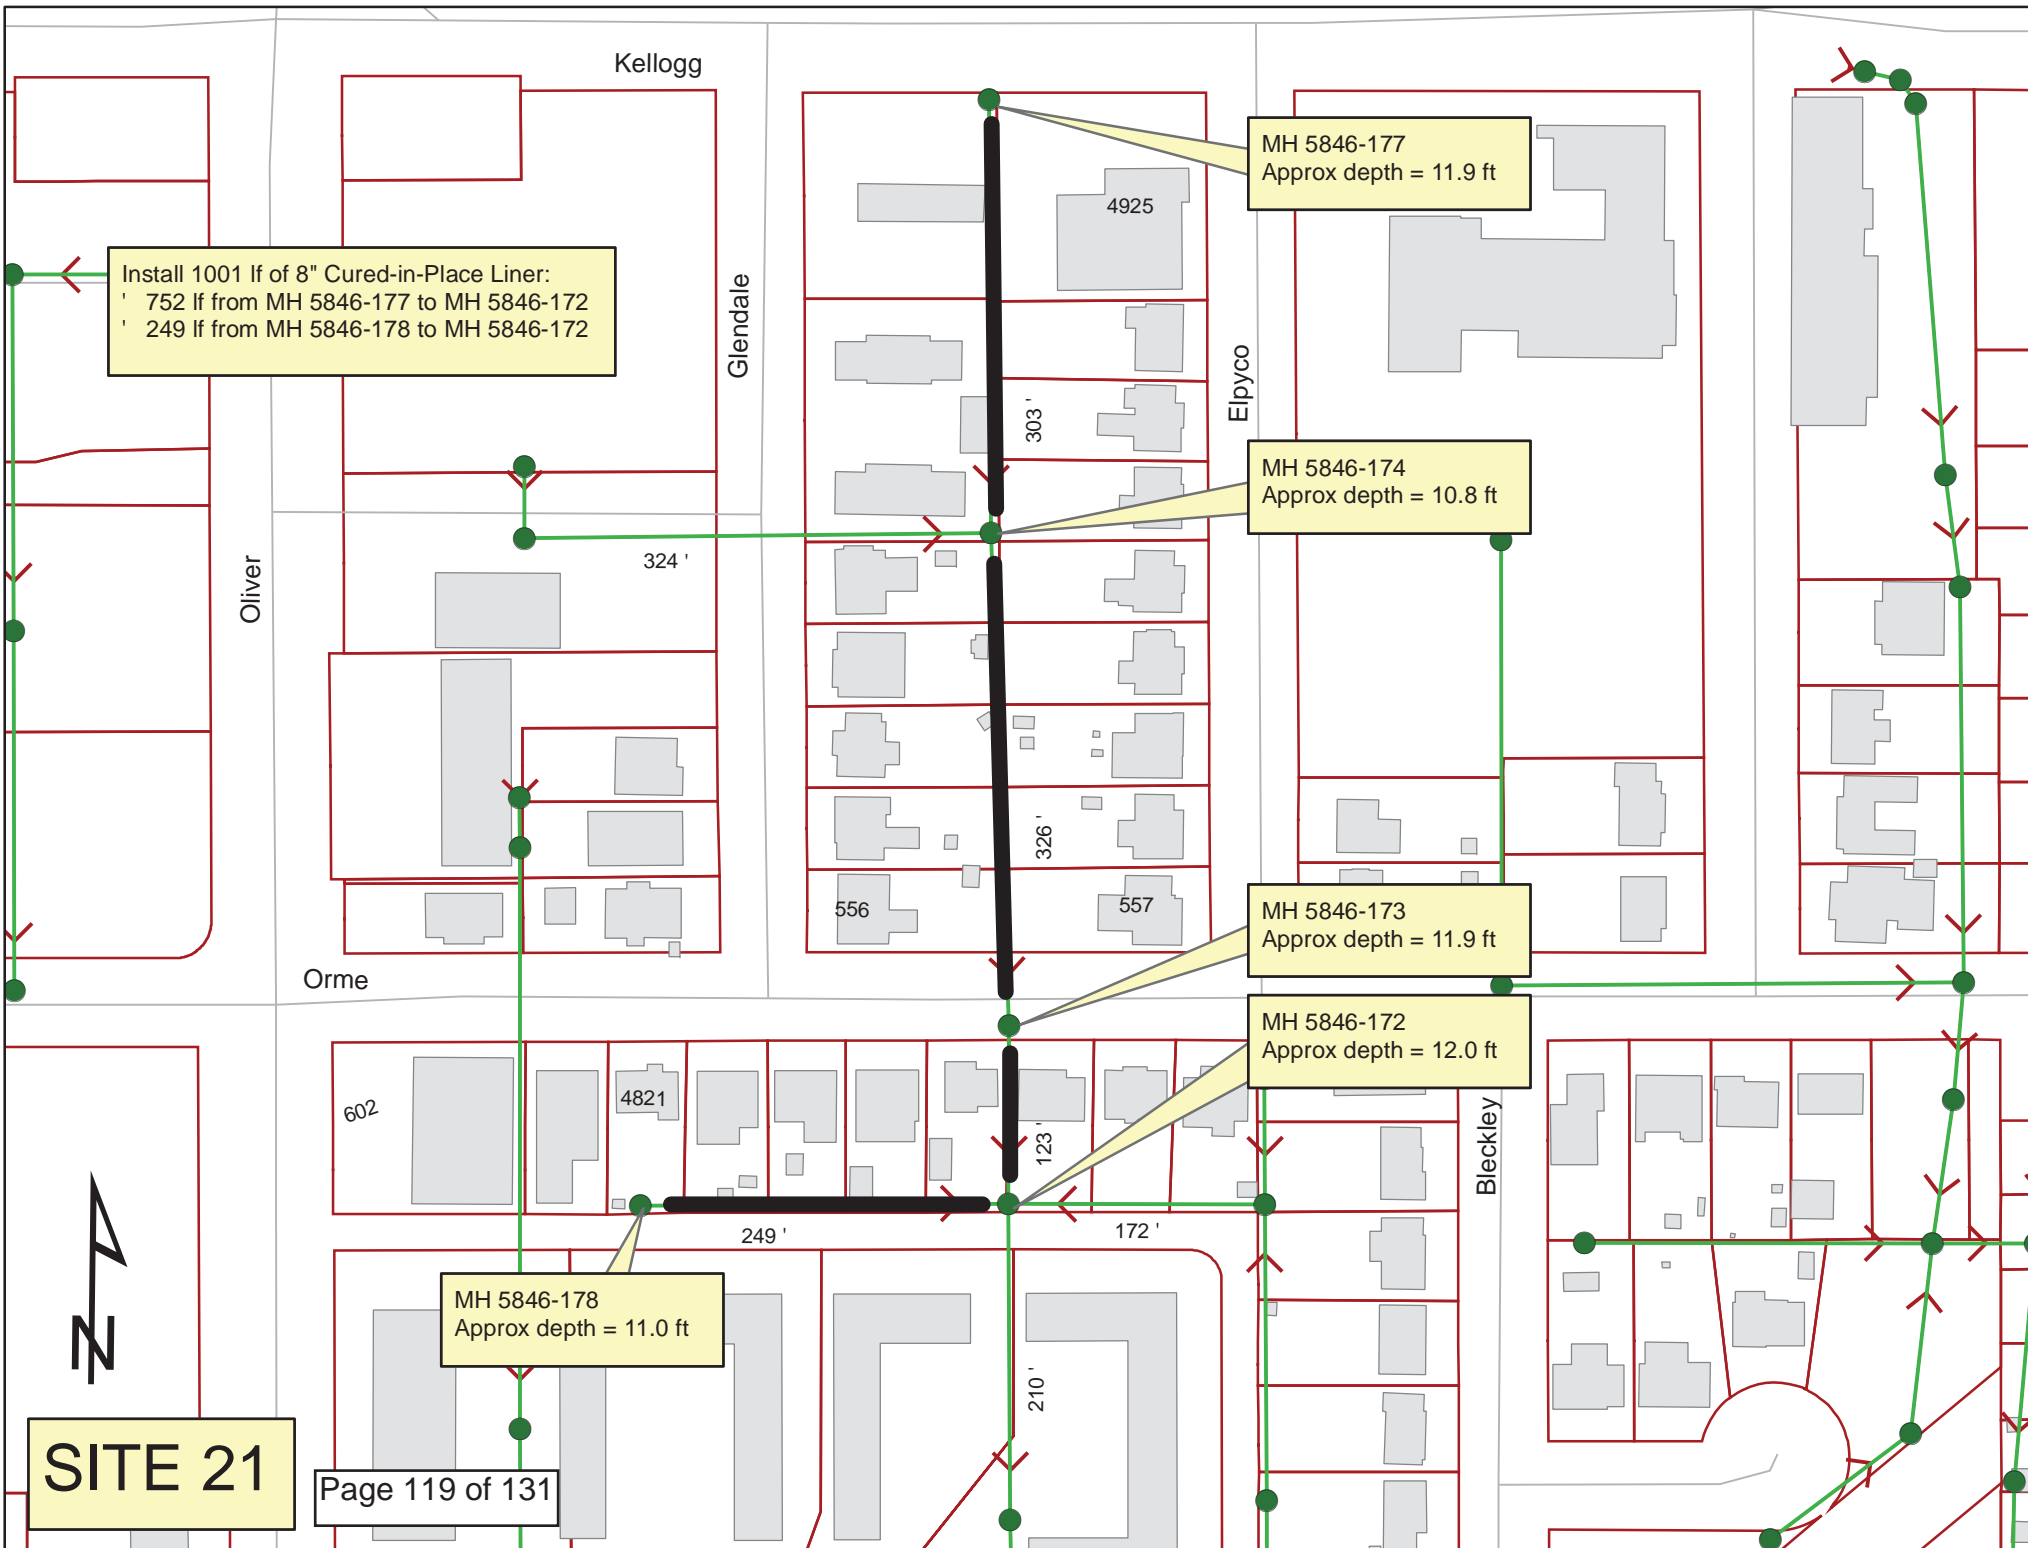
SITE 21

MH 5846-177
 Approx depth = 11.9 ft

MH 5846-174
 Approx depth = 10.8 ft

MH 5846-173
 Approx depth = 11.9 ft

MH 5846-172
 Approx depth = 12.0 ft

MH 5846-178
 Approx depth = 11.0 ft

Install 1001 lf of 8" Cured-in-Place Liner:
 ' 752 lf from MH 5846-177 to MH 5846-172
 ' 249 lf from MH 5846-178 to MH 5846-172

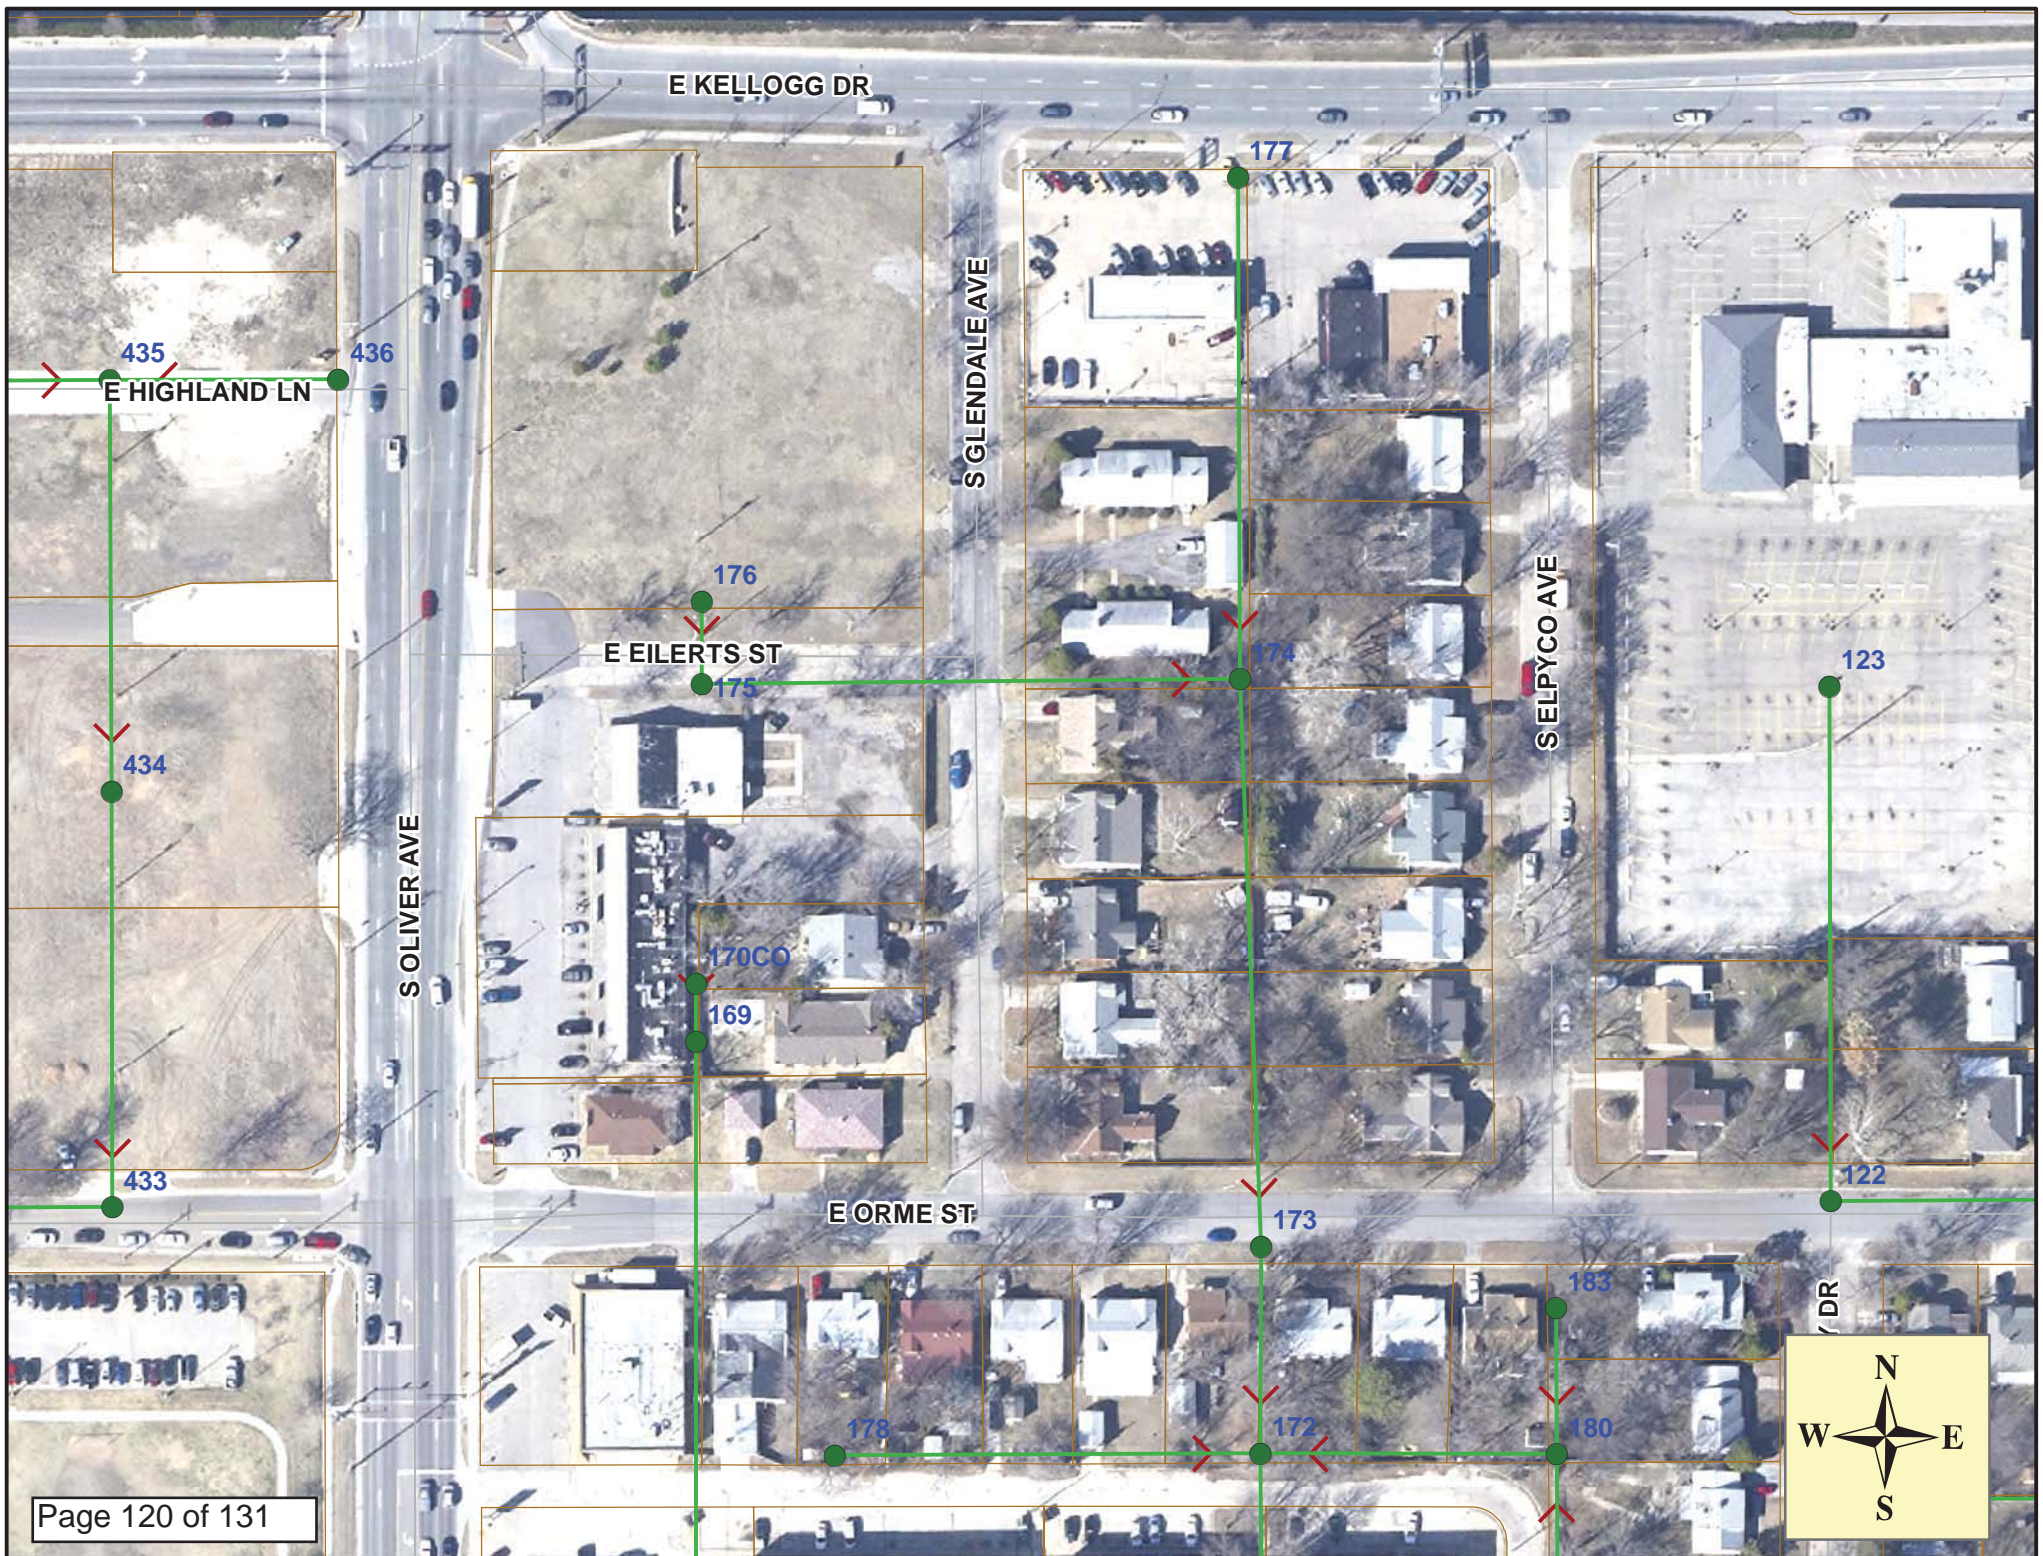
US Structure: 5846-177 4925 E KELLOGG ST **Date Insp:** 1/30/2012 **Basin:** E04C
DS Structure: 5846-174 526 S GLENDALE AVE **Dir Televised:** Upstream To Downstream

Obs. #	VTR Counter	Distance	Location	Description	Rating	Ratings				
						Obsrvd (gpm)	Est. (gpm)	Struct	Clean	Remain (gpm)
1		0.0	5846-177	US Manhole	1					
2		8.6	4901 E KELLOGG DRIVE	Wye Service	1					
3		20.7	<i>(wyes w/o addresses are sealed off)</i>	Wye Service	1	seal is leaking				
4		48.0		Wye Service	1					
5		51.3		Wye Service	1	seal is leaking				
6		72.6		Wye Service	1	seal is leaking				
7		85.6	4901 E KELLOGG DRIVE	Break-In Conn	1					
8		96.8		Wye Service	1					
9		99.9	4925 E KELLOGG DRIVE	Wye Service	1	roots				
10		121.1	<i>(not sealed at the main?)</i>	Wye Service	2					
11		142.0		Wye Service	1	seal is leaking				
12		144.2	518 S GLENDALE	Wye Service	2					
13		149.3		Scaling	3	mineral deposits				
14		155.4		Scaling	2	mineral deposits				
15		167.6		Scaling	3	mineral deposits				
16		168.5		Wye Service	3	seal is leaking				
17		172.1		Wye Service	2	seal is leaking				
18		175.1	520 S GLENDALE	Break-In Conn	2

19		176.6		Scaling	3	mineral deposits				
20		179.4		Scaling	3	mineral deposits				
21		196.8	517 S ELPYCO	Wye Service	1					
22		205.9		Wye Service	1					
23		207.1		Scaling	3					
24		221.5		Wye Service	1					
25		245.4	523 S ELPYCO	Wye Service	1					
26		262.2		Scaling	2					
27		270.0		Wye Service	1	seal is leaking				
28		274.4		Scaling	3					
29		294.7	529 S ELPYCO	Wye Service	1					
30		299.2		Scaling	3					
31		303.1	5846-174	DS Manhole	2

Needs lined for the infiltration issues - LML
