25th Street North

SITE 1

Television Inspection Master Report

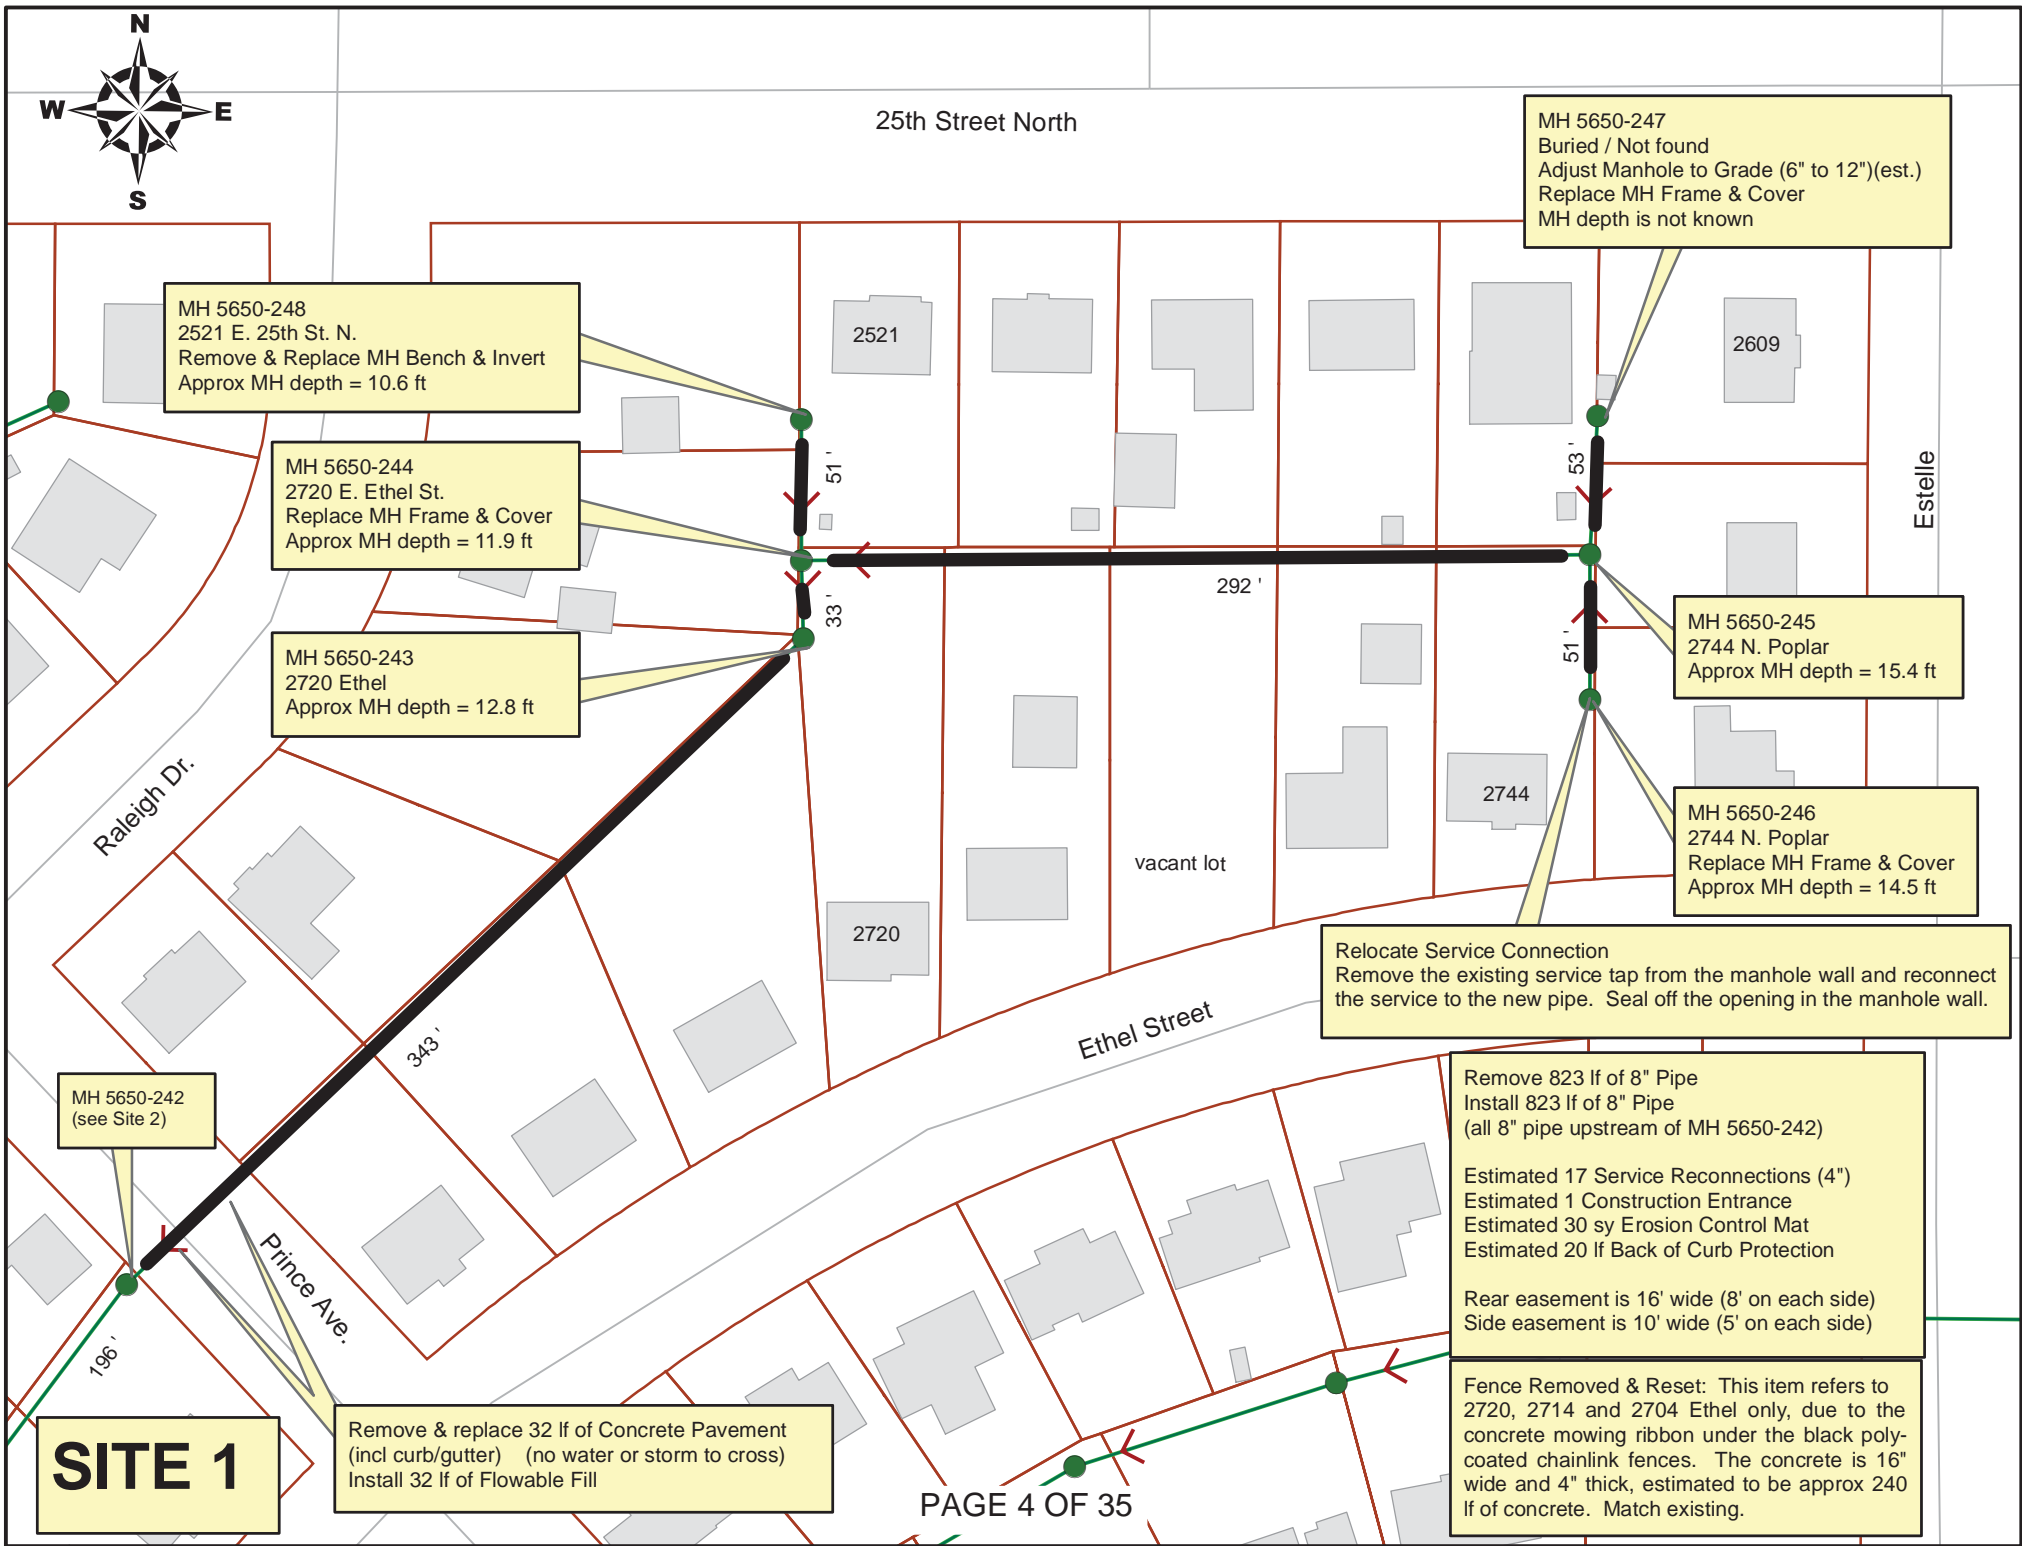
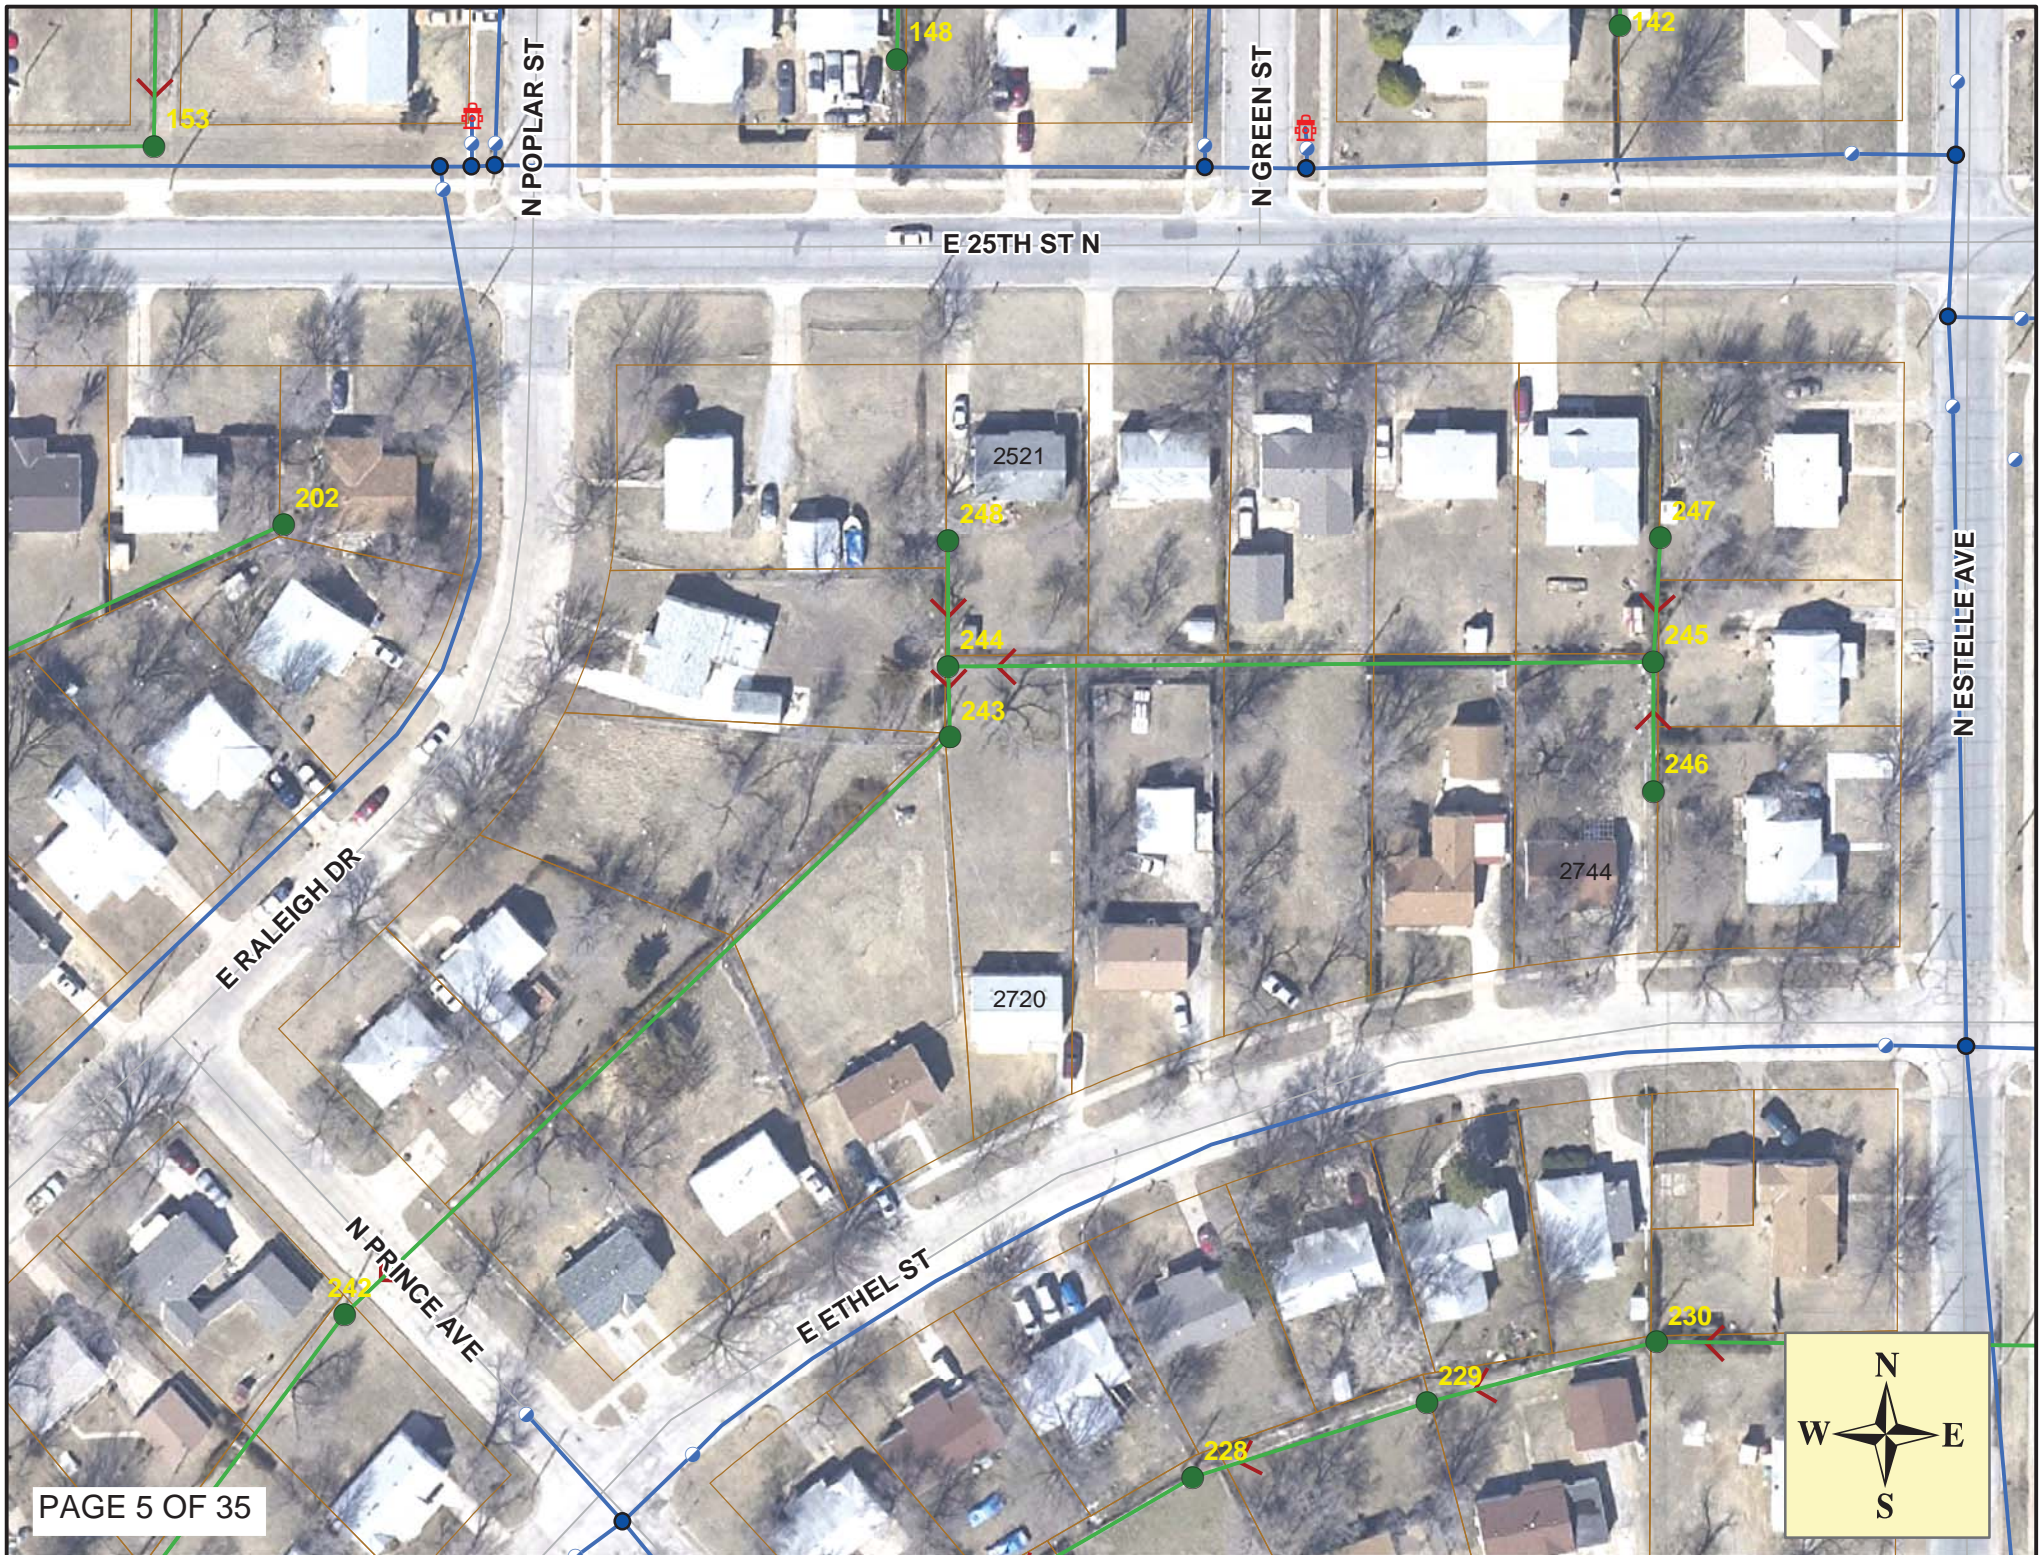
MH 5650-247
Buried / Not found
Adjust Manhole to Grade (6" to 12")(est.)
Replace MH Frame & Cover
MH depth is not known

MH 5650-248
2521 E. 25th St. N.
Remove & Replace MH Bench & Invert
Approx MH depth = 10.6 ft

MH 5650-244
2720 E. Ethel St.
Replace MH Frame & Cover
Approx MH depth = 11.9 ft

MH 5650-243
2720 Ethel
Approx MH depth = 12.8 ft

MH 5650-245
2744 N. Poplar
Approx MH depth = 15.4 ft

MH 5650-246
2744 N. Poplar
Replace MH Frame & Cover
Approx MH depth = 14.5 ft

Relocate Service Connection
Remove the existing service tap from the manhole wall and reconnect the service to the new pipe. Seal off the opening in the manhole wall.

Remove 823 lf of 8" Pipe
Install 823 lf of 8" Pipe
(all 8" pipe upstream of MH 5650-242)

Fence Removed & Reset: This item refers to 2720, 2714 and 2704 Ethel only, due to the concrete mowing ribbon under the black poly-coated chainlink fences. The concrete is 16" wide and 4" thick, estimated to be approx 240 lf of concrete. Match existing.

Remove & replace 32 lf of Concrete Pavement (incl curb/gutter) (no water or storm to cross)
Install 32 lf of Flowable Fill
