**SITE 7**

PAGE 32 OF 45

## Video Inspection Master Report

US Structure: 5347-147                      447 N MILLWOOD                      Date Insp: 5/30/2013                      Basin: C07B  
 DS Structure: 5347-145                      442 N VINE                                      Dir Televised:Upstream To Downstream

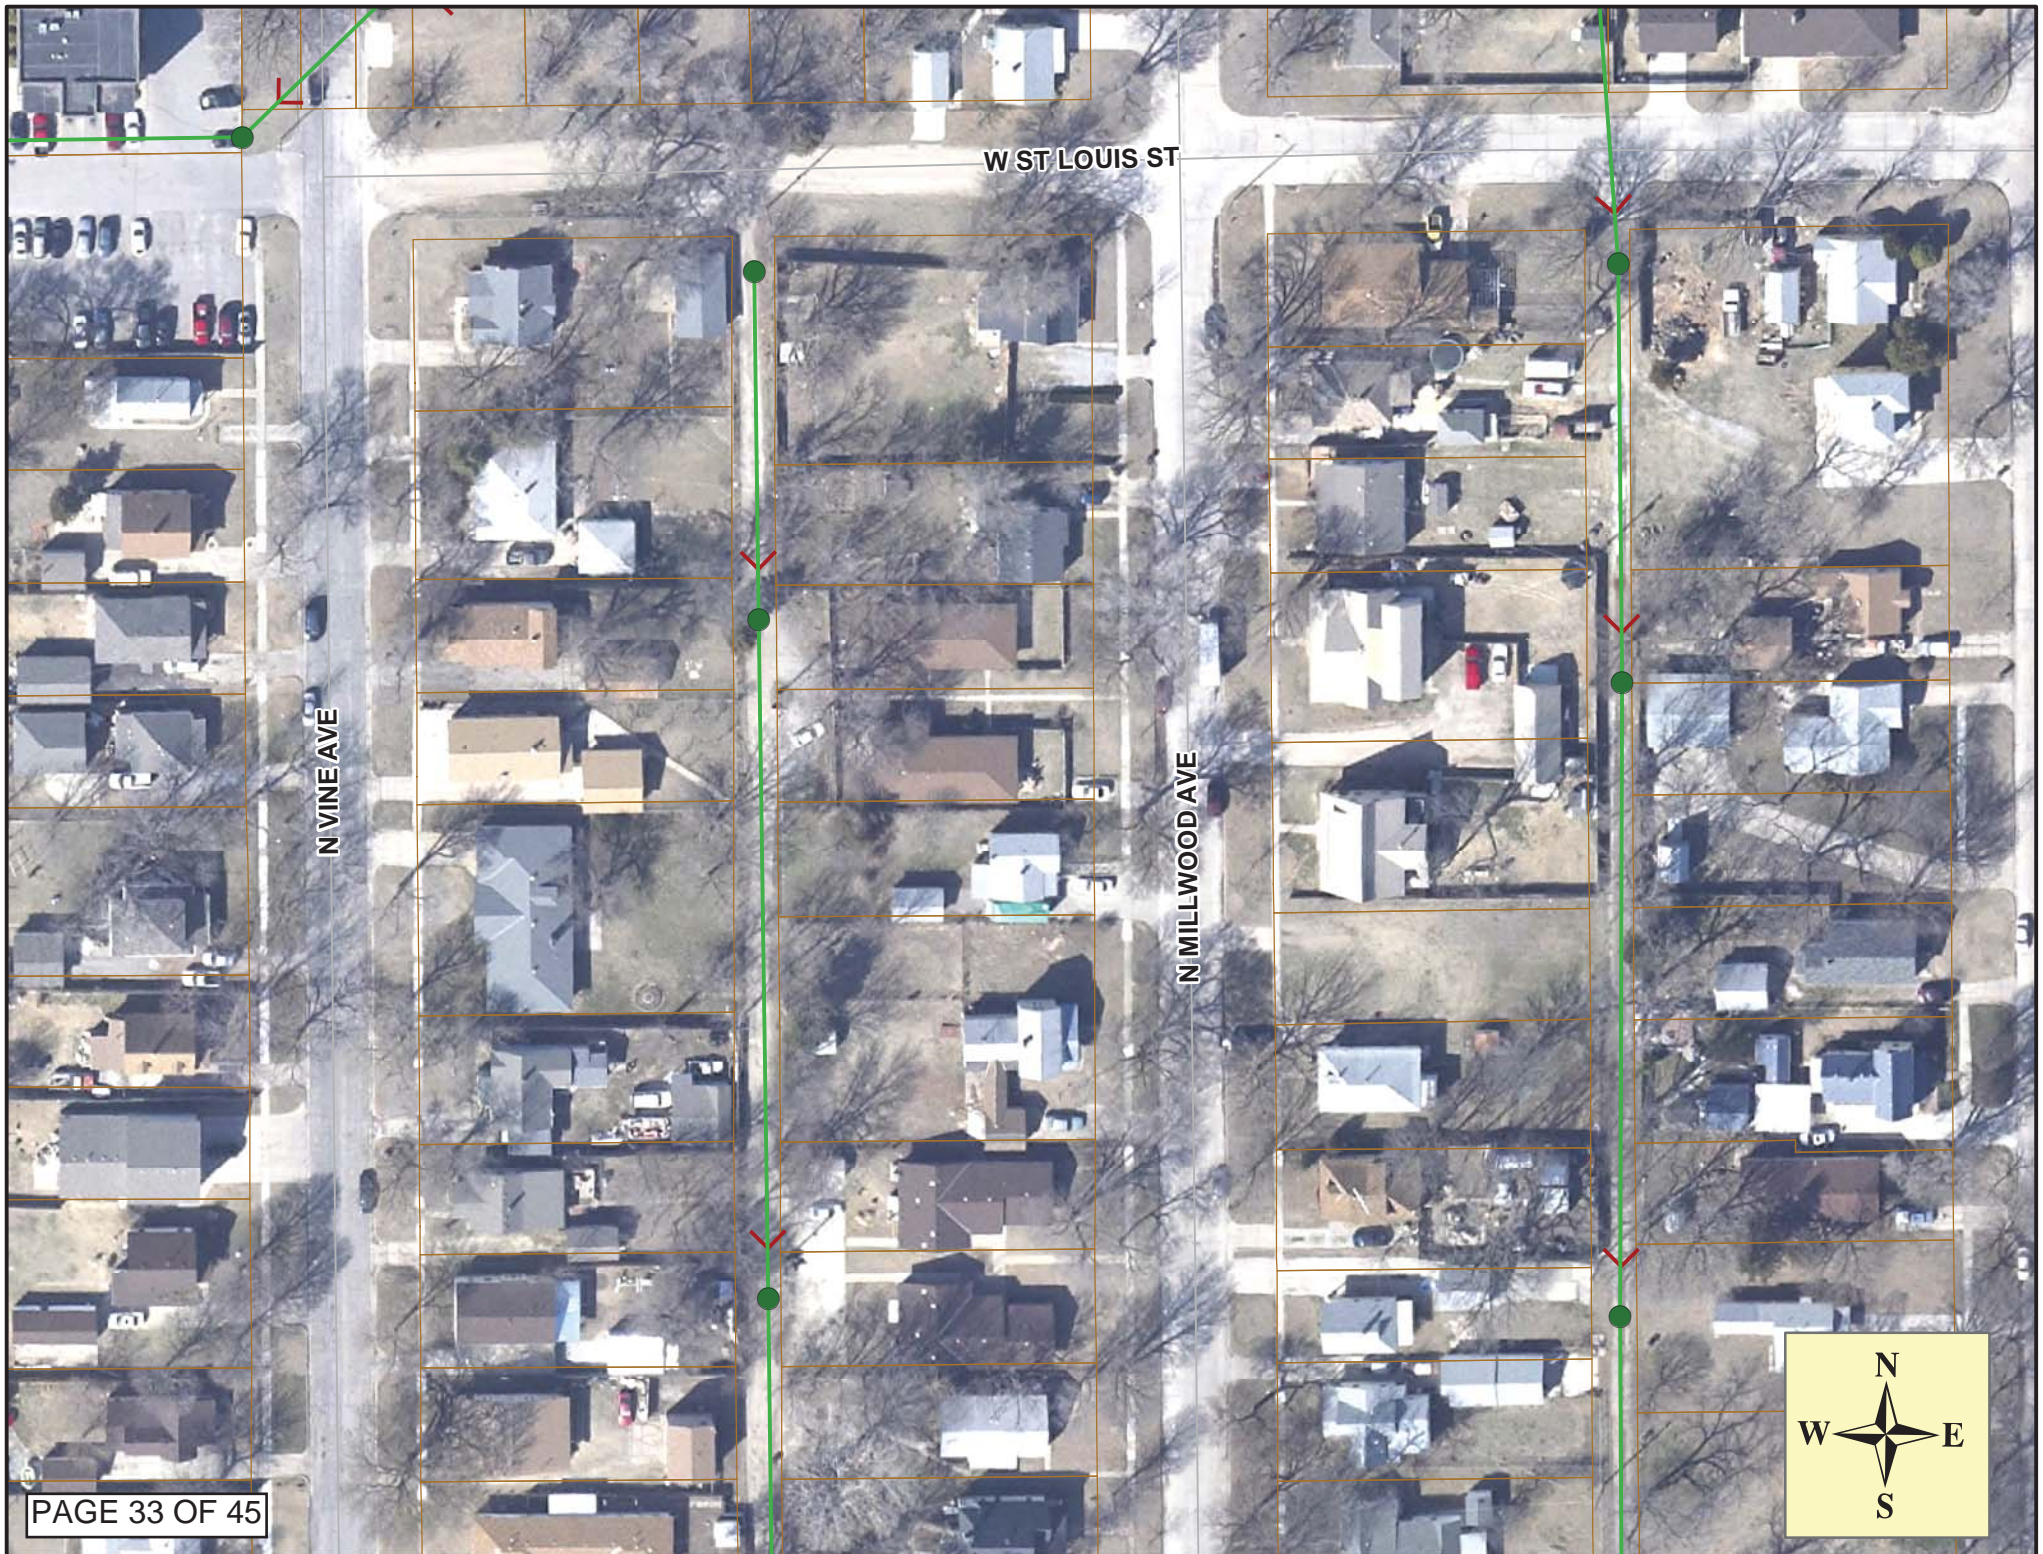
MH 5347-147  
Replace MH Frame & Cover  
Depth not measured

MH 5347-145  
Remove Manhole  
Construct Shallow Manhole  
Approx depth = 4.0 ft

MH 5347-158  
Remove Manhole  
Construct Shallow Manhole  
Approx depth = 3.8 ft

MH 5347-142  
Approx depth = 4.3 ft

Remove 455 lf of 8" Pipe  
Install 455 lf of 8" Pipe  
Estimated 14 Service  
Reconnections (4")
