MAP 2

Television Inspection Master Report

US Manhole: 5744-219
DS Manhole: 5744-218 2669 S FEES ST

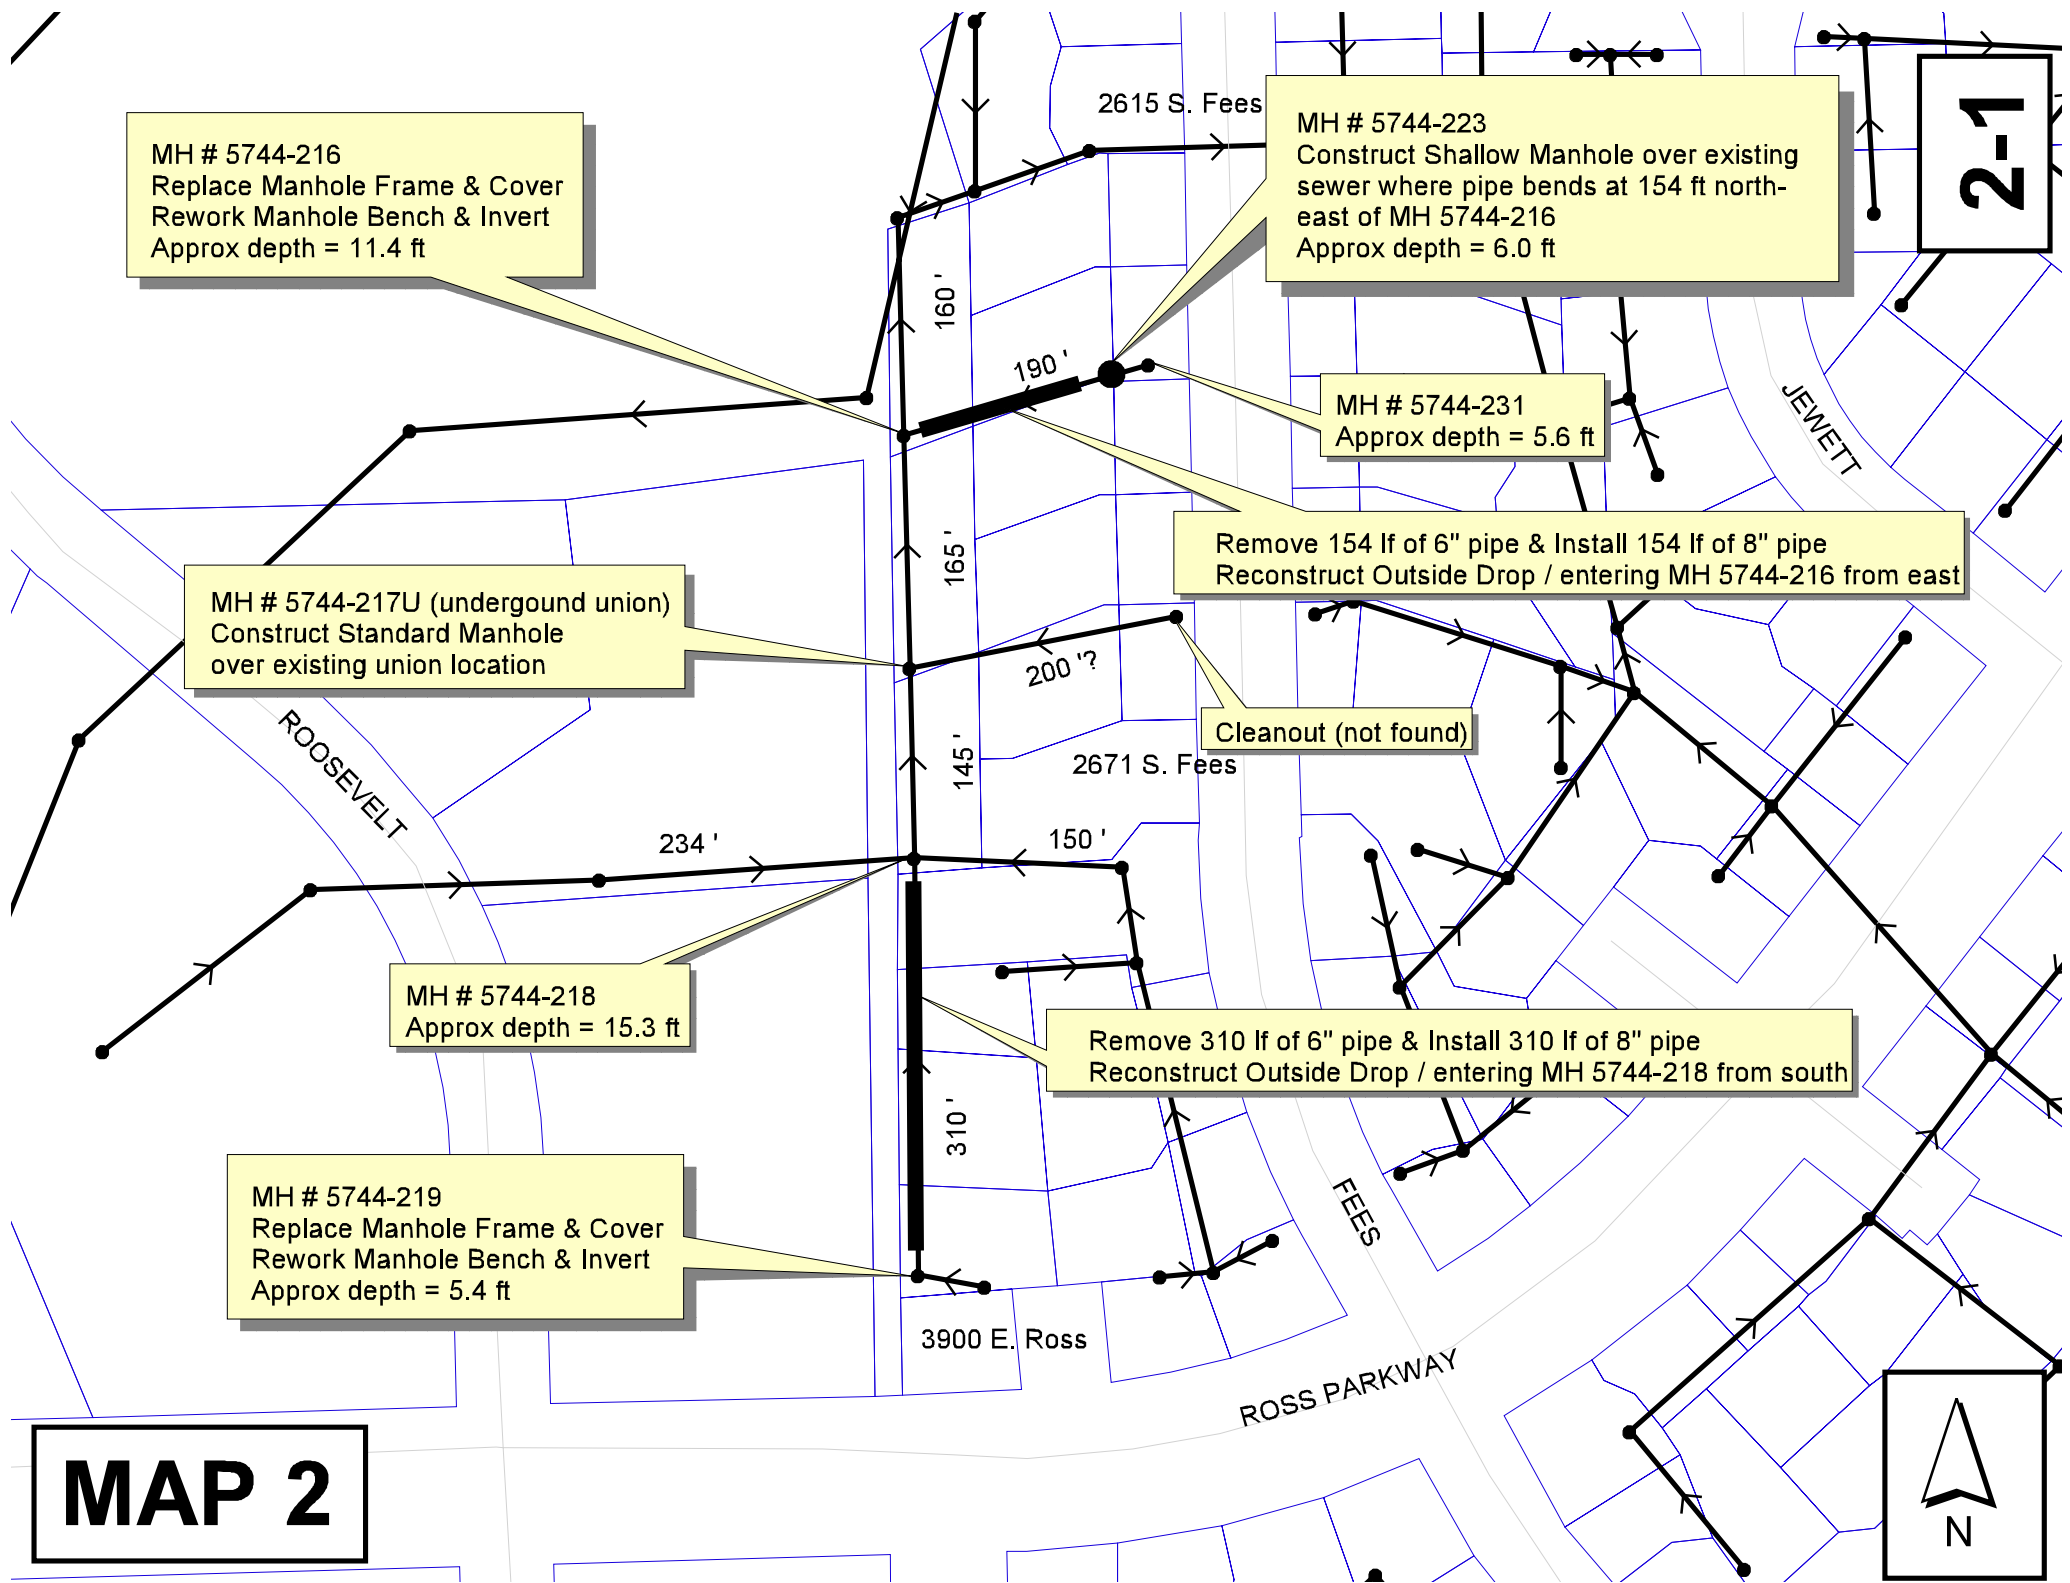
MH # 5744-216
Replace Manhole Frame & Cover
Rework Manhole Bench & Invert
Approx depth = 11.4 ft

MH # 5744-223
Construct Shallow Manhole over existing sewer where pipe bends at 154 ft north-east of MH 5744-216
Approx depth = 6.0 ft

MH # 5744-231
Approx depth = 5.6 ft

MH # 5744-217U (underground union)
Construct Standard Manhole over existing union location

Cleanout (not found)

MH # 5744-218
Approx depth = 15.3 ft

MH # 5744-219
Replace Manhole Frame & Cover
Rework Manhole Bench & Invert
Approx depth = 5.4 ft

Remove 154 lf of 6" pipe & Install 154 lf of 8" pipe
Reconstruct Outside Drop / entering MH 5744-216 from east

Remove 310 lf of 6" pipe & Install 310 lf of 8" pipe
Reconstruct Outside Drop / entering MH 5744-218 from south
