MH # 5744-684
Replace Manhole Frame & Cover
Rework Manhole Bench & Invert
Reconstruct Outside Drop for
line coming into MH from the south
Approx depth = 12.0 ft

Remove and replace 353 lf of 8" pipe
from MH 5744-686 to MH 5744-684

Television Inspection Master Report

US Manhole: 5744-686 3037 S CLIFTON ST
DS Manhole: 5744-685CO (bend)

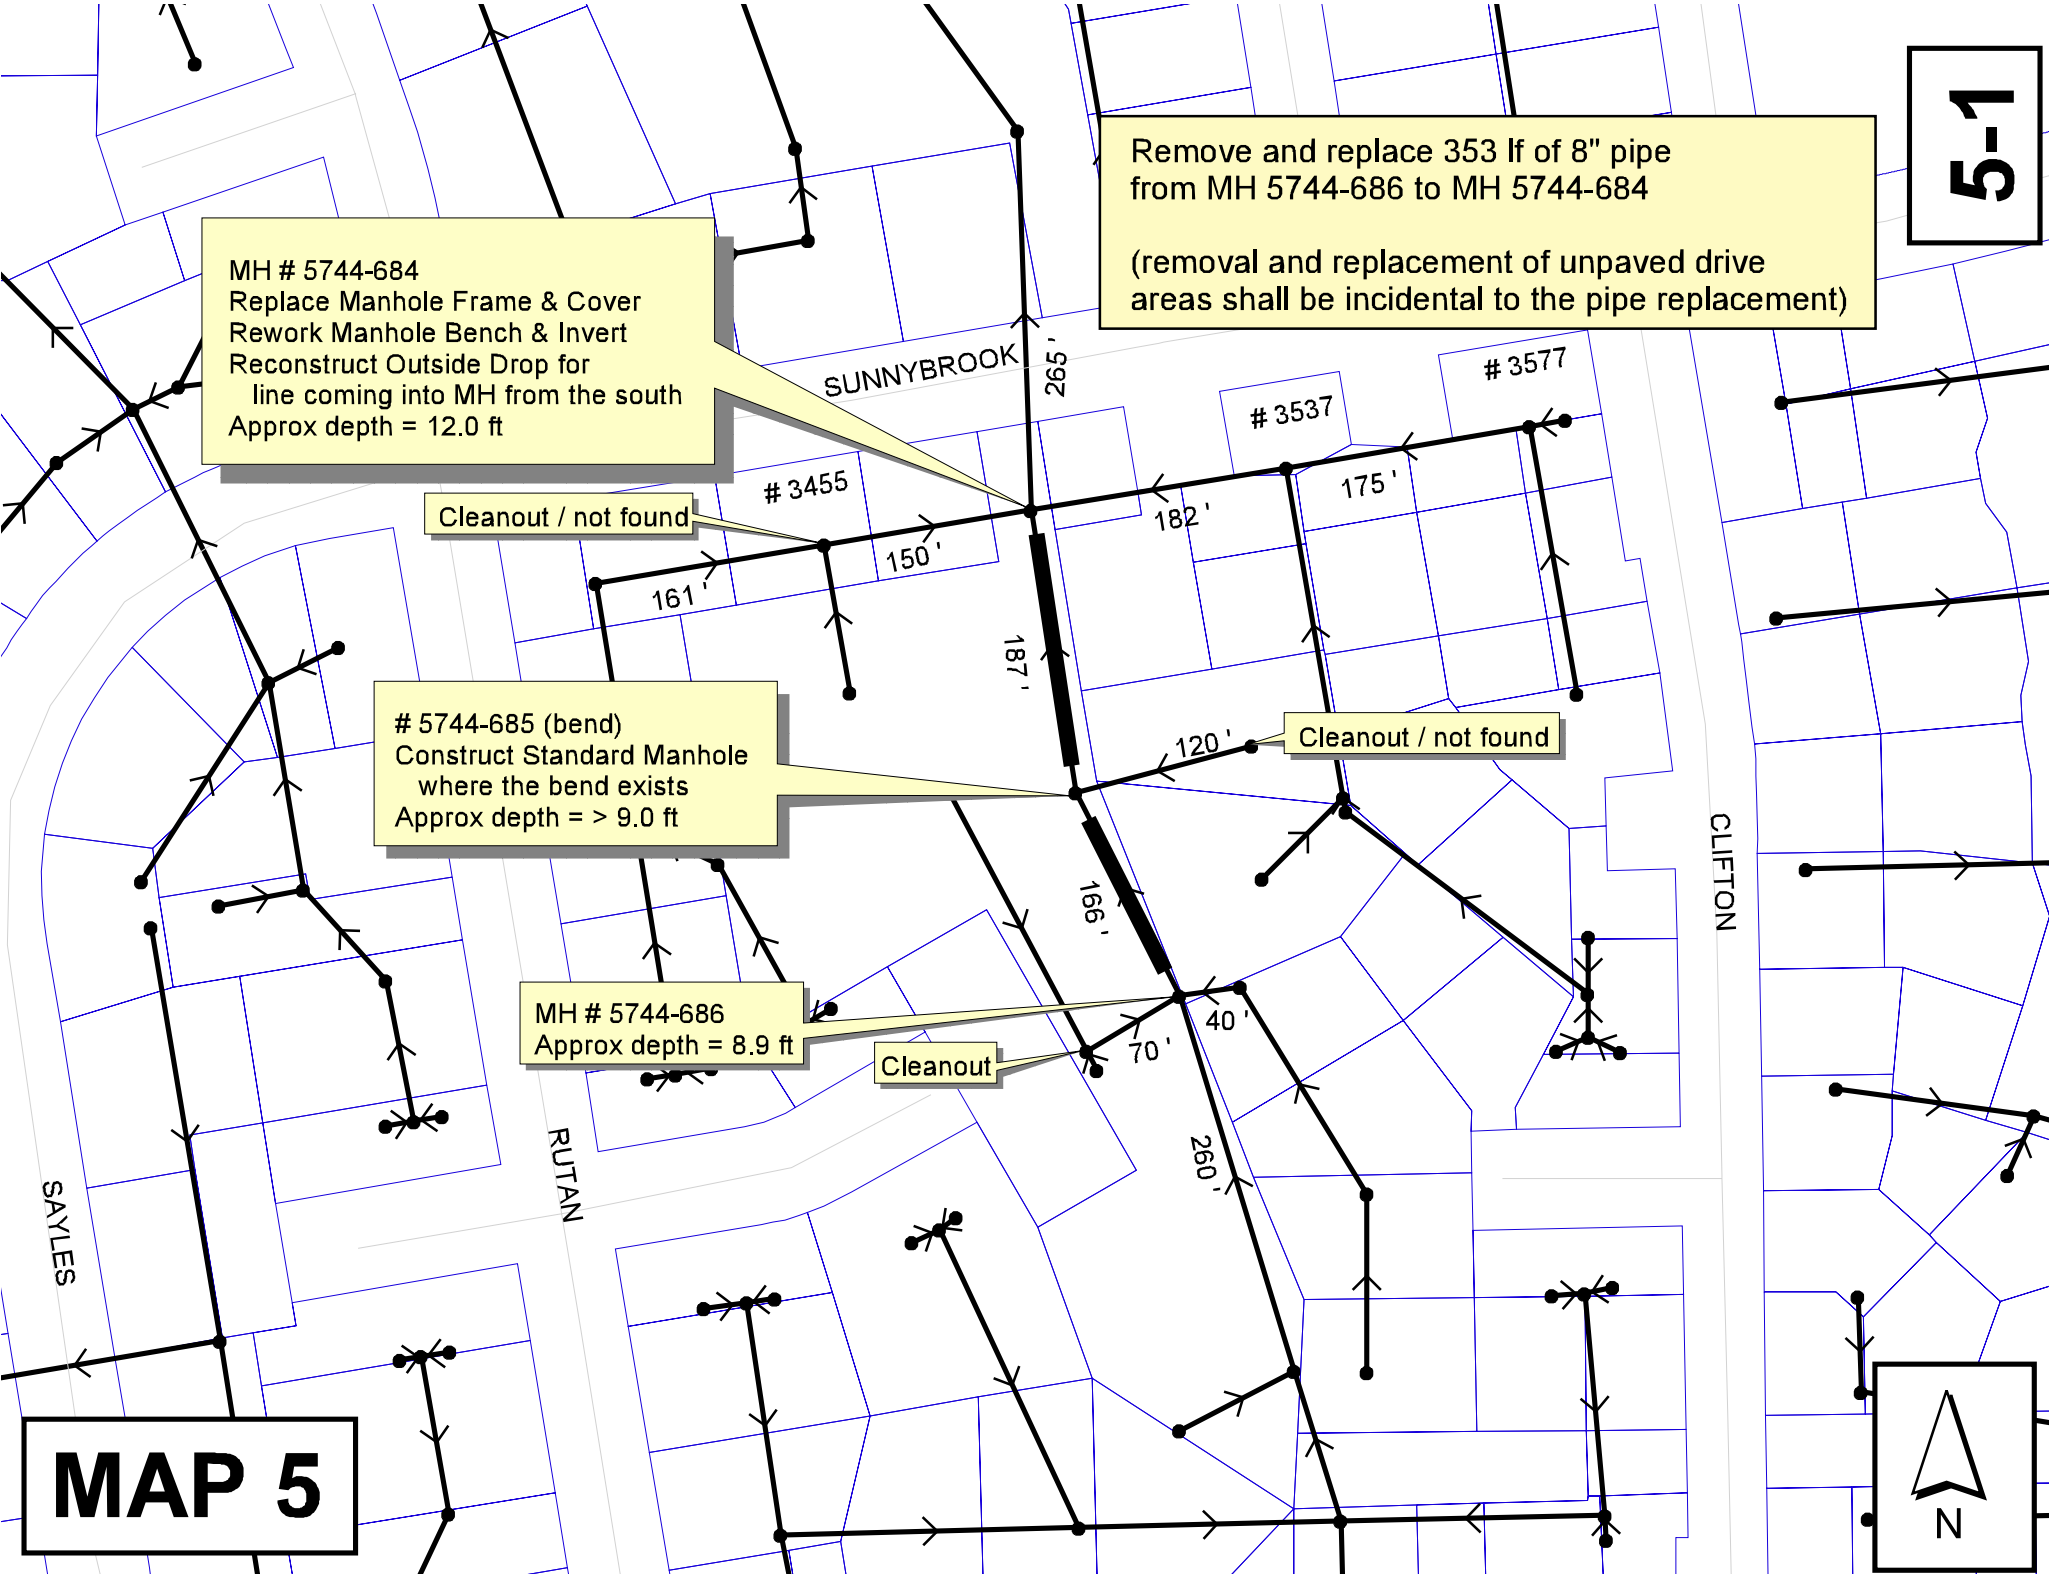
5-2

5744-685 (bend)
Construct Standard Manhole
where the bend exists
Approx depth = > 9.0 ft

MH # 5744-686
Approx depth = 8.9 ft

Cleanout / not found

Cleanout

(removal and replacement of unpaved drive
areas shall be incidental to the pipe replacement)
